HISTORIC BUILDING SURVEY:
THE GEORGE HOTEL, DUKE STREET, SOUTHPORT, MERSEYSIDE
(Updated)

Planning Reference: pre-application
NGR: SD 33951 15902
AAL Site Code: SODS 22
OASIS Reference Number: allenarc1-507147

By
Allen Archaeology Ltd
Report Number AAL 2022038

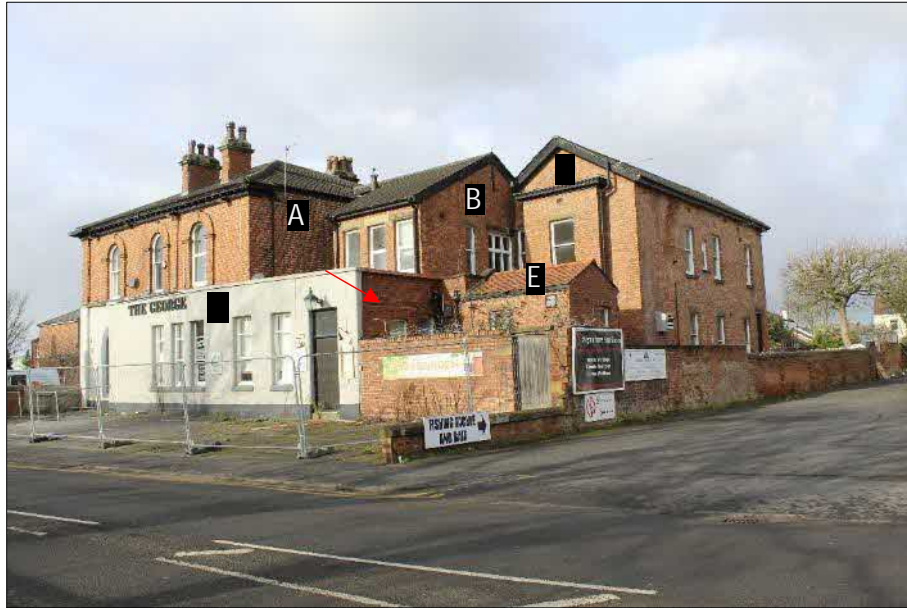
- 6.1 The George Hotel is made up of five contiguous structures (Figure 2, Plate 1). The main, two-storey hotel and restaurant (A) is L-shaped in plan with a northeast-southwest wing to the north. It has a two-storey, northeast-facing annex (B). Both the annex and the adjacent north wing (of A) are abutted by a two-storey, northwest-southeast wing (C) to the northeast. Along the southeast elevation of the main hotel, is a single-storey, southwest-northeast pub extension (D) which is joint to a single-storey toilet block (E) situated on the southeast corner of the overall hotel complex. The following section will give an account of the exterior followed by an interior description.

Plate 1 (shot 16): General view of the George Hotel, showing its various extensions. Arrow points to raised roof or incorporating earlier structure into a new extension. Looking west-northwest

- 6.5 The ground floor of the southwest elevation also has paired, rounded windows, each in a flat roofed bay. The ground floor including the bay windows and arches, the porch facing Duke Street and the modern ground floor extension (D), are rendered and painted grey. The northeast elevation of Extension D shows a raised roof line or having incorporated an earlier elevation into its structure (Plate 1).

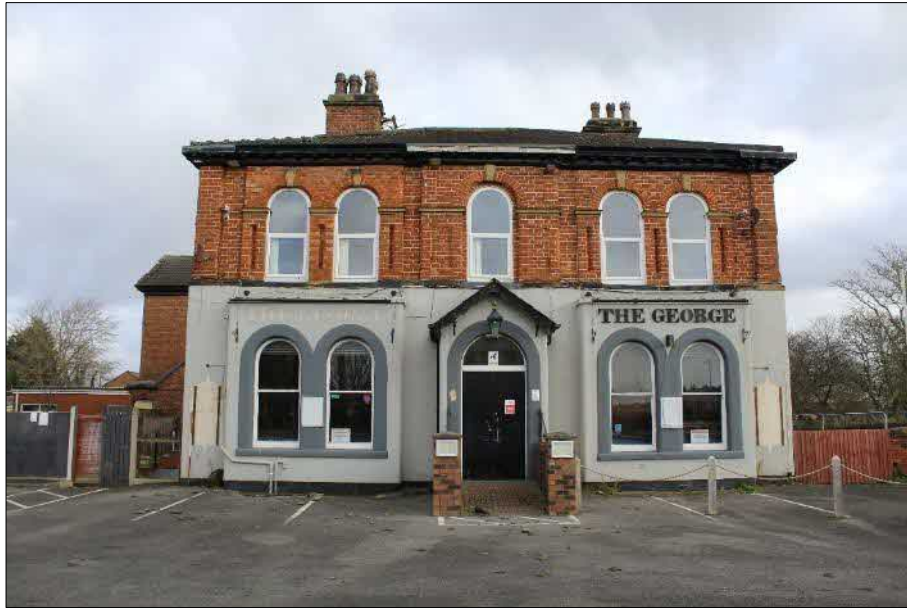
Plate 2 (shot 2): View of five-bayed front elevation. Looking northeast, 2m scale

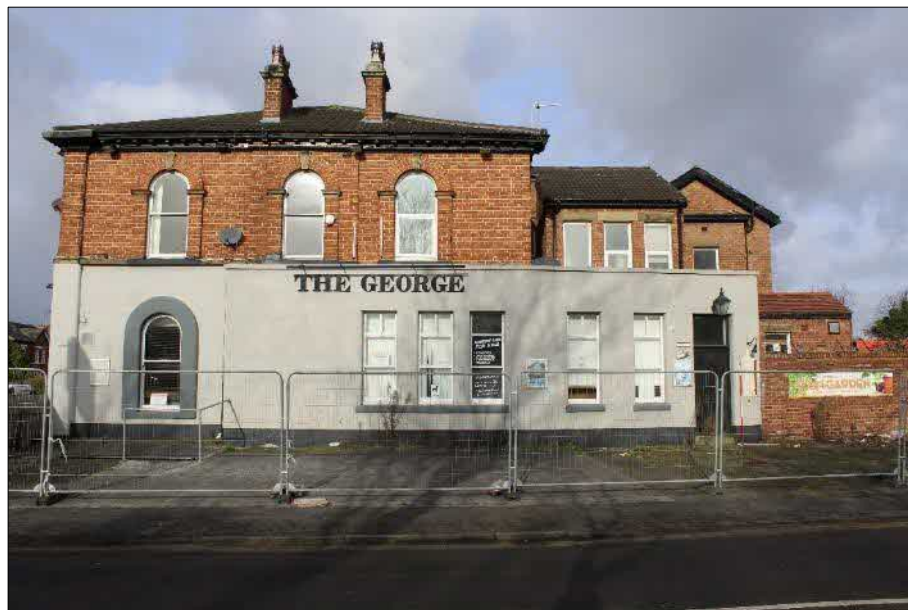
Plate 3 (shot 15): Southeast elevation with a later, ground floor extension carrying the signage. Looking northwest, 2m scale

- 6.6 The single storey, six-bay flat roof extension facing Cemetery Road has five tall, horned sash windows in late 19th century, Queen Anne style and a door with a transom window at the northeast end (Plate 3).

- 6.7 The two-storey annex (B) has a double pitched gabled roof covered in concrete pantiles. The southeast elevation (Plate 3) displays later sash windows with frosted glass and all have stone lintels, as do the similar styled sash windows on the northeast elevation (Plate 5). Stretcher bond has been used throughout.

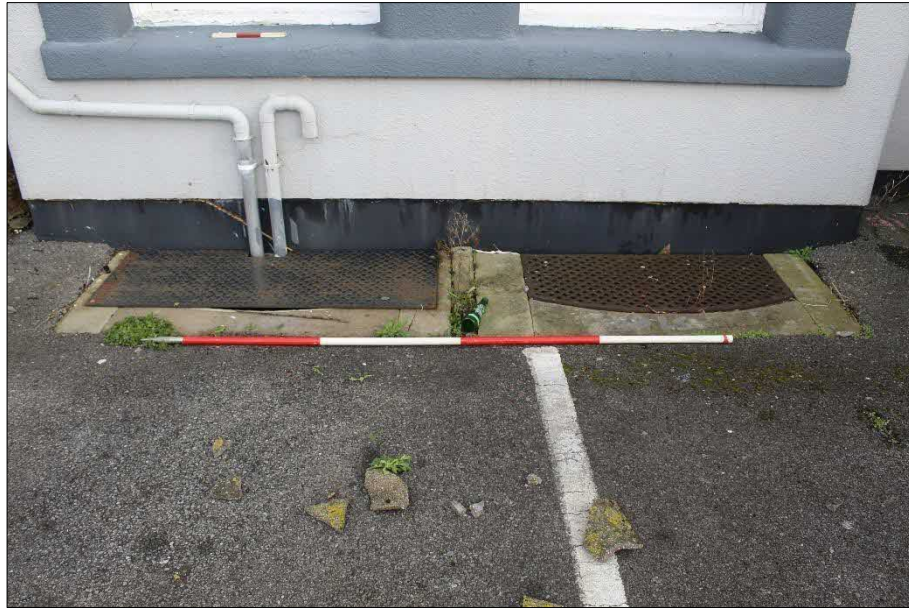
Plate 4 (shot 3): Capped off cellar lights. Looking northeast, 2m scale

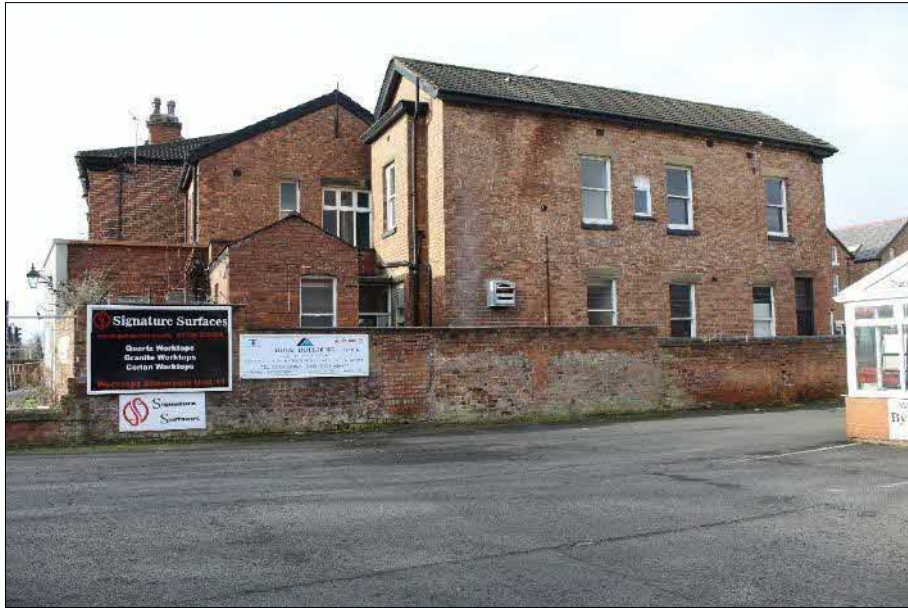
- 6.8 The two-storey northeast wing (C) has a similar brick stock to the adjacent annex (B) and is also built in stretcher bond (Plate 5). The double pitched gabled roof is covered in concrete pantiles. It has a shallow, projecting two storey bay window on the southeast elevation, with a chamfered stone lintel above. On the first floor is a horned sash window with no glazing bars. This type of window is repeated on the northeast elevation with three sash windows on each floor and with a smaller window with soldier arch on the first floor, and a doorway with large transom window on the ground floor towards the northeast corner. There are no windows to the southeast where the chimney breast is located. The stacks have been removed from both the southeast corner and towards the north apex of the roof.

Plate 5 (shot 17): General view of the northeast elevations. Looking west-southwest

- 6.9 The toilet block (E) is best seen from the northeast (Plate 5). It is a small, single-storey structure with double pitched gabled roof covered in concrete pantiles. The probably reused handmade bricks are laid in a stretcher bond. There are horned sash windows on the southeast and northeast elevations under a segmental brick arch.
- 6.10 The northwest elevations face a yard/garden. A moulded cornice on the northeast wing (C) creates a pediment on the northwest gable. A horned sash window under a segmental brick arch is seen on the ground floor (Plate 6).

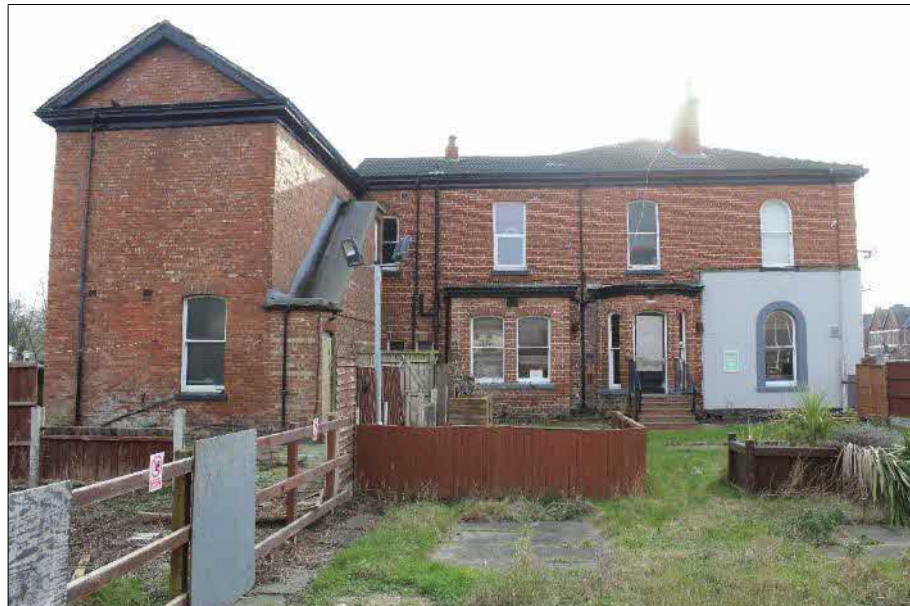
Plate 6 (shot 22): General view of the northwest elevations and yard area. Looking southeast

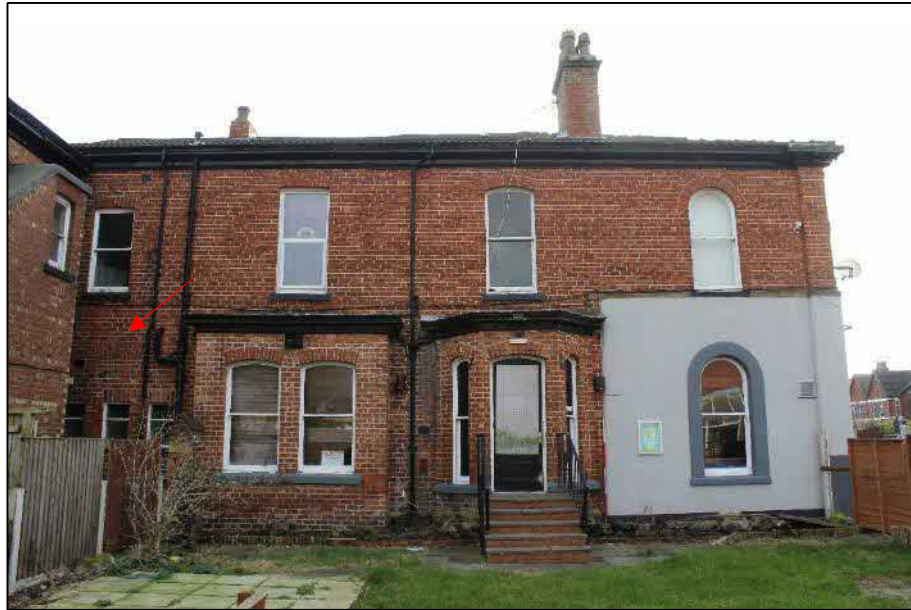
- 6.11 The northwest elevation of the main hotel has a canted bay window with entrance, on the second bay from the southwest (Plate 7). To the northeast, is a shallow, square bay, which is a later addition. The majority of windows follow the same style as seen on the northeast wing, being

horned sash windows under a segmental brick arch. However, this elevation also has round headed windows on the southwestern bay and a first floor window on the third bay, under a gauged brick arch. A similar opening has been bricked up on the ground floor at the northeast corner. It has been replaced by three, small, windows with top opening casements, each under a soldier brick arch.

Plate 7 (shot 23): Close up of northwest elevation of the main hotel structure (A). Arrow points to blocked opening. Looking southeast, 2m scale

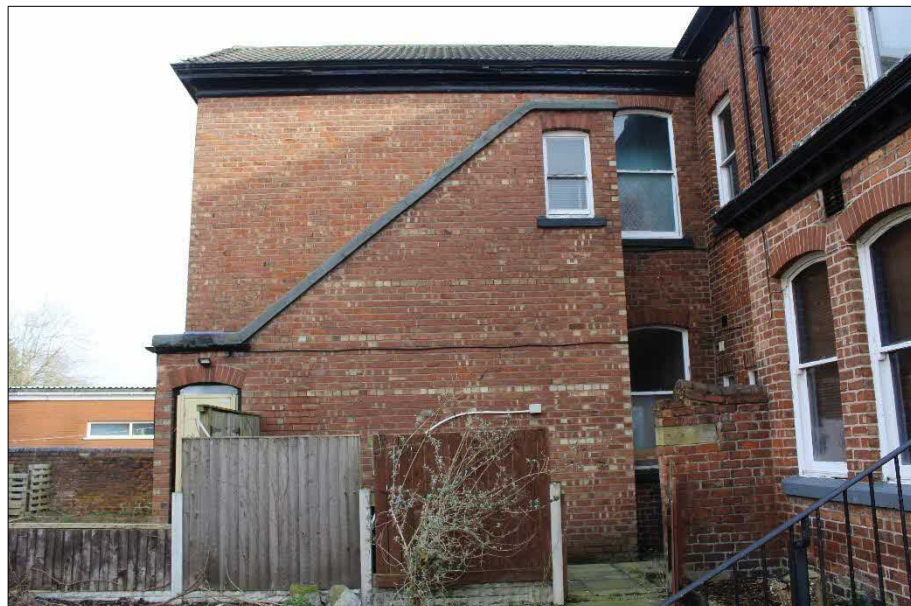
6.12 A later two-storey staircase has been added to the southwest elevation of the northeast wing (Plate 8).

Plate 8 (shot 34): View of added staircase to the southeast wall of the northeast wing. Looking northeast

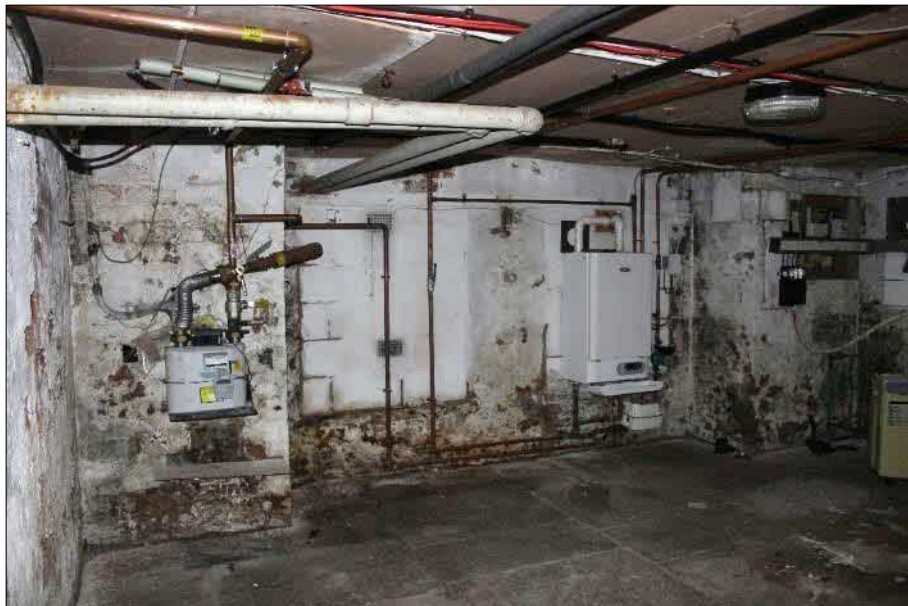
6.16 Two bricked up former cellar windows and a fireplace were noticed in A.01 (Plate 9-Plate 10). This room may have served as the original kitchen/scullery.

Plate 9 (shot 162): General view of southwest cell (A0.1), showing two blocked cellar windows on the southwest wall. Looking west-southwest

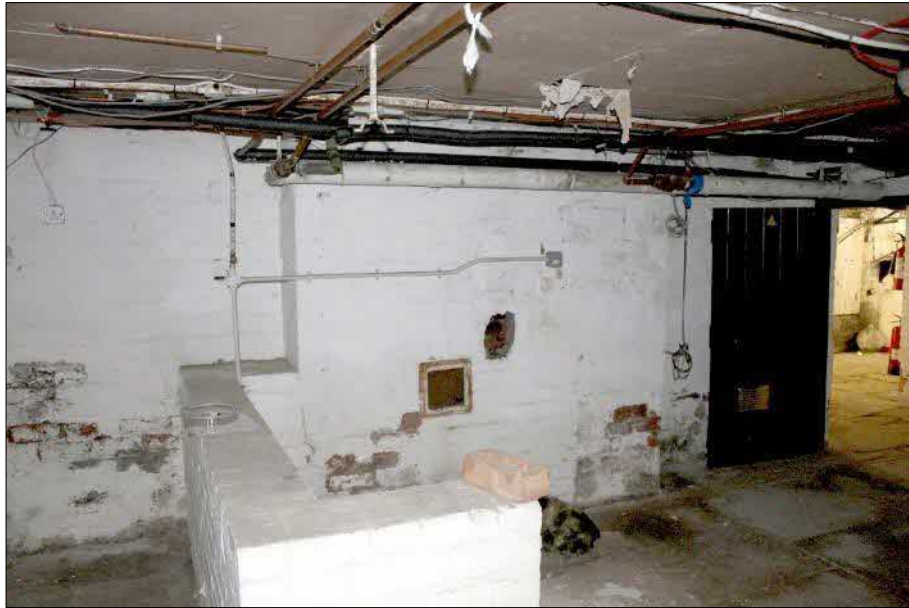
Plate 10 (shot 164): Bricked up fireplace on the northeast wall in A0.1. Looking east-northeast

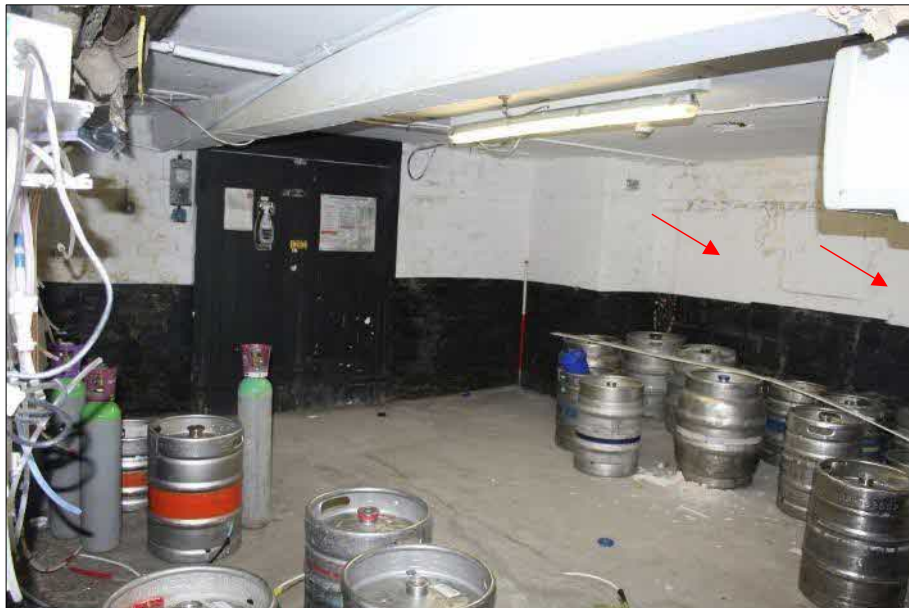
- 6.17 Beer kegs and drinks dispensary fittings partially covered the floors and walls in Cell A0.2 (Plate 11). Concrete covered what is likely to be a stone flag floor. As in A0.1, blocked cellar openings were present in A0.2 on the southwest wall (Plate 11). The southeast wall has a double door through which the kegs are delivered from the ground level above.

Plate 11 (shot 156): General view of A0.2 with bricked up openings on the southwest wall, see arrows. Looking southwest

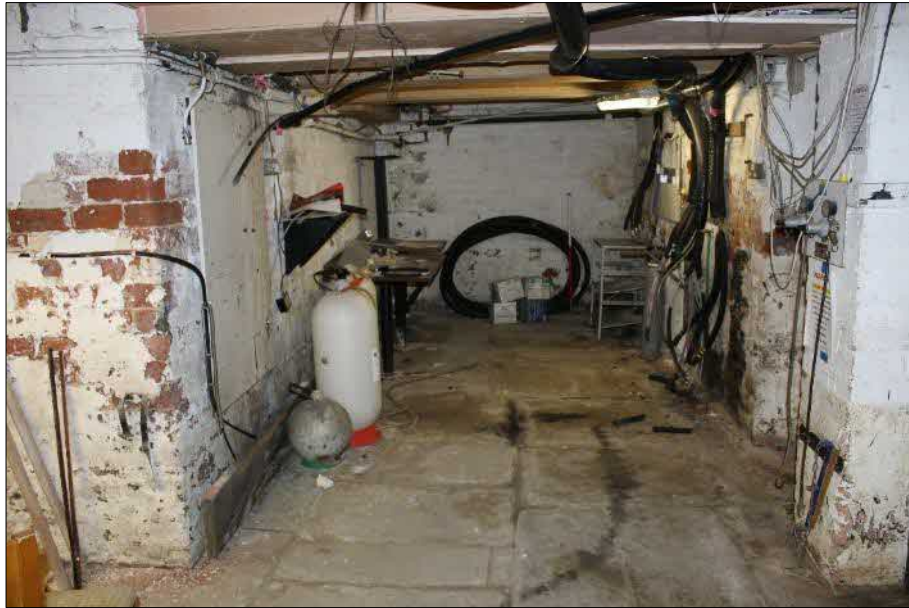
- 6.18 Cell A0.3 is open to and acts as the terminus of the L-shaped corridor, various pipe fittings cover the ceiling and walls (Plate 12).

Plate 12 (shot 153): General view of cell A0.3. Looking southeast, 1m scale

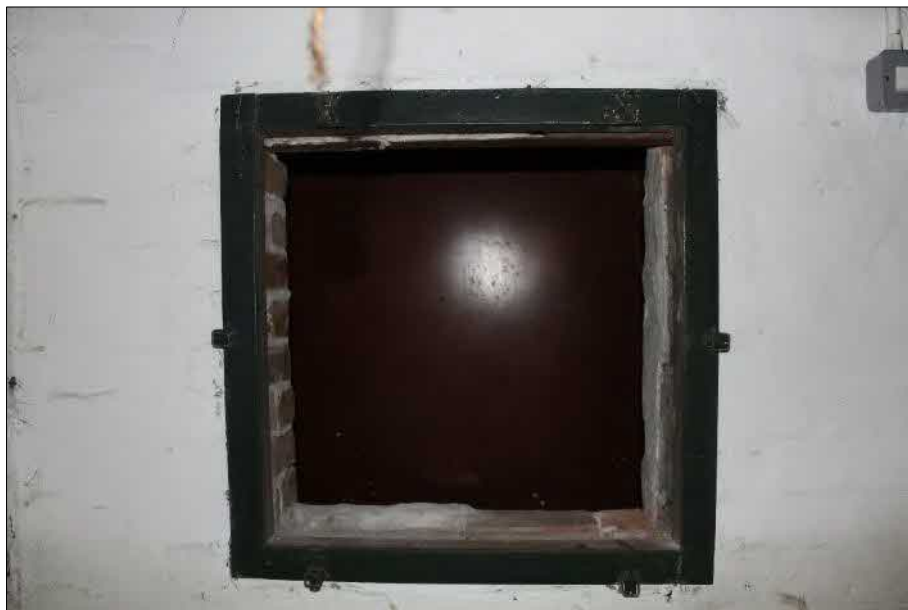
- 6.19 A blocked possible former dumbwaiter is located on the southwest wall between C1 and C2 (Plate 13). Should this be the case then some walls have been removed from the ground floor above as it would have required supporting walls for the lift shaft.

Plate 13 (shot 166): Possible former dumbwaiter. Looking southwest

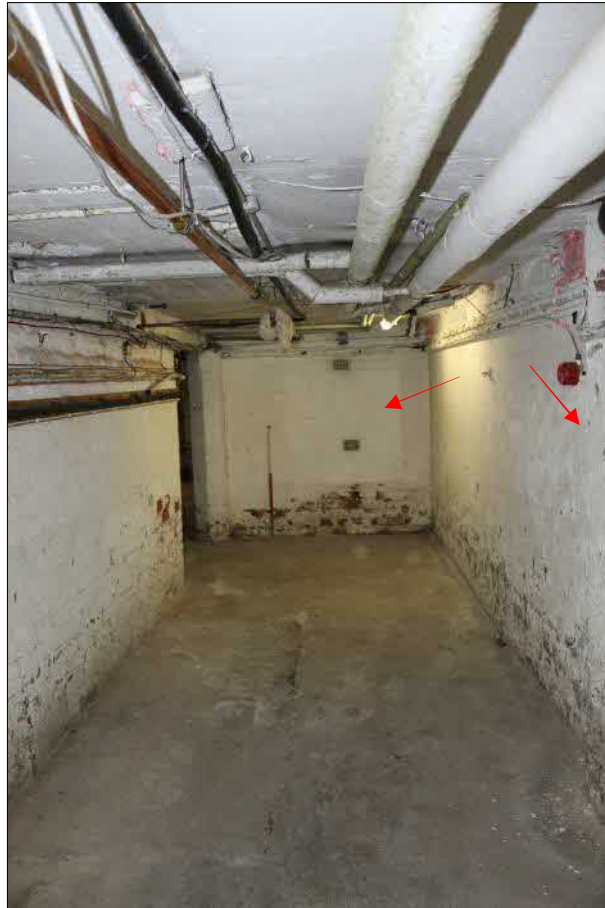
- 6.20 A former cellar entrance has been blocked on the southeast wall, as has a window on the northeast wall of the corridor before the return to the northwest where it terminates in Cells C0.1-C0.3 (Plate 14). The access stairs from the ground floor are also located in here. The floor is covered in concrete and the walls and ceilings are white painted. There is a slight downward slope from northeast to the southwest in the corridor.

Plate 14 (shot 150): View of cellar corridor, arrows point to blocked openings. Looking northeast, 1m scale

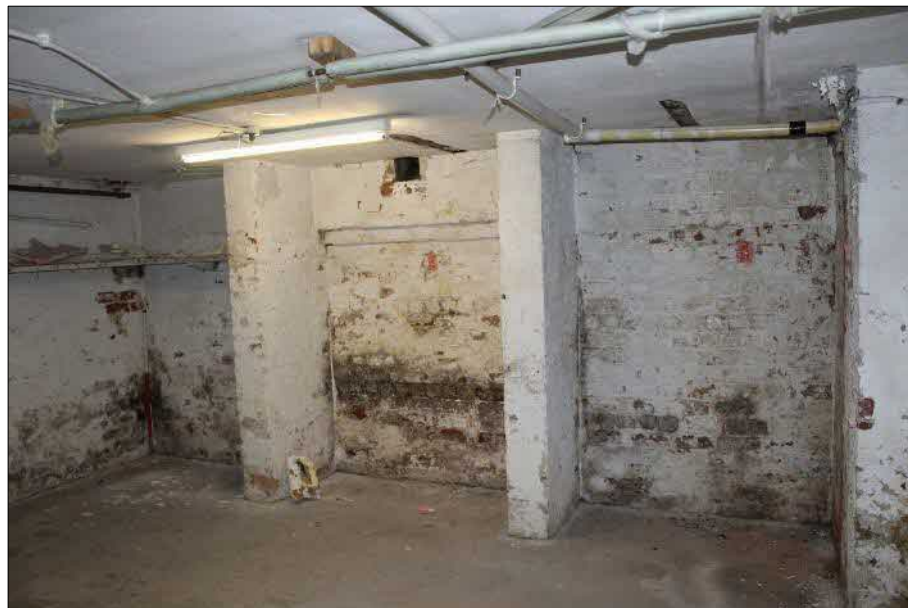
- 6.21 Cell C0.1 has two side walls from a removed fireplace along the northeast wall (Plate 15) and two blocked openings on the southeast wall (Plate 16).

Plate 15 (shot 145): General view of Cell C0.1 Looking northeast, 1m scale

- 6.32 In the northeast wing is a modernised kitchen with tiled walls and concrete floor (Plate 31). The original chimney breast has been removed as indicated by the removed fireplace found within the cellar directly below (Plate 15).

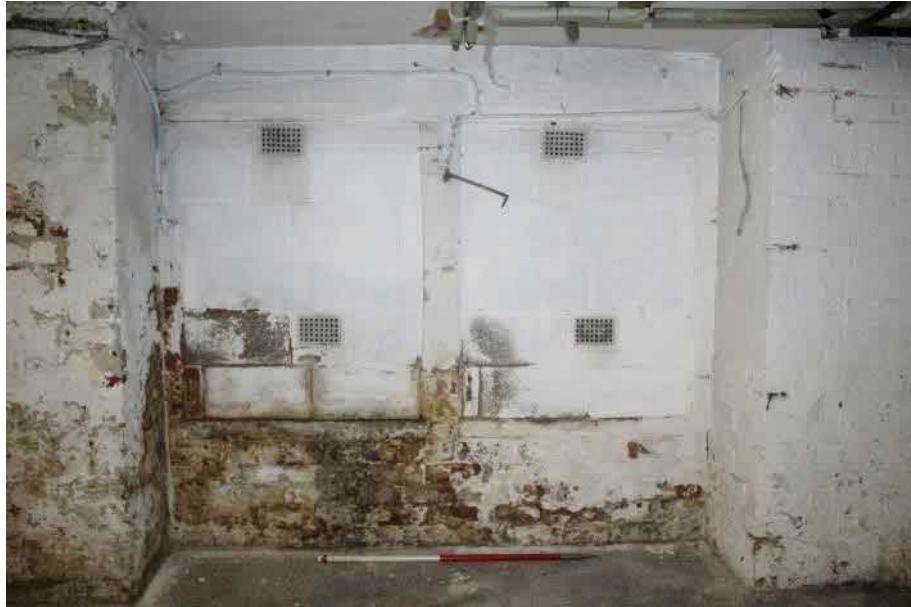
Plate 16 (shot 146): Blocked openings on the southeast wall. Looking southeast, 1m scale

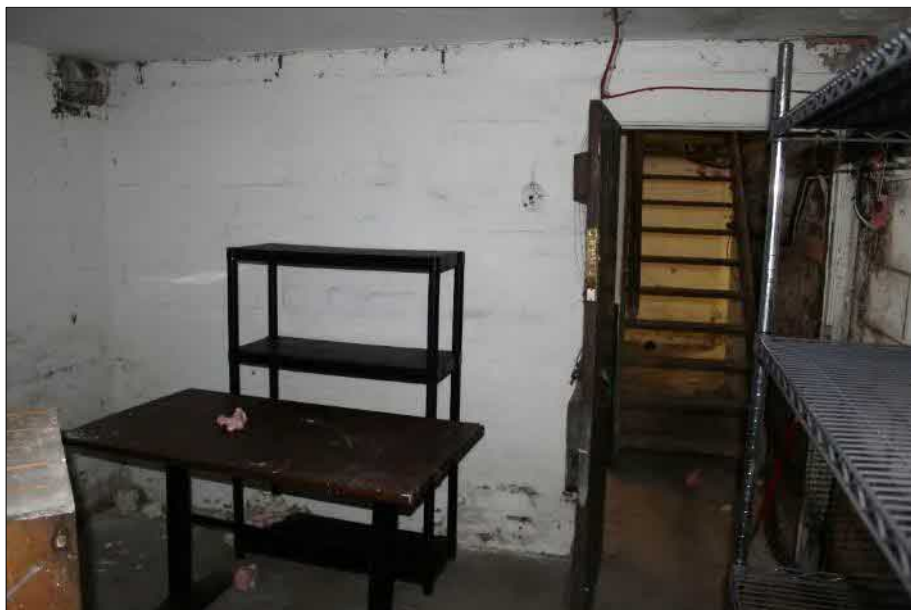
Plate 17 (shot 169): General view of Cell C0.2, looking southeast

- 6.22 The adjacent cells C0.2 and C0.3 have recently been used as storage facilities with cell C0.3 containing a blocked cellar light (Plate 17, Plate 18).

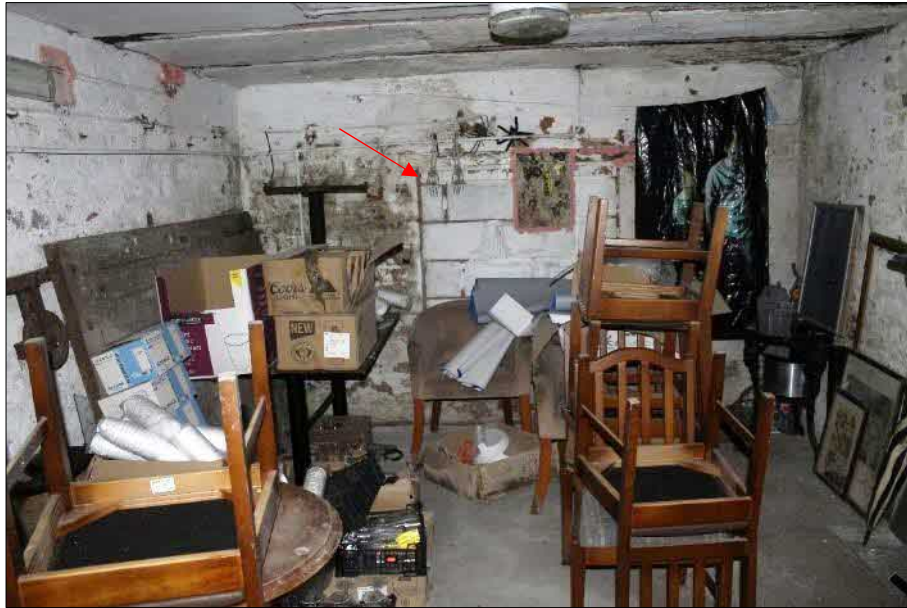
Plate 18 (shot 167): General view of Cell C0.3 with a blocked opening on the northwest wall (see arrow). Looking northwest

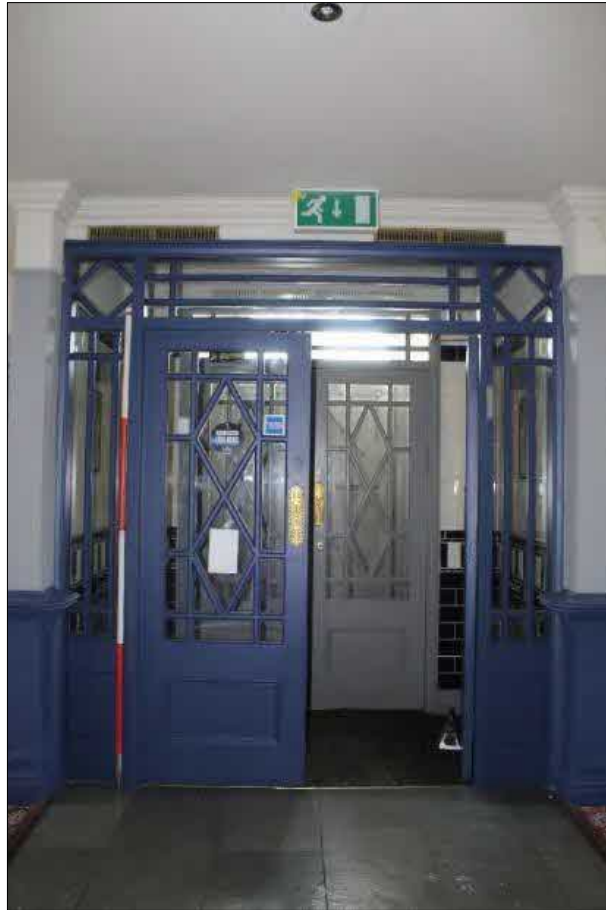
- 6.23 The main entrance leads through two sets of double doors with large glass panels with geometrical tracery (Plate 19). The entrance area between the two sets is covered with white and black tiles (of modern date).
- 6.24 The floors are either covered in modern tiles or carpets.
- 6.25 The main bar and restaurant area is largely open plan. A canted L-shaped bar with fluted and raised field panelling, is positioned along the partition wall between Lounges 2 and 3 and could be of from the 1940s (Plate 20, 7.107.0). Modern panelling over the bar has been fitted with tv screens.

Plate 19 (shot 121): Main entrance from Duke Street. Looking southwest, 2m scale

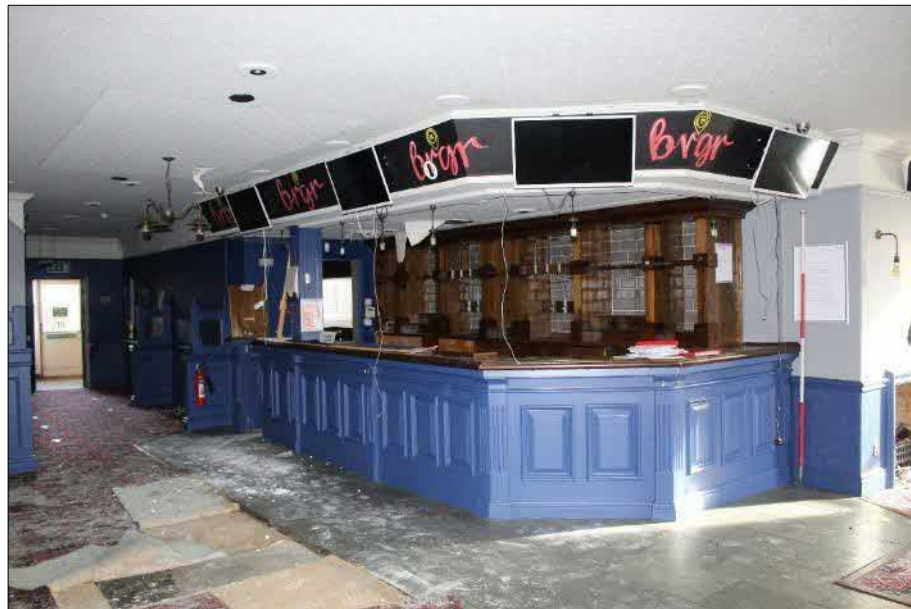
Plate 20 (shot 115): General view of the main bar. Looking east-northeast

- 6.26 The panelled dado seen throughout this area matches the bar and is likely to be contemporary. Earlier and original features of likely represented by the picture rails, cornices and fireplaces (Plate 21). A fireplace has been retained but modernised in Lounge 1 on the northeast wall.

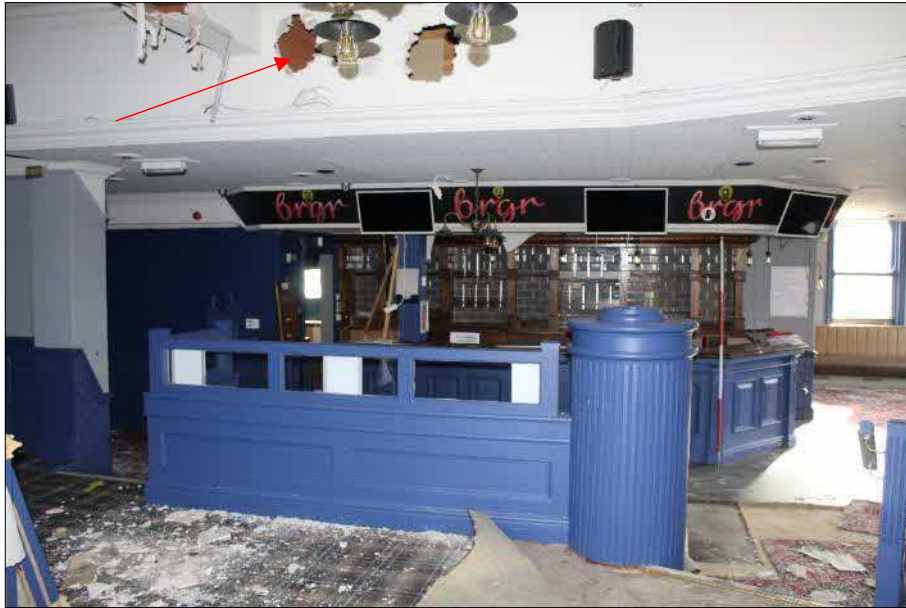
6.27 Evidence for a removed staircase was seen in the ceiling of Lounge 1, where a hole in the plasterboard shows a moulded timber resembling that of a closed string on a staircase (Plate 23-Plate 24). It is highly likely the long corridor which runs through the centre of the building, once offered access to the first floor via a flight of stairs but has since been removed.

Plate 23 (shot 113): View from Lounge 1, arrow points to possible closed string of a former staircase. Looking southeast, 2m scale

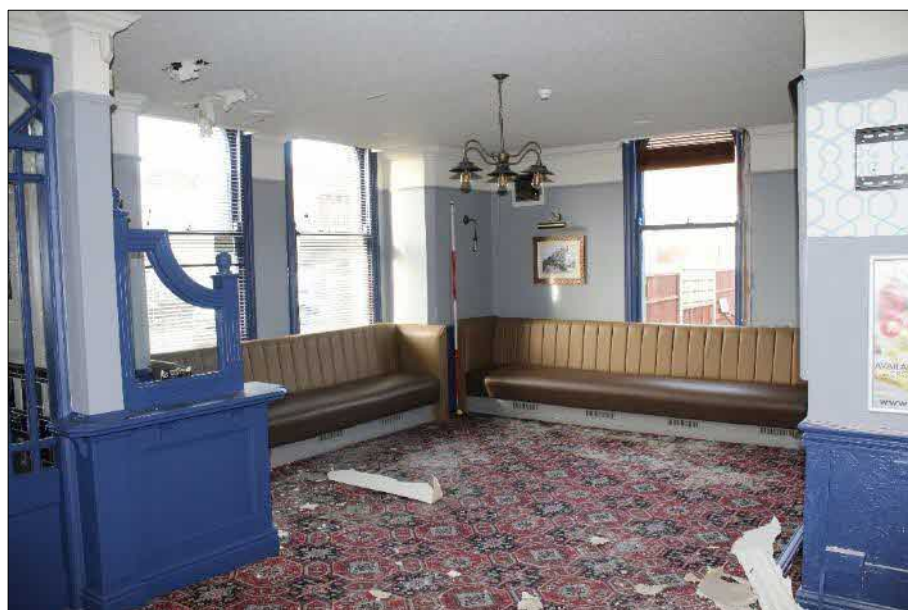
Plate 26 (shot 122): General view of Lounge 2. Looking west-northwest, 2m scale

6.29 Most of the walls have modern bench seating fitted (Plate 26, Plate 27).

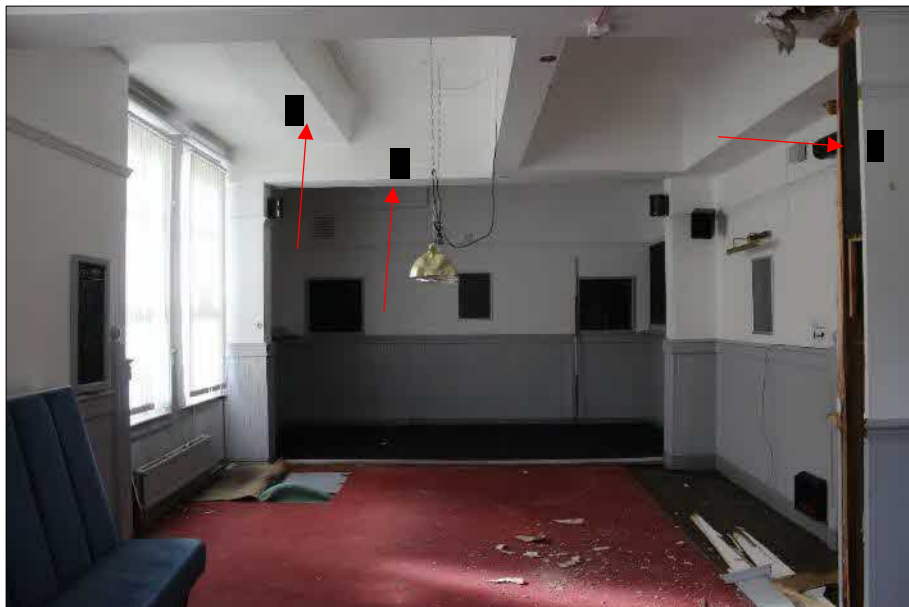
- 6.30 Large parts of Lounge 3 represent a later addition (D) and has of late functioned as a pool room (Plate 28, Plate 29). The upper part of removed walls (a-c) prompted by the later extensions to the lounge to the southeast and northeast are still present. The southeast wall (a) was once the exterior wall of the hotel, presumably there was a doorway in wall (b). The extension allowed for two new windows along the southeast wall. When D was constructed or shortly thereafter access was created by removing the former exterior northeast wall (c) and a column has been added for extra support (Plate 29). The modern timber plank panelling on the walls differs from that seen in Lounge 1 and 2, but an earlier vaulted ceiling has remained. An entrance has also been added to the southeast corner.

Plate 28 (shot 130): General view of Lounge 3. Arrows point to locations of removed walls
Looking southwest, 2m scale

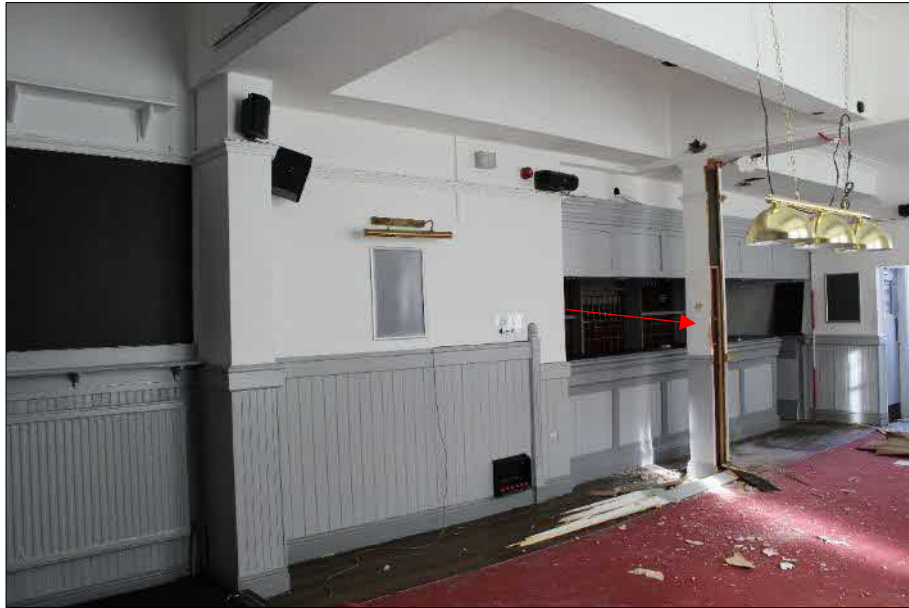
Plate 29 (shot 134): General view of Lounge 3. Arrow point to supporting column. Looking north-northeast, 2m scale

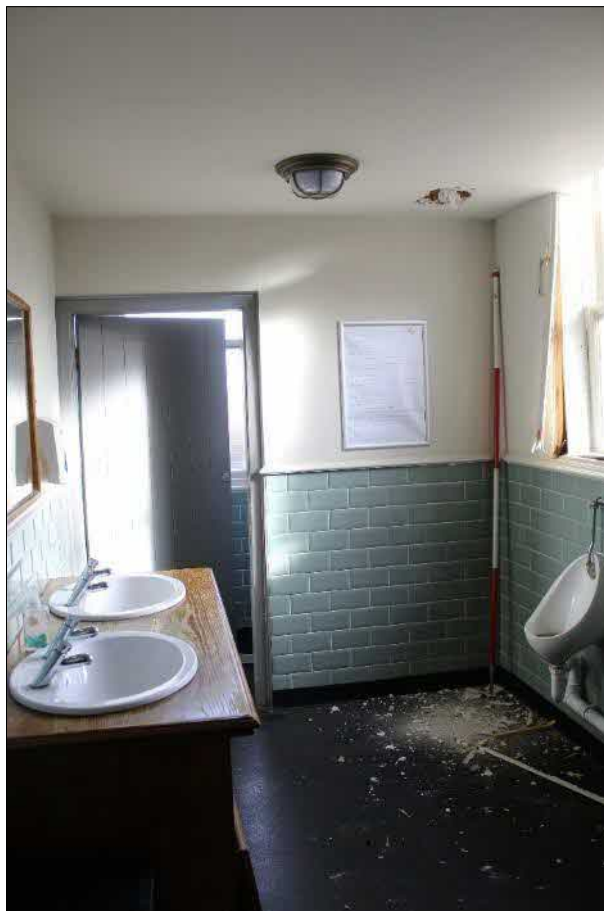
Plate 30 (shot 140): General view of the toilet block E. Looking northeast, 2m scale

- 6.31 The toilet block E, situated in the northeast corner of the site, can be accessed from Lounge 3 via a short corridor, and has been modernised throughout (Plate 30). The same goes for the former ladies' toilets situated northeast of Lounge 1. Adjacent to toilet block is a later added fire escape.

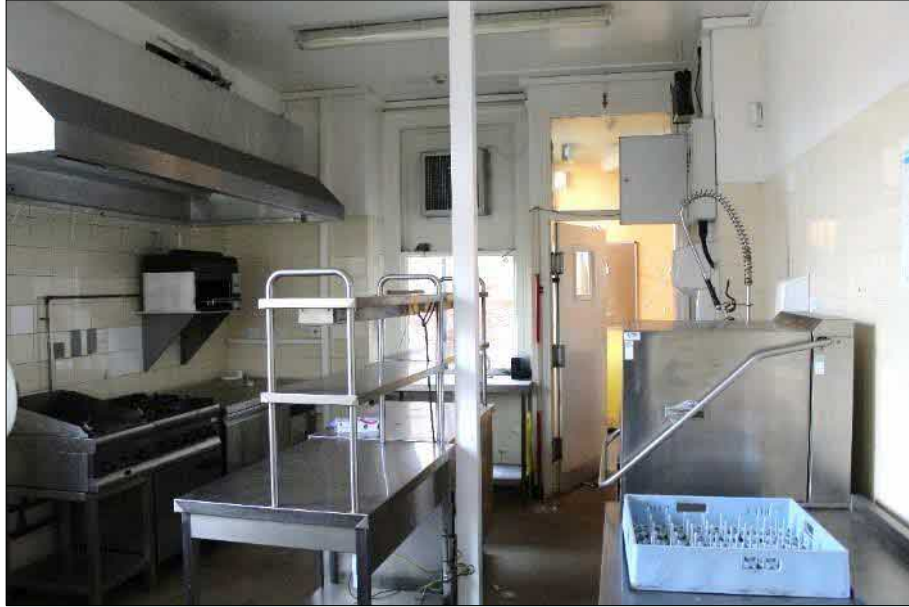
Plate 31 (shot 102): General view of the kitchen. Looking southeast, 2m scale

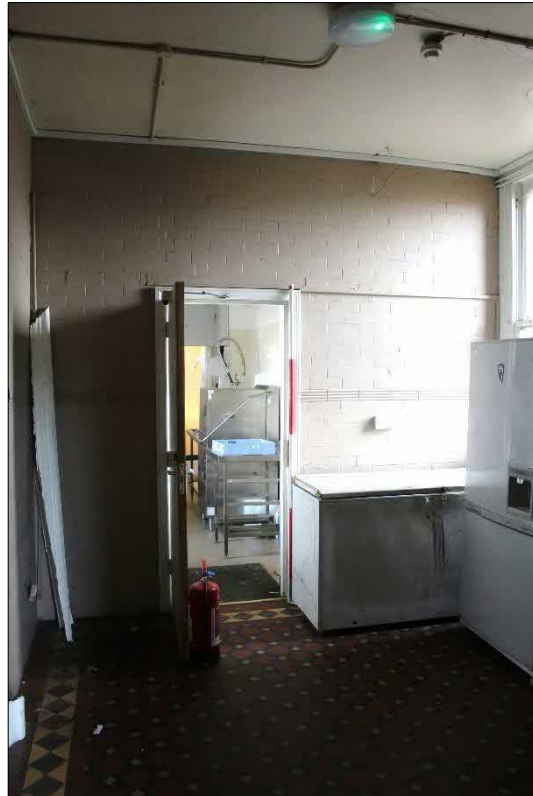
Plate 32 (shot 97): General view of the pantry. Looking southeast, 2m scale

- 6.33 On the northwest wall of the kitchen is a doorway leading to the pantry, and through that, the scullery. The pantry has an Edwardian style geometric tiled floor in red, black and ochre (Plate 32). Most rooms to be found tiled in the Edwardian period were the hallways and service rooms (Yorke 2008, 77). The staircase to the first floor is accessible via the adjacent scullery and the hotel yard. Apart from the floor, the pantry and the scullery were devoid of any architectural features of note (Plate 33). The fireplace in the scullery has been removed but the hearth remains below the sink.

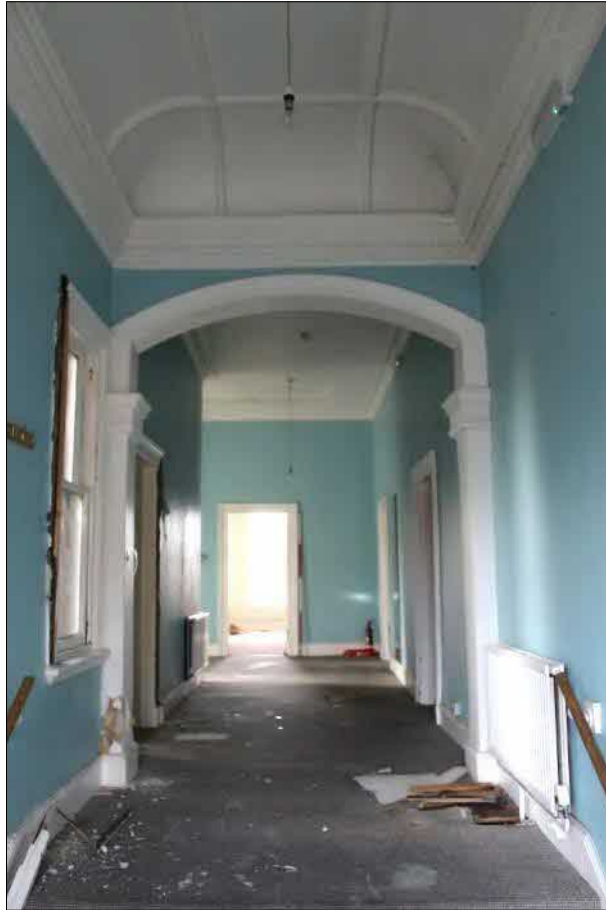
Plate 34 (shot 62): General view of the first floor corridor of the main hotel. Looking southwest, 2m scale

- 6.34 The entire first floor is accessible via the stairs in the northeast wing, although it is likely the main building once had a staircase towards the southwest to access the first floor and the broad central L-shaped corridor (Plate 34).

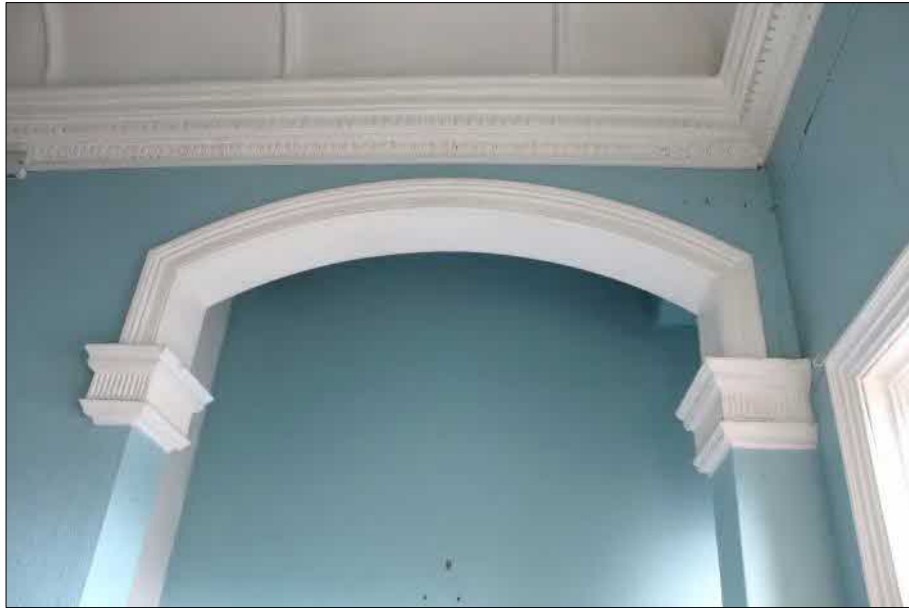
Plate 35 (shot 67): Close up of moulded architectural features with egg and dart motif and dentil above on the cornice and reeding on the corbels. Looking northwest

- 6.35 The corridor is in an ornate Italianate style. The décor shows thick moulded cornices, depressed arches over pilasters and vaulted, plastered ceilings (Plate 35). The cornices display mouldings of a repeated egg/dart motif as well as dentilation. Corbels as well as capitals on the pilasters have reeded mouldings (Plate 35). The majority of doors on this floor are typical four-fielded Victorian doors with moulded architrave.

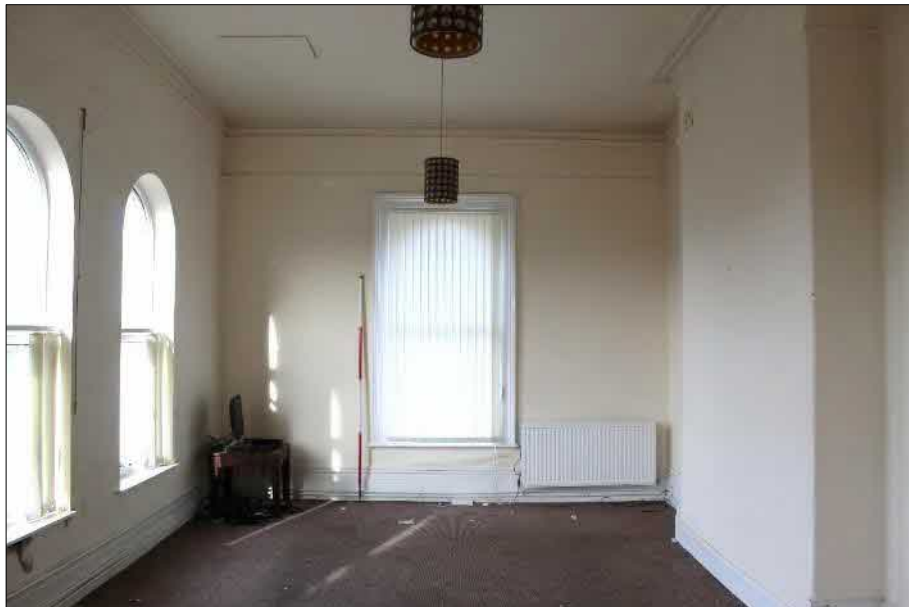
Plate 36 (shot 86): General view of room 1.1 with blocked fireplace to the right and later skirting board. Looking northwest, 2m scale

- 6.36 The two rooms facing Duke Street (1.1-1.2) are large and each has a chimney breast with blocked fireplace on the northeast walls. Both rooms have retained some early features such as moulded covings and picture rails. Broad, early skirting boards also survive in room 1.1 with later, narrower skirting in front of the blocked fireplace and in 1.2 (Plate 36, Plate 37). As architectural details such as these were reserved for the best rooms, both rooms 1.1 and 1.2 are likely to originally have functioned as lounges rather than bedrooms.
- 6.37 Adjacent to room 1.2, is a much smaller single bedroom or office 1.3 (Plate 38). It faces Cemetery Road and lacks the picture rail seen in the larger rooms and the covings, although moulded, are not as deep.

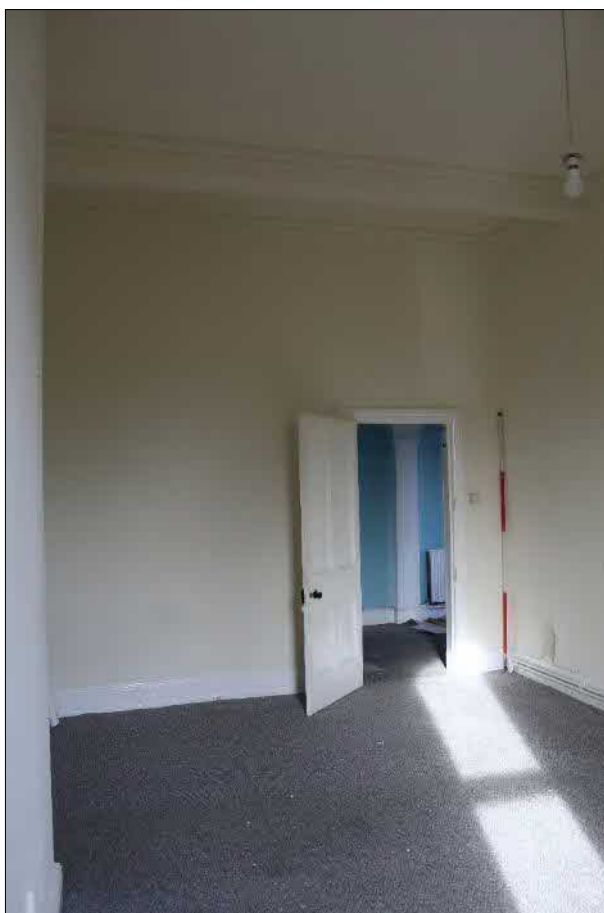
- 6.38 Bedroom 1.4 also faces Cemetery Road. The covings in this room are narrower but stylistically similar to those seen in 1.1 and 1.2, there is however no picture rail. The skirting boards are the same as found in room 1.2. The fireplace has been blocked also in this room. In the ceiling, approximately 1m from the northwest wall, is a beam, which may suggest the room has been extended, probably in the 1940s (7.10). If so, then the architectural features seen in the corridor represent a later alteration.

Plate 39 (shot 69): Bedroom 1.4 showing an extra beam in the ceiling. Looking northwest, 2m scale

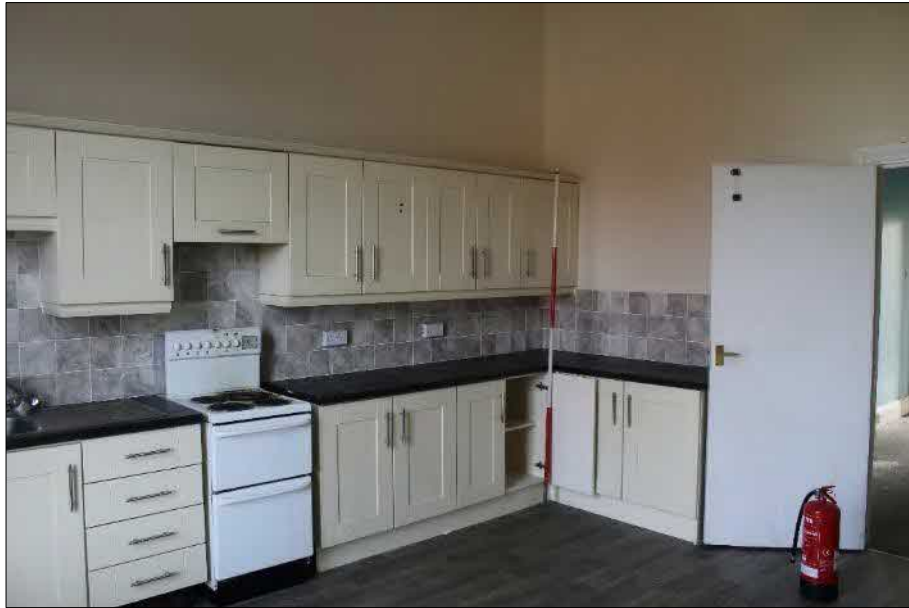
Plate 40 (shot 78): General view of modern kitchen in 1.5. Looking east-southeast, 2m scale

- 6.39 Former bedroom 1.5 facing the yard has of late been adapted as a kitchen, with modern fittings along the northeast and southwest walls (Plate 40). The door for this room is also modern. The covings and skirtings are the same as in room 1.3. A late Victorian fireplace has been retained on the southwest wall, but the flue has recently been boarded up (Plate 41, Plate 42). The hearth extends well beyond the width of the extant fireplace, indicating it is a replacement of a larger fireplace.

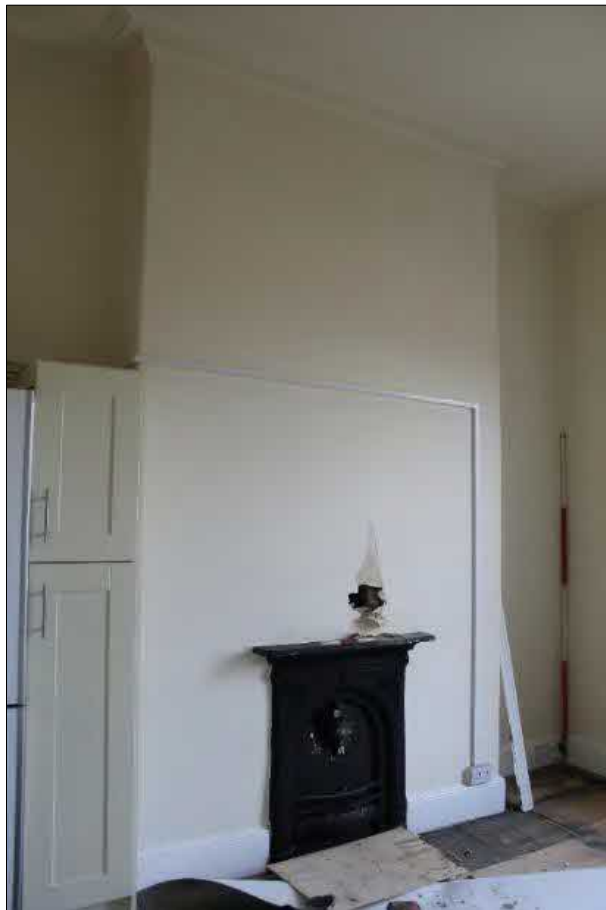
Plate 41 (shot 81): Retained fireplace along the southwest wall in room 1.5. Looking west-northwest, 2m scale
