HISTORIC BUILDING SURVEY:
THE GEORGE HOTEL, DUKE STREET, SOUTHPORT, MERSEYSIDE
(Updated)

Planning Reference: pre-application
NGR: SD 33951 15902
AAL Site Code: SODS 22
OASIS Reference Number: allenarc1-507147

By
Allen Archaeology Ltd
Report Number AAL 2022038

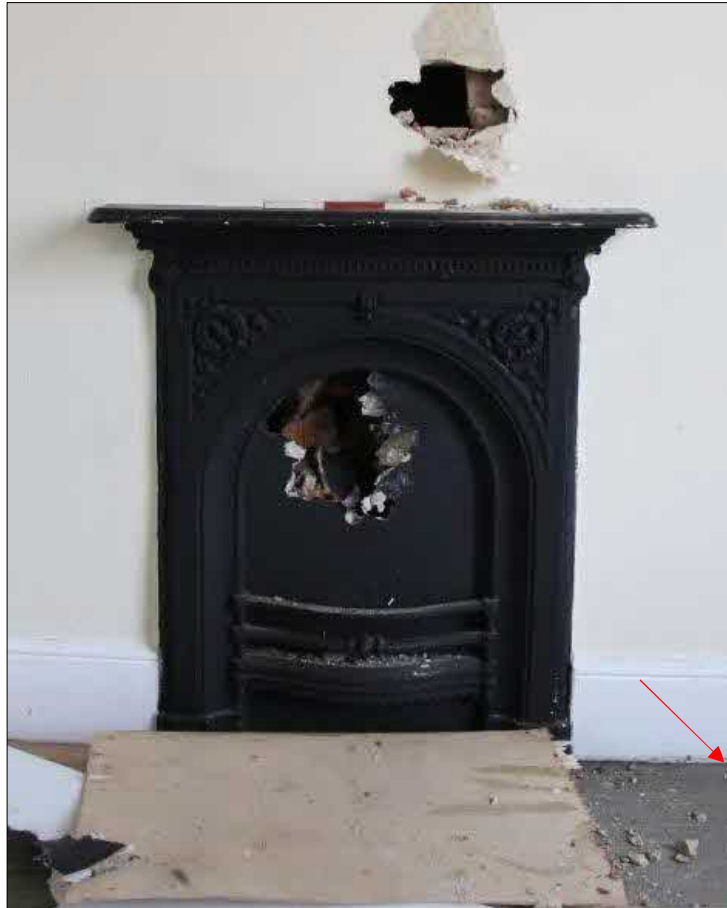
- 6.39 Former bedroom 1.5 facing the yard has of late been adapted as a kitchen, with modern fittings along the northeast and southwest walls (Plate 40). The door for this room is also modern. The covings and skirtings are the same as in room 1.3. A late Victorian fireplace has been retained on the southwest wall, but the flue has recently been boarded up (Plate 41, Plate 42). The hearth extends well beyond the width of the extant fireplace, indicating it is a replacement of a larger fireplace.

Plate 42 (shot 79): Close up of boarded up fireplace in 1.5. Arrow points to edge of hearth
Looking southwest, 0.3m scale

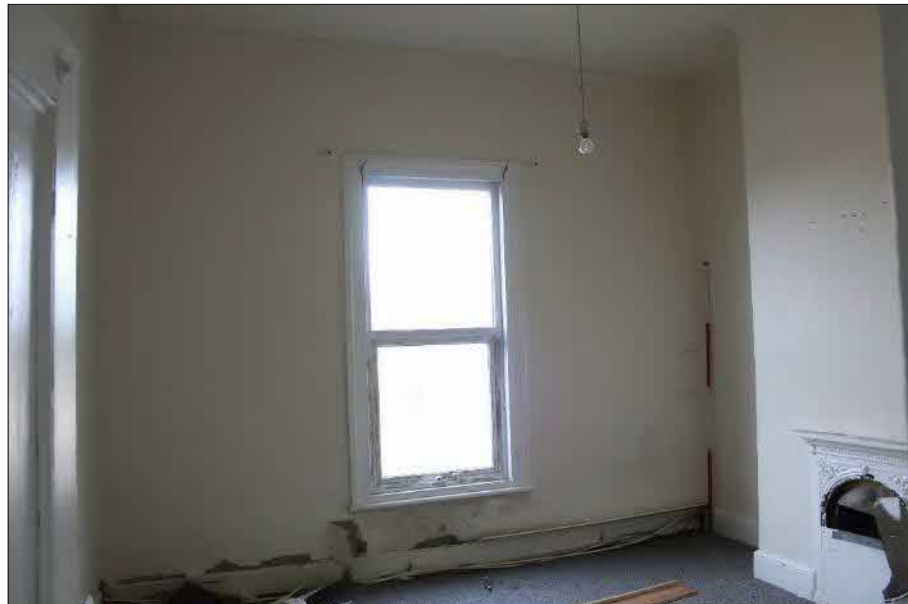
Plate 43 (shot 72): General view of bedroom 1.6, looking north-northwest, 2m scale

- 6.40 The late Victorian cast-iron fireplace within bedroom 1.6 matches that in room 1.5, once again the flue has been boarded up (Plate 43). The built-in cupboard in the space next to the

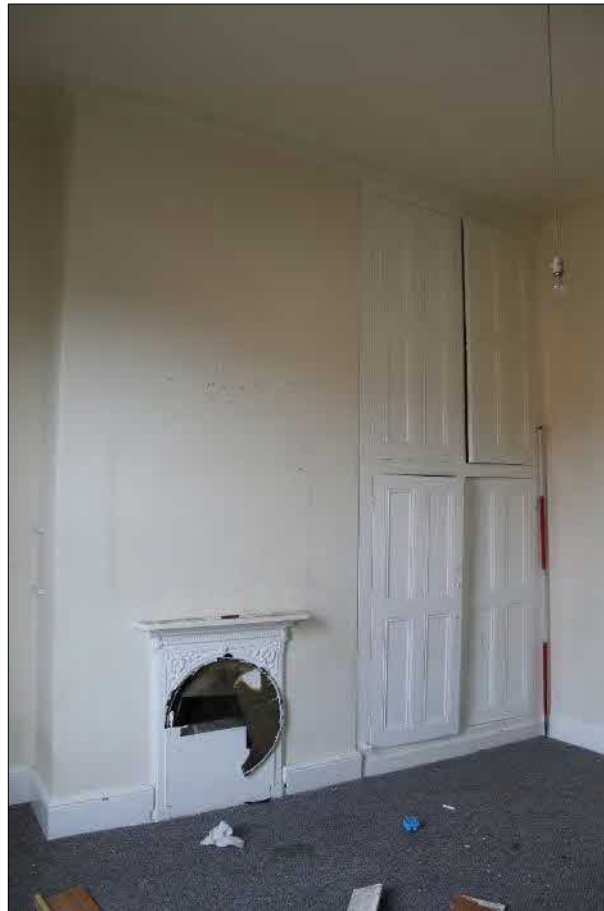
Plate 44 (shot 75): View of fireplace and built-in cupboards. Looking east-southeast, 2m scale

chimneybreast is potentially an Edwardian feature (Plate 44). The skirting is similar to that seen in rooms 1.2-1.4 and the covings are the same shallow moulded covings as in 1.3 and 1.5.

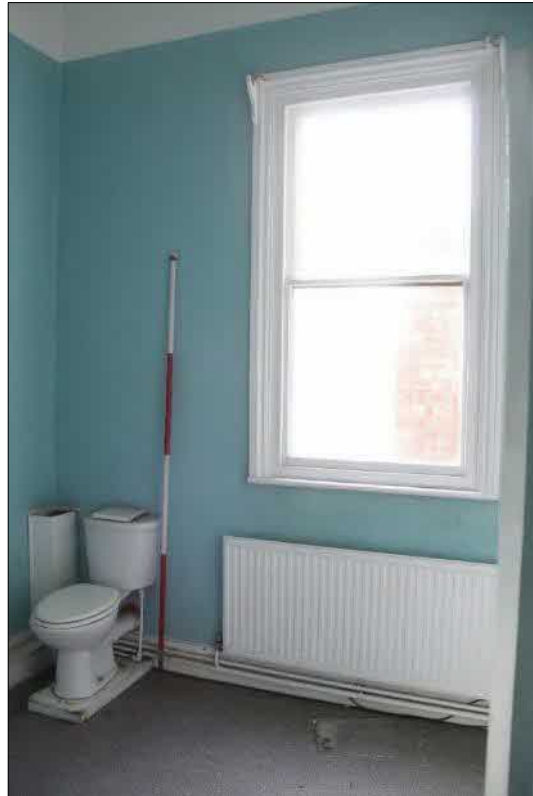
Plate 45 (55): General view of bathroom 1.7, in the northwest wing. Looking west-northwest, 2m scale

- 6.41 Both the northeast-southwest wing of A and the northwest-southeast annex B contain a modern bathroom (1.7 and 1.8). Bathroom 1.7 (Plate 45), contains no features of architectural interest. It is accessed from a later doorway to the northeast facing a corridor in extension C. The original access would have been along a now removed southeast wall. The wall was likely moved to create the extant corridor when annex B and northeast wing C were constructed. Bathroom 1.8, displays covings similar to those found in 1.3 and 1.5 (Plate 46).

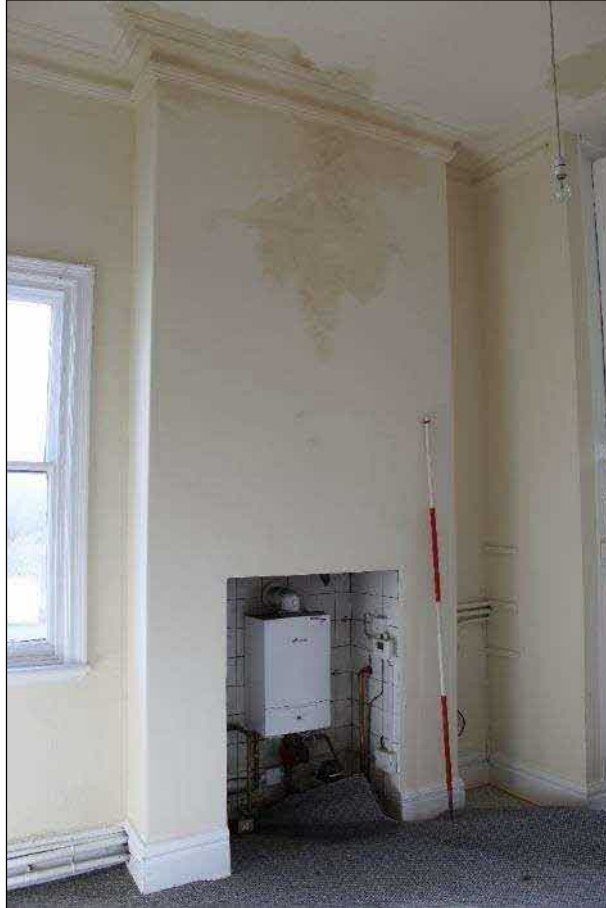
Plate 47 (shot 52): Modified fireplace in Bedroom 1.9. Looking east-northeast, 2m scale

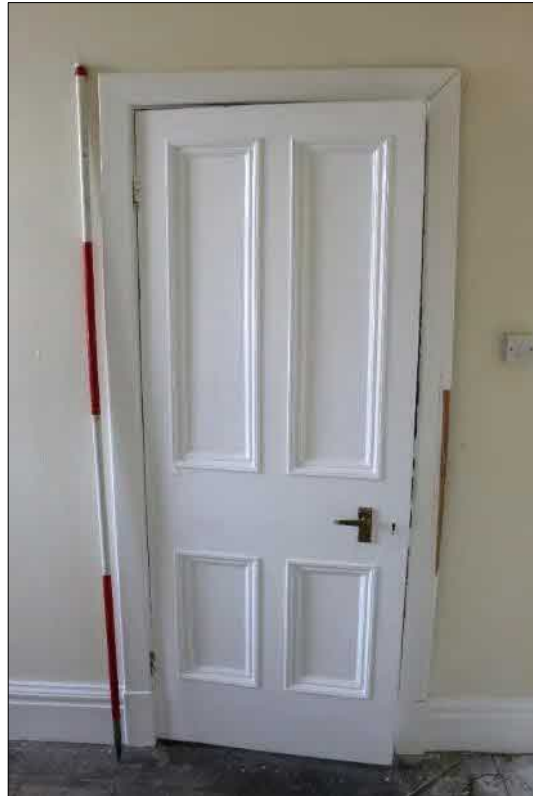
Plate 48 (shot 48): Representative shot of door (in Bedroom 1.10). Looking southeast, 2m scale

- 6.42 The northeast wing contains a further three bedrooms (1.9-1.11) and a small storage room (1.12) (Plate 47-Plate 49). All bedrooms contained the same architectural features including sash windows, moulded covings and skirting boards as seen in room 1.5. The fireplace was modified in bedroom 1.9 and there was a blocked fireplace in room 1.11. Bedroom 1.10 was devoid of such a feature.
