Former George Hotel, Duke  
Street, Southport

Bat Report

Central England Cooperative

RSE\_5853\_R1\_V3

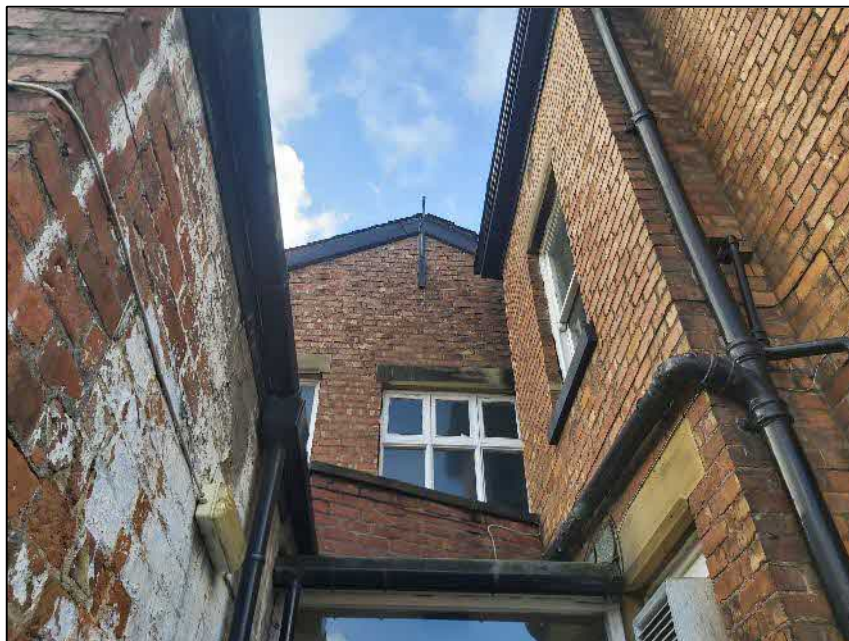
Figure 2: Northern elevation

- i The building is a detached, two storey former Public House of brick construction with a large beer cellar area. The building is glazed to all aspects on the ground and first floors with original window frames (glazing intact). Brick work is largely intact but with some minor cracking to the upper south-western aspect. There are various vents and vent bricks present externally and floor grates ventilating the cellar.

- ii The roof is multi-pitched with the main pub section comprising a hipped roof, and a secondary main section to the north being single pitch. There is a small terracotta slate roof to a single storey section to the north and a flat roof to the east. The main roofing is comprised of interlocking concrete tiles with timber fascias or timber soffits to most roof edges. Internally, the main roof is underlined with timber sarking. The roof is in poor condition with numerous missing tiles and rotten timber soffits/ fascias providing access into the fabric of the roof.

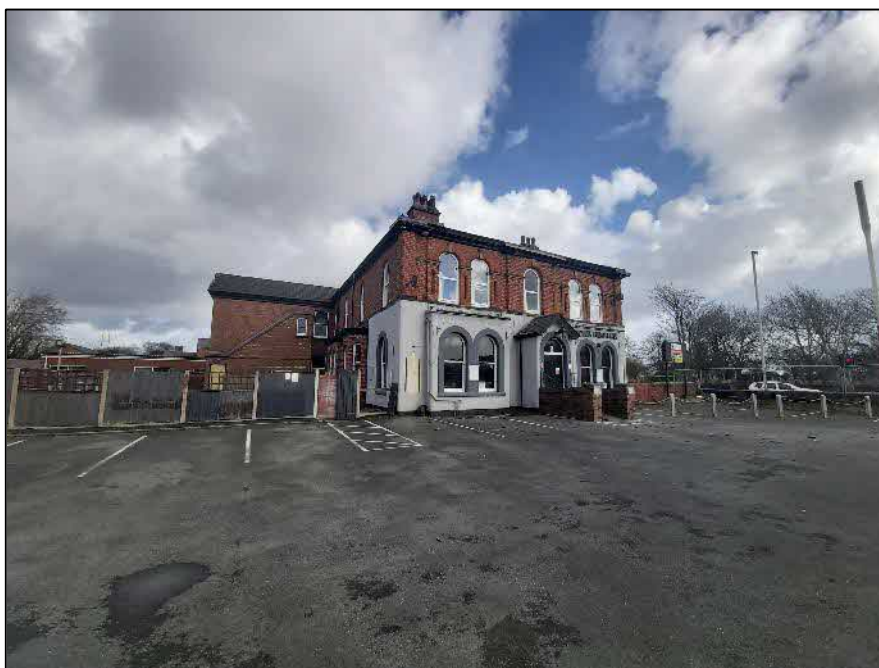
Figure 5: Southern elevation and context

- iv Externally, there is a large carpark to the south of the building and a former beer garden to the west (comprising of unmanaged amenity grassland).

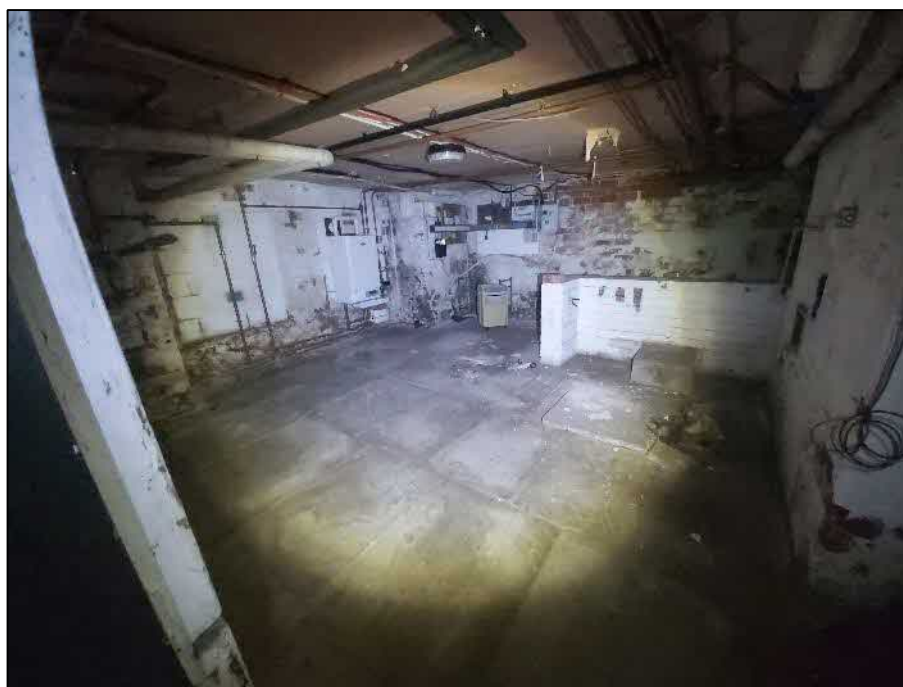
Figure 7: Cellar

have to work their way through the whole building to access the cellar to hibernate. When in use, disturbance levels would have been too significant with the cellar used to store beer kegs and with strip lighting fitted throughout.

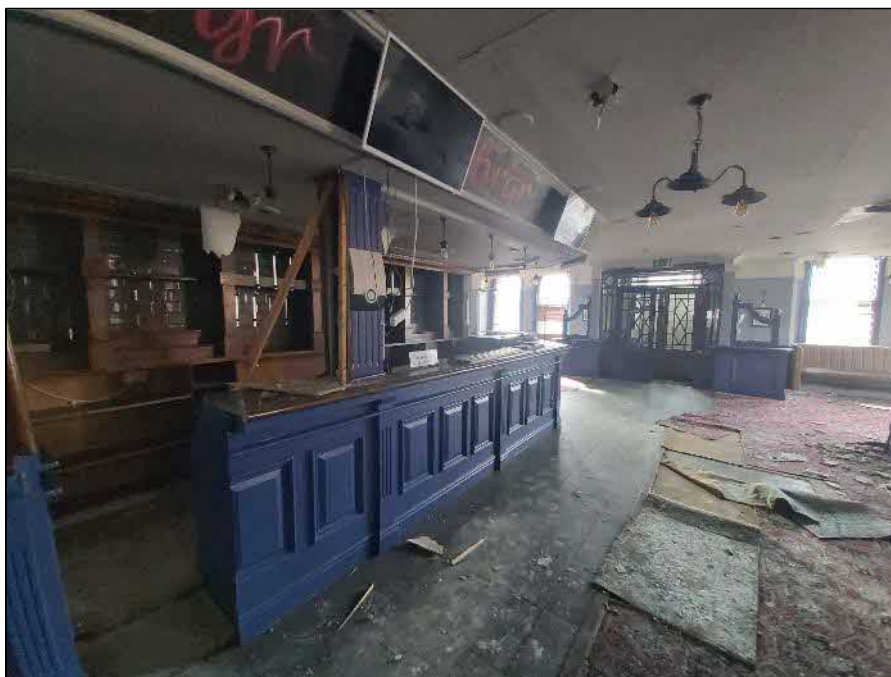
Figure 8: Ground floor

- iii The interior of the building comprises of multiple rooms over two levels. The ground floor comprises of the main public house, kitchen and utility rooms. The upstairs comprises of the former living quarters with bedrooms, living spaces, kitchen and bathrooms. The cellar was a beer cellar and utilised for other storage.

- iii The main body of the building lacks crevices/internal potential roost features for bats other than cupboards or similar.

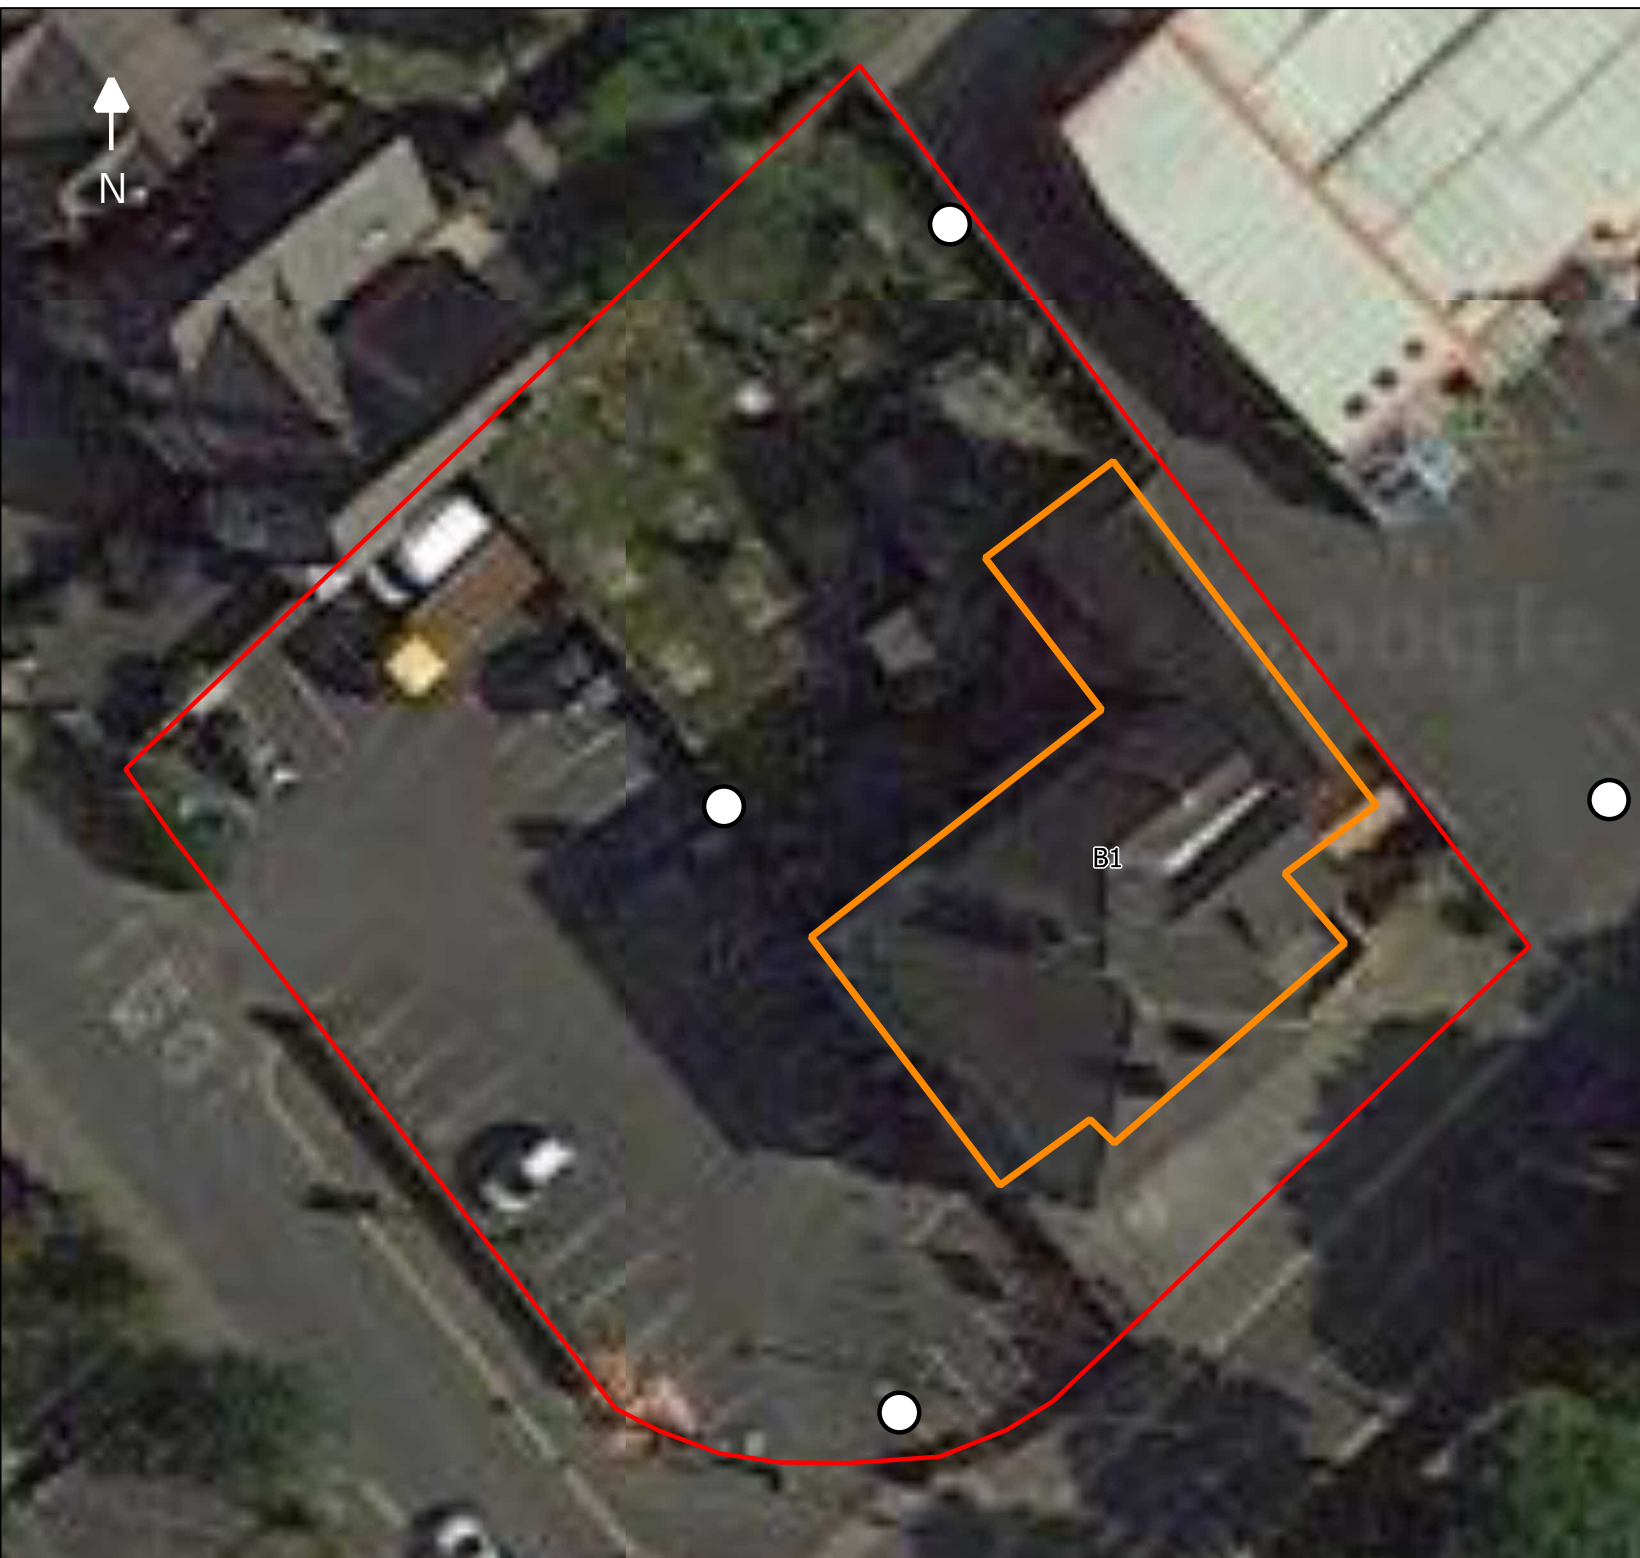
Drawing Title:  
Bat Building Plan V2

- I Four surveyors were optimally positioned to survey the building, as shown in Figure 10.
- ii The emergence survey commenced at 21.05hrs, sunset was at 21.20hrs and the survey ended at 22.50hrs. The survey lasted 1 hours 45 minutes in total and was uninterrupted.

- iii No bats were recorded emerging from the building throughout the survey.
- iv During the survey a Common pipistrelle (*Pipistrellus pipistrellus*), was recorded by the surveyors at 21.52hrs (32 mins after sunset) commuting west-east through the Site.

- v Further activity within the Site was limited to occasional foraging (single common pipistrelle) to the west of the building between 21.56 and 22.20. Distant foraging was also recorded, with no visual confirmation but it is likely that foraging was occurring in association with garden trees to the north west of the Site and cemetery to the south east.
