HERITAGE STATEMENT

The Formal Terrace, Yorkshire Sculpture Park

Repairs to the Formal Terrace, Yorkshire Sculpture Park

January 2024

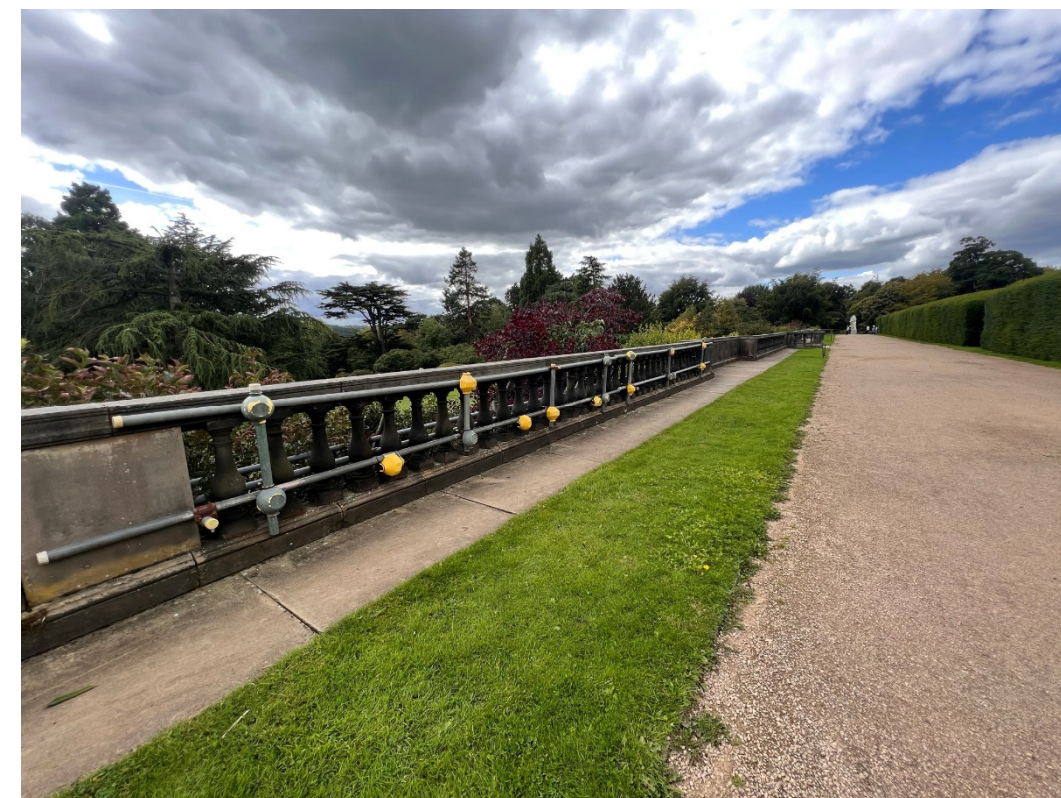
Figure 1 – View of Terrace from East showing temporary scaffolding supports.

4.3.1 The balustrade and handrail to the Formal Terrace has been gradually deteriorating for some time, resulting in the installation of temporary scaffolding supports in a number of locations. The balustrade has suffered from historic and thermal movement which has ultimately caused the balusters to become loose whilst others have eroded, cracked or fractured completely. This combination of factors has led to sections of balustrade to become unstable. In addition, the thermal movement has affected the stone returns at the stair locations.

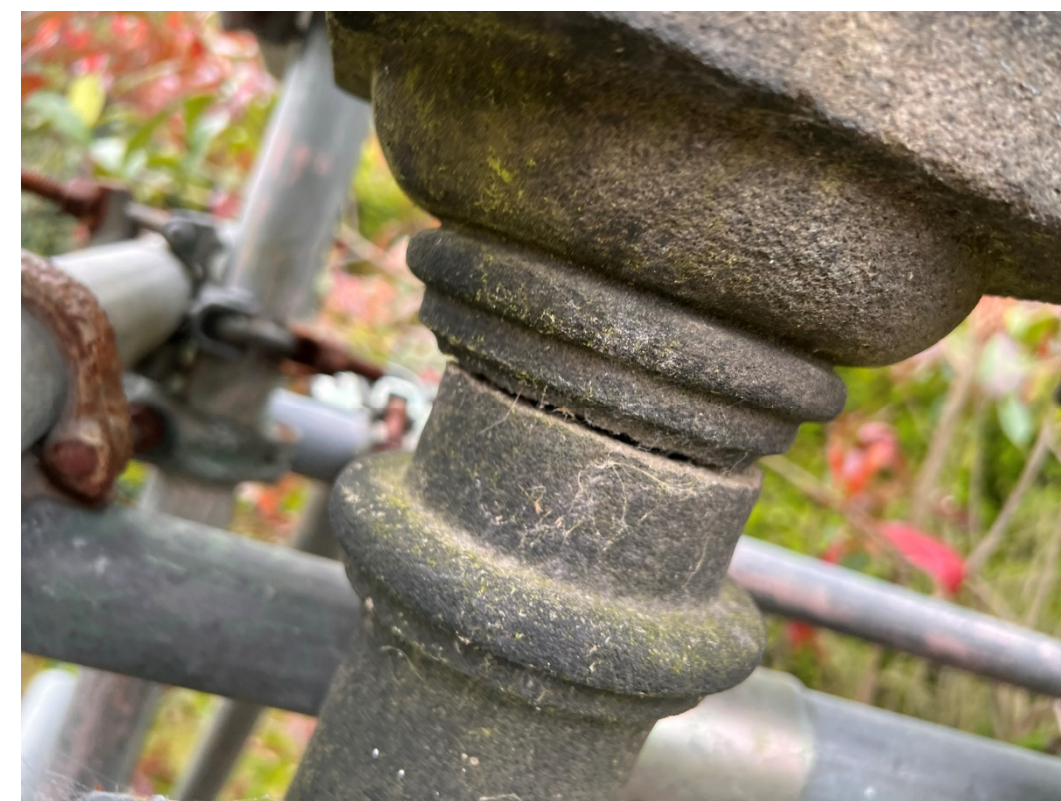
Figure 3 – Typical Cracking to Balusters

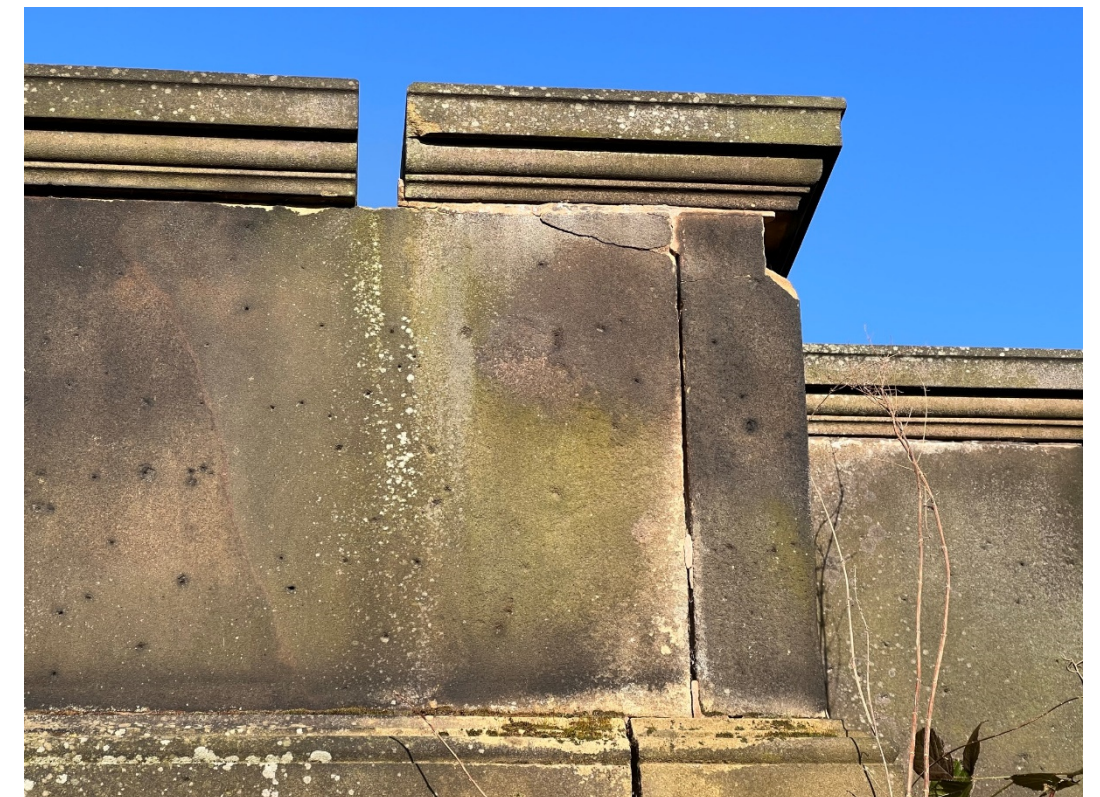
Figure 9 – Defects at staircase return showing cracking and movement.

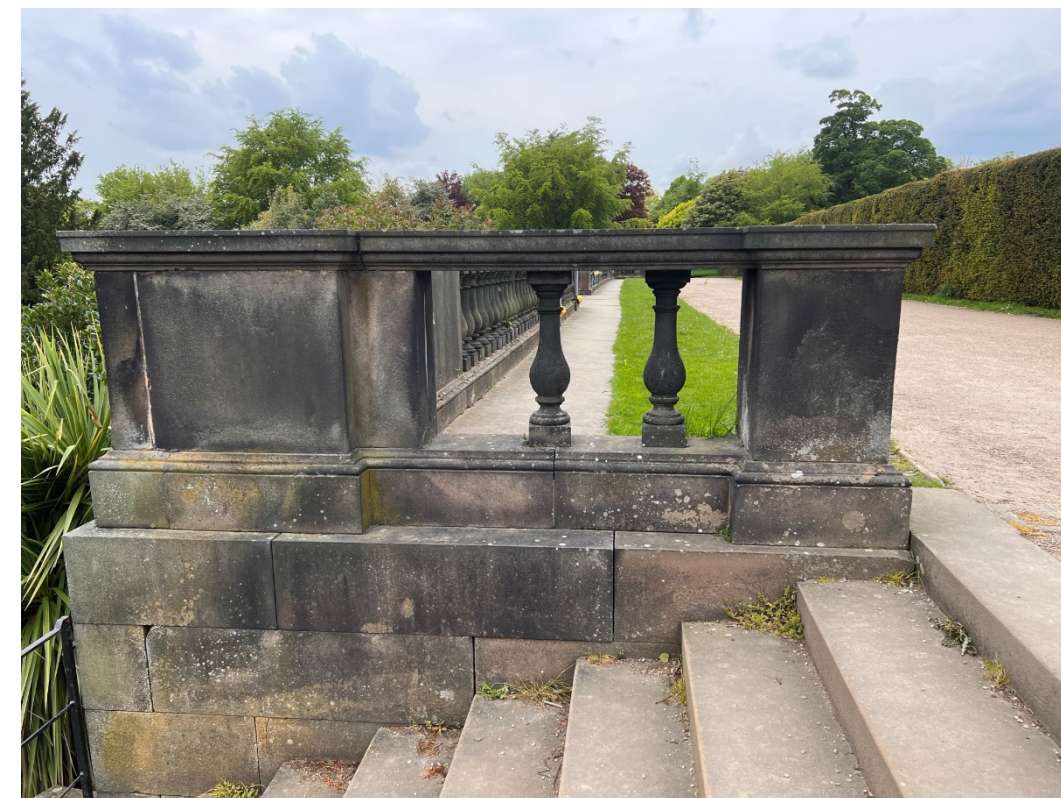
Figure 10 – Staircase showing missing balusters.

- Replace approximately 62 No missing and severely damaged balusters in various locations.
- Refix approximately 198 No loose balusters a number of sections of the balustrade.
- Loose, distorted and displaced handrails should be removed to allow for proper replacement by insertion of steel dowels between adjoining sections. Approximately 50m of handrail requires repair in this manner.
- Carefully remove plant growth from between stonework joints. Reset and rebed any loose stones, approximately 8 No stones in total.
- The front elevation of the Terrace is generally in need of complete repointing in conjunction with repair programme.

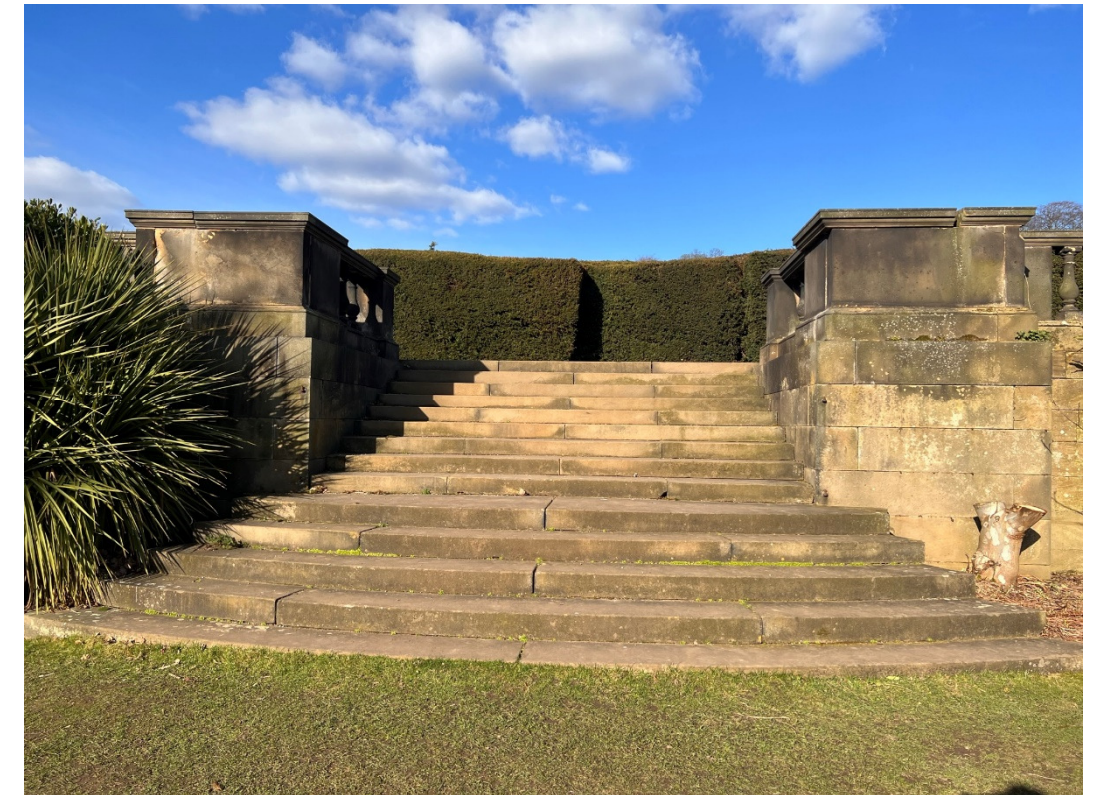
Figure 11 – Typical staircase to Terrace

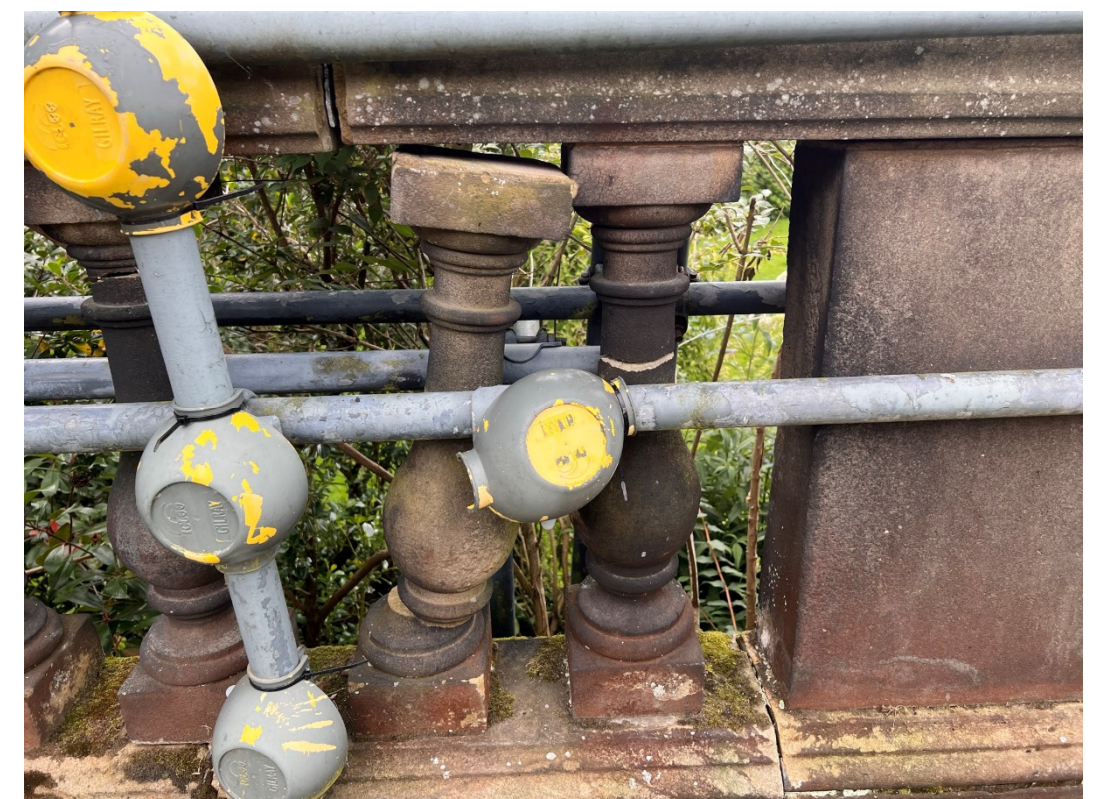
Figure 12 – Loose and fractured balusters with scaffolding supports.

4.3.3 Given the extent of the defects the repairs will involve the careful dismantling of the entire balustrade and buttress walls, setting aside sound materials for reuse in the rebuilding to match the existing, together with new, matching, replacement materials. Complete dismantling will enable the structure to be rebuilt securely incorporating mechanical fixings where necessary and ensuring a long term solution.

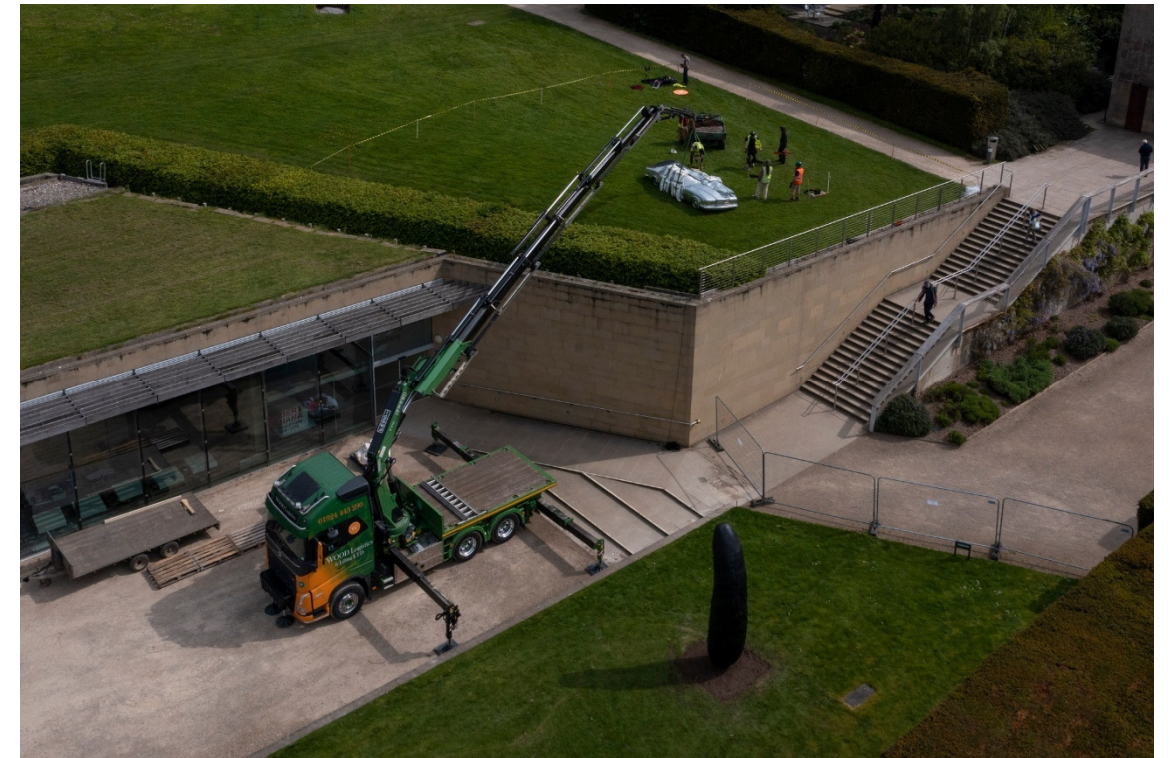
Figure 13 – Image showing typical crane lifting activities at YSP

- 4.2.2 The concrete pad foundations comprise 2.1m x 2.1m x 0.8m concrete pads, located to accommodate lifting positions for the crane which is used by YSP to install and remove sculptures and artwork on and around the Terrace. The pads will be located at a depth of 300mm below the gravel surface and will therefore not be visible once the works are completed.

4.3.5 As described above and detailed in the submitted drawings, this involves the installation of 4 No sets of concrete pads in 4 No locations. This will allow the cranes to safely access a wide area to each side of the terrace, as well as the terrace itself, but will cause minimal disturbance to the listed structure during, and after the works are completed.
