ENVIRONMENTAL TECHNICAL NOTE

Installation of UV Treatment at Halling Water Treatment Works

Method Statement for Protected Species

Ecological Compensation and Enhancement Measures

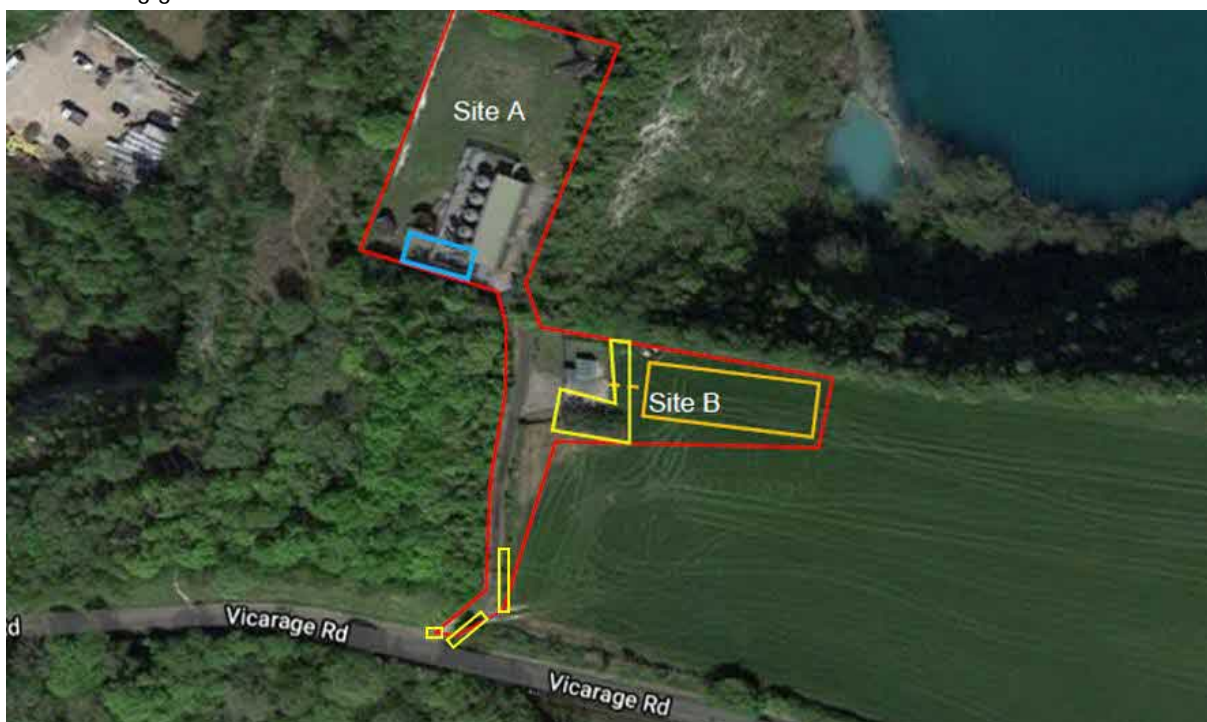
Figure 1: Location of Halling Greensand WTW, Kent. The orange outline is the indicative location of the new UV kiosk and access track, the blue outlines the proposed compound location within the WTW site, and the yellow area outlines the area of scrub/hedge to be removed to facilitate access to the works.

The proposed Scheme is for the installation of a new UV treatment facility kiosk on site at Halling Greensand WTW. The location of the UV kiosk is proposed within the arable farmland habitat in Site B adjacent to the existing Borehole. The UV Installation will be set back away from the northern hedgerow boundary which has dormice potential. Habitat loss will be required to facilitate the construction of the new kiosk including removal of arable habitat and a section of hedgerow with associated hardstanding access track (approximately 35m²). Temporary impacts will also occur to the surrounding grassland on site to facilitate construction traffic to the new kiosk site.

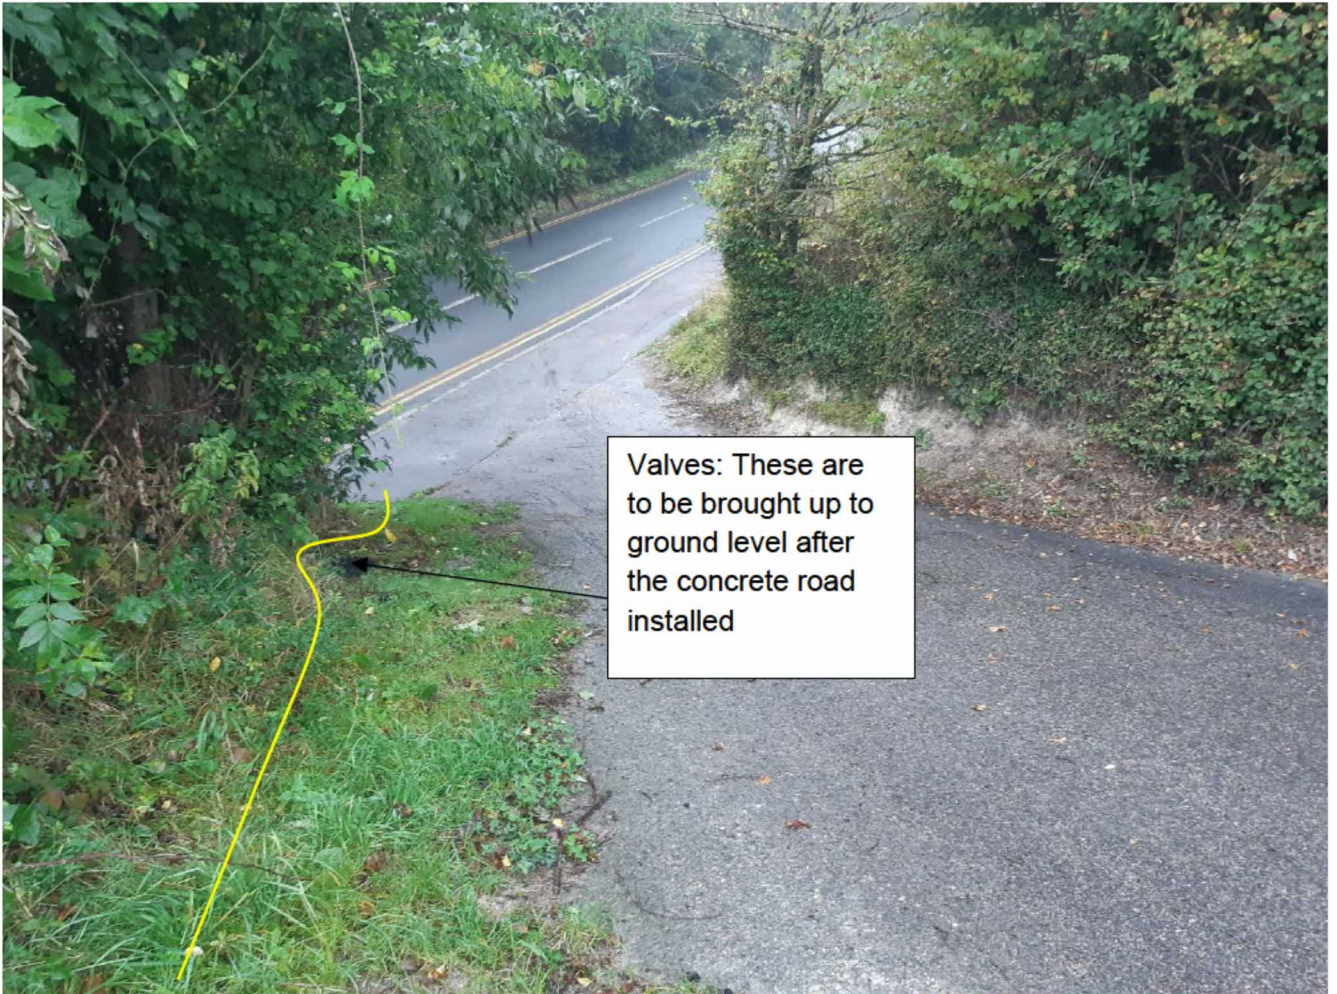
Photo 1: Right Hand Side (West of entrance)

Cutting back of the embankment – dead elm tree on the lower bank can be removed. Work modified to minimise the area of bank to be removed so that only the elm tree is to be removed. Works to take place under a Precautionary Method Statement for dormice. If any animals or nests found the works will have to stop and further surveys needed.

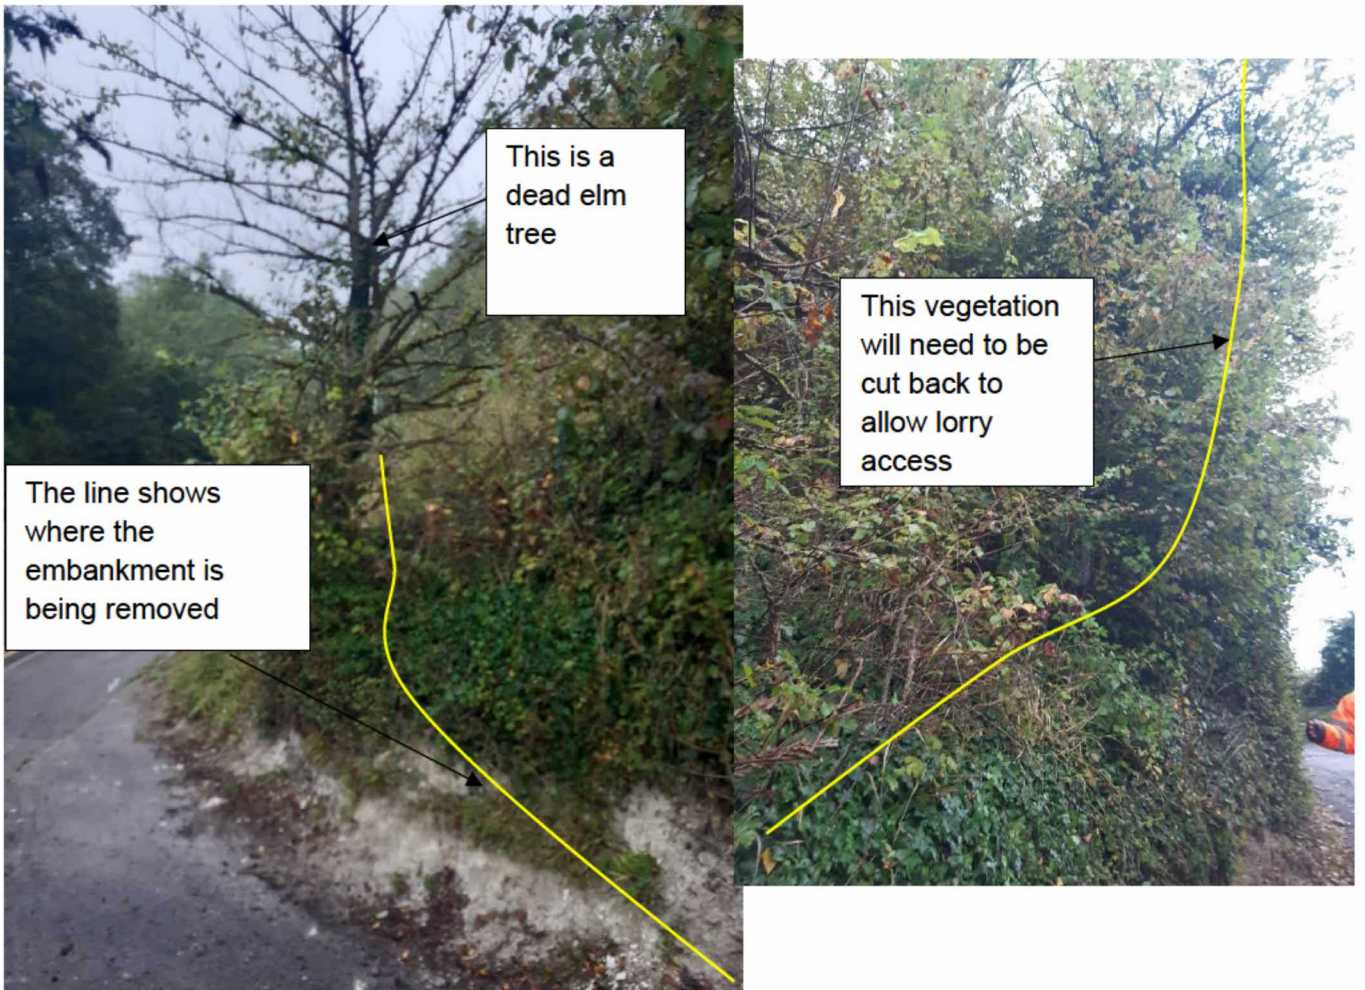
Photo 2: Left Hand Side (East of entrance)

- On the left hand side (Photo 2) west of the trackway a more substantial vegetation clearance is required. The first part of the works are to remove part of the embankment and the dead elm tree which is at the corner of the trackway. This has been checked for its stability if the tree is to be removed and it has been confirmed to be safe. Although this embankment contains brambles, hazelwood, elder trees and other species. This area has excellent connectivity to the woodland behind which has high dormice potential. This will require more extensive vegetation clearance to ensure that the lorries can get through the trackway.

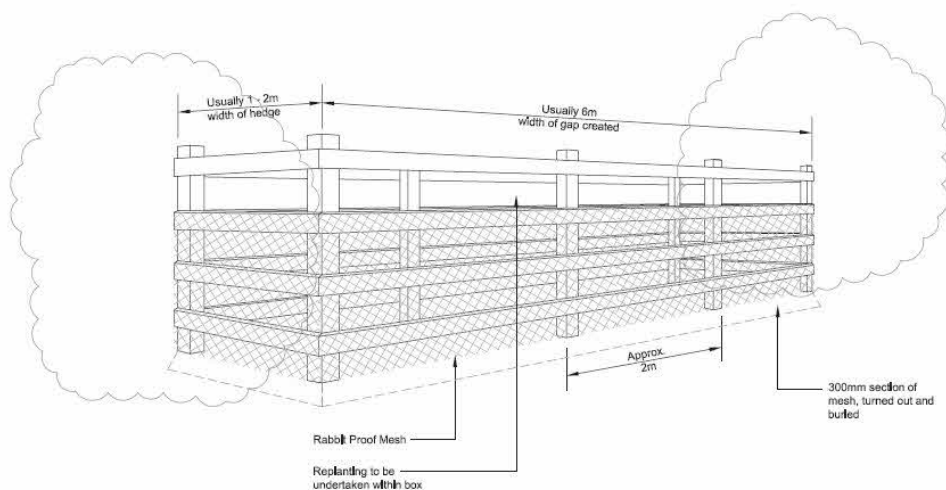
HEDGE BOX

Pits shall be 150mm wider than the root ball in any dimension. If planting into established turf, cut turf 300mm square and 200mm deep. Invert turf and place in the base of the planting pit before planting and back filling. Pits shall be dug with vertical sides and horizontal base and shall maintain the specified minimum depth throughout. The base of the pit shall be broken up to a further 100mm depth. When backfilled, planting pits shall be finished to existing contours. Carefully prune any badly damaged roots before planting. Plant trees upright in the centre of the pit with roots spread evenly

outwards and downwards without restriction. All wrappings and insulation shall be removed from root balls immediately before backfilling. Backfill the pit with the excavated material and the backfill shall be lightly firmed.
