## **Preliminary Bat Survey Report for 6, Ridgeway, Farnsfield, Nottinghamshire**

**20<sup>th</sup> January 2024**

Report Number: 2401/04-MLE-01

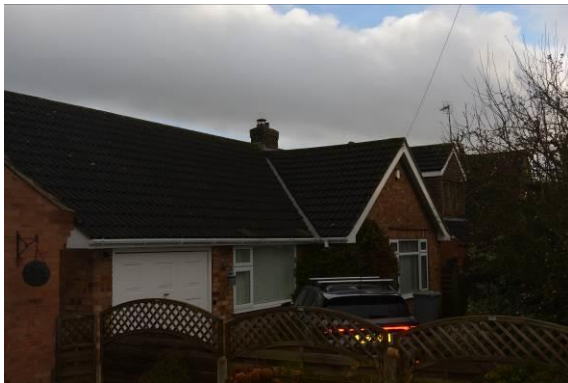
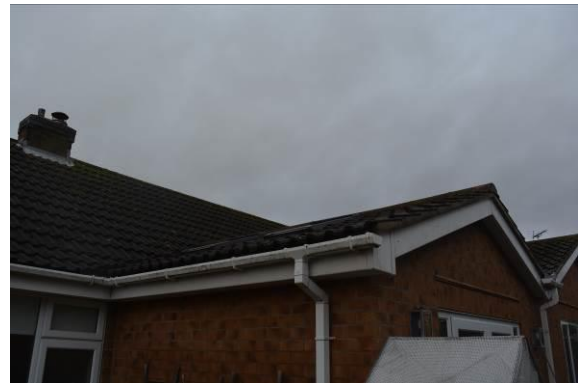
**Figs. 1 & 2 6 Ridgeway, Farnsfield**

The site comprised a detached bungalow with pitched tiled roof, with small rear, shallow pitched roofed extensions (Figs. 1 and 2).

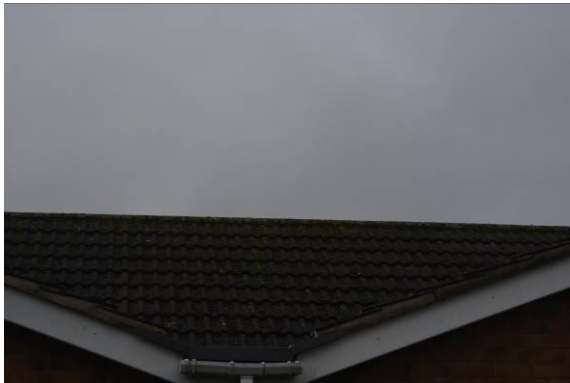
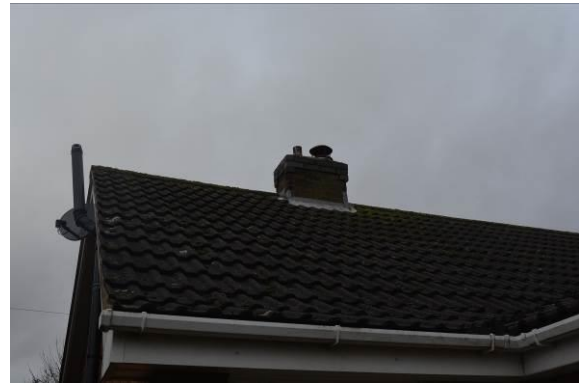
Externally, the inspection of revealed an absence of any suitable gaps or crevices; the roof was in good condition throughout, with all of the pitched tiles tightly fitting, along with fully sealed main ridges (Figs. 3 and 4).

**Figs. 3 & 4 External roof detail– no gaps/crevices present**

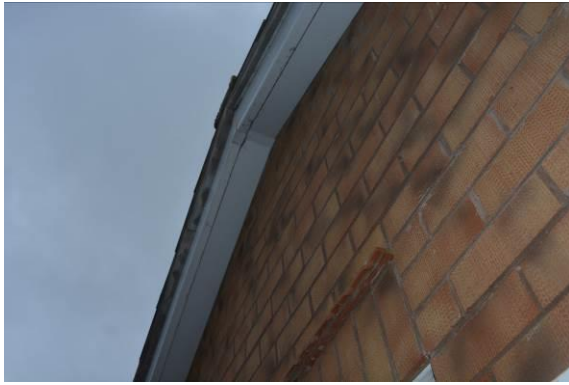
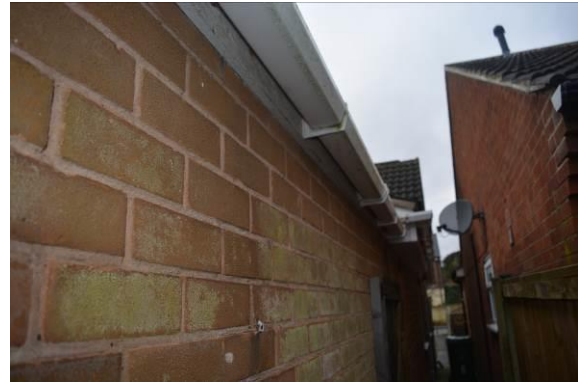
All of the roof overhangs/UPVC eaves detail were fully sealed and fitting tightly to the brickwork, whilst gable ends were fully sealed mortar (Figs. 5, 6 and 7 - overleaf)

Additionally, all of the windows and doors fitted tightly within casements.

**Figs. 5 & 6 Eaves fully sealed/soffits tightly fitting**

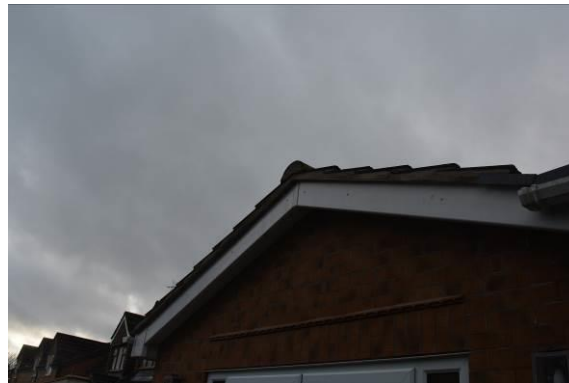
**Fig. 7 Gable ends sealed with mortar**

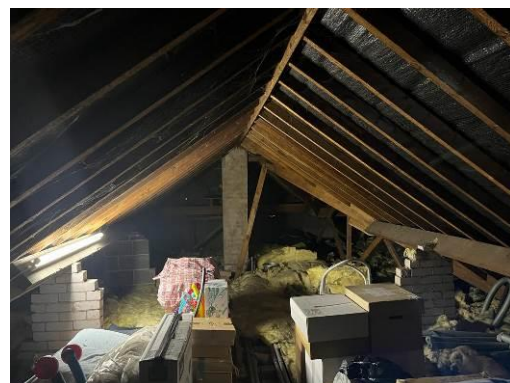
Internally, the inspection revealed three connected voids were present, all of which were lined with tightly fitting bitumen felt (Figs. 8 and 9).

**Figs. 8 & 9 Roof voids lined with bitumen felt**

No light penetration was observed anywhere within the roof voids, which were evidently fully sealed internally.
