# LAND TO THE NORTH OF RHALLT LANE, WELSHPOOL

## Site Investigation & Ground Assessment

Report Ref: BEK-23048-2 (Rev A)

April 2023

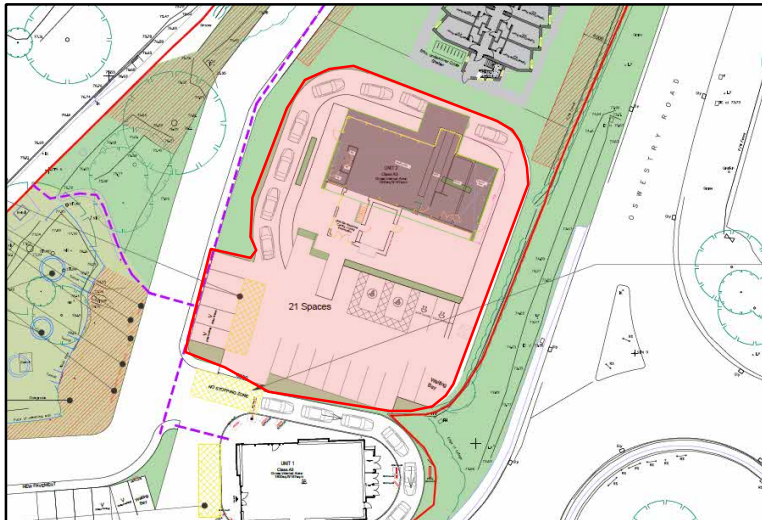
Figure 1: Red Line Site Boundary

1.3.3 The area to which this site investigation and contamination assessment report applies is highlighted in red in Figure 1.

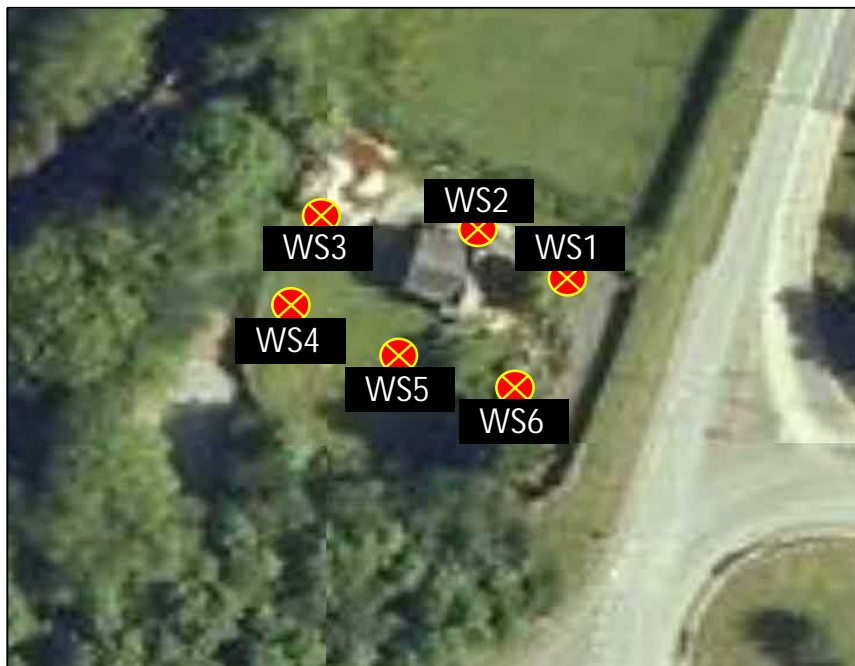
Figure 2: Borehole Location Plan

3.1.3 Six exploratory locations were initially set out by the site engineer and the exploratory locations are illustrated on Figure 2 below.

3.1.4 Note, it was not possible to drill Borehole No WS4 due to the presence of a septic tank and services in this location. However, BEK considers a reasonable spatial spread has been achieved across the site.

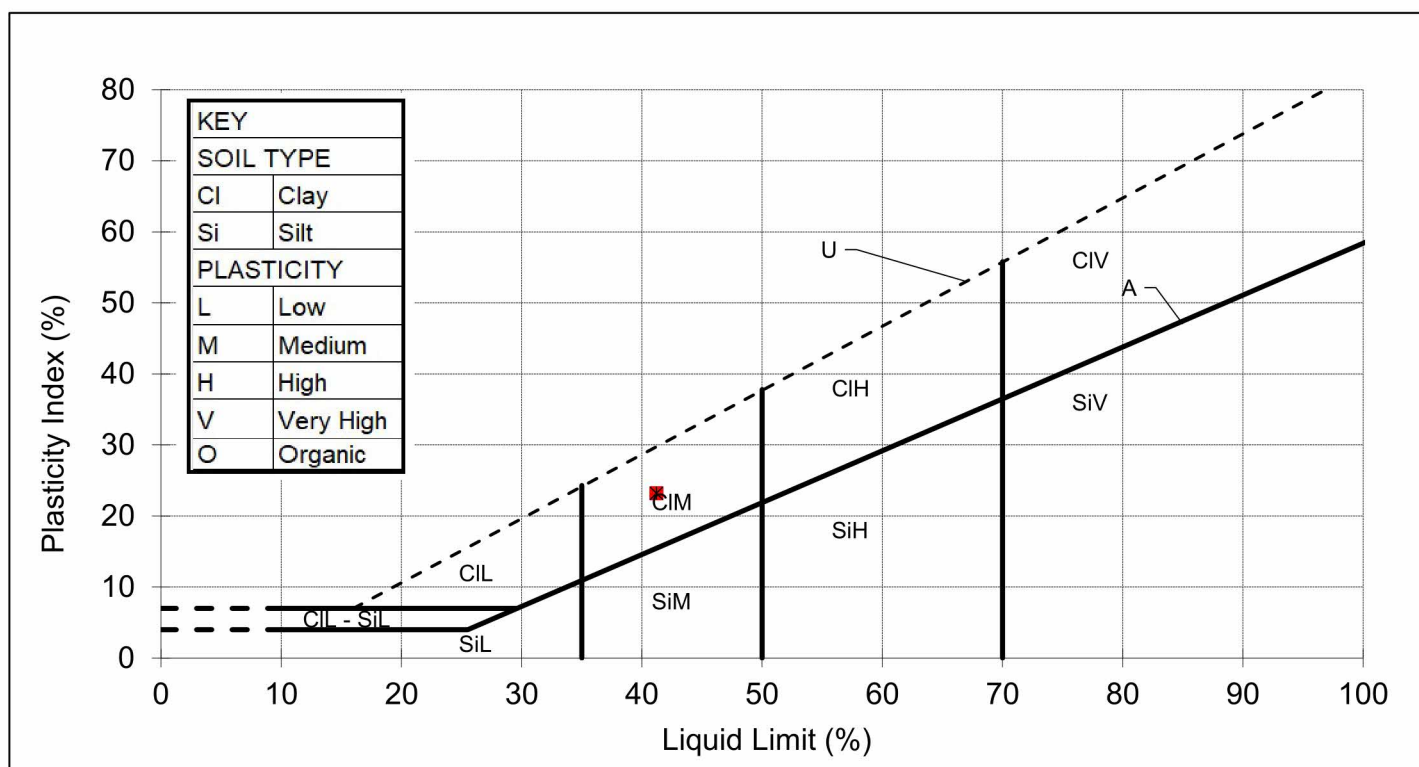
Test Readings mm (average)	Moisture Content %	Correction Factor	Correction factor from Clayton and Jukes 1978
Determination 1 (avg)	21.8	0.976	
Determination 2 (avg)	21.4

Natural Moisture Content (%)	Liquid Limit (%)	Plastic Limit (%)	Plasticity Index (%)	Passing 425 micron (%)
22.5	41	18	23	92

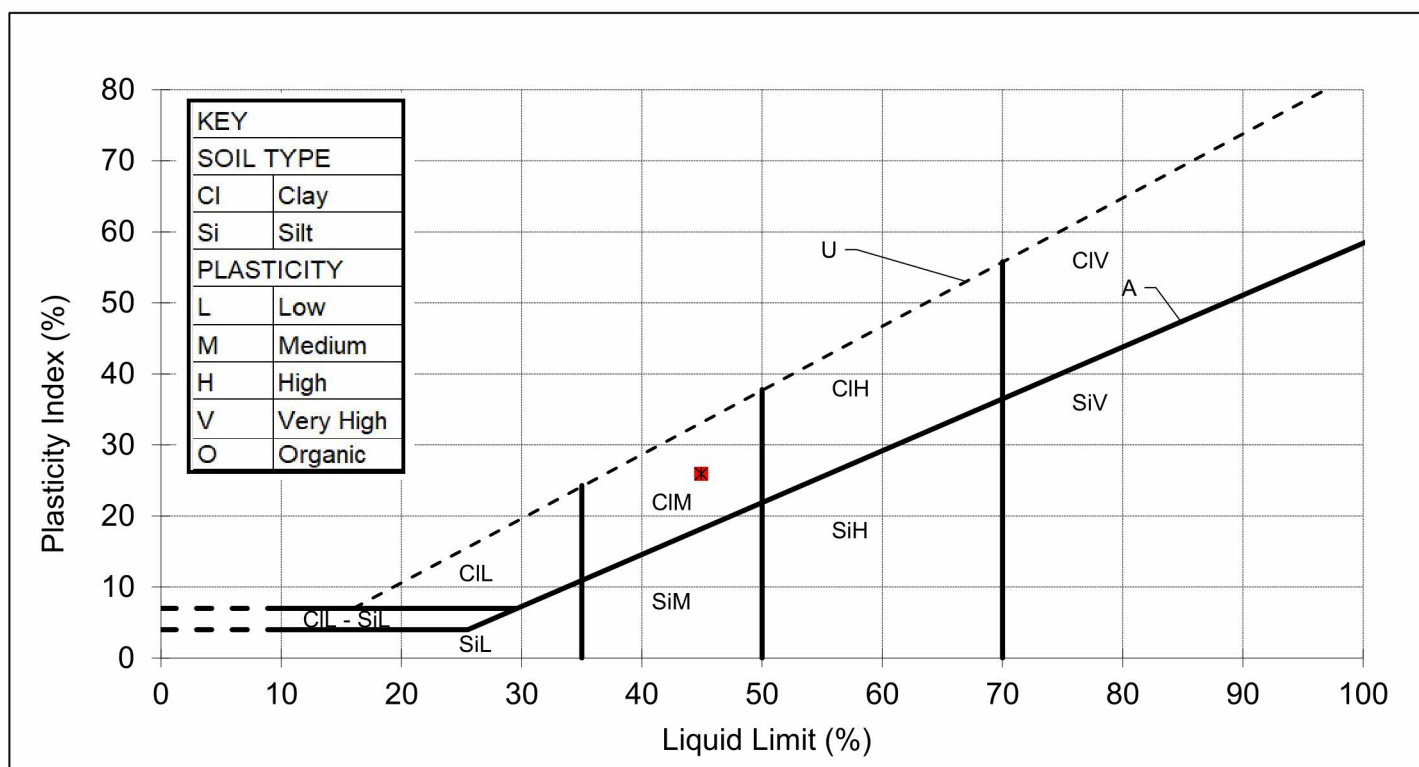
Test Readings mm (average)	Moisture Content %	Correction Factor	Correction factor from Clayton and Jukes 1978
Determination 1 (avg)	19.5	1.012	
Determination 2 (avg)	19.3

Natural Moisture Content (%)	Liquid Limit (%)	Plastic Limit (%)	Plasticity Index (%)	Passing 425 micron (%)
29.3	45	19	26	87

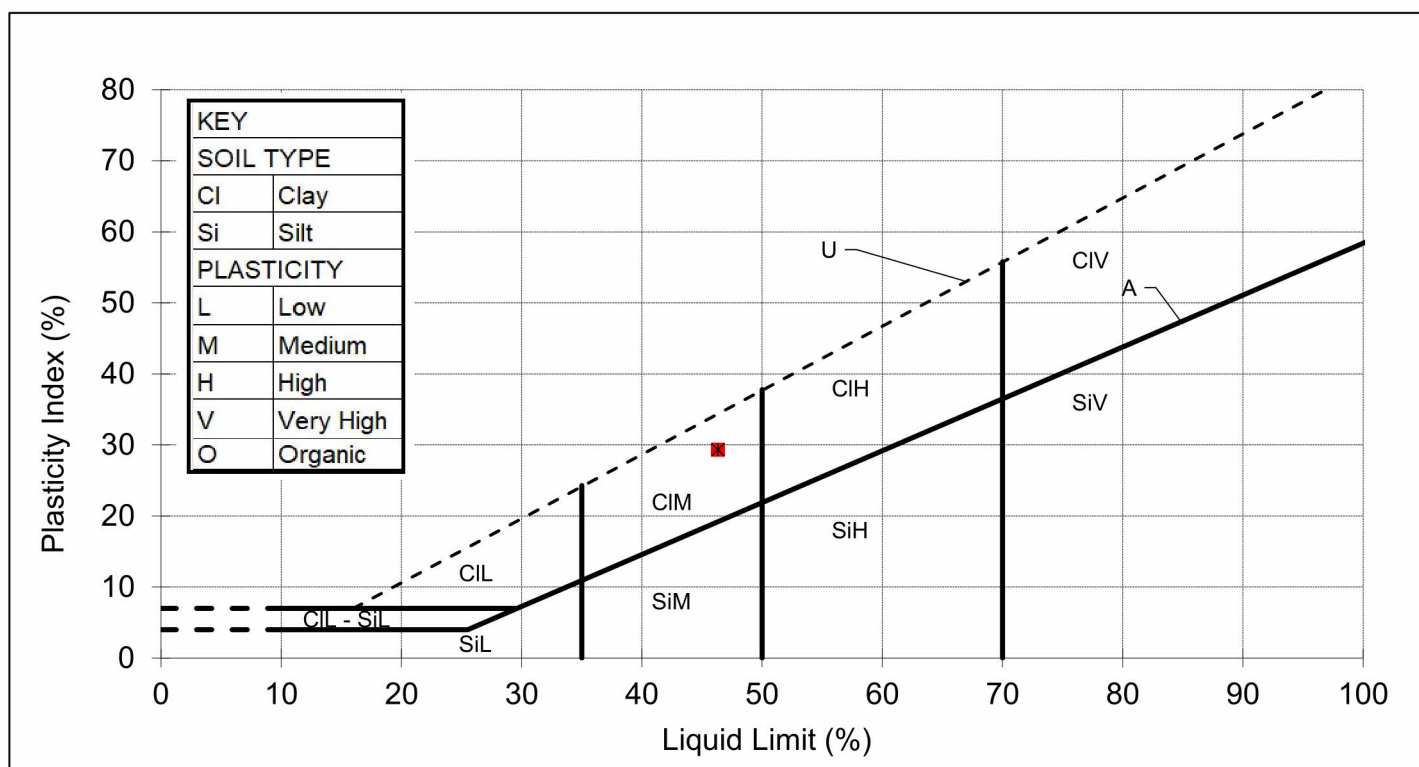
Test Readings mm (average)	Moisture Content %	Correction Factor	Correction factor from Clayton and Jukes 1978
Determination 1 (avg)	18.4	1.029	
Determination 2 (avg)	18.4

Natural Moisture Content (%)	Liquid Limit (%)	Plastic Limit (%)	Plasticity Index (%)	Passing 425 micron (%)
22.6	46	17	29	94

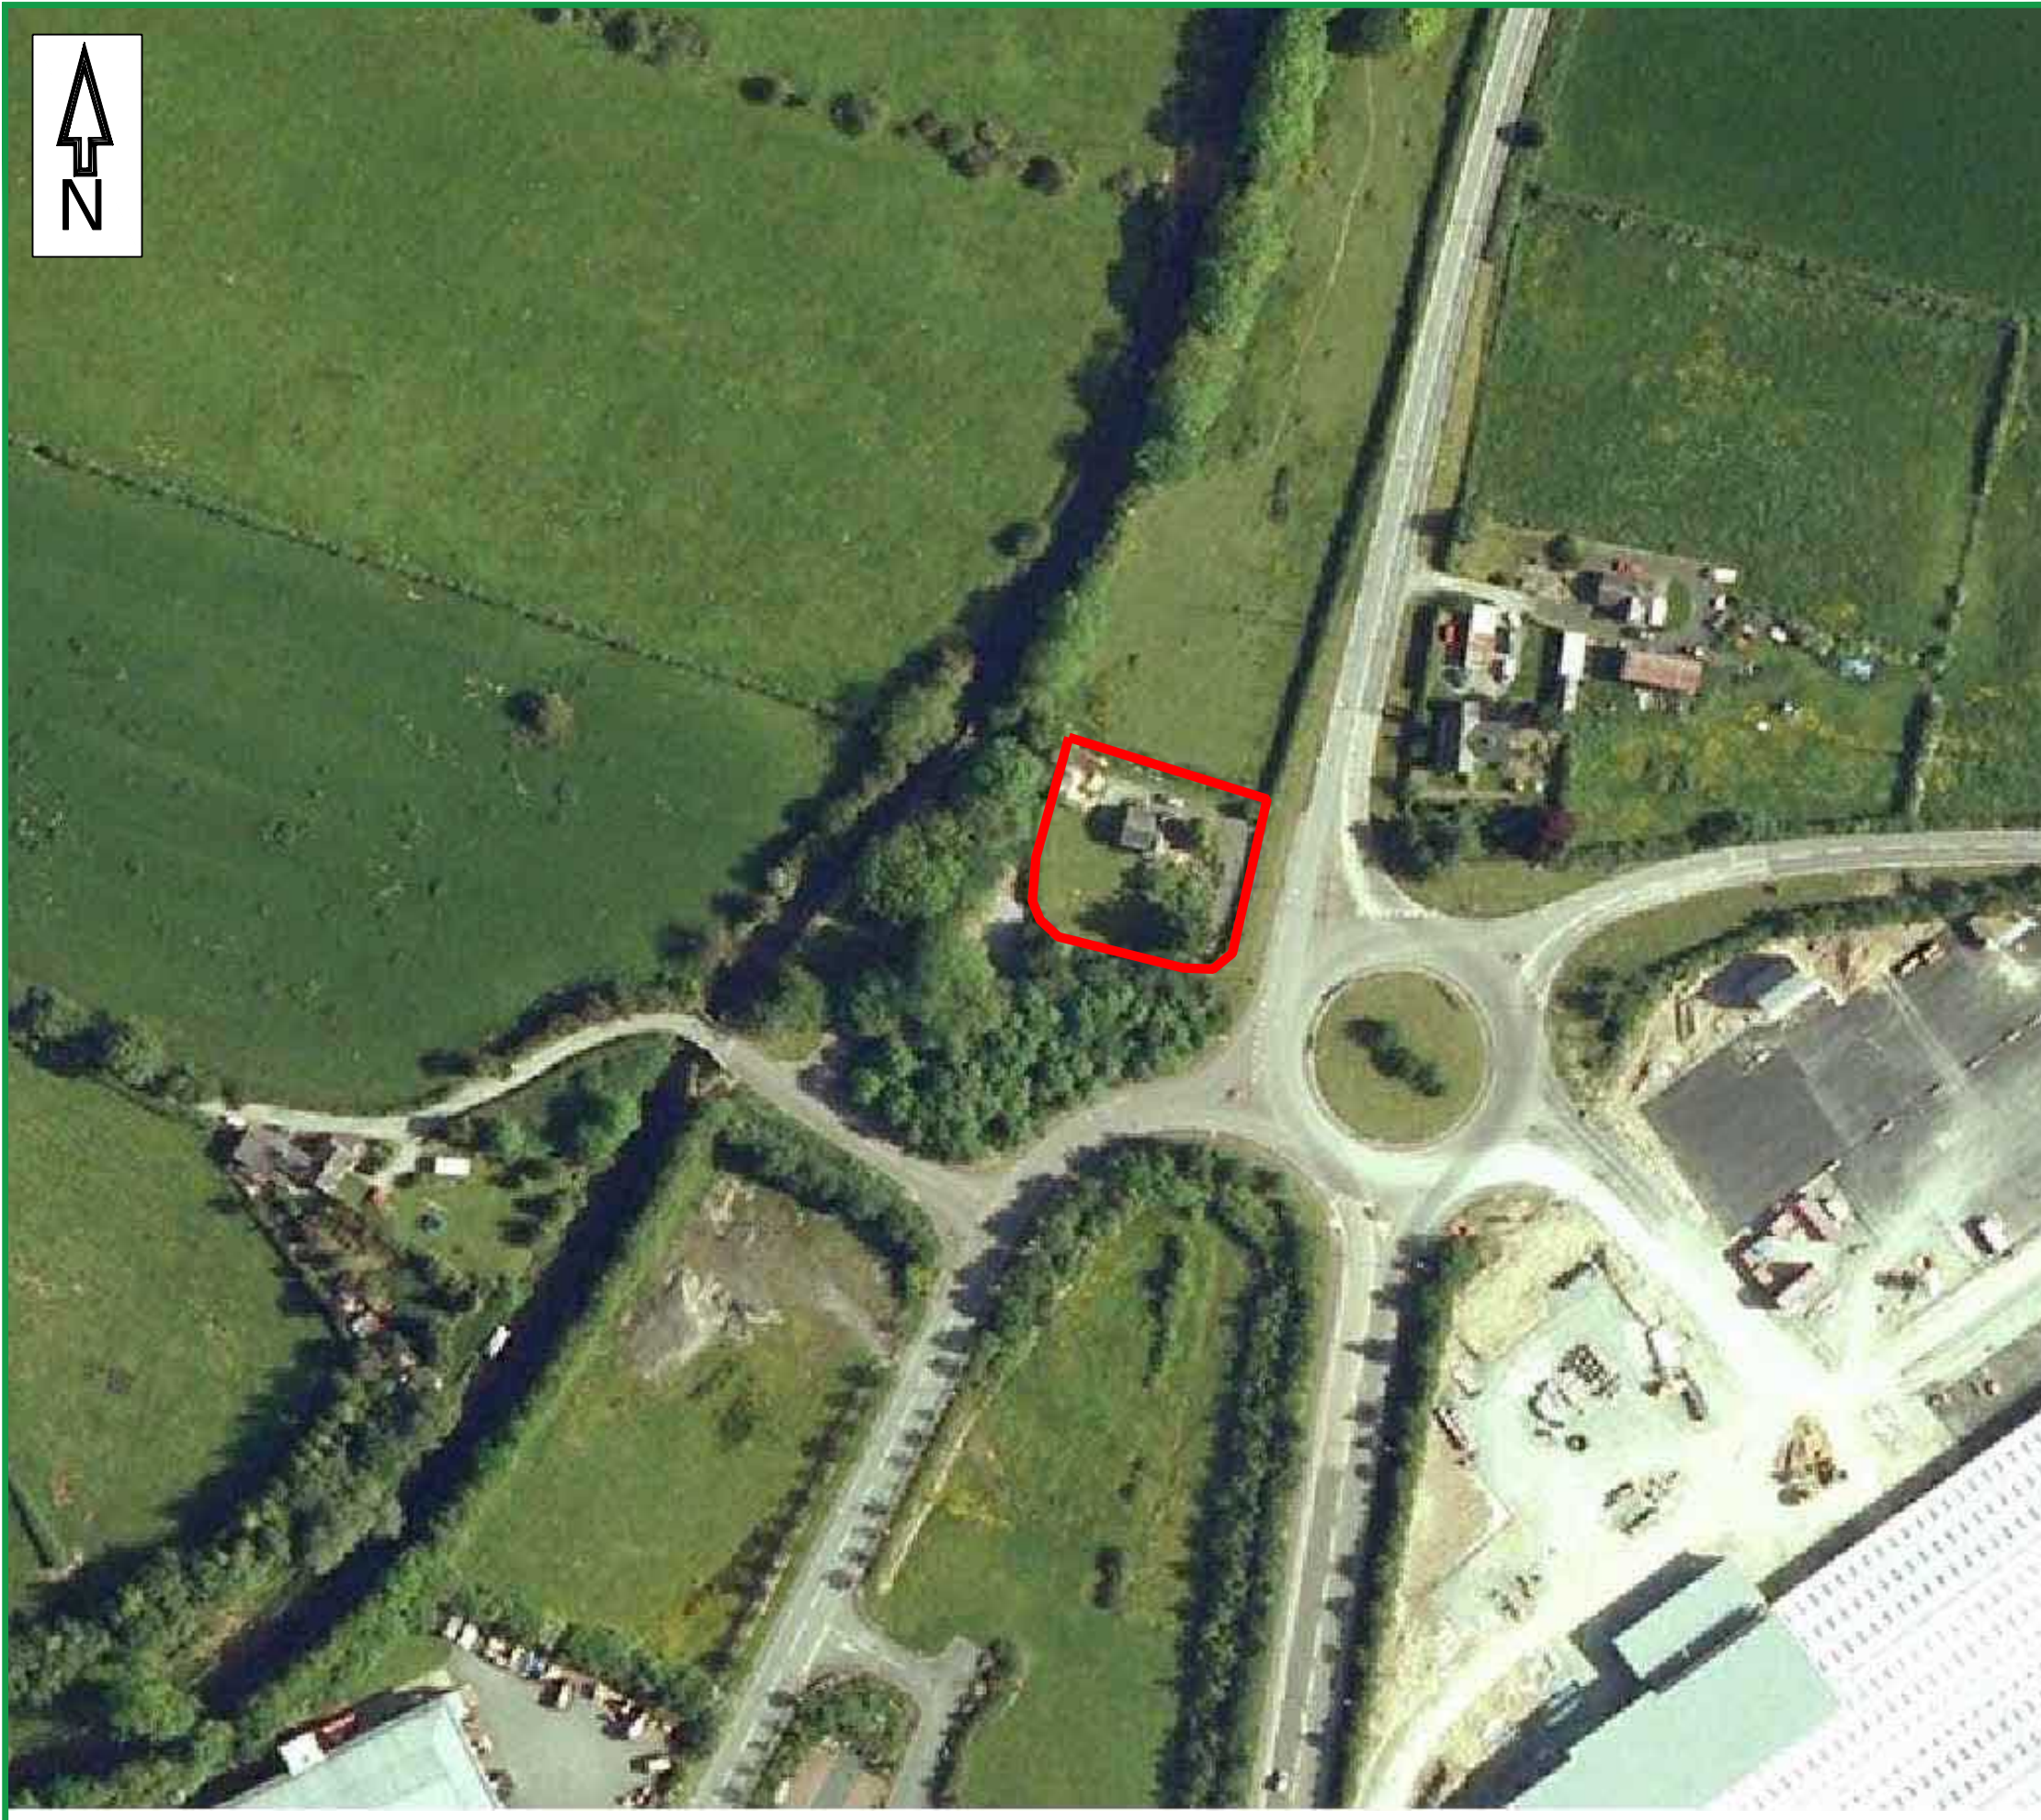
SITE LAYOUT

1.2.2 The site location and site layout are presented on BEK Drawing No 23048-1 and BEK Drawing No 23048-2, respectively. Copies of these drawing are presented in Appendix F.
