LAND TO THE NORTH OF RHALLT LANE, WELSHPOOL

Site Investigation & Ground Assessment

Report Ref: BEK-20771-2

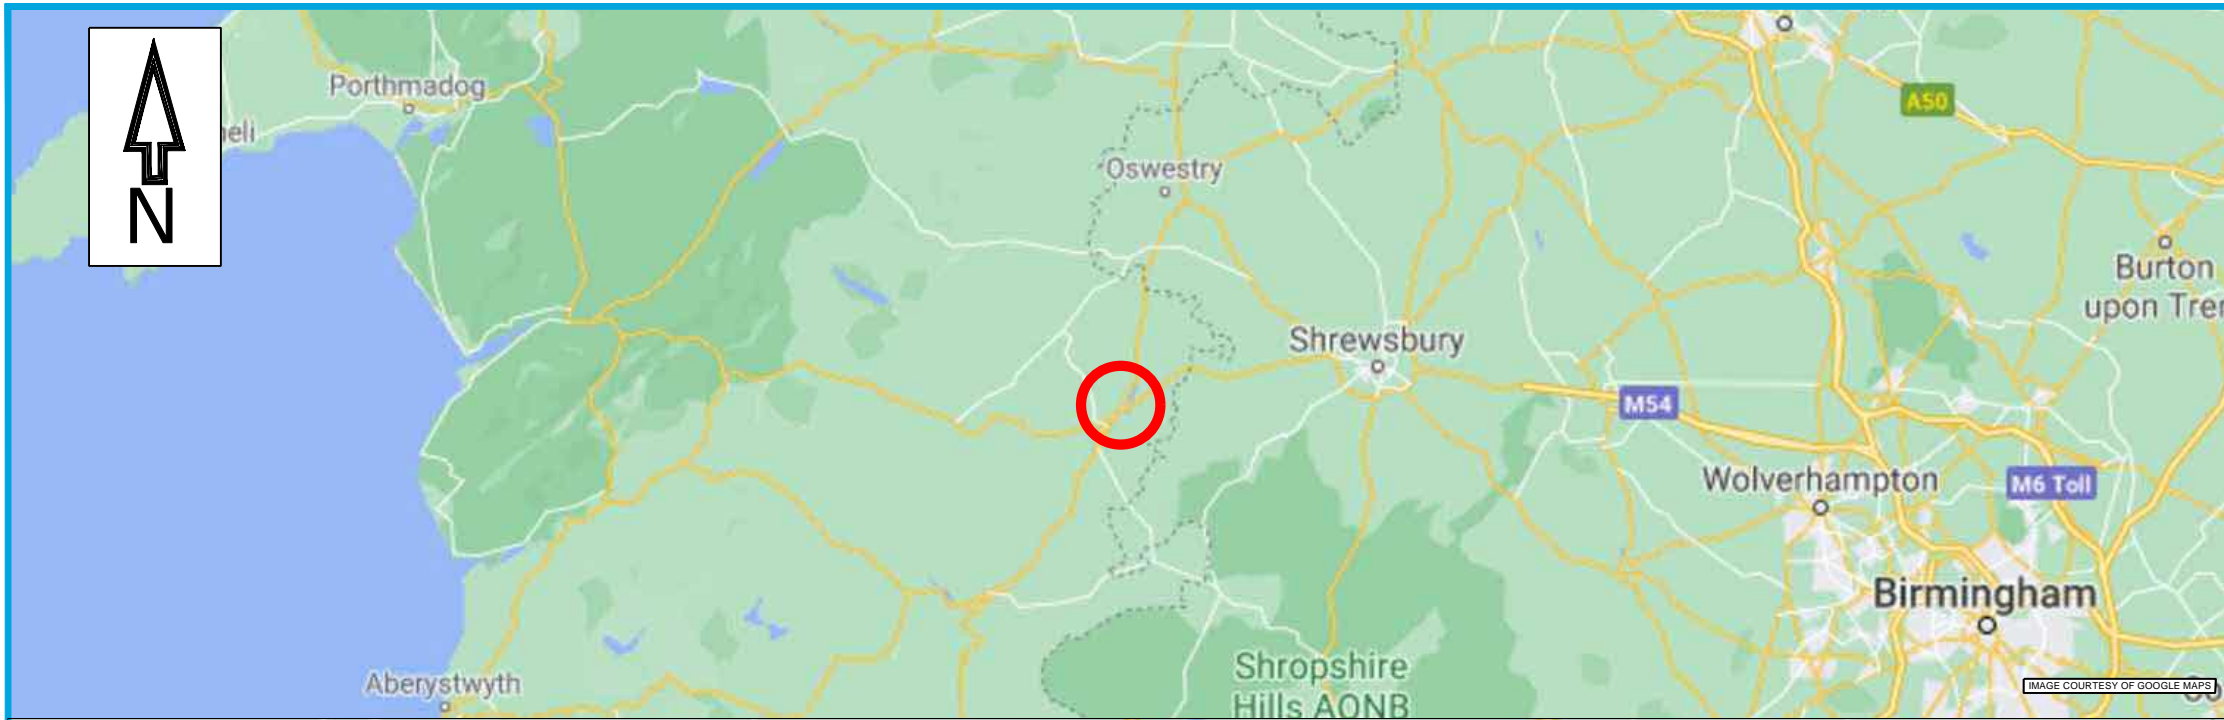
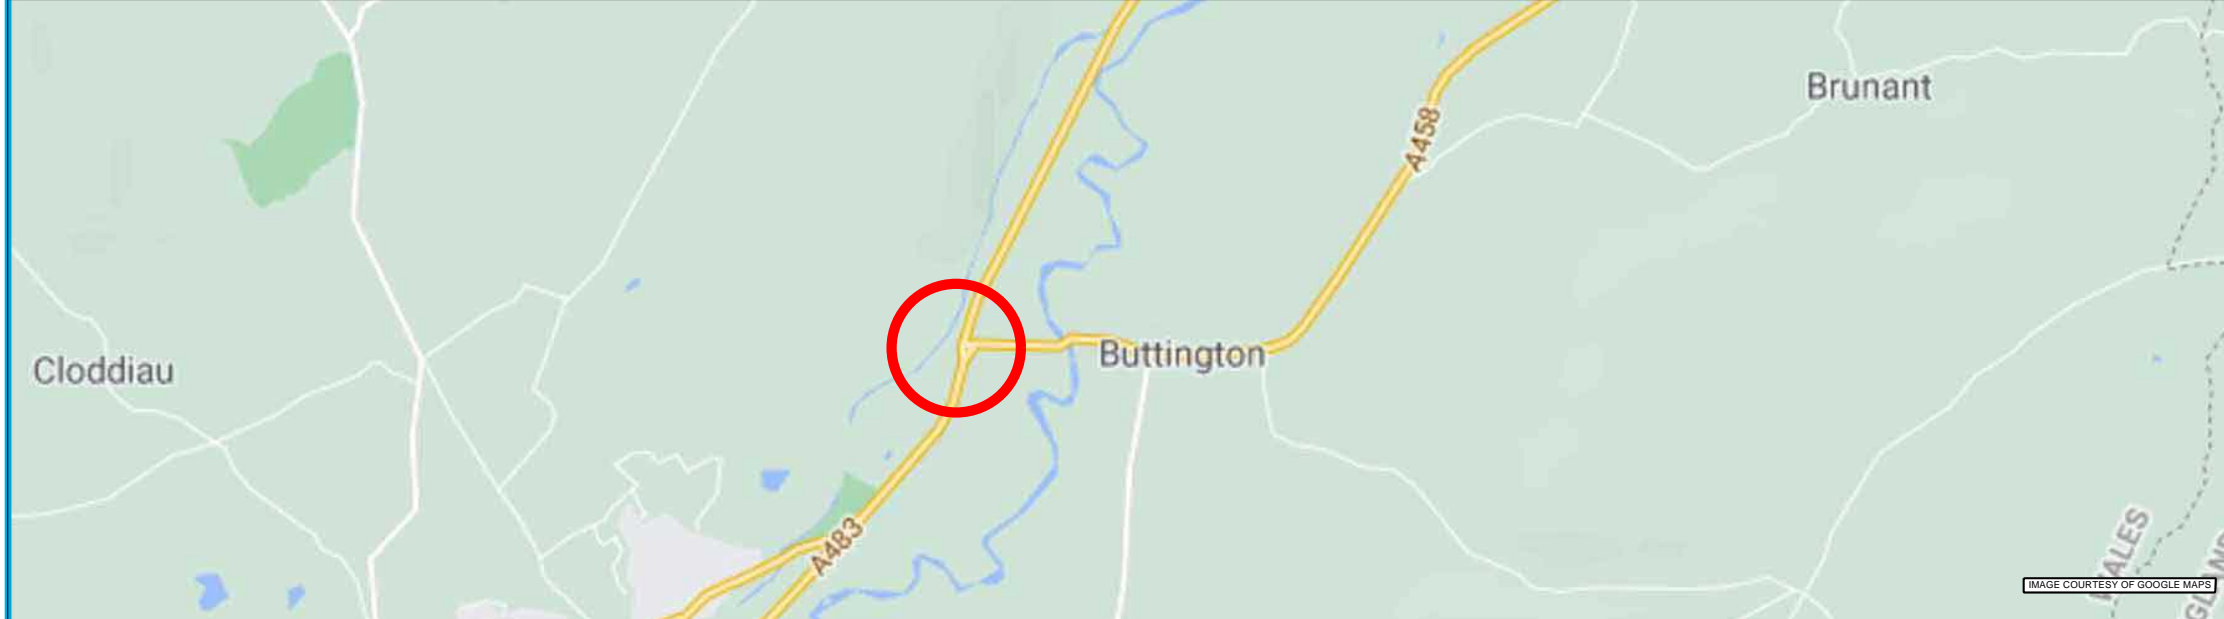
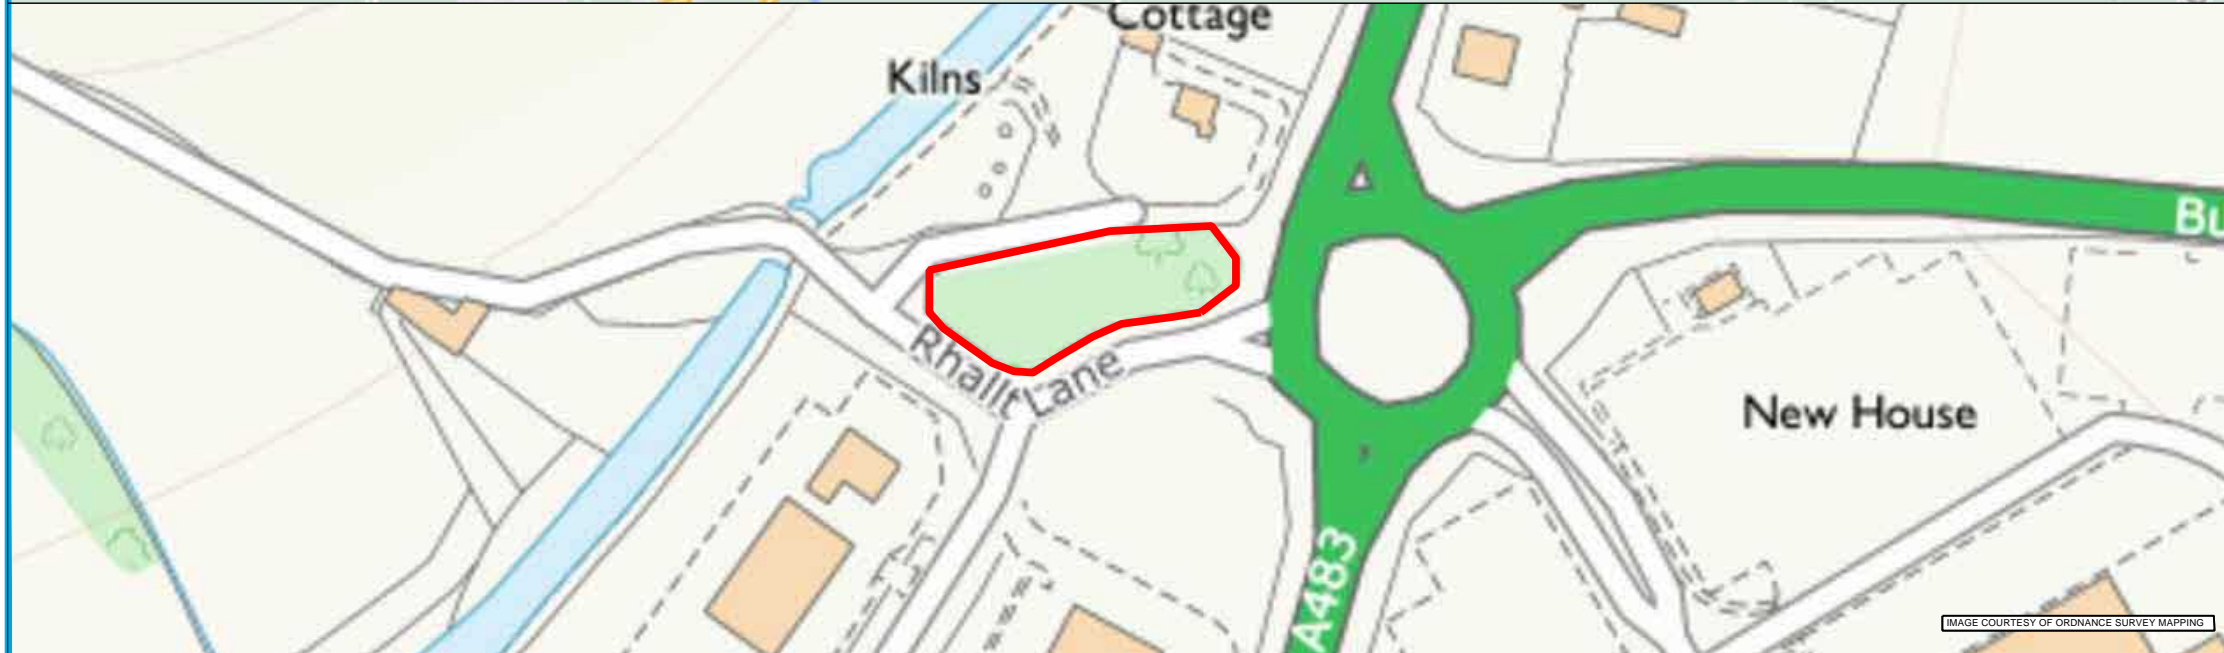
SITE LOCATION PLAN

1.2.2 The site location and site layout are presented on BEK Drawing No 20771-1 and BEK Drawing No 20771-2, respectively. Copies of these drawing are presented in Appendix D.

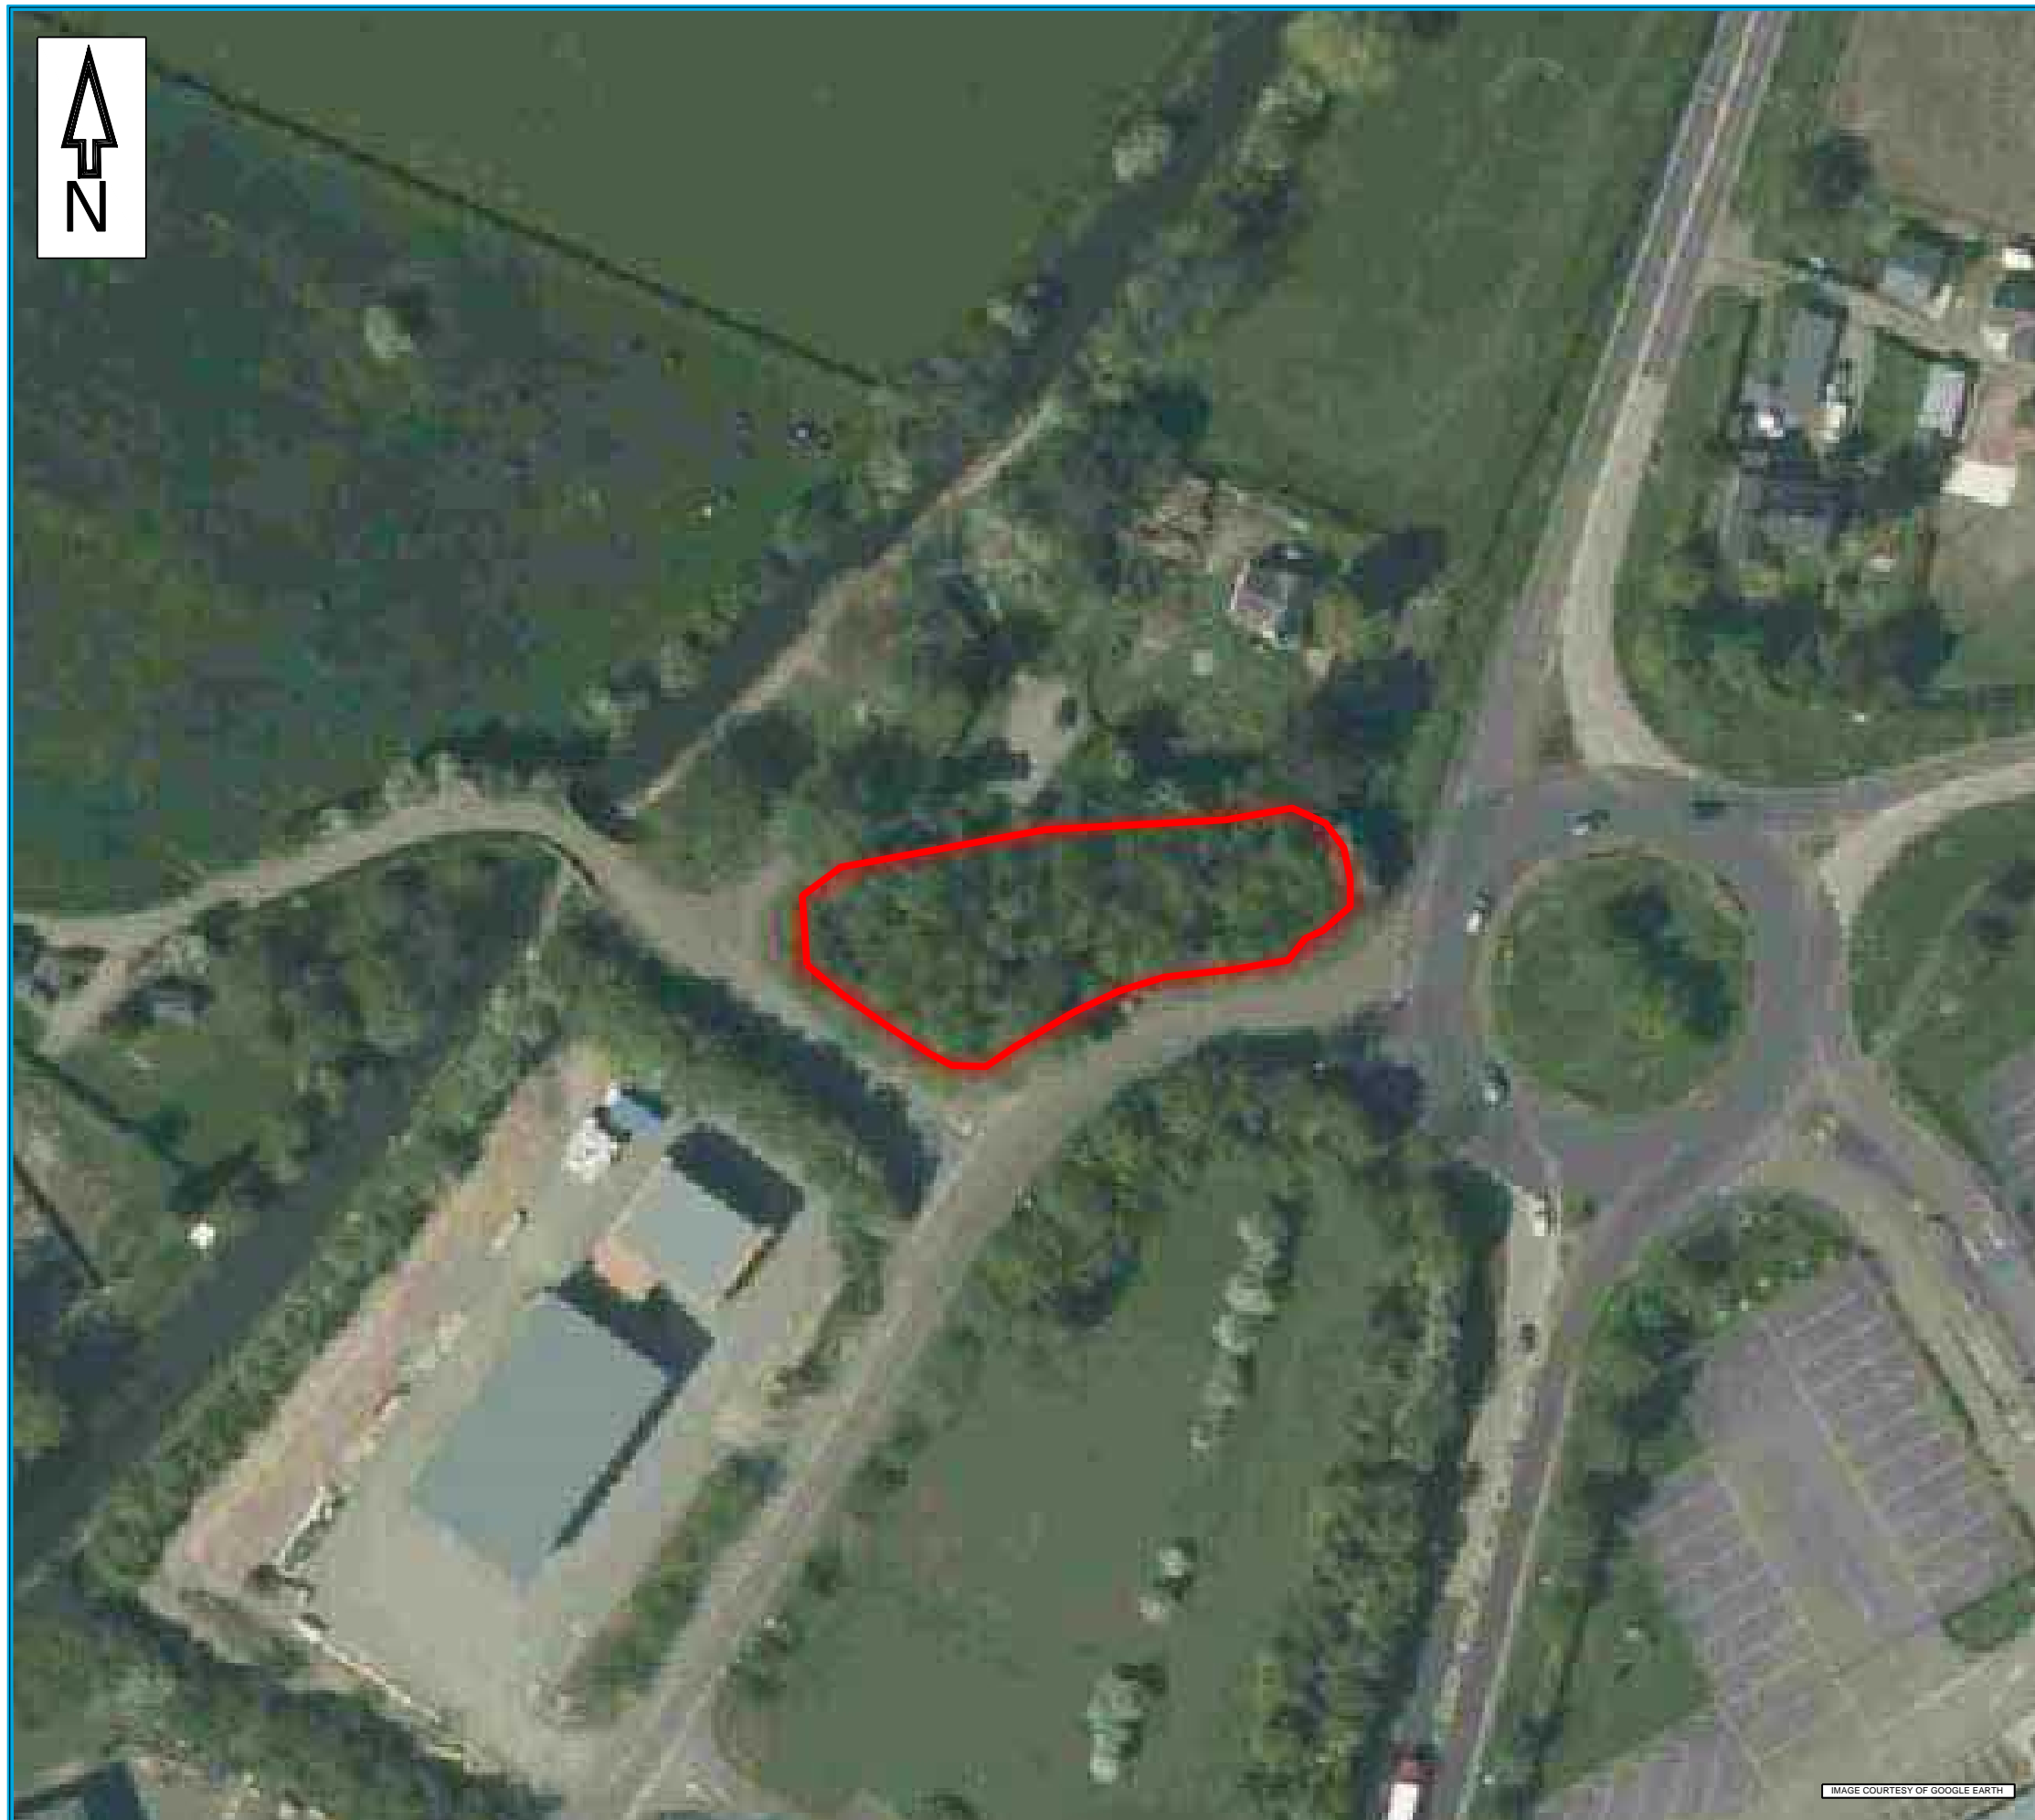
DRAWING No. 20771-2	REV. -
------------------------	-----------

2.1.3 The site location and site layout are presented on BEK Drawing No 20771-1 and BEK Drawing No 20771-2, respectively. Copies of these drawing are presented in Appendix D.

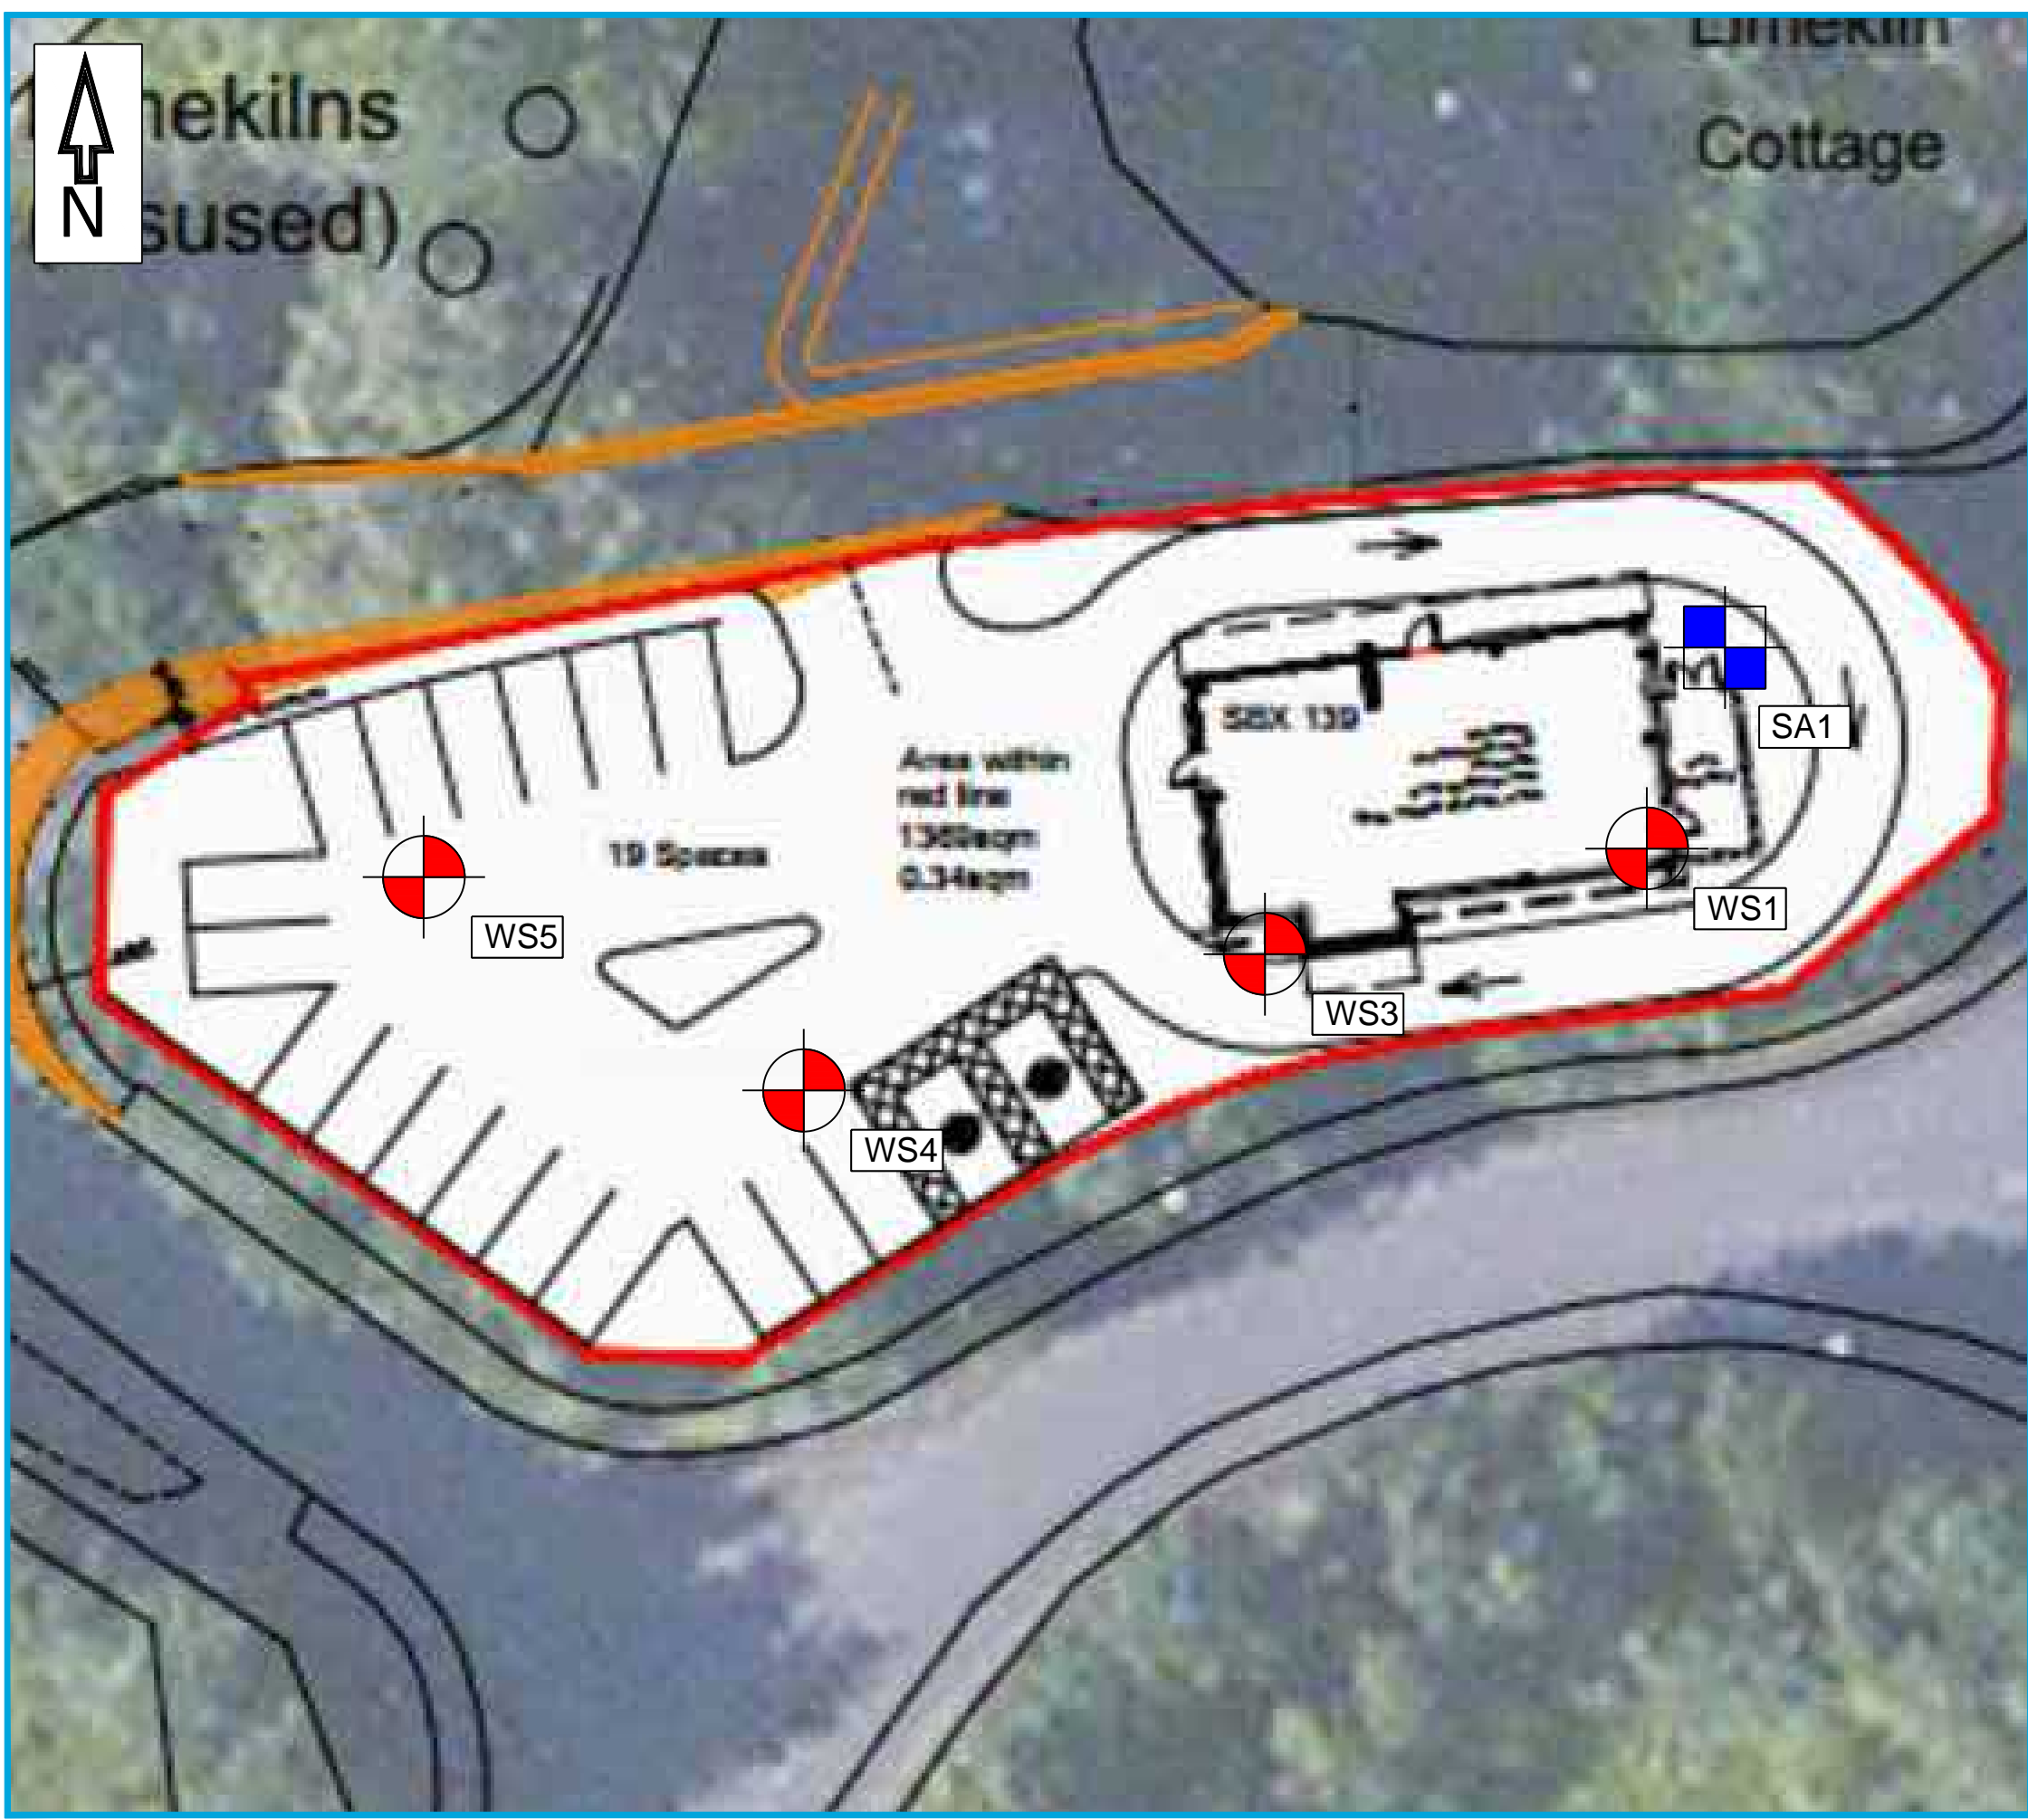
SITE INVESTIGATION
LOCATION PLAN

3.1.3 Five exploratory locations were set out by the site engineer and the exploratory locations are illustrated on BEK Drawing No 20771-3, a copy of which is presented in Appendix D.

3.2.3 The window sample borehole locations are illustrated on BEK Drawing No 20683-3 presented in Appendix D.

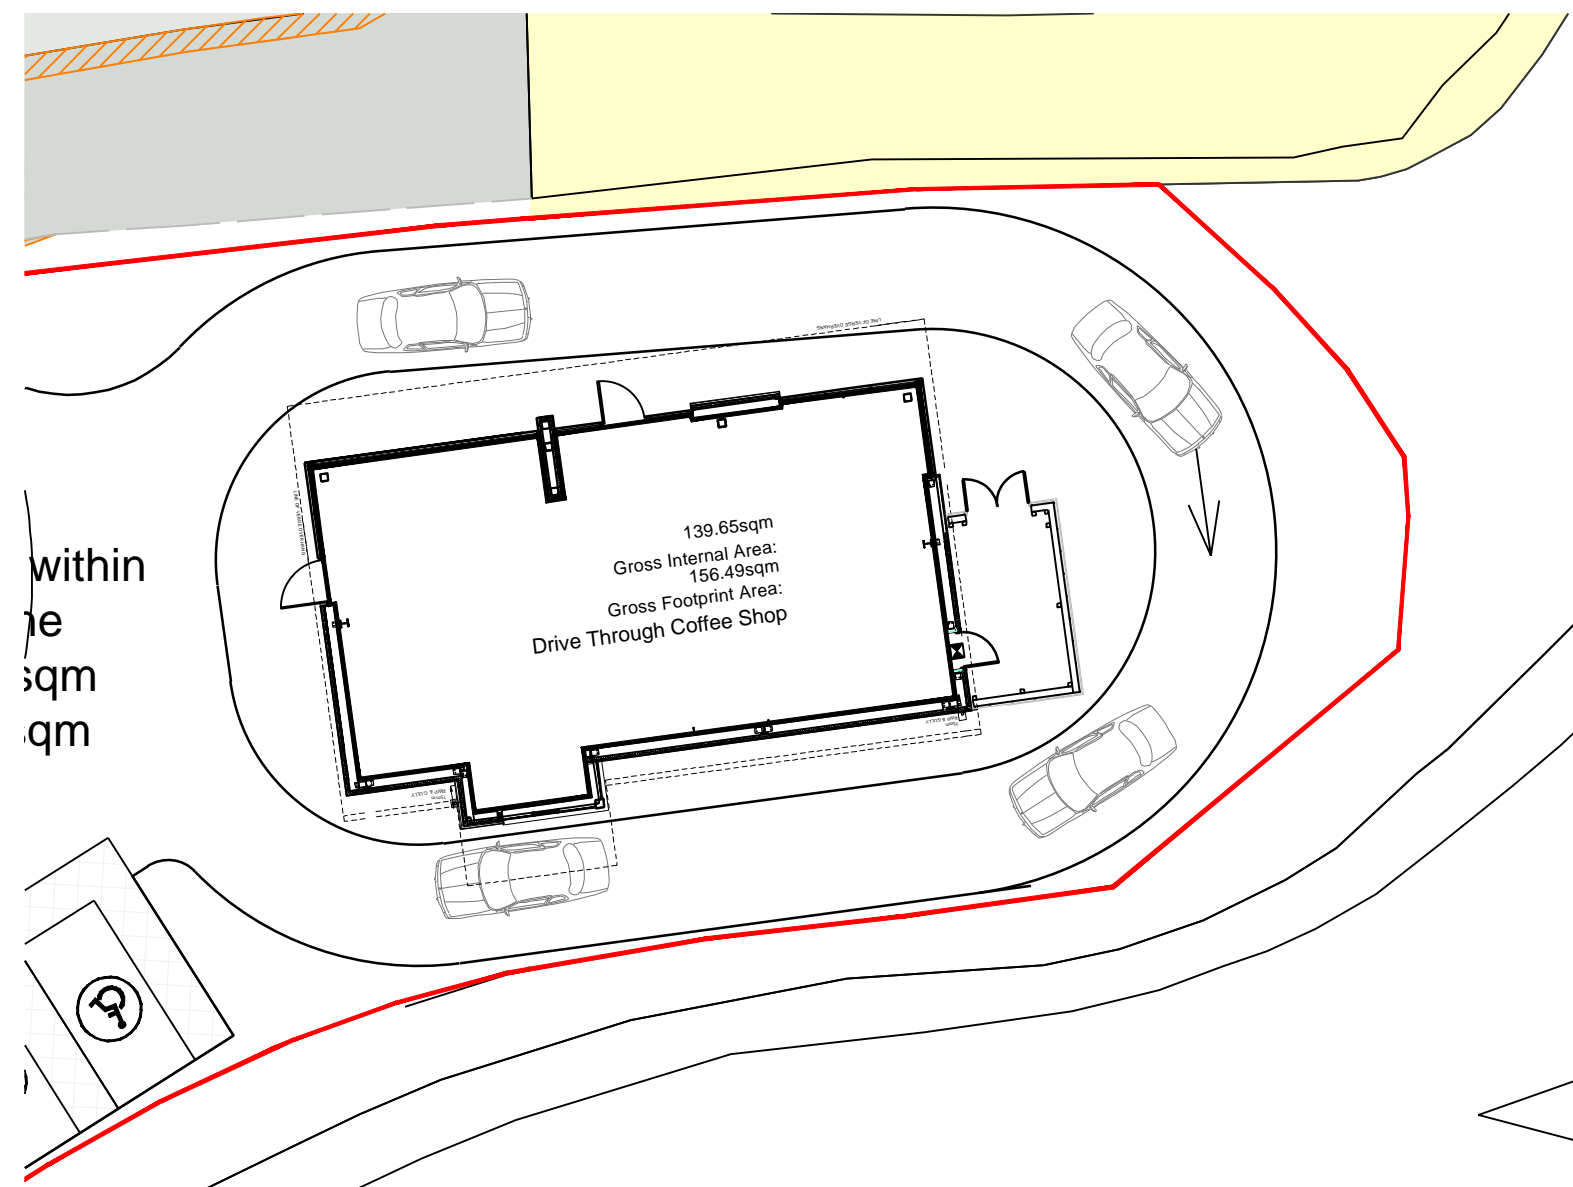
1.3.1 It is proposed to construct a drive through coffee shop associated access/exit and car parking at the site. The proposed development can be seen on REV-A Associates Drawing entitled 'Retail A1 Drive Thru Option' dated 16 September 2019, Drawing Number 'SHR17056-REVA-SE-A-035', a copy of which is presented in Appendix D.
