DRAINAGE STATEMENT Phase 1b

Phase 1b, Lime Kiln Cottage, Welshpool

KIM Properties Ltd

SBK-23-118-C-502

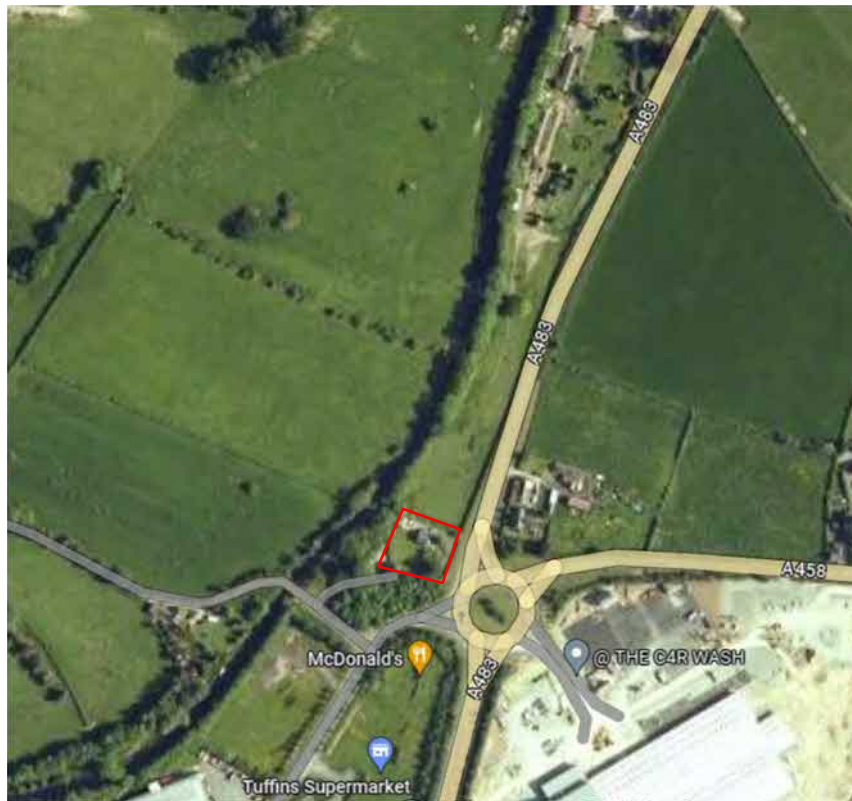
Figure 1 - Site location with approximate Phase 1b boundary (source Google Maps)

2.04 The site is currently occupied by a cottage, Lime Kiln Cottage, an access road, historic lime kilns and vegetation. The south-east corner of the site was formerly a copse.

2.05 The site slopes from the west to east from approximately 76.16m AOD to 73.89m AOD. A topographical survey of the site undertaken by Battlefield Land Surveys Ltd in May 2023 can be found in Appendix 2.

2.03 A Google Map screenshot of the site location is shown below in Figure 1. A location plan can be found in Appendix 1.

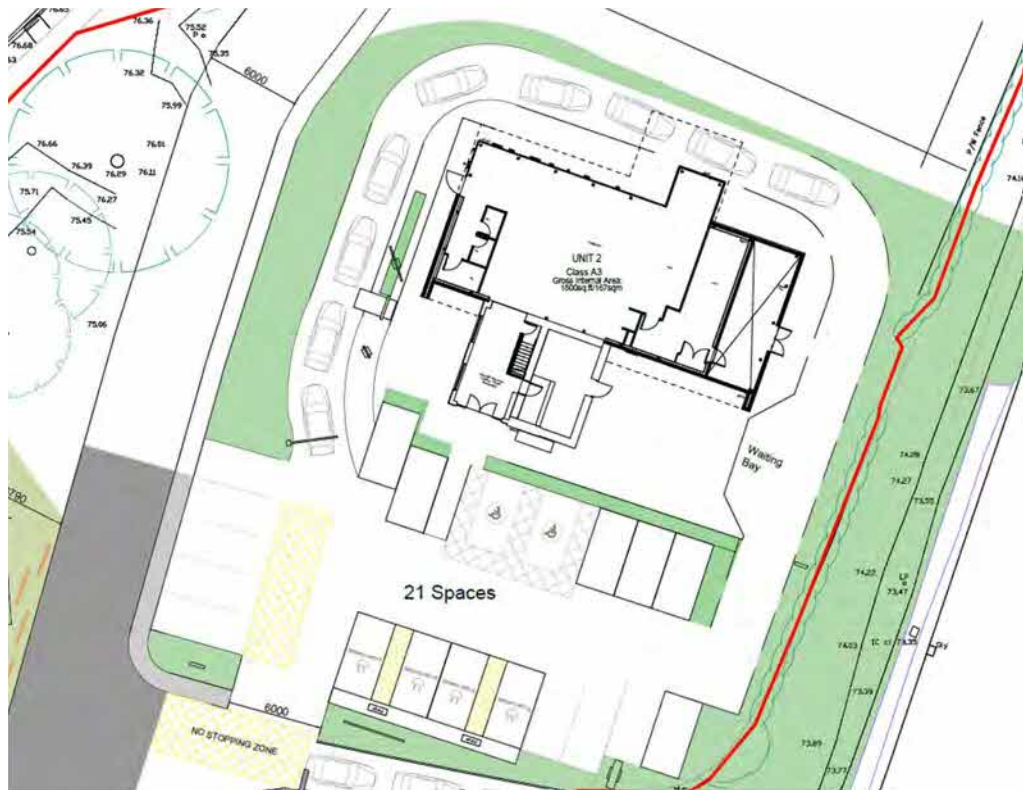
Figure 2 - Proposed Masterplan (by Rev-A Associates)

3.01 The development proposal will provide 1800 sq m of Class A3 floorspace with associated drive thru lane and car parking.

3.02 Figure 2 below shows an extract of the proposed masterplan. The full drawing can be found in Appendix 4.

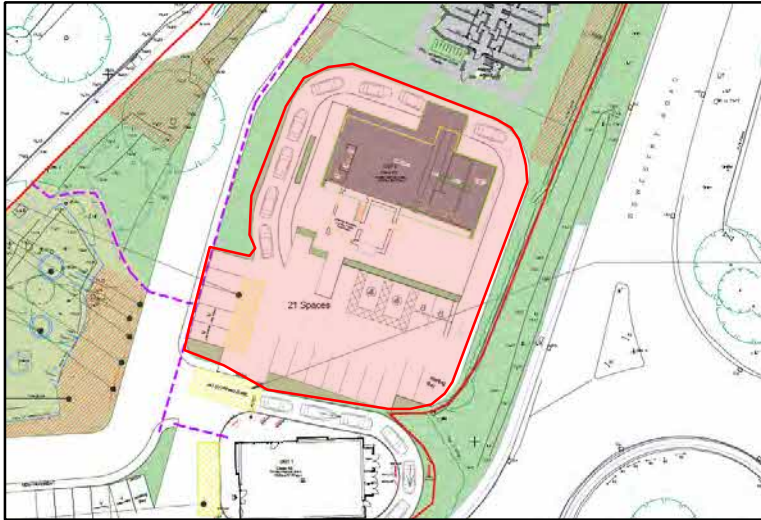
Figure 1: Red Line Site Boundary

1.3.3 The area to which this site investigation and contamination assessment report applies is highlighted in red in Figure 1.

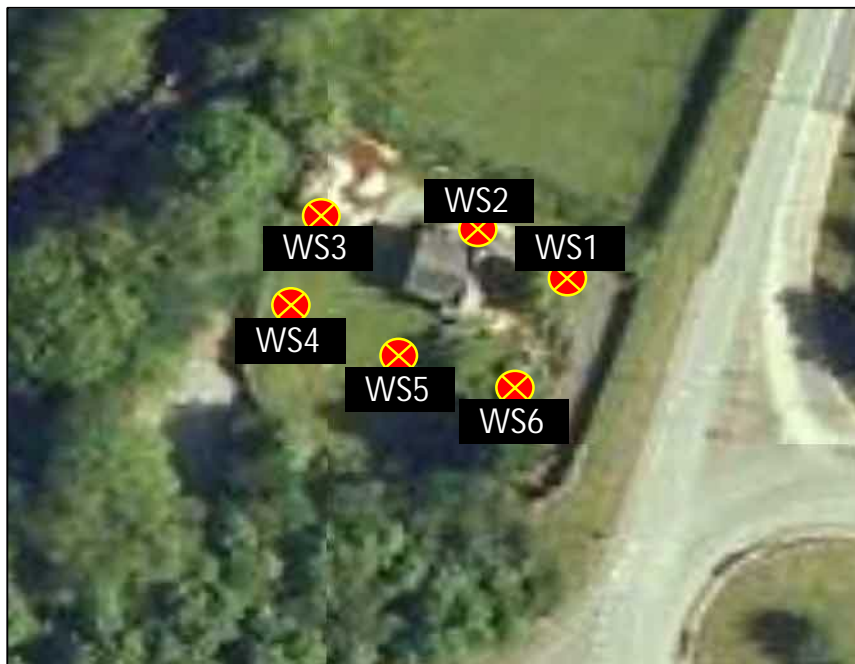
Figure 2: Borehole Location Plan

3.1.3 Six exploratory locations were initially set out by the site engineer and the exploratory locations are illustrated on Figure 2 below.

3.1.4 Note, it was not possible to drill Borehole No WS4 due to the presence of a septic tank and services in this location. However, BEK considers a reasonable spatial spread has been achieved across the site.
