Unit 3, 5 Fore Street, Chudleigh, Devon TQ13 0HX

23rd January 2024

RE: 39 Lopez Road, Plymouth – Ecological Assessment (Updated)

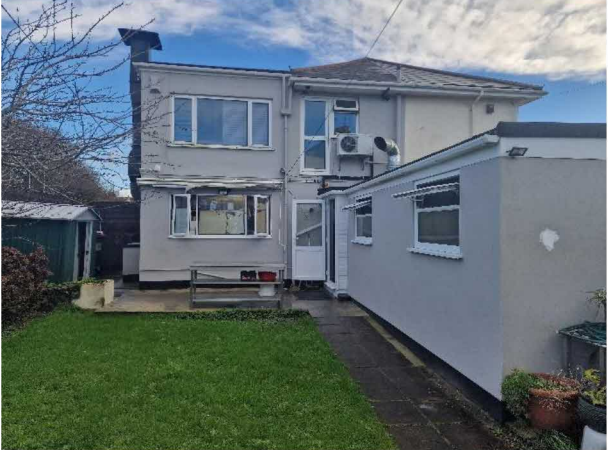
Notes	Photograph
Rear elevation and garden area to be affected.

The ridge and roof tiles of the main building were mainly all tight with no suitable gaps for bats to access, although the roof will not be affected by the proposals. The existing single storey flat roofed extension has no features suitable for bats, the fascia boards are tight into the wall with no gaps.

The area to be built on for the rear single-storey extension is a small area of concrete patio and amenity grass lawn, which has very limited ecological value. There is a possibility that common

A photograph showing the rear elevation of a two-story house. The house has a grey exterior and a white door. There are several windows, some with white frames. A small garden area with green grass is visible in the foreground. A paved path leads to the back door. To the right, there is a smaller, single-story extension of the house. The sky is blue with some clouds.

There are limited opportunities to provide appropriate biodiversity enhancements to this property, however, to achieve a biodiversity net gain it is proposed to include an extensive green roof on the new extension (**Table 2**). An extensive green roof is largely self-perpetuating and low maintenance, planted with sedum, mosses and low grasses on a thin substrate to minimise weight.
