**The Olde Ship, School Lane, Pilling, Preston,
PR3 6HB.**

Bats: Building Inspection and Surveys

Ref: SE/ARQ008/01

January 2023

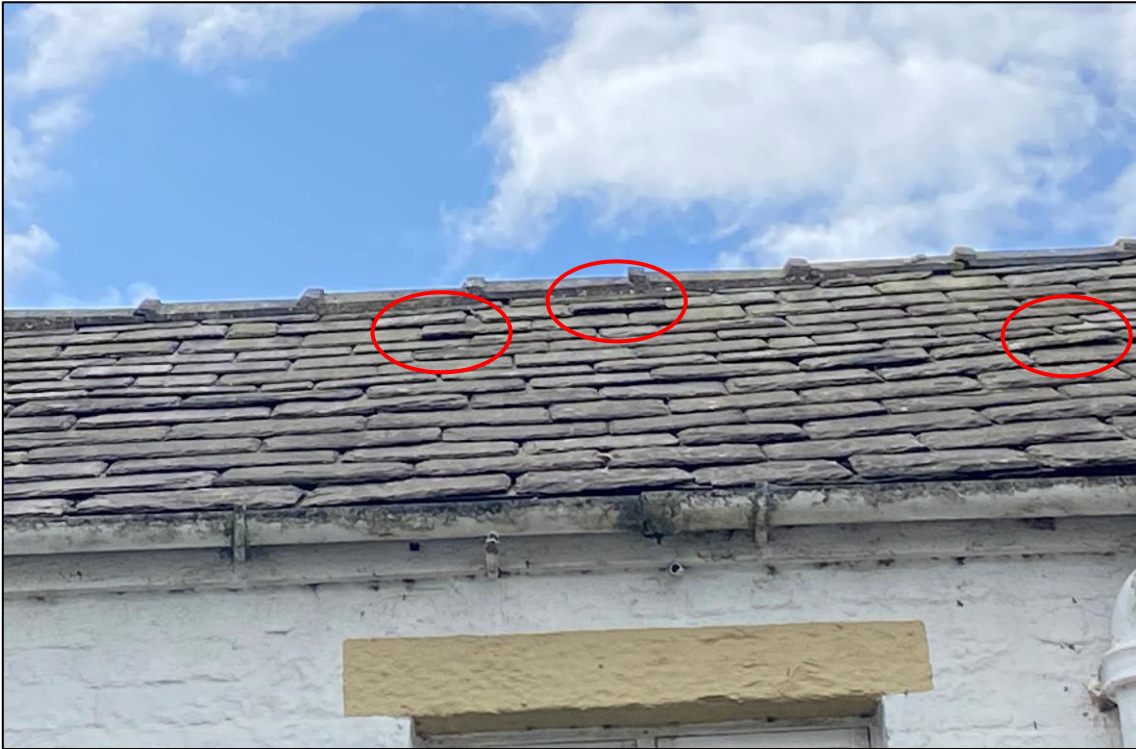
- 3.1.2 The pitched roof and ridges were overall in good condition. The ridge tiles were generally tight fitting with no gaps. However, numerous gaps were apparent beneath slate tiles which offer Potential Roost Features (PRFs) for bats (see Plate 3). The coping stones on the gable end of the barn had cracks in the mortar between and beneath the stones, offering PRFs (see Plate 4). Gaps were apparent along the verges of the lean-to garage roof at the rear of the barn which offers roosting potential (see Plate 5).

Plate 3: The pitched roof and ridges were generally in good condition but with lots of gaps beneath slate tiles offering PRFs.

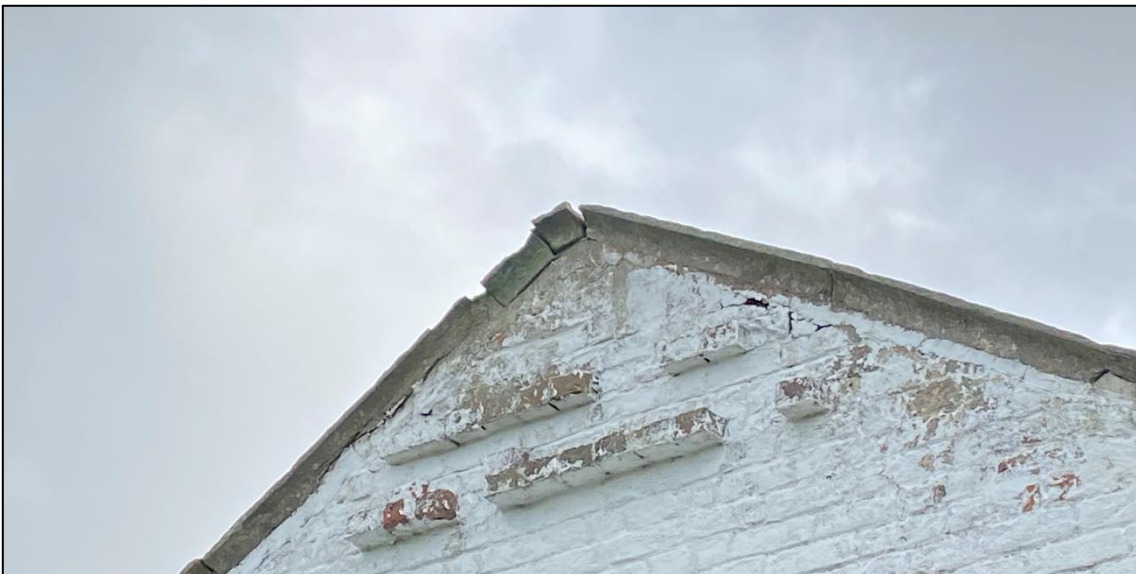
Plate 4: Cracks in the mortar beneath and between coping stones offers gaps for roosting.

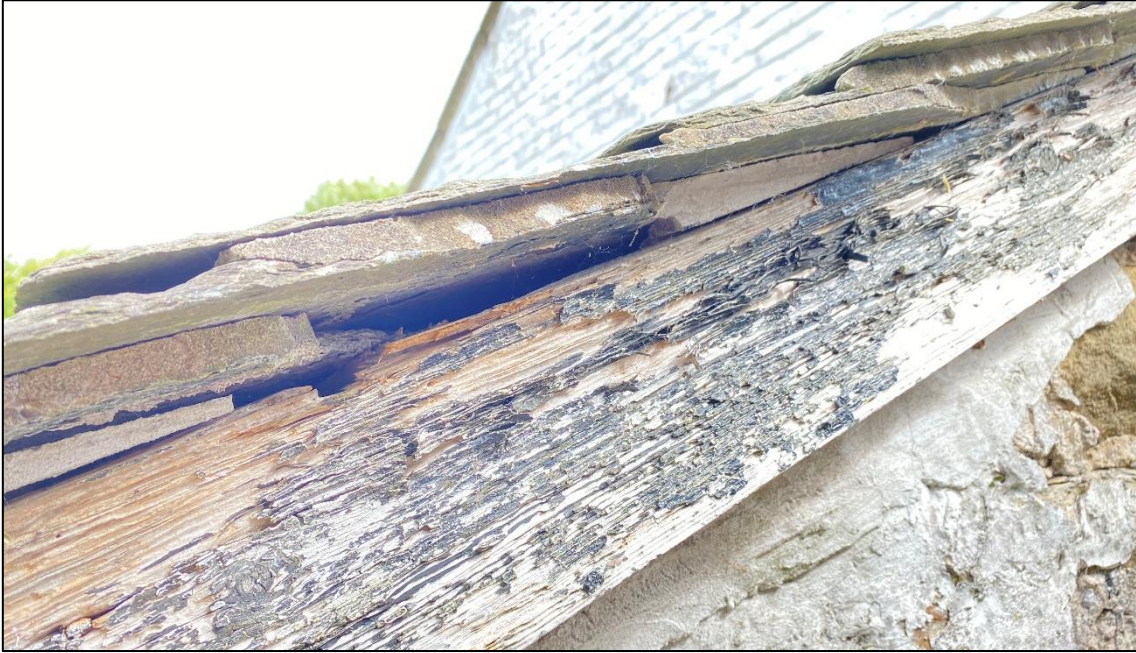
Plate 5: Gaps in the verges of the lean-to garage roof, offering PRFs.

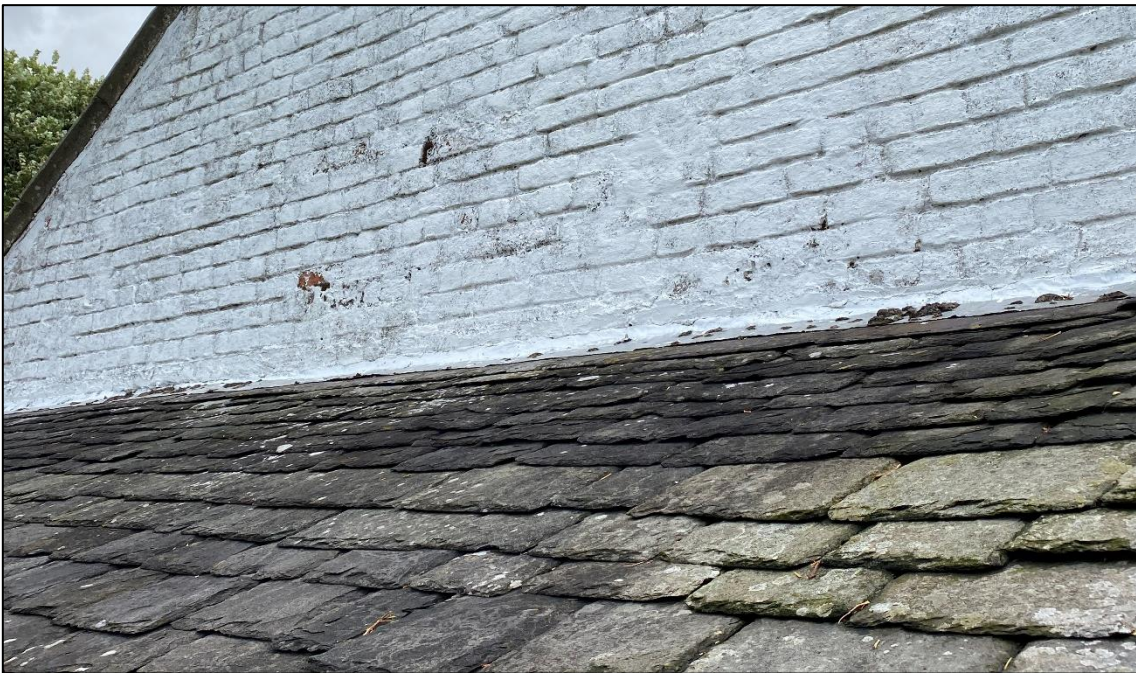
- 3.1.3 Flashing between the garage lean-to roof and the gable of the rear barn was in good condition and well-sealed, offering no PRFs (see Plate 6).
- 3.1.4 The roof of the outbuilding was generally in good condition. Ridge tiles and slate tiles were intact and tight fitting, offering no PRFs (see Plate 7). However, large gaps were apparent along the verges of the outbuilding which offer access into the internal spaces and offers roosting potential (see Plate 8).

Plate 6: Flashing between the lean-to garage roof and gable of the barn was well sealed.

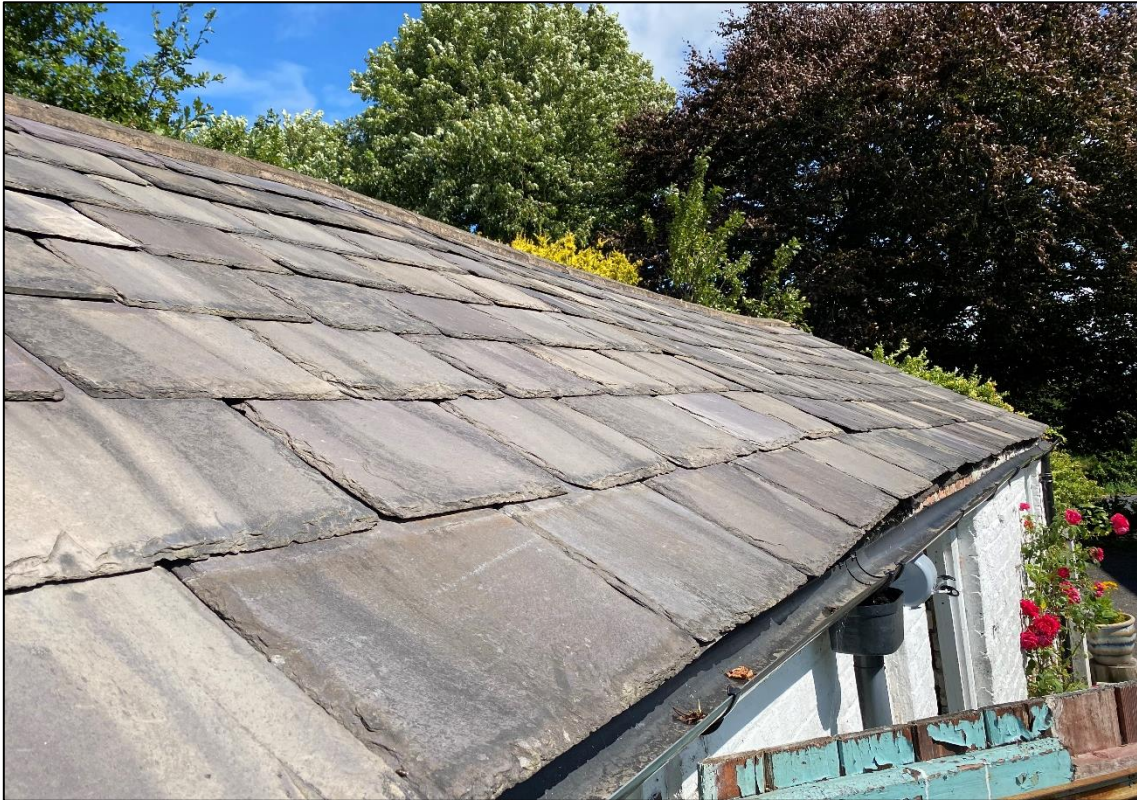
Plate 7: Slate tiles and ridge tiles on the outbuilding were generally tight fitting and in good condition.

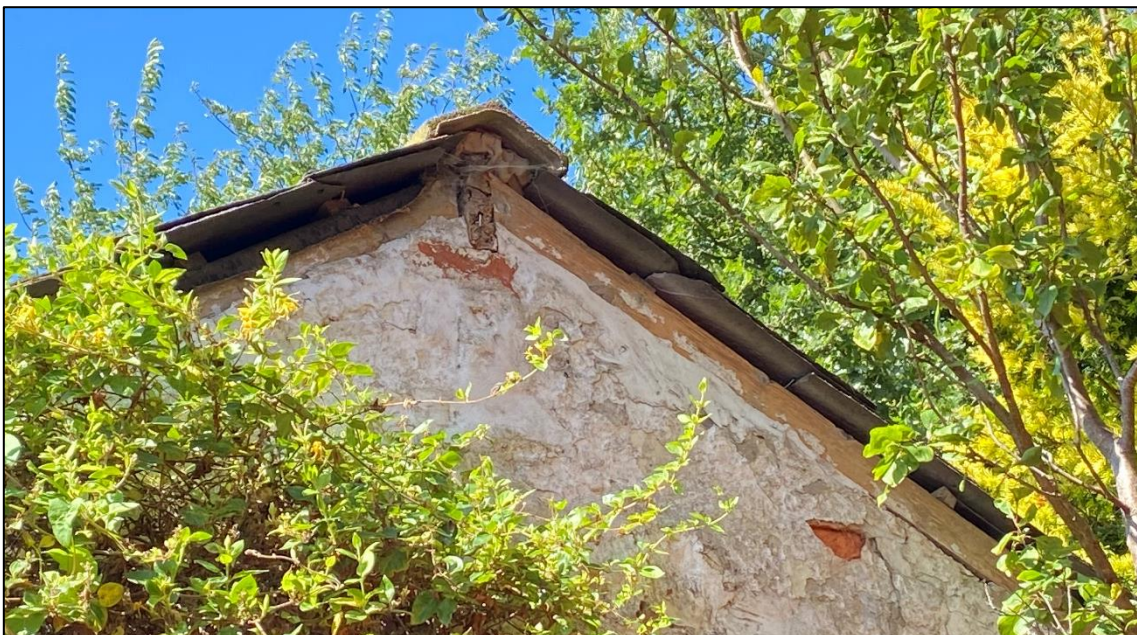
Plate 8: Verges of the outbuilding had large gaps apparent offering potential roost features and offering access into the internal spaces.

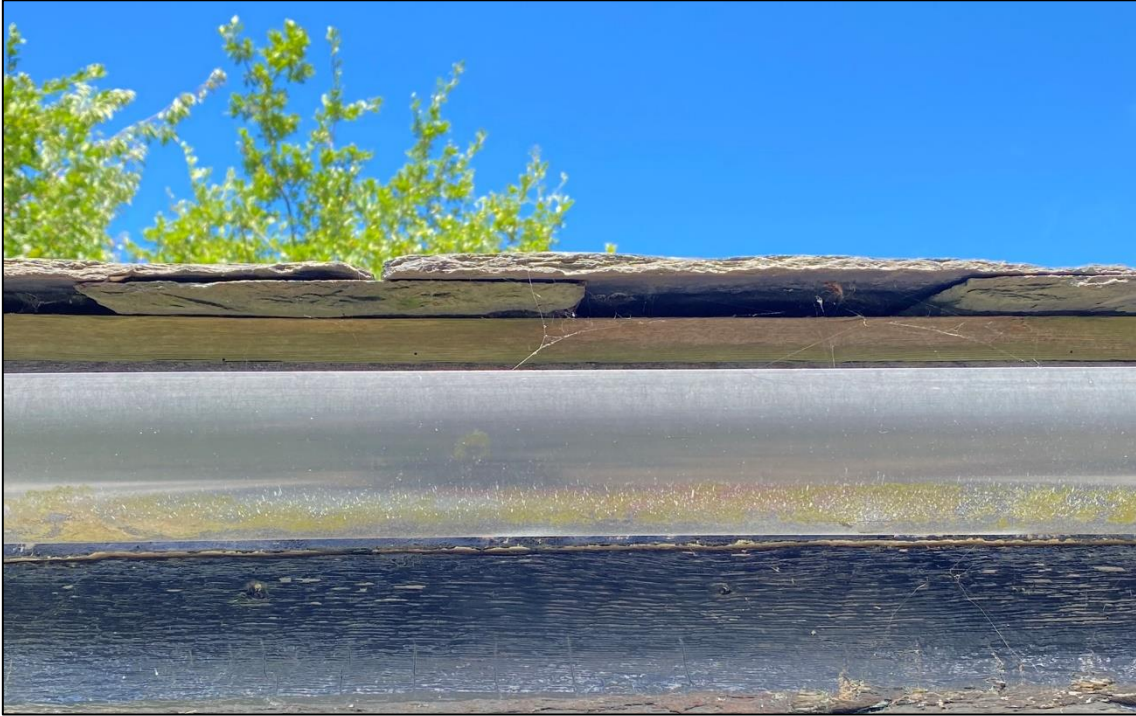
- 3.1.5 Fascia boards were generally tight fitting and had guttering attached, offering no PRFs. However, gaps under slate tiles along the roof edge offer PRFs and access for bats into the internal spaces (see Plate 9).

Plate 9: Fascia boards had guttering attached and were generally tight fitting. Gaps under slates along the roof edge offer PRFs and access for bats.

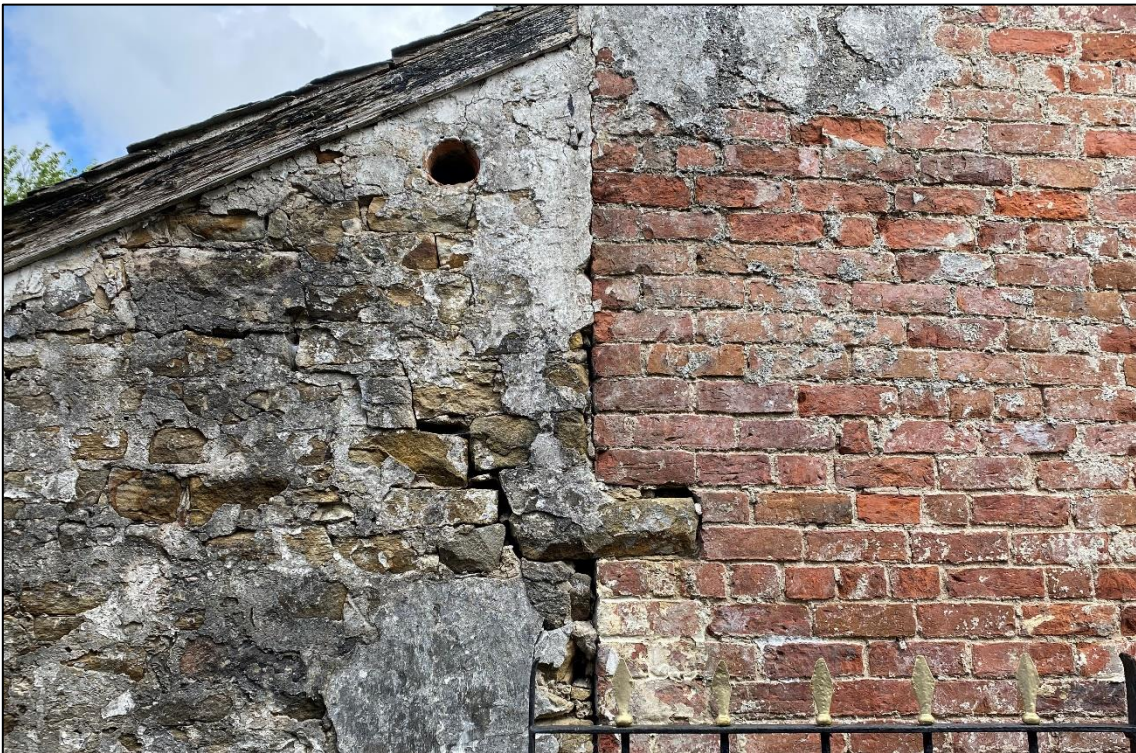
- 3.1.6 There were large gaps and cracks in the brickwork of the main building which offer roosting potential (see Plate 10). These cracks/gaps were inspected with an endoscope and no evidence of bat presence or activity (e.g., staining, droppings, discarded prey items) were found (see Plate 11).

Plate 10: Large gaps and cracks in the brickwork of the main building offer PRFs.

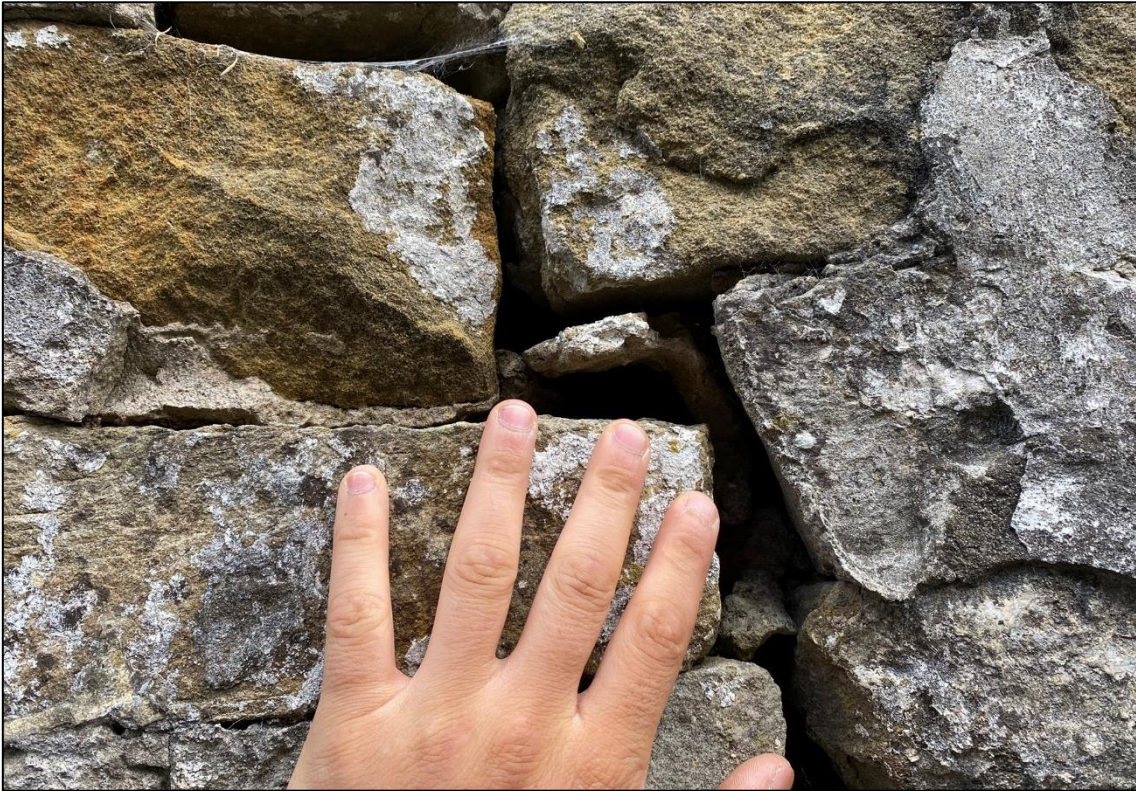
Plate 11: Large gaps were inspected with an endoscope and no evidence of bat presence or activity were found.

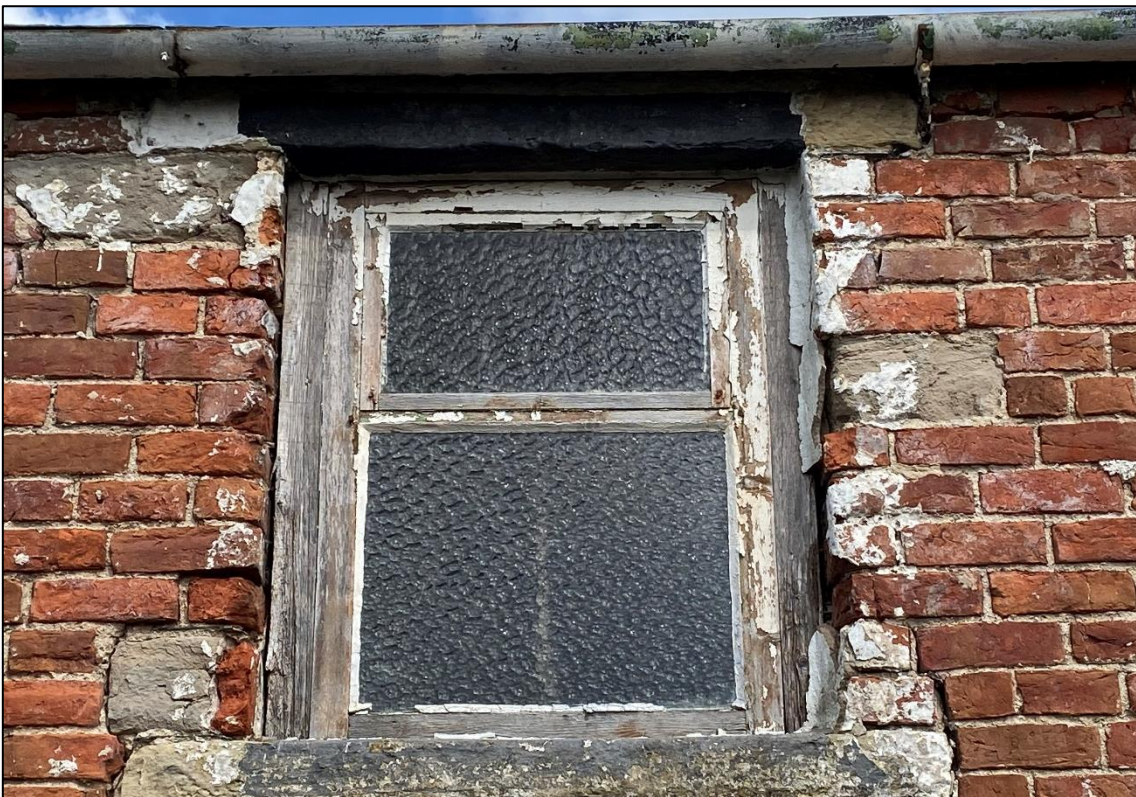
- 3.1.7 Windows and doors around the site were generally intact and well fitted. However, a window on the south-facing aspect of the rear barn had gaps apparent around the edges of the frame which offers access into the internal spaces for bats and provides potential roosting opportunities (see Plate 12).

Plate 12: Window on the south facing aspect of the rear barn had gaps between the frame and the brick walls, offering PRFs and access into the internal spaces.

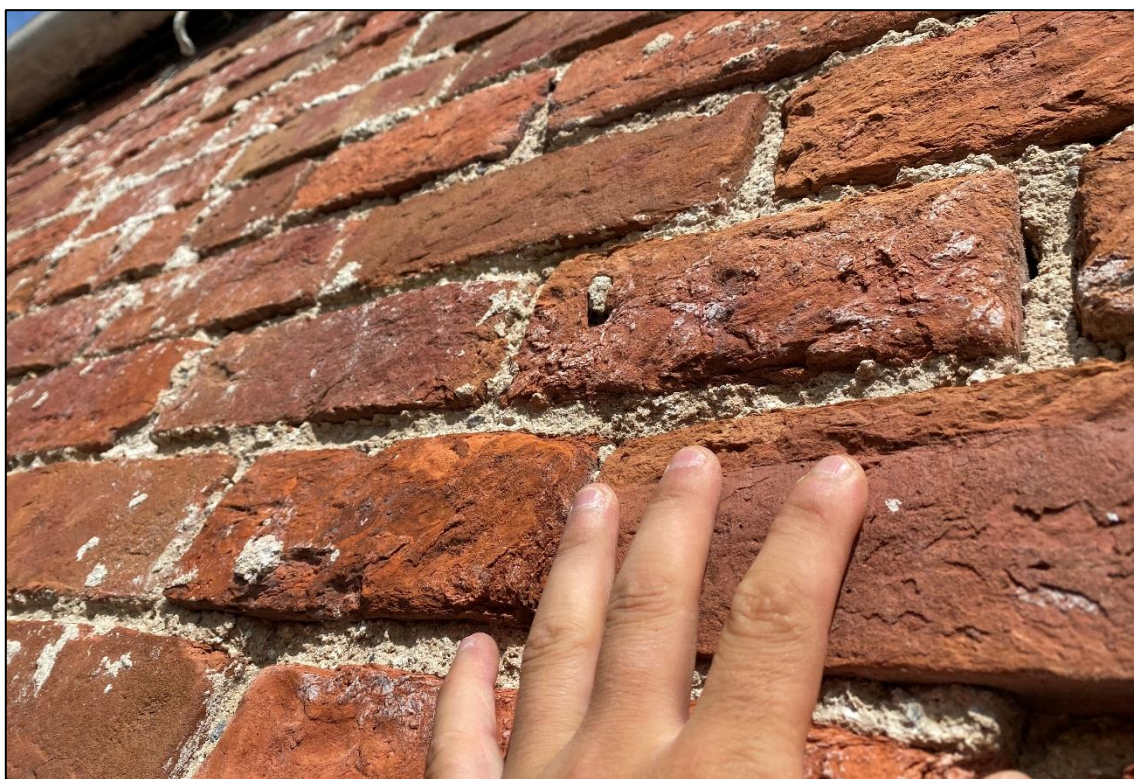
- 3.1.8 The external walls were thoroughly searched for evidence of bat activity (e.g., discarded prey items, droppings). The rough brickwork provides an ideal substrate for bat activity to adhere to and these would have been easily visible if present, but no evidence was found (see Plate 13).

Plate 13: No evidence of bat activity was found on the external surfaces around the site.

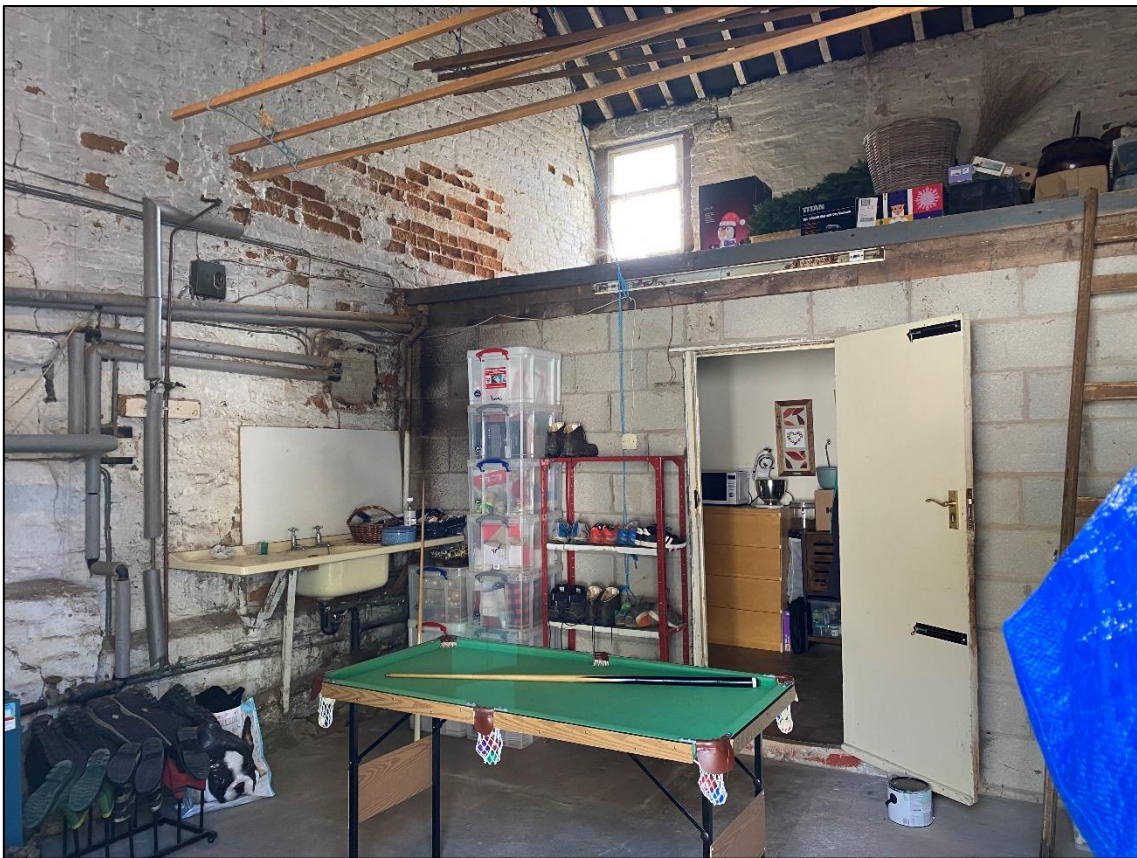
- 3.1.9 The barn was in use and was accessed via the kitchen. The barn consisted of a single open internal space (see Plate 14). The garage to the rear of the barn consisted of a single open internal space (see Plate 15). The outbuilding was divided into three sections, each of which consisted of a single open space with no ceilings (see Plate 16). No bats were present in any of the buildings. All internal spaces were thoroughly searched for evidence of bat activity, and none was found.

Plate 14: The rear barn consisted of a single open internal space which was in-use and accessed via the kitchen.

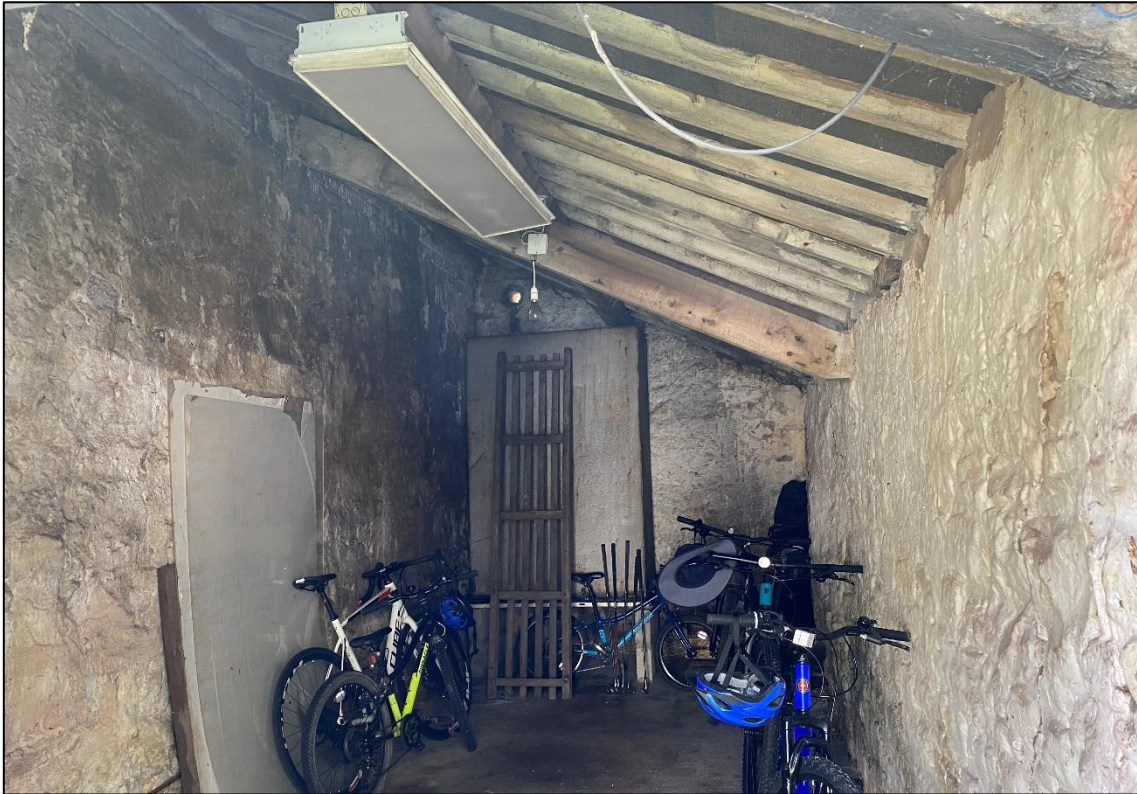
Plate 15: The rear garage consisted of a single open space. No bats were present.

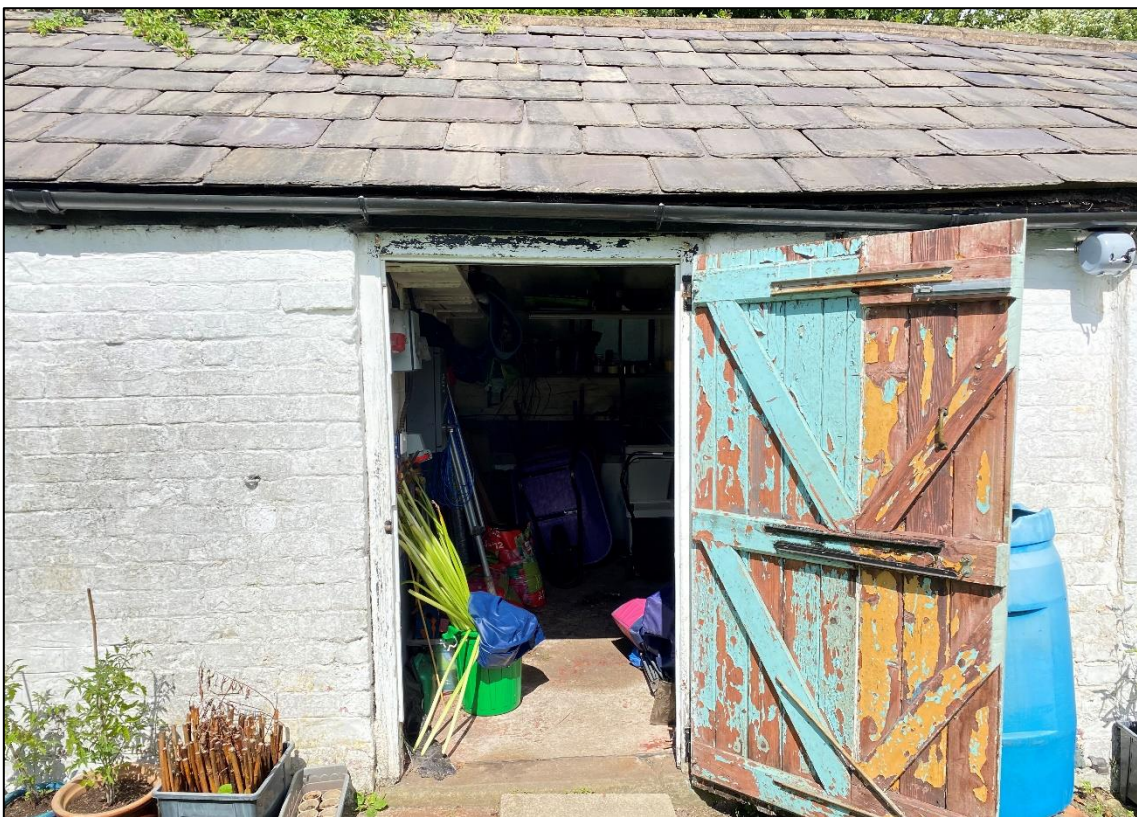
Plate 16: The outbuilding was divided into three sections which were open spaces with no ceilings.

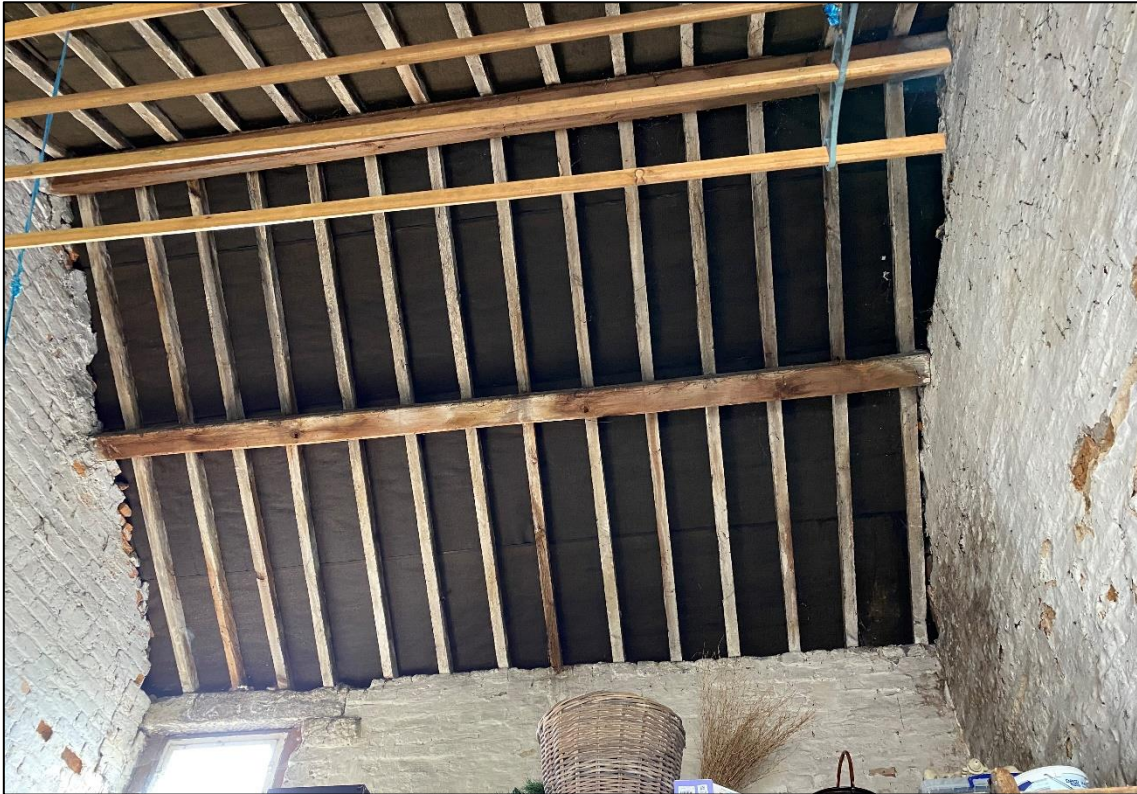
- 3.1.10 The barn building was lined with roofing membrane. The membrane and timber support structures were all exposed and visible with no Potential Roost Features and no bats were present (see Plate 17). Similarly, the lean-to garage roof had exposed timbers and membranes which were intact, and no bats were present (see Plate 18). The outbuilding was divided into three sections. Two of the sections had exposed timbers and membrane and one section had exposed timber boarding beneath the slate tiles (see Plate 19). Although no bats were present in any of the internal spaces, the membranes and timber-boarding posed constraints when looking for evidence of bats. The timber boarding and membranes prevent the underside of the slates from being observed, therefore any bats or bat activity above the membrane would not be seen.

Plate 17: Timbers and membranes in the barn were intact and exposed. No bats were present.

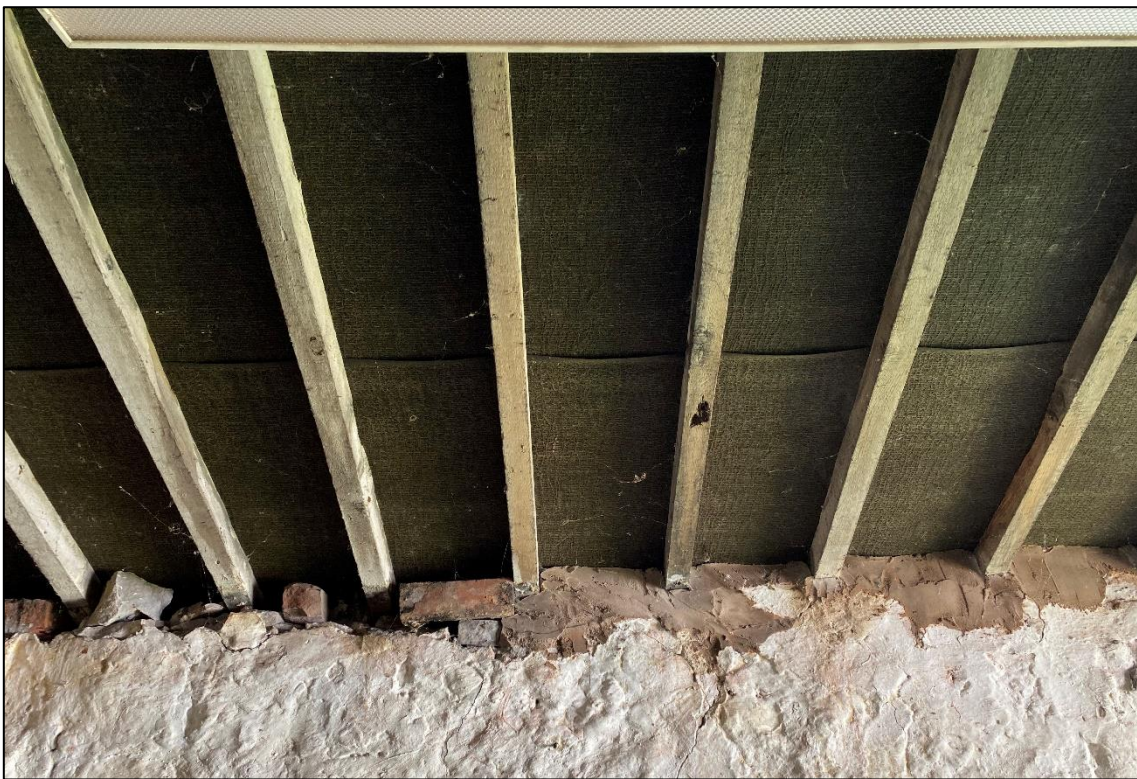
Plate 18: Timbers and membranes in the garage were exposed and intact. No bats present.

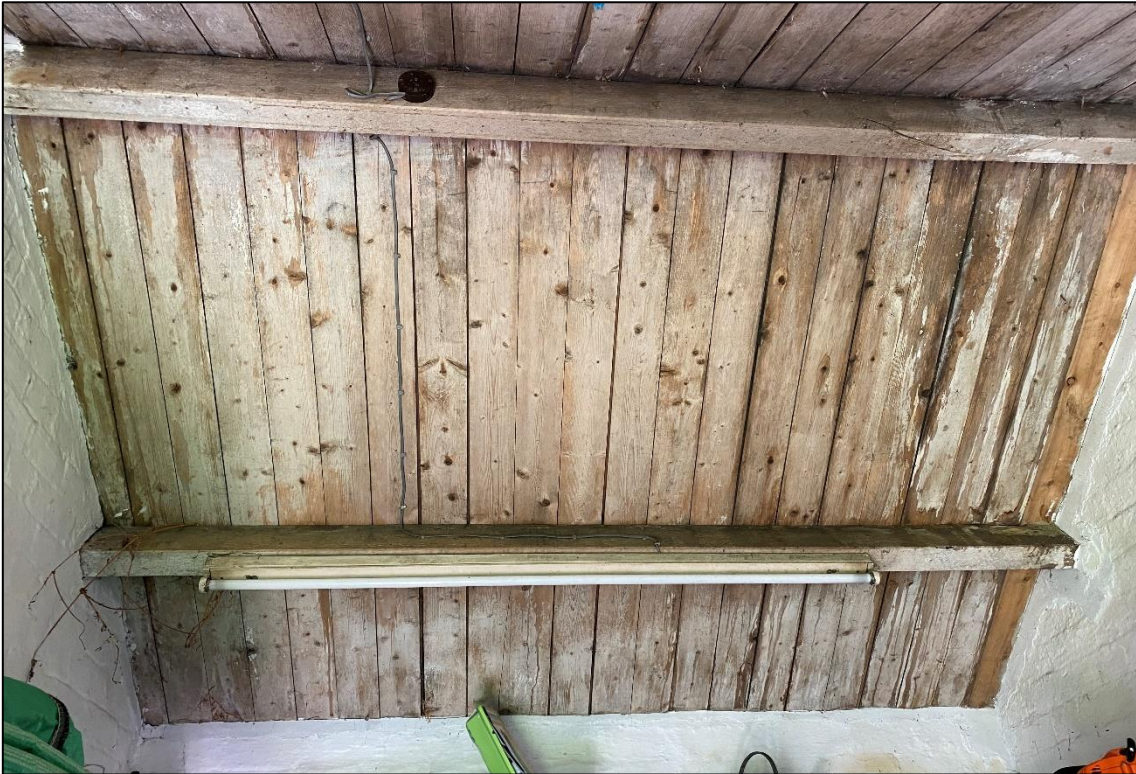
Plate 19: The outbuilding had timber boarding beneath tiles making the underside of the roof un-observable.

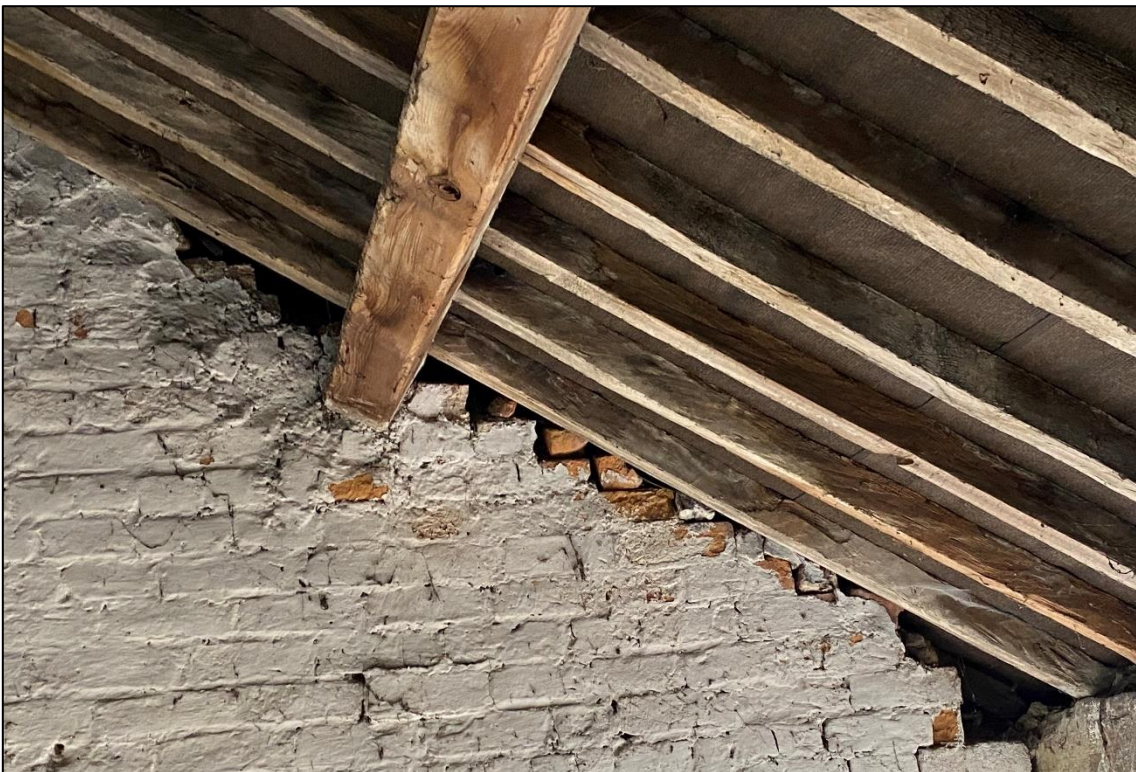
- 3.1.11 Gaps which offer roosting potential were identified on the top of the gable wall in the barn building (see Plate 20) and in the walls of garage building (see Plate 21).

Plate 20: Gaps were apparent on top of the gable wall of the barn, offering PRFs.

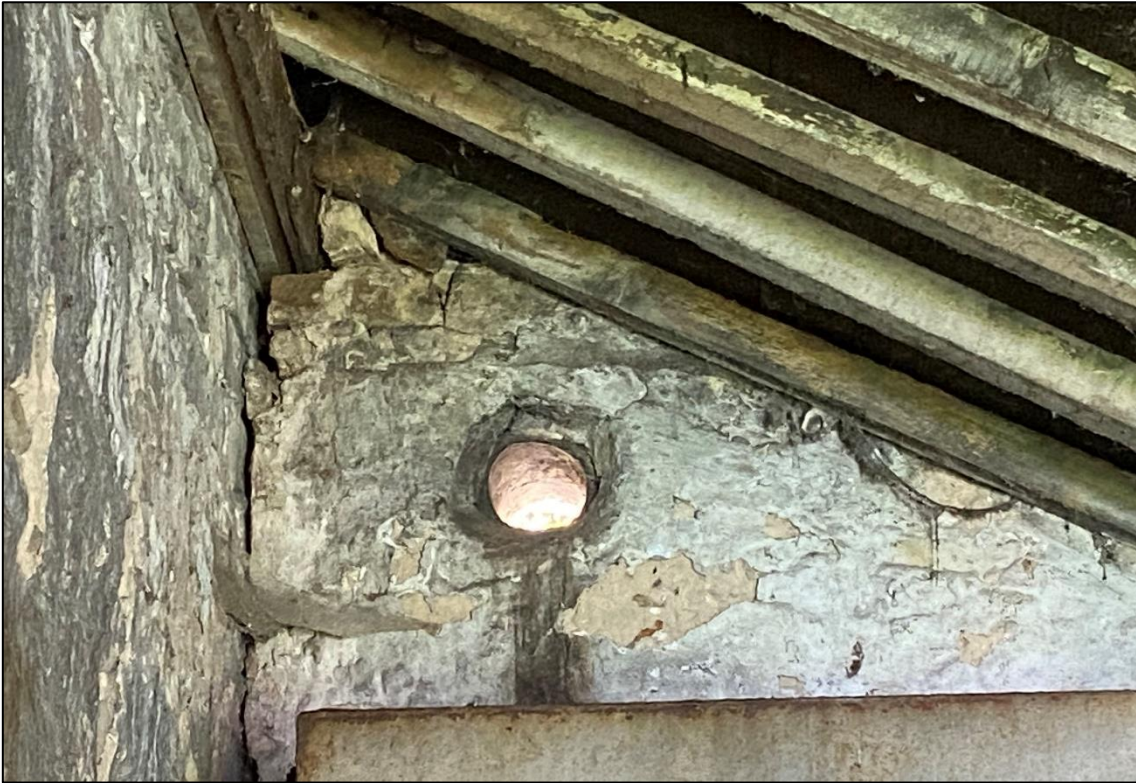
Plate 21: Gaps and cracks offering PRFs were identified in the garage.

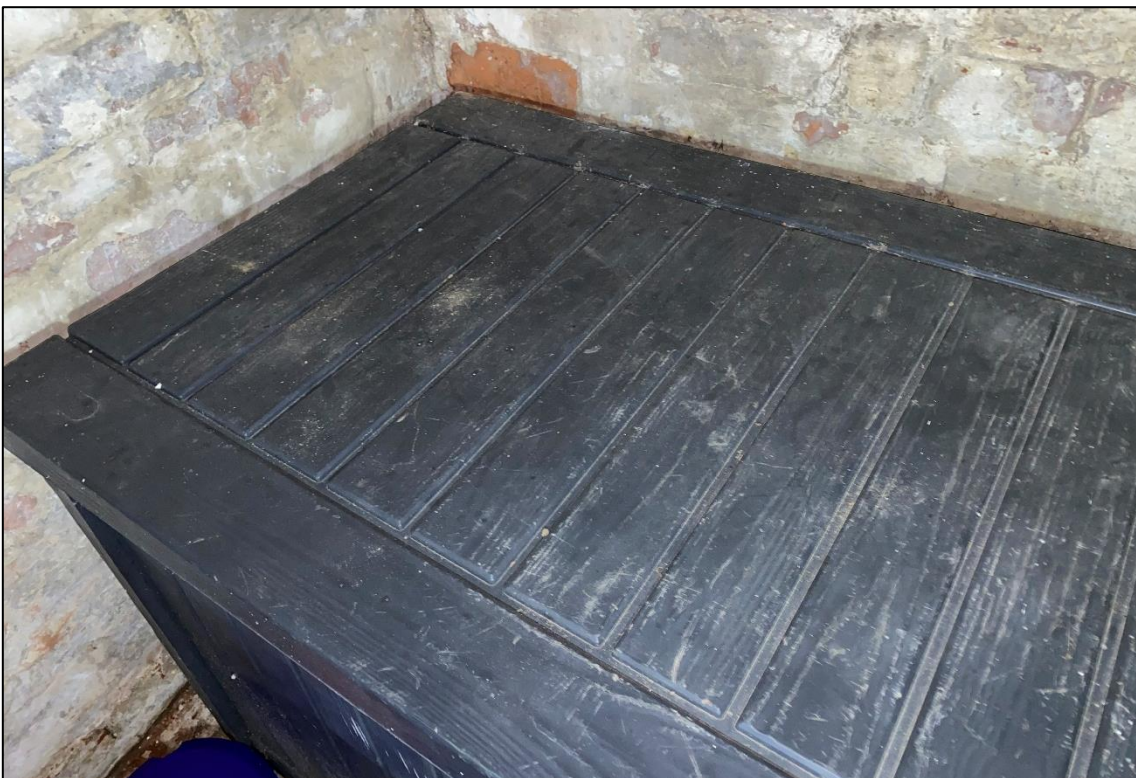
- 3.1.12 Flat surfaces and floors were thoroughly searched for evidence of bat activity (e.g., droppings, discarded prey items) throughout all the internal spaces and no evidence was found (see Plate 22, Plate 23). However, floors were tidy and regularly swept therefore any bat activity, if present, would likely not be found.
- 3.1.13 The interior walls around the internal spaces were thoroughly searched for evidence of bat activity. The brickwork provides an ideal substrate for bat activity to adhere to and this would have been easily visible, especially against the contrasting white paint, but no evidence was found (see Plate 24).

Plate 22: Flat surfaces throughout the internal spaces were searched for evidence of bat activity and none was found.

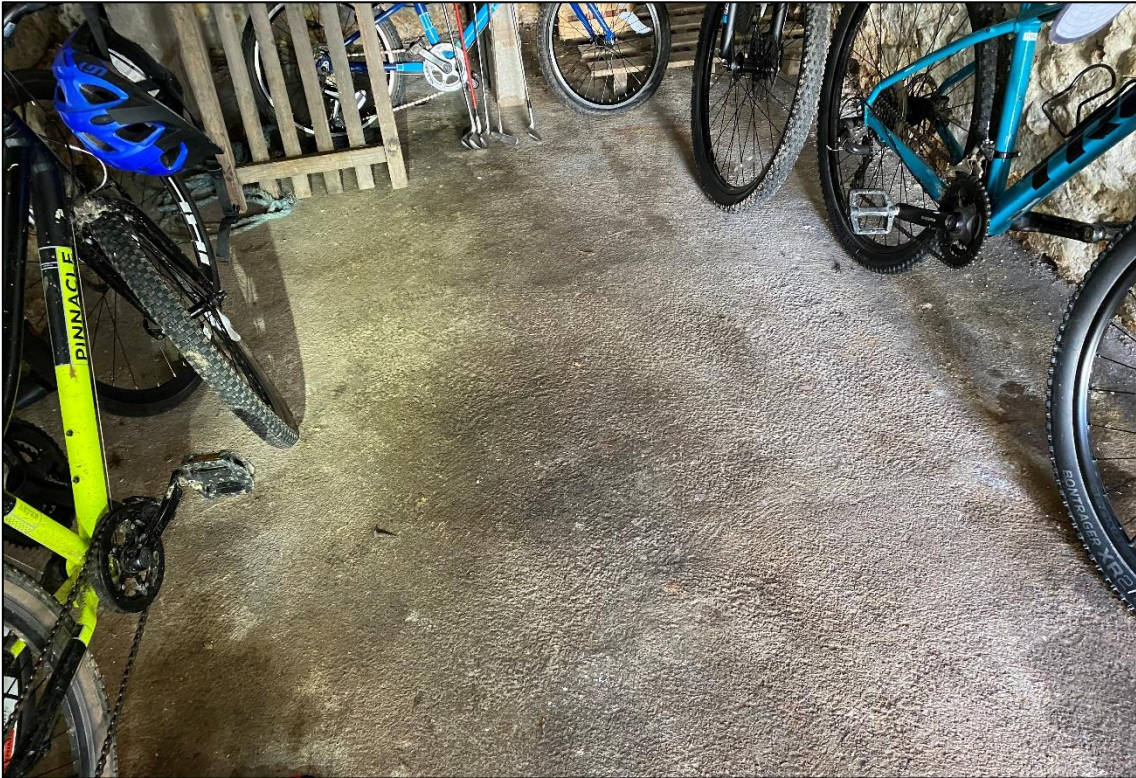
Plate 23: Floors within the internal spaces provided no evidence of bat activity.

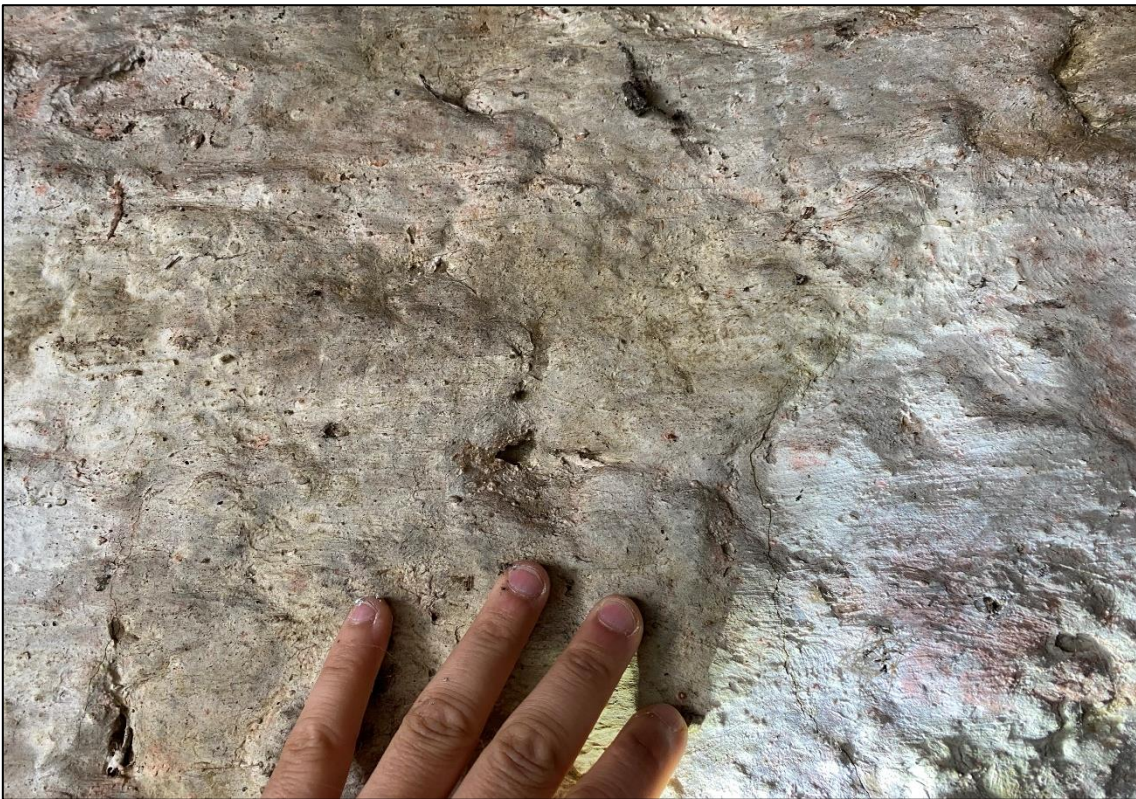
Plate 24: Interior walls were searched for evidence of bat activity, and none was found.

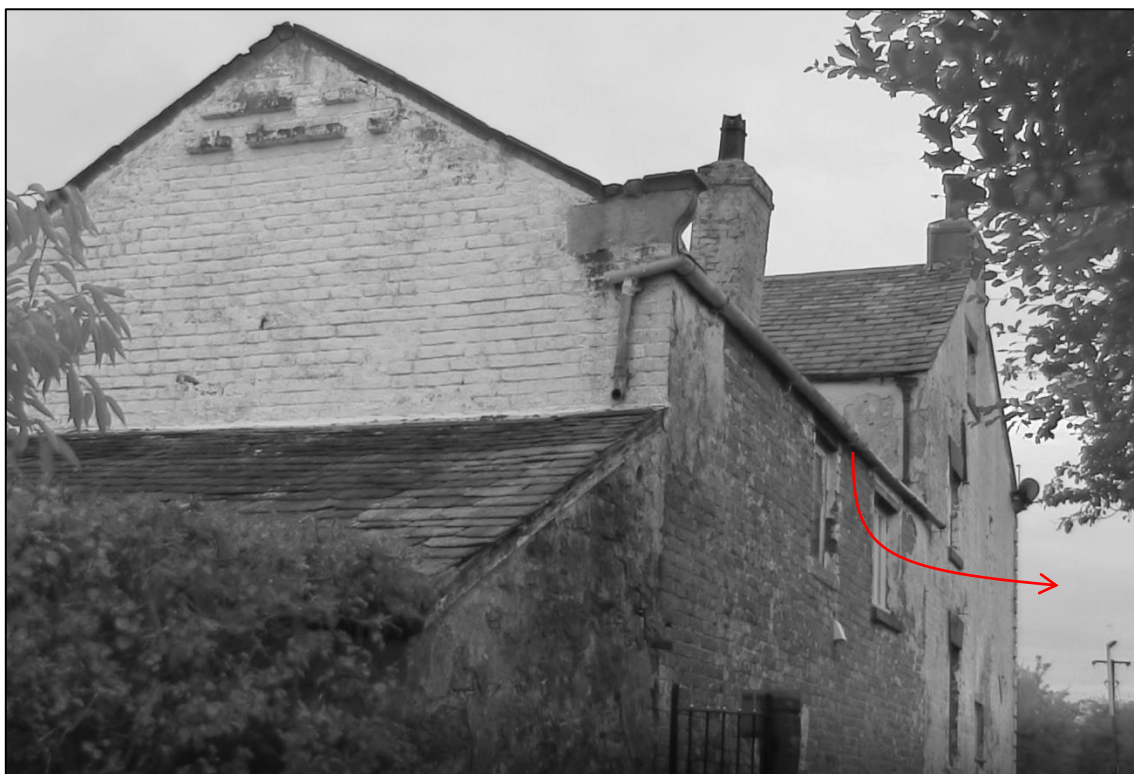
- 3.2.4 **At 19:43 a single common pipistrelle emerged from behind the gutter of the south facing aspect of the main building (see Plate 25).**
- 3.2.5 After this, up to 2x common pipistrelles could be seen foraging around the garden. Bats were circling the site using the road alongside the house and the section of the garden between the house and outbuilding.

Plate 25: At 19:43 a single common pipistrelle emerged from behind the gutter on the south facing aspect.

4.2.2 Night-time bat activity surveys were carried out. Overall levels of bat activity around the site were low (which is typical of the large, open agricultural landscape around Pilling), but a day roost for 1x common pipistrelle was identified on the south facing aspect of the building on 23rd September 2022 (see Plate 25).

4.2.3 Given the known location of the roost and the scale and duration of the proposed renovation works, without mitigation, will result in the disturbance (or possible loss) of a single common pipistrelle day roost.

- *It is recommended that* a Natural England licence will be necessary for the works to go ahead as there will be a small impact upon a known bat roost within the building. Appropriate working methods and mitigation will be necessary, and these are detailed in Section 6.0 Mitigation and Compensation. It is **ESSENTIAL** that the client understands the obligations placed upon them to only carry out these works **AFTER** planning permission has been granted and **WORKING JOINTLY WITH THE APPOINTED ECOLOGIST** once the necessary Natural England licence has been granted. Reason: This will deliver compliance with: Section 9 (1 & 4) of The Wildlife & Countryside Act 1981 (as amended), Part 3 (43; 1 & 2) of The Conservation of Habitats and Species Regulations 2017 and Section 11 (179 & 180) of the National Planning Policy Framework (2021).
