**The Olde Ship, School Lane, Pilling, Preston,
PR3 6HB.**

Bats: Building Inspection and Surveys

Ref: SE/ARQ008/01

January 2023

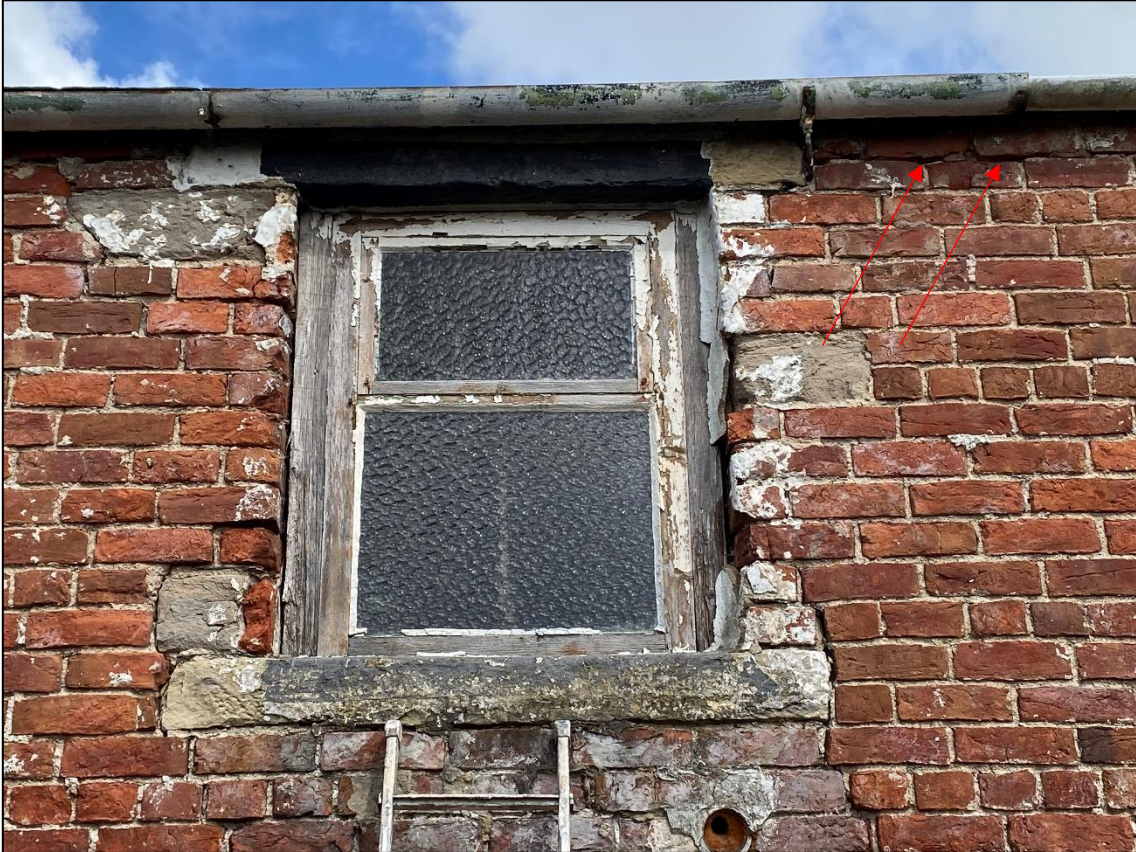
Plate 26: During construction, gaps will be incorporated into the brickwork that are suitable for crevice dwelling species and are similar to the existing gaps.

- 5.6.1 In order to compensate for any loss of the small bat roost in the building, it is advised that roost provision is built into the building redevelopment. This can be incorporated into the design of the new building in the form of gaps in the brickwork and gaps under the tiles at the wall top.
- 5.6.2 It will be straightforward to incorporate crevice roosts under the tiles and in the brickwork of the redeveloped building similar to the existing gaps (see Plate 26, Figure 1). These should be a gap of 15mm – 20mm underneath the tiles, between the tiles and the top of the wall, and their creation will be overseen by the Appointed Ecologist. It is anticipated that these roost locations will ensure long term provision for year-round roosting bats. The gaps under the tiles will compensate for the loss of the 1x individual pipistrelle day roost.

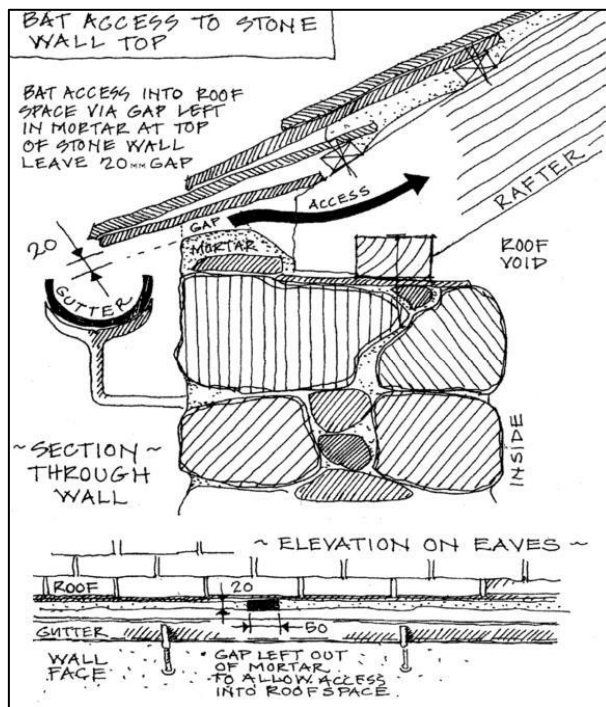
Figure 1: During construction, gaps can be incorporated under the tiles at the top of the brick wall that are suitable for crevice dwelling species (Natural England, 2007).

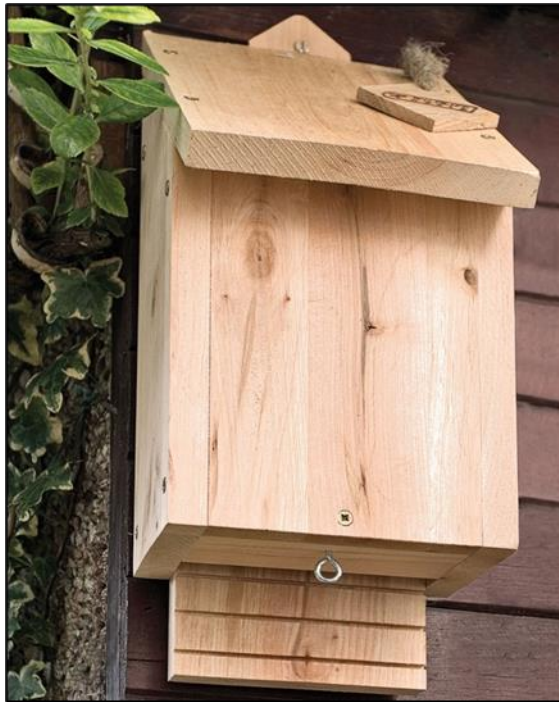
Plate 27: The 1x wall mounted bat roost will be installed prior to any redevelopment works.

- 5.6.3 It is essential that temporary bat roost accommodation is provided on site prior to redevelopment of the building. This would be in the form of 1x traditional wooden bat box, to be fitted at least 4m above ground on a wall or tree on site (see Plate 27). This should face south-west, south or south-east. If any bats are found during the commencement of construction. Then they would be put into the bat box.
