CALDER COTTAGE ECOLOGICAL IMPACT ASSESSMENT

July 2023

Ecological Matters Environmental
Consultancy [REDACTED] BSc MSc
MCIEEM

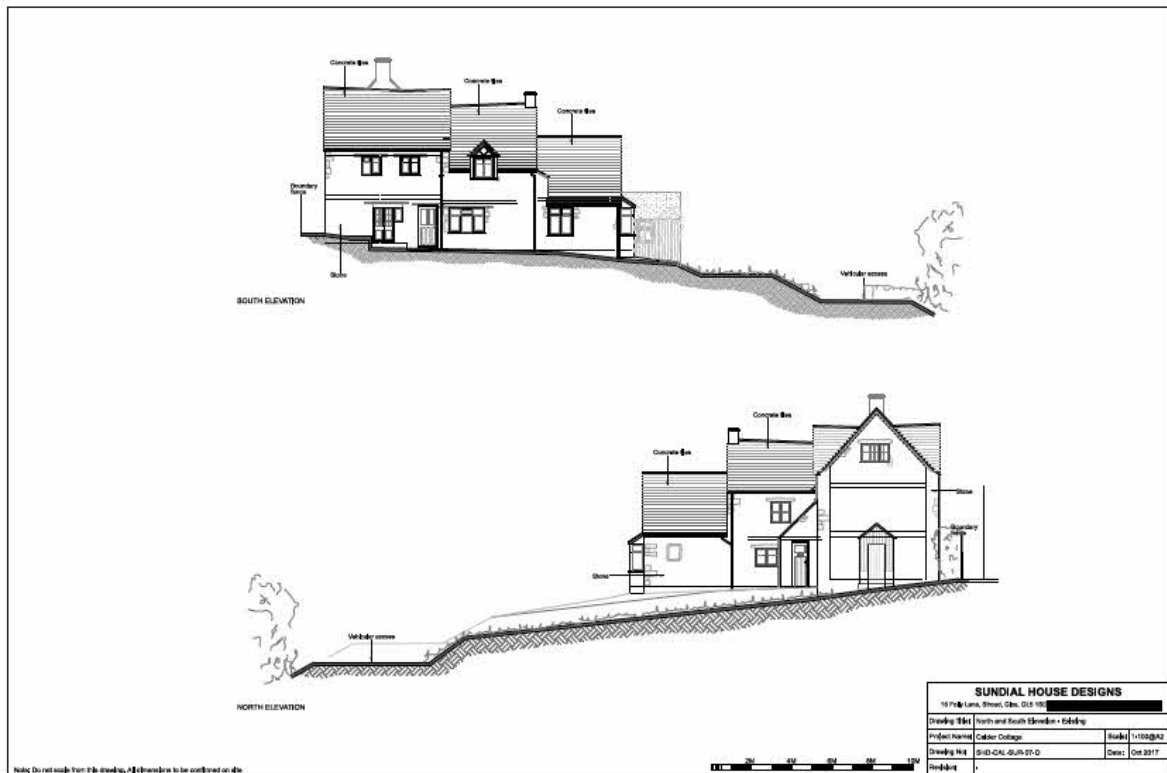
Figure 4 Existing elevations (south elevation - top image, north elevation - bottom image) ©Sundial House Designs

47. The cottage, which is a Grade II listed building, consists of the original structure built in the 17th century onto which a single-storey and a two-storey extension have been constructed resulting in a stepped down-hill dwelling with three ridge heights (figures 4 & 5).

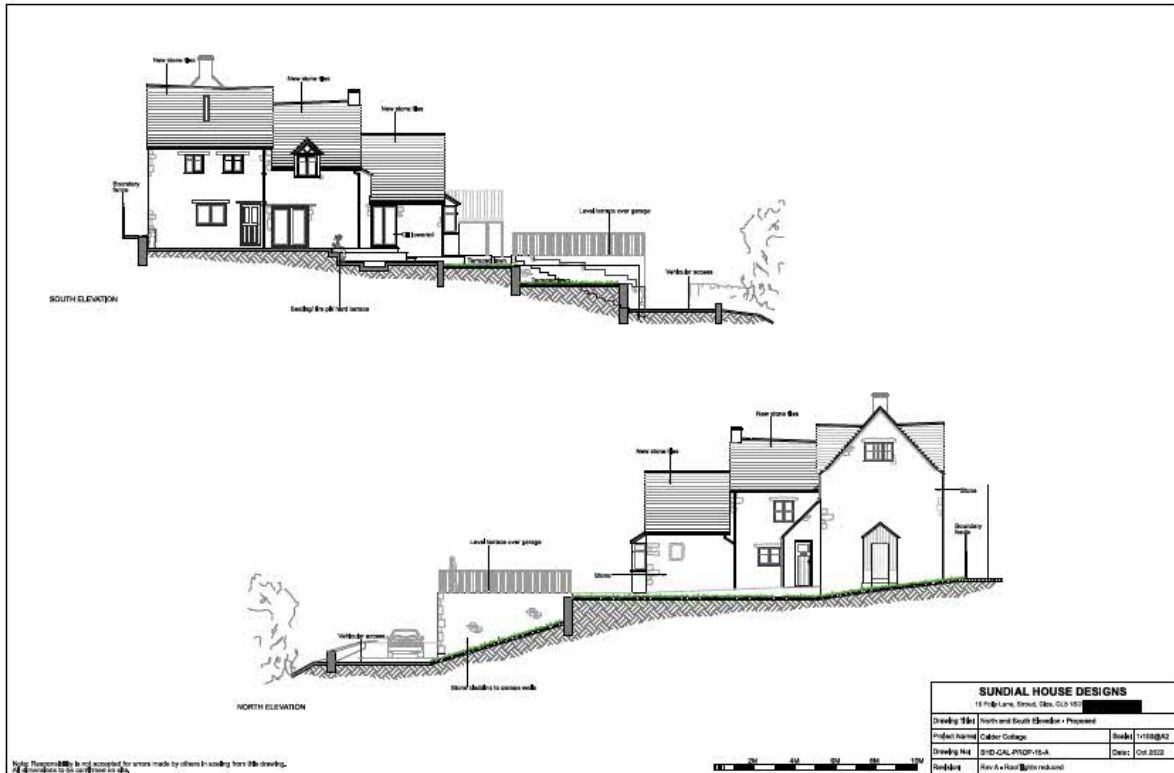
Figure 7 Proposed elevations (south elevation – top image, north elevation -bottom image)© Sundial House Designs

50. The development proposal is for the refurbishment of the existing dwelling, to make it habitable and improve access, replacement of the existing timber outbuilding with a new timber framed building, renewal of the vehicle access and provision of a parking/turning site and a garage (figures 7-9).

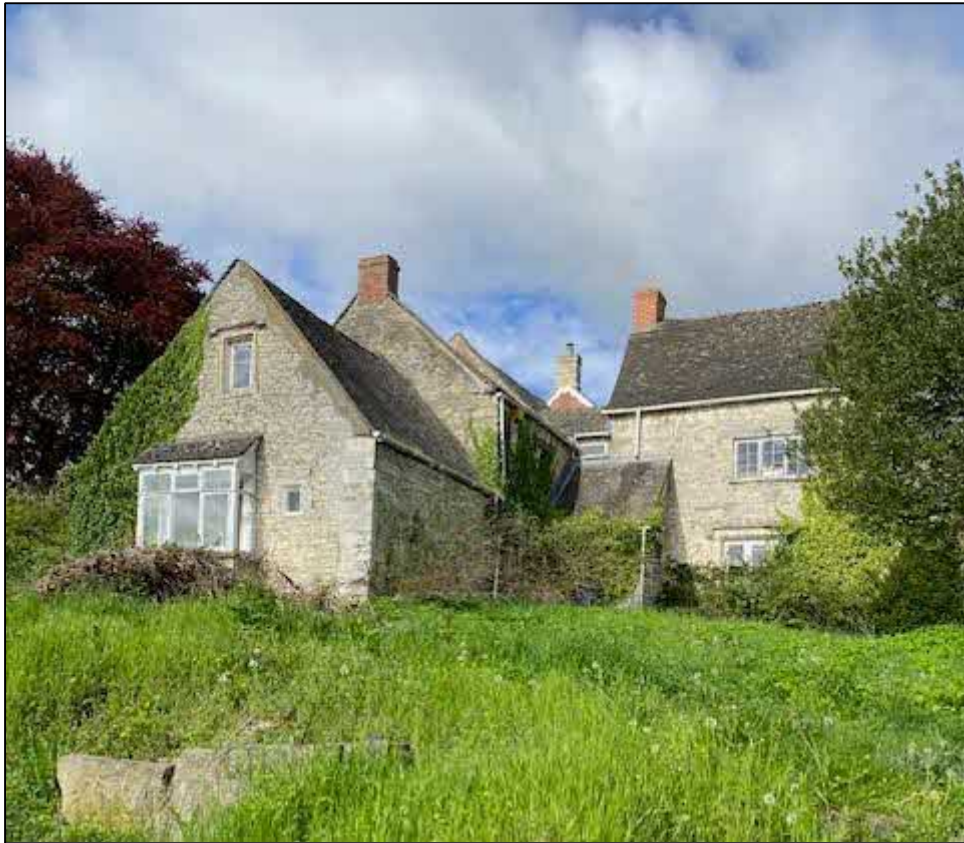
Figure 16 East elevations

68. The survey site contains a detached derelict Cotswold stone cottage (figures 16-19) surrounded by a large overgrown garden (figure 20). At the time of the walkover survey the site also contained a dilapidated timber outbuilding (figure 21).

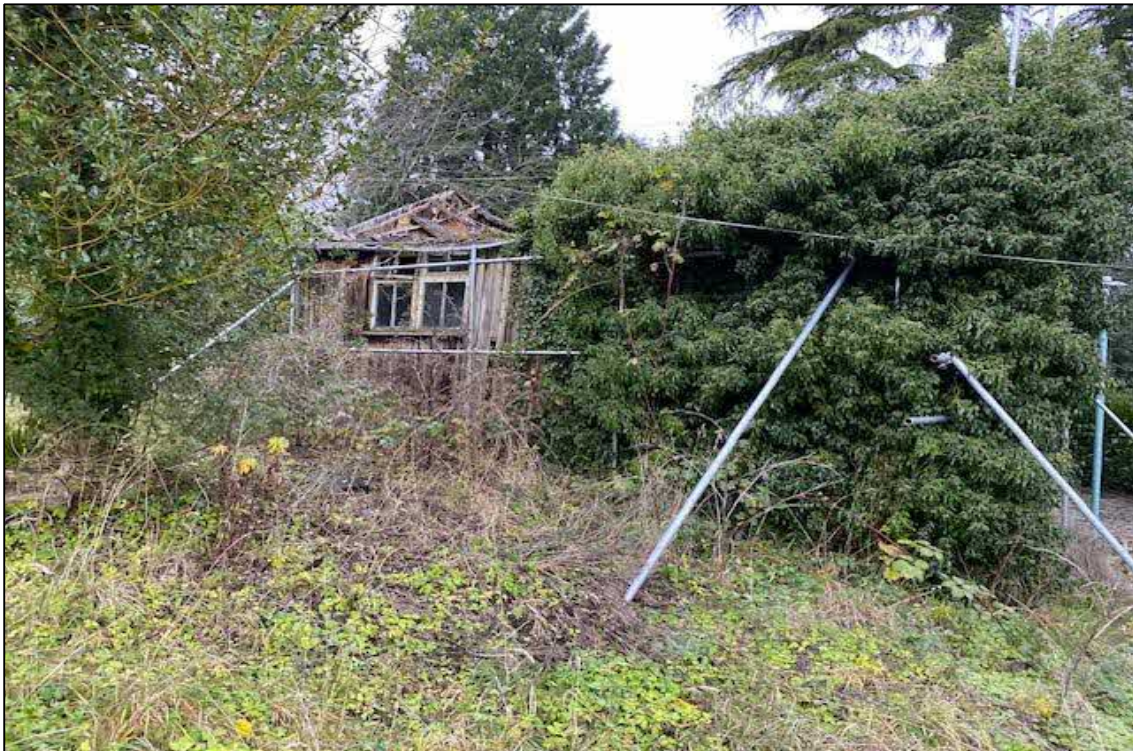
Figure 21 Dilapidated timber shed

88. A derelict timber outbuilding, referred to on plans as the chapel, existed on site when the walkover survey was undertaken. The roof had completely collapsed, and although the walls remained upright, no potential roost features that could be exploited by crevice-dwelling bats were observed.

89. As a consequence of its dilapidated condition, it was not possible to undertake an internal survey of the outbuilding; however, the collapse of the roof meant that no bat roosting habitat was associated with it.
90. Due to its condition the outbuilding was assessed as having negligible suitability to support roosting bats and no further surveys were required.

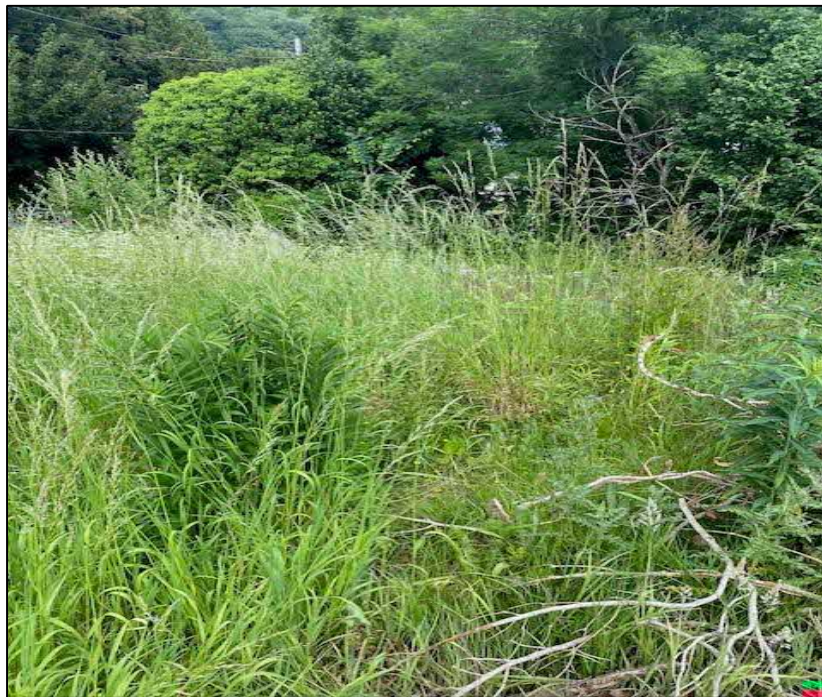
Figure 22 Garden showing tall grass sward

70. The cottage is surrounded on three sides by an overgrown lawn (figure 22) containing scattered scrub. A small holly *Ilex aquifolium* tree, a small yew tree *Taxus baccata* and an immature sycamore *Acer pseudoplatanus* are present in the lawn. The scattered scrub includes bramble *Rubus fruticosus*, Buddleja *Buddleja davidii* and willow *Salix* sp. saplings. The lawn is dominated by tall grasses and tall ruderals. The dominant grass species are cock's foot *Dactylis glomerata*, false oat grass *Arrhenatherum elatius*, barren brome *Anisantha sterilis* and meadow foxtail *Alopecurus pratensis*. The dominant ruderal species include nettles *Urtica dioica*, creeping thistle *Cirsium arvense*, ground elder *Aegopodium podagraria* and rosebay willow herb *Chamenon angustifolium*.

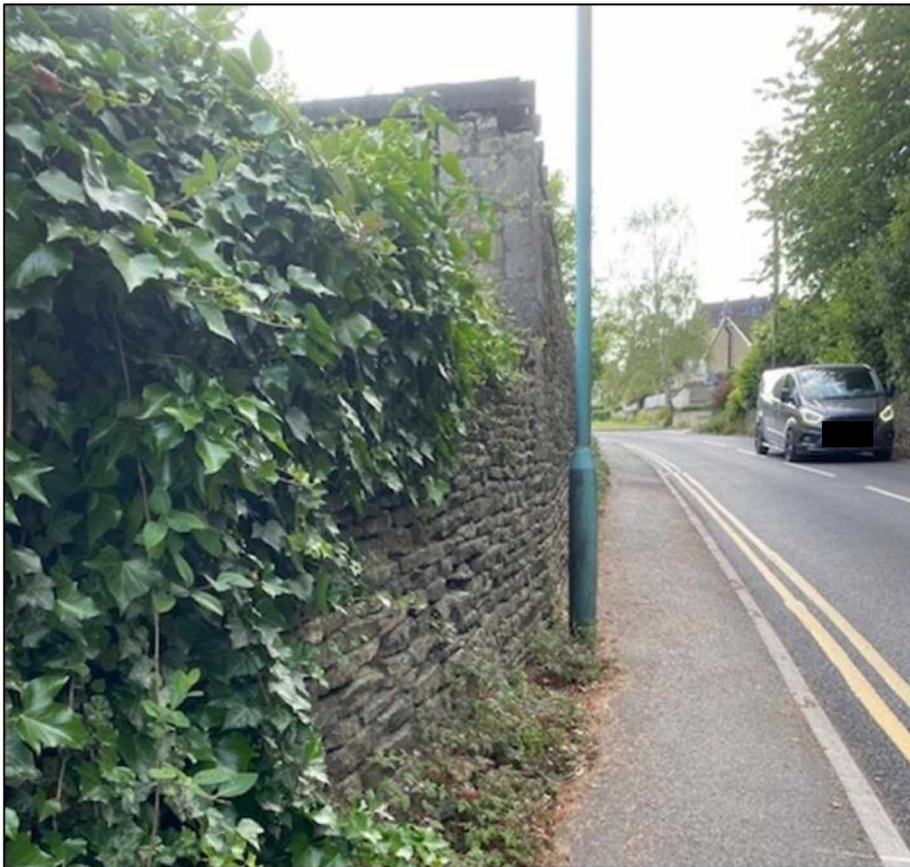
Figure 23 North boundary

72. The northern boundary of the site is delineated by a high stone wall covered in ivy *Hedera helix* which runs parallel with the road (figure 23). The eastern boundary of the site is formed by soil bank (figure 24) and a large cherry laurel hedge *Prunus laurocerasus*, with some hazel *Corylus avellana*, wych elm *Ulmus glabra* and a mature ash tree *Fraxinus excelsior* (figure 25). The dense cherry laurel hedge becomes gappy as it extends along the southern boundary of the site. The western site boundary of the site is made up of an ornamental box *Buxus sempervirens* hedge with adjacent bramble and buddleia scrub. As the boundary extends towards the road the box is replaced by a red brick wall and a then wooden fence which is in close proximity to the west elevation of the cottage (figure 26).

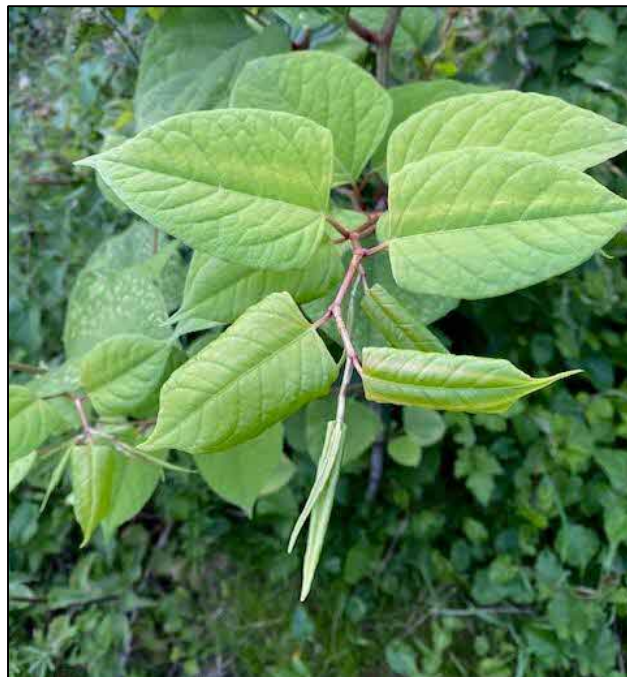
Figure 27 Japanese knotweed

73. Evidence of Japanese knotweed *Reynoutria japonica* (figure 27) and wall spray *Cotoneaster horizontalis* both species are listed in Schedule 9 of the Wildlife & Countryside Act 1981, was seen during the site walkover survey in December. The cotoneaster is growing against the cottage's east elevation and the Japanese knotweed is scattered along the bank.

74. Later on in the year it was evident that the Japanese knotweed was considerably more widespread, with a sizable stand being noted in the site's southeast corner.

153. The presence of Japanese knotweed does not present restrictions to the reptile mitigation proposal as the route of the fence will avoid it. To ensure compliance with legislation relating to preventing the spread of invasive non-native plant species installation of the reptile exclusion fence should be undertaken by a specialist in invasive weed control.

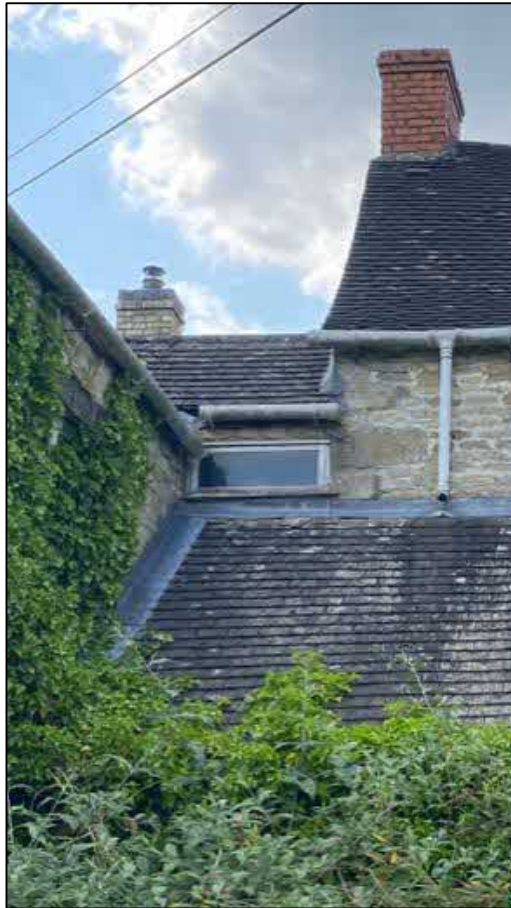
Figure 29 Photo showing lead flashing

84. There are no soffit, barge, or fascia boards associated with the cottage roof. However, lead flashing is extensively used, and it can be seen in these locations: where the extensions abut the cottage walls; where it lines the valleys between the roof pitches and encircles the bases of the chimney stacks; and where it meets the south-facing roof pitch at the dormer window intersection points (figures 29 & 30). In a number of locations the lead flashing is raised and the gaps beneath offer numerous potential roosting opportunities to crevice dwelling bats. Additional potential roosting habitat is offered to crevice dwelling bats beneath raised roof tiles particularly those associated with the roof verges and eaves and the tiles lining the porch roof, and within crevices associated with the timber lintels (figure 31).

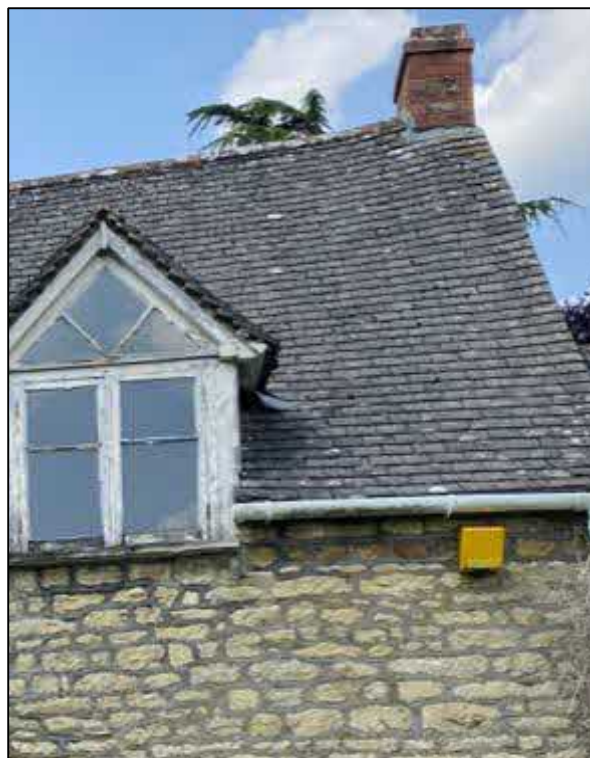
Figure 30 Lead flashing associated with dormer window

102. The first bat that was recorded was a common pipistrelle bat that emerged from beneath raised lead flashing associated with the dormer window on the south facing roof slope (figure 41). After emerging from its roost the bat flew off in a westly direction. Very little bat activity was recorded during the survey and, with the exception of one soprano pipistrelle bat, activity that was recorded was attributed entirely to commuting common pipistrelle bats.

To minimise the risk of killing or injuring bats during the proposed works recommendations outlined within this report must be adhered to, notably, removal of roofing materials in the vicinity of the existing roost will be undertaken as a soft strip, which will be carried out under the supervision of a licensed ecologist.

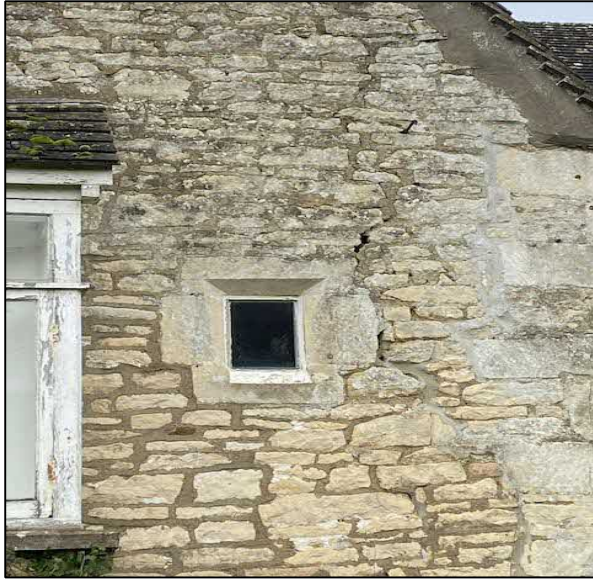
Figure 32 Gaps between stones caused by missing mortar

85. The walls of the cottage are constructed out of Cotswold stone and in number of locations the mortar between the stones has crumbled away resulting in crevices that are likely to provide suitable roosting features which could be exploited by crevice dwelling bats (figure 32).

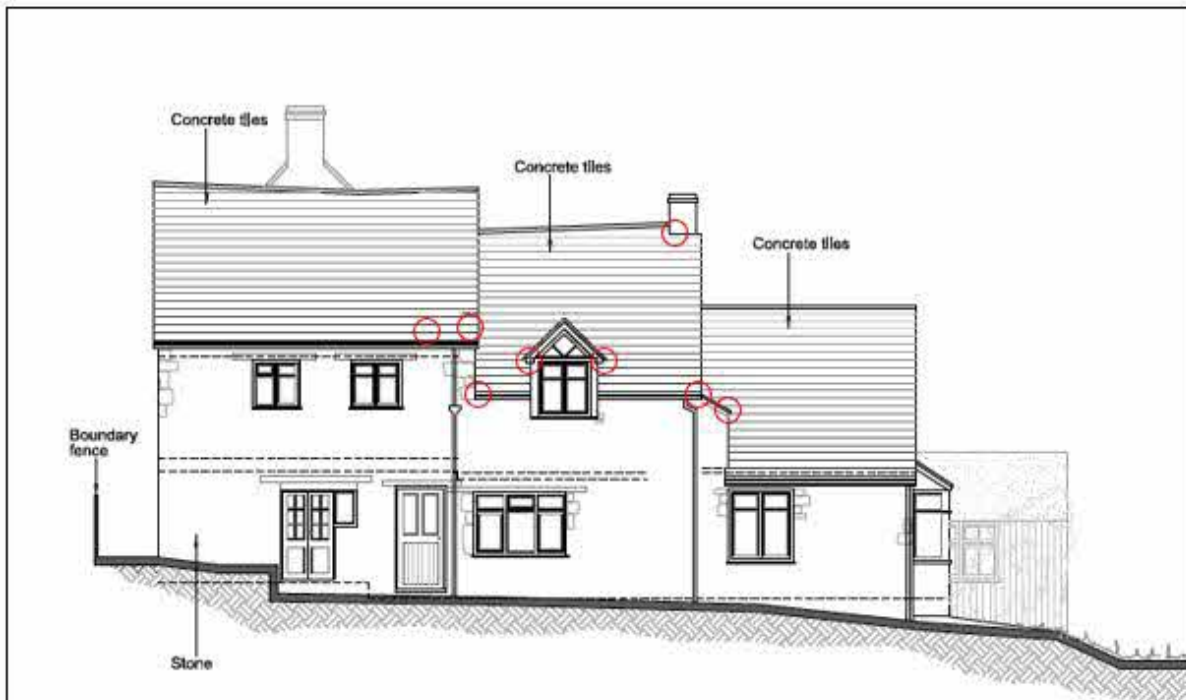
Figure 33 Potential roost features for crevice-dwelling bats. South elevation

87. The annotated figures below illustrate the potential roost features for crevice dwelling bats discovered during the external inspection (figures 33 & 34).

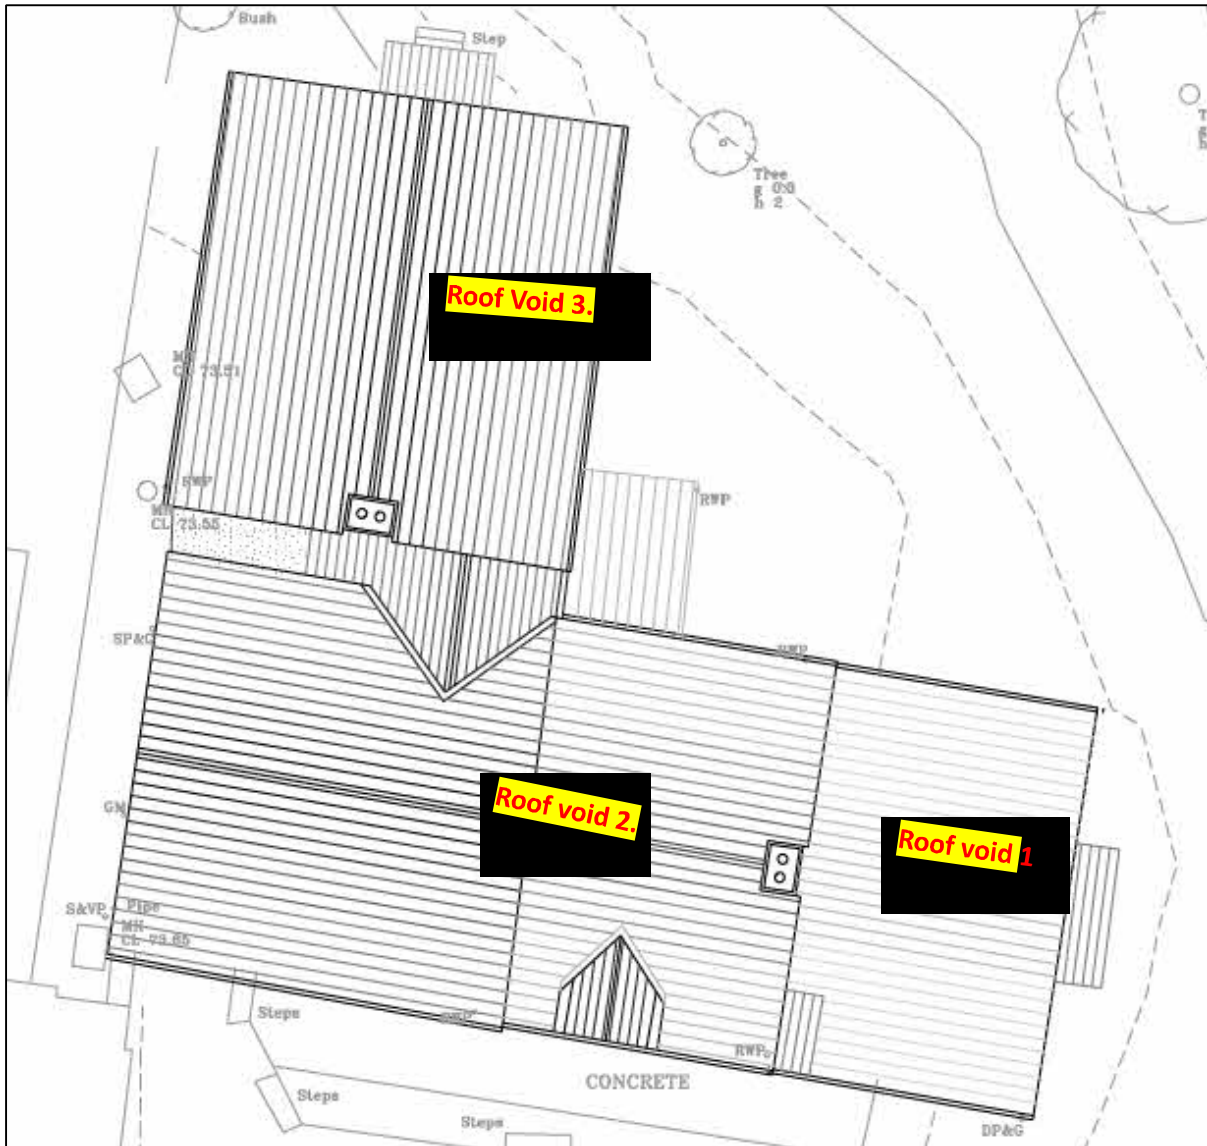
Figure 35 Roof plan © Sundial House Designs

91. The cottage is currently derelict; however, internal restoration work on the building had already begun when the internal inspection was undertaken.
92. There are three roof voids (figure 35) associated with the cottage, two of which have always formed part of the residential space within the cottage and are fully open to the roof ridge; the third roof void is an enclosed attic space (figures 36-38).

93. The roof pitches are supported by a timber purlin and rafter structure with collar beams. There is evidence that remedial roofing works have been undertaken in the past, but the majority of the roof timbers are original, and although no cracks within the old timbers were evident, crevices that could provide potential roosting habitat to bats are present where the purlins insert into the rafters.

94. The roof lining is traditional roofing felt which is in good condition except for two small tears seen in the roof void associated with the north facing elevation (roof void 3). Potentially these could provide crevice-dwelling bats with access into the interior of the building. Additional access points into the interior of the cottage which could be exploited by crevice-dwelling bats were observed around the frames of the windows.

96. The smallest loft void (roof void 1.) associated with the cottage is separated from the room below by a ceiling; the attic above is not residential space (figure 36). An open loft hatch offers access into the attic; however, this was not examined during the internal inspection due to the poor condition of the floor.

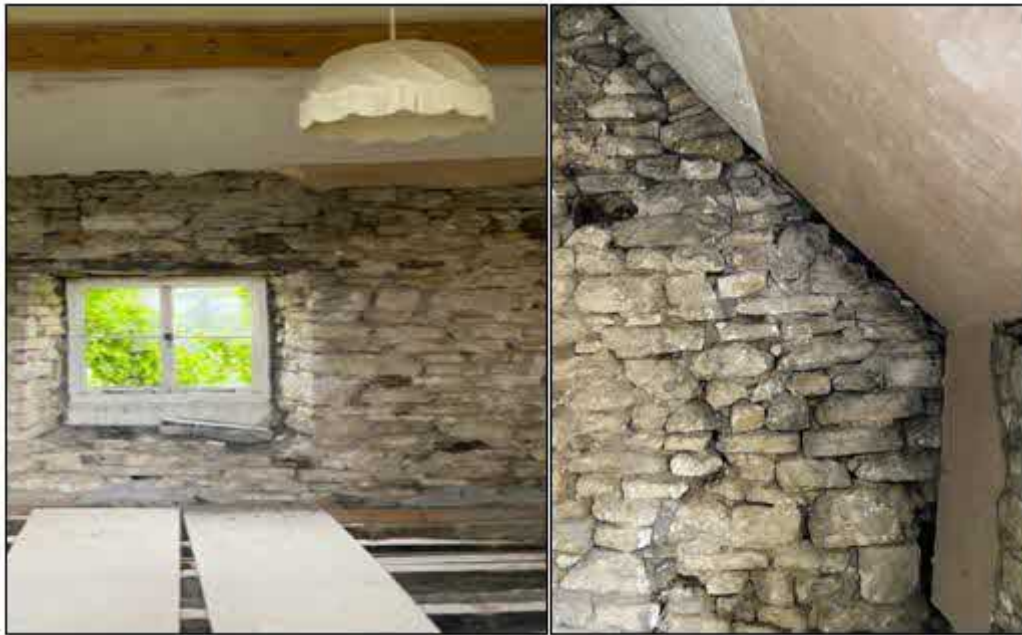
Figure 40 Internal crevices

95. The open roof voids are naturally well-lit due to the presence of windows in the gable ends and consequently unlikely to offer day roosting opportunities to bats, however the internal walls of the cottage contain numerous crevices where the mortar between the stones has crumbled away, these features offer dark roosting habitat to crevice-dwelling bats and therefore could be exploited by bats at night or during the day (figure 40).

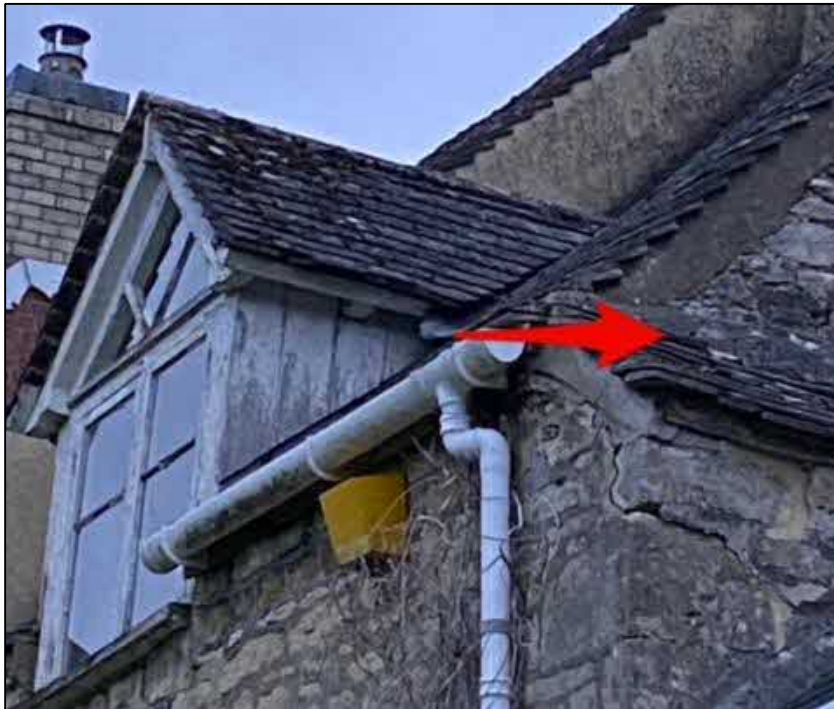
Figure 41 Common pipistrelle bat roost red arrow indicates direction of flight

128. The cottage was found to support a non-maternity day roost containing an individual common pipistrelle bat and is therefore classified as a low conservation status roost. In the absence of mitigation, the proposed work has the potential to disturb, injure and/or kill bats and will result in the destruction of a bat roost. The work will consequently trigger the legislation protecting bats and their roosts and will therefore require a derogation licence from Natural England to ensure legislative compliance.

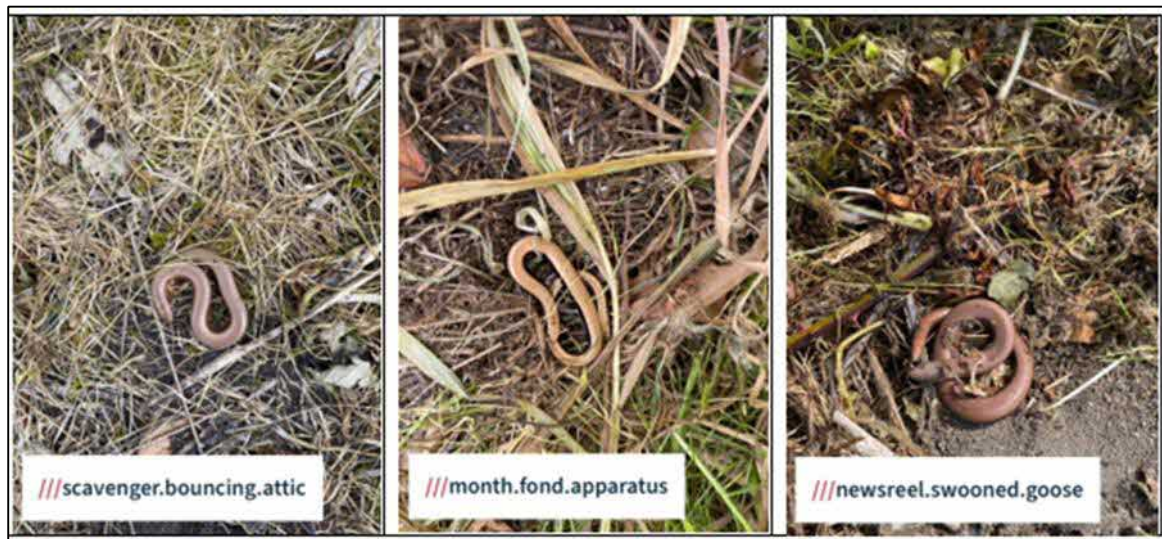
Figure 42 Reptiles on site

105. The site contains optimum reptile habitat and the reptile survey revealed it supports a small population of slow worms *Anguis fragilis*. The results of the reptile survey are tabulated below (table 3). Figure 42 illustrates recording of slow worms on site.
