**Land at Newlands Farm, Old Wokingham Road, Wokingham –  
Proposed SANG**

**ECOLOGY TECHNICAL NOTE –  
BIODIVERSITY NET GAIN CALCULATIONS**

December 2023

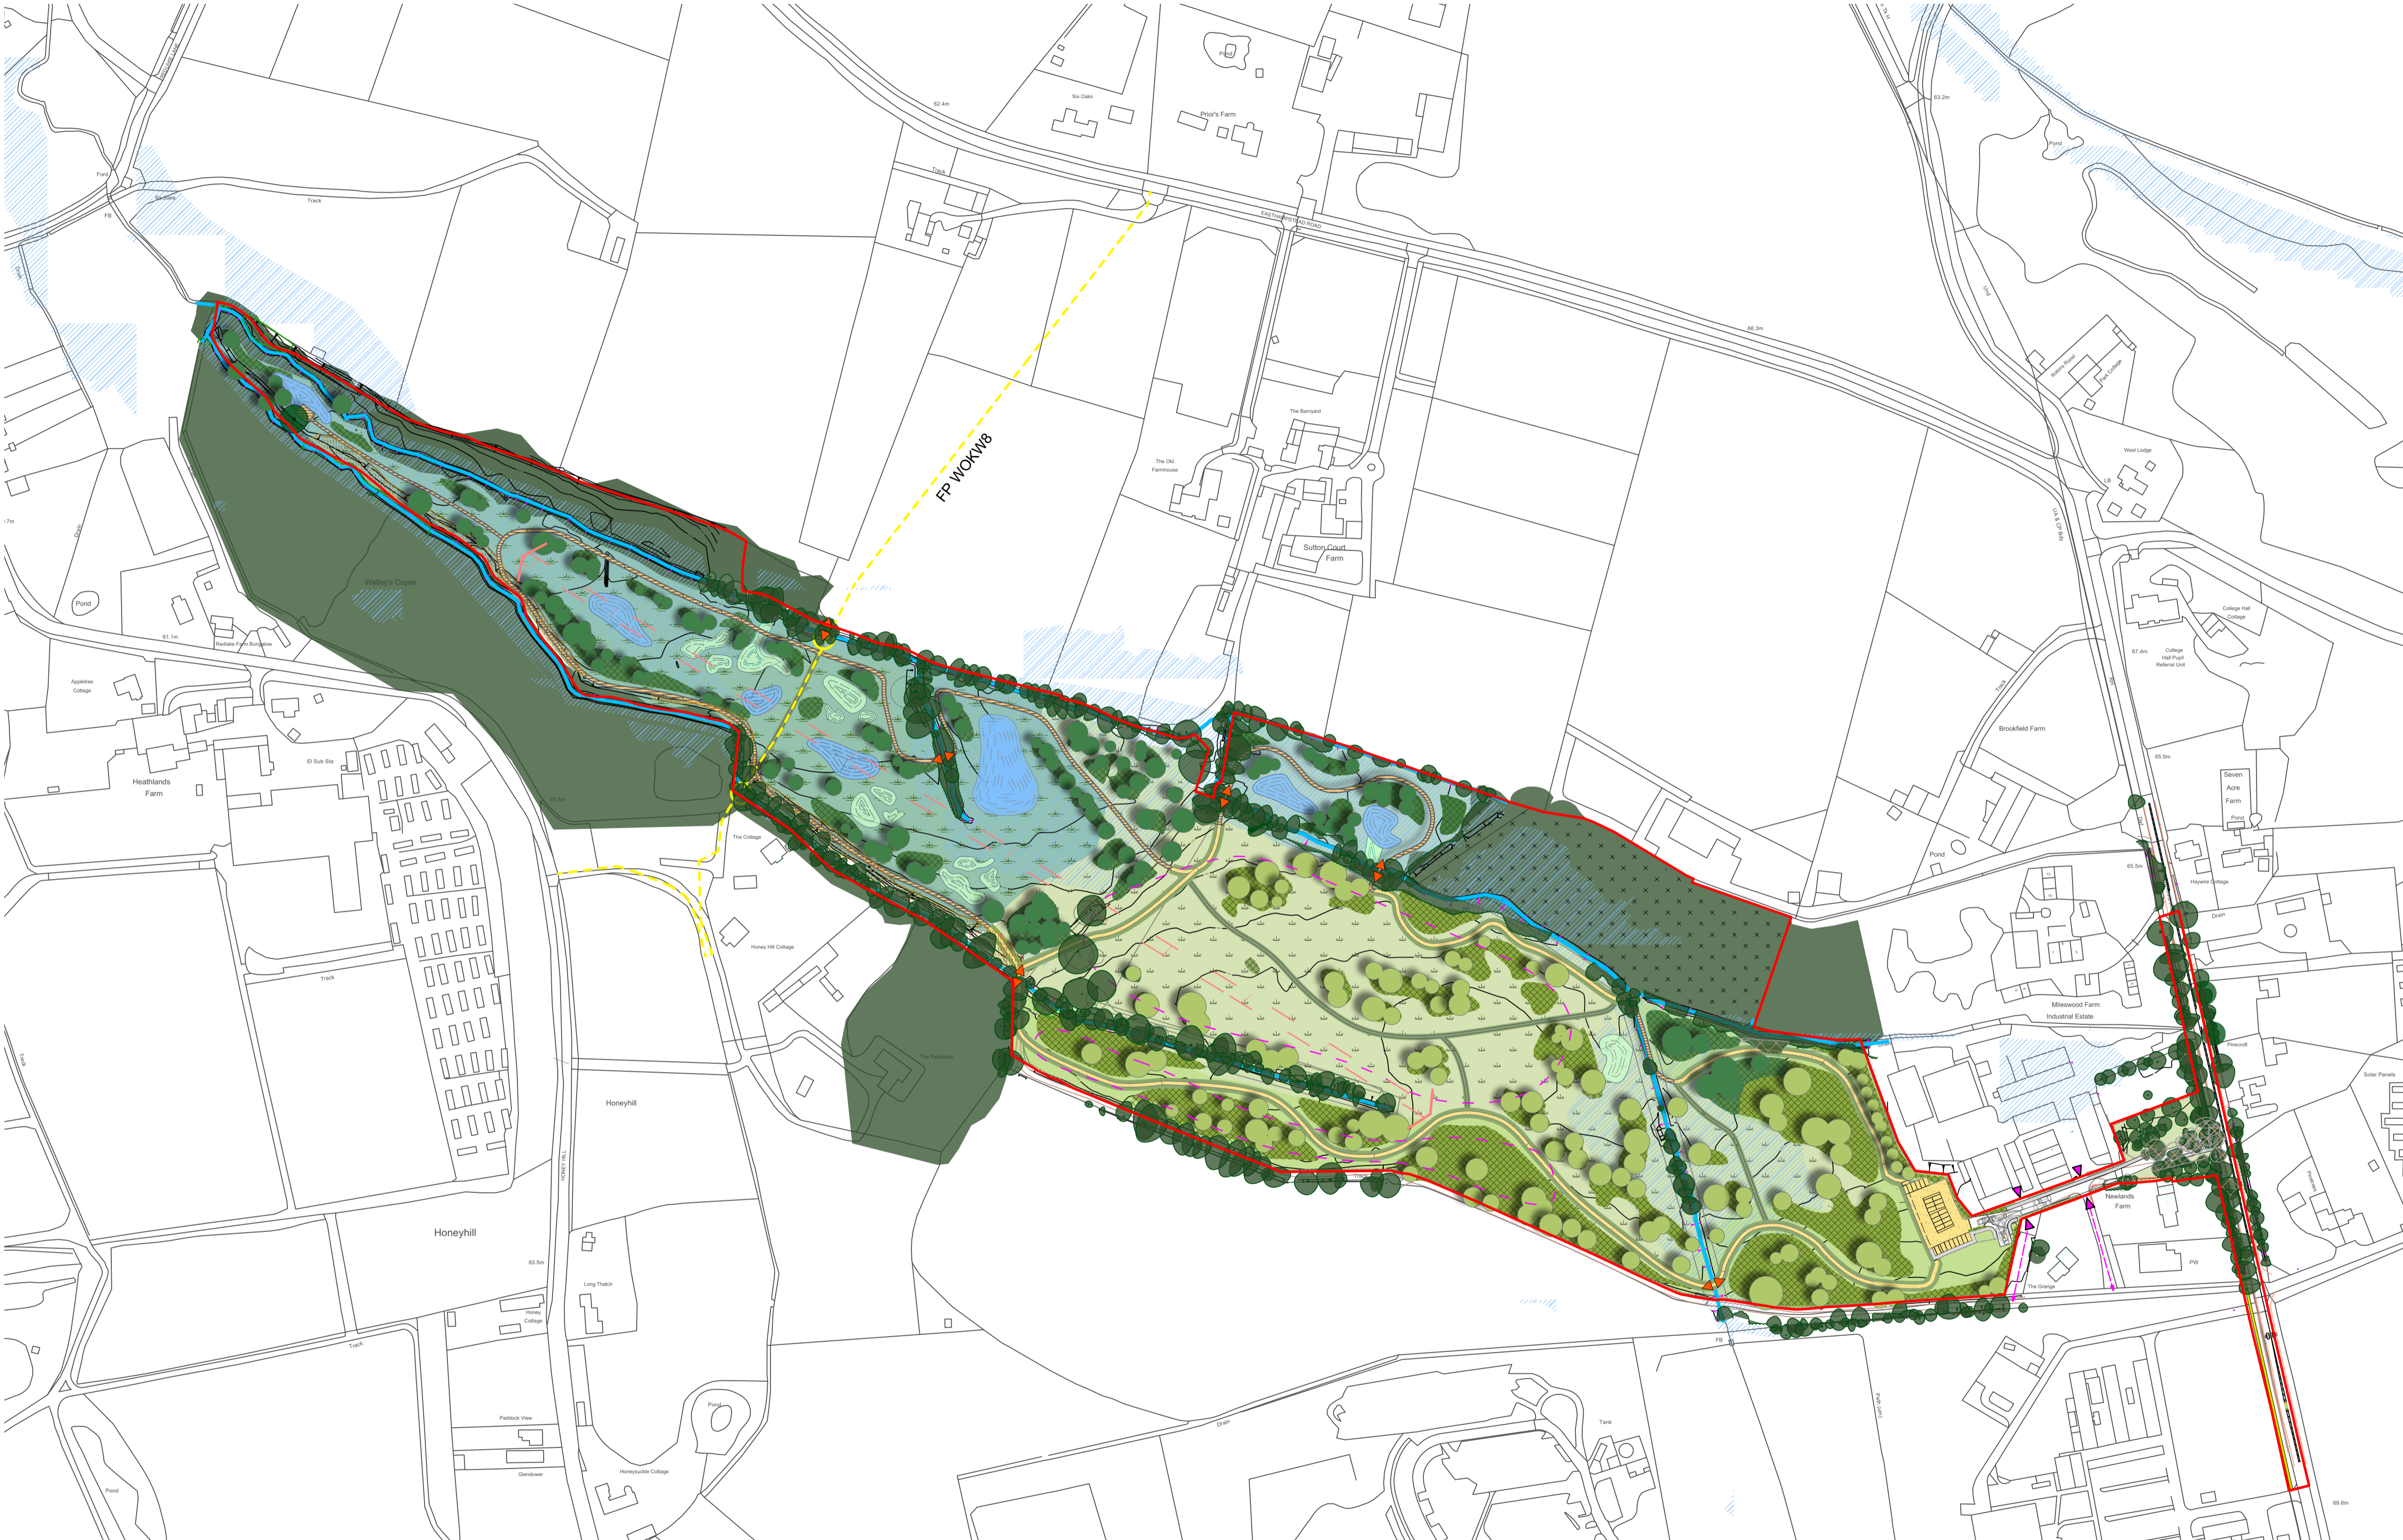
- KEY**
- Site Boundary (16.37 ha)
  - Main site vehicular access point
  - Existing trees
  - Existing Wet woodland within site
  - Wet woodland planting
  - Dry woodland scrub planting

- Flower rich grassland - dry seed mix
  - Flower rich grassland - wet seed mix
  - Dry Woodland tree planting
  - Wet Woodland tree planting
  - Ponds with wetland planting (see typical detail for excavation)

- Boardwalk path route - 2m wide
  - Self-binding gravel / hoggin 2m wide with 1m wide mown edges
  - Mown grass paths 1.5m wide
  - Existing track
  - Existing footbridges replaced

- 1.4 Results are discussed in line with the SANG Framework Plan produced for the Site (**Appendix A**).
- 1.5 This submission does provide the principles which can be applied at the detailed designed stage and will be subject of a planning condition for the submission of an ecological management plan and detailed biodiversity net gain plan.
