Bat Assessment Report

Mint Cottage

**Easebourne Lane
Easebourne
Midhurst
GU29 9AZ**

**23-184
January 2024**

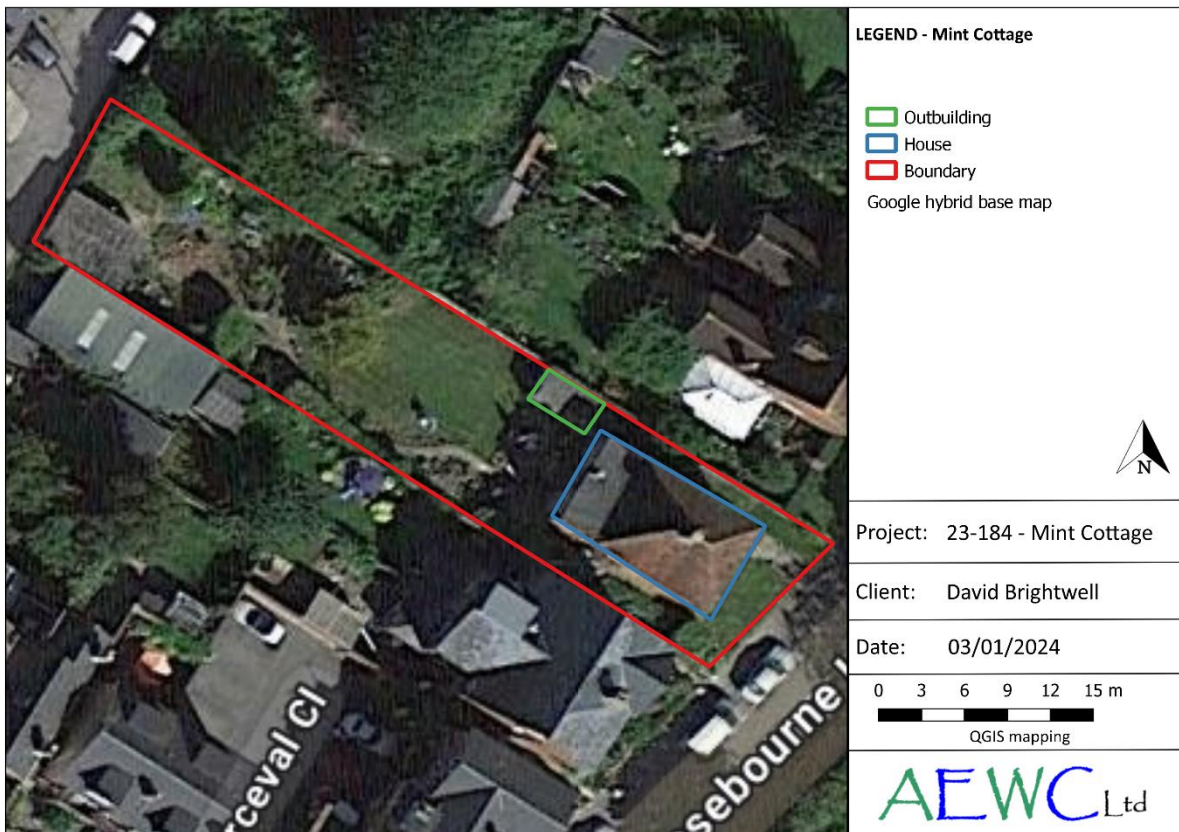
1.7 The site contains a detached dwelling with an associated outbuilding within an amenity plot.

FIGURE 2: SHOWING THE BUILDINGS SUBJECT TO SURVEY.

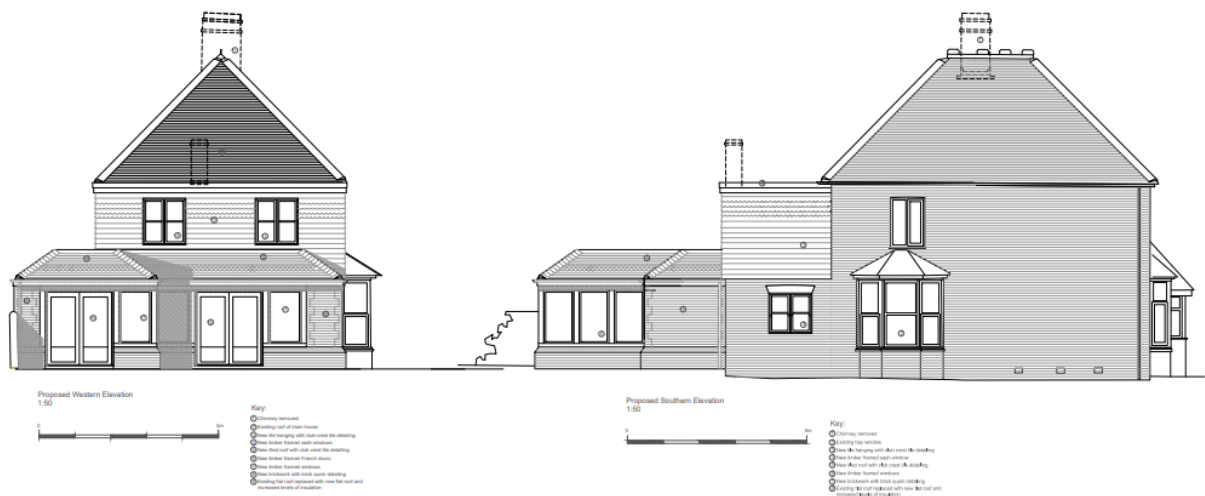
- 1.12 The proposal is for a single storey extension to the northwest elevation which will involve the demolition of the outbuilding, in addition to the removal of the chimneys on the main house.

FIGURE 3: SHOWING THE PROPOSED PLANS.

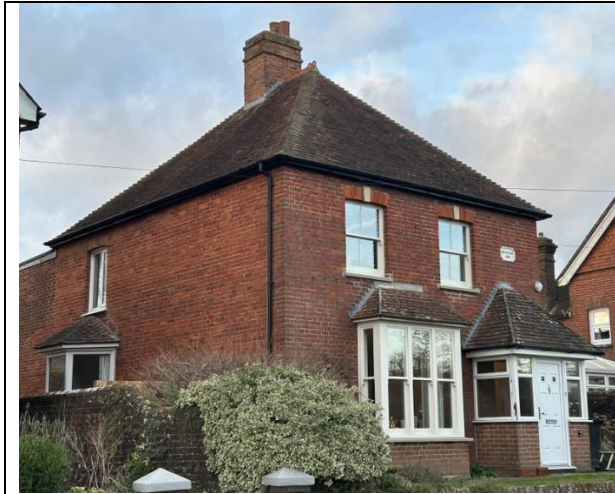
- 4.2 The chimney is lined externally with lead flashing which was noted to be in good condition, with no raised areas or gaps.
- 4.3 The roof supports clay tiles which are largely flat, with some having a natural camber. Low numbers of gaps were noted beneath uneven or lifted roof tiles on all elevations which could provide potential access points for bats into the batten spaces of the roof and potentially into the roof void.

Photograph 1: East corner of house

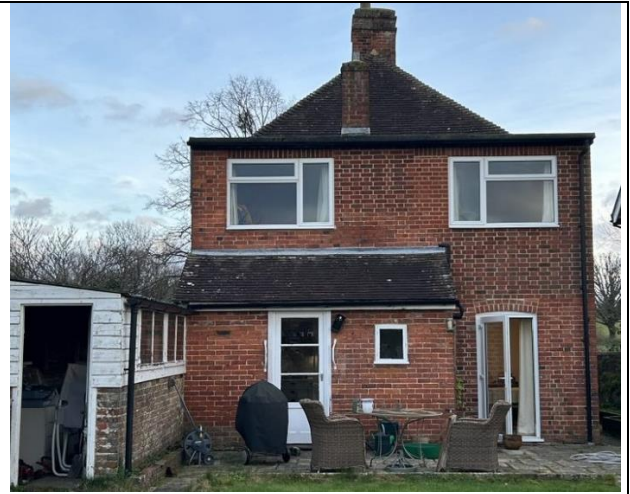
- 4.1 The site contains a brick-built two-story dwelling with a hipped roof supporting clay tiles. There is a two-storey extension with a flat roof attached to the north west elevation with a single-storey extension with mono-pitch clay tile roof.

Photograph 2: North West elevation of house

- 5.4 The flat roofed extension, and outbuilding were identified as having negligible potential for use by bats due to a lack of potential access points and roosting features.

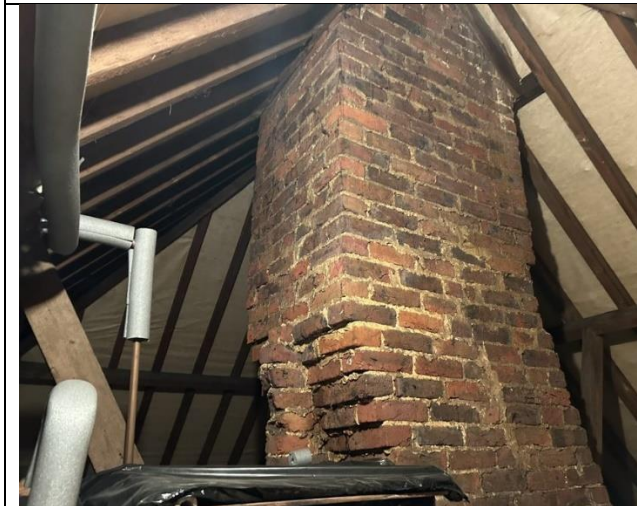
- 4.4 Internally there is a single roof void present extending over the full area of the main structure of the house. The roof is wooden framed and lined with a non-bitumen coated breathable membrane and has fibreglass wool insulation at floor level. The chimney breast runs through the centre of the void. High levels of dust and cobwebbing were noted amongst the rafters and throughout the majority of the void, especially in the apexes. No evidence of bats was recorded within the void.

Photograph 3: Void and chimney within

- 5.7 The proposed works include the removal of the external central chimney. The tiles, and lead flashing around this area were noted to be tight fitting with no potential access points for bats present, however these works will cause disturbance to the roof.

- 5.9 It is therefore considered that no further surveys are required for the site, but the works to the central chimney must be carried out under non-license method statement as a lack of any mitigation could result in a negative impact on bats if present. A mitigation plan for the works is detailed in section 6 of this report will have to be carried out under a non-license method statement.**

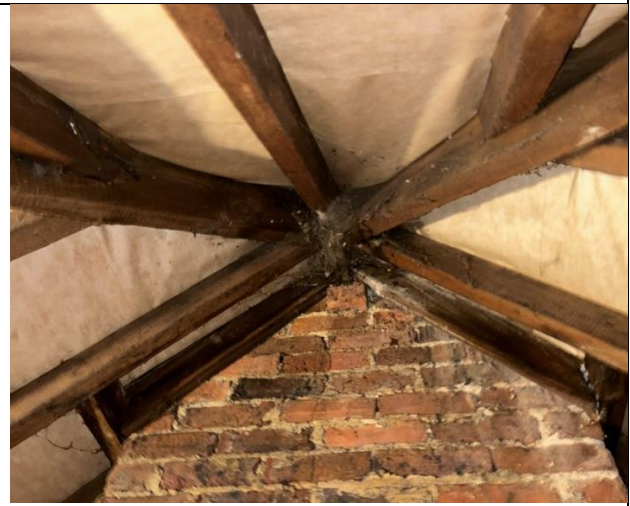
Photograph 4: Dust and cobwebbing around beams

- 5.8 Based on the low likely impact of the works, and the high level of cobwebbing around the internal chimney and lack of external features in this area it would be disproportionate to the level of likely impact to postpone works until an emergence survey has been carried out as this is unlikely to alter the proposed mitigation strategy for the chimney removal works.
