Heritage Statement on the site of
The Old Nursery
Lodsworth GU28 9DD

Report prepared by
Penelope Olsen BA (Hons) MSc
The Research Workshop
August 2022

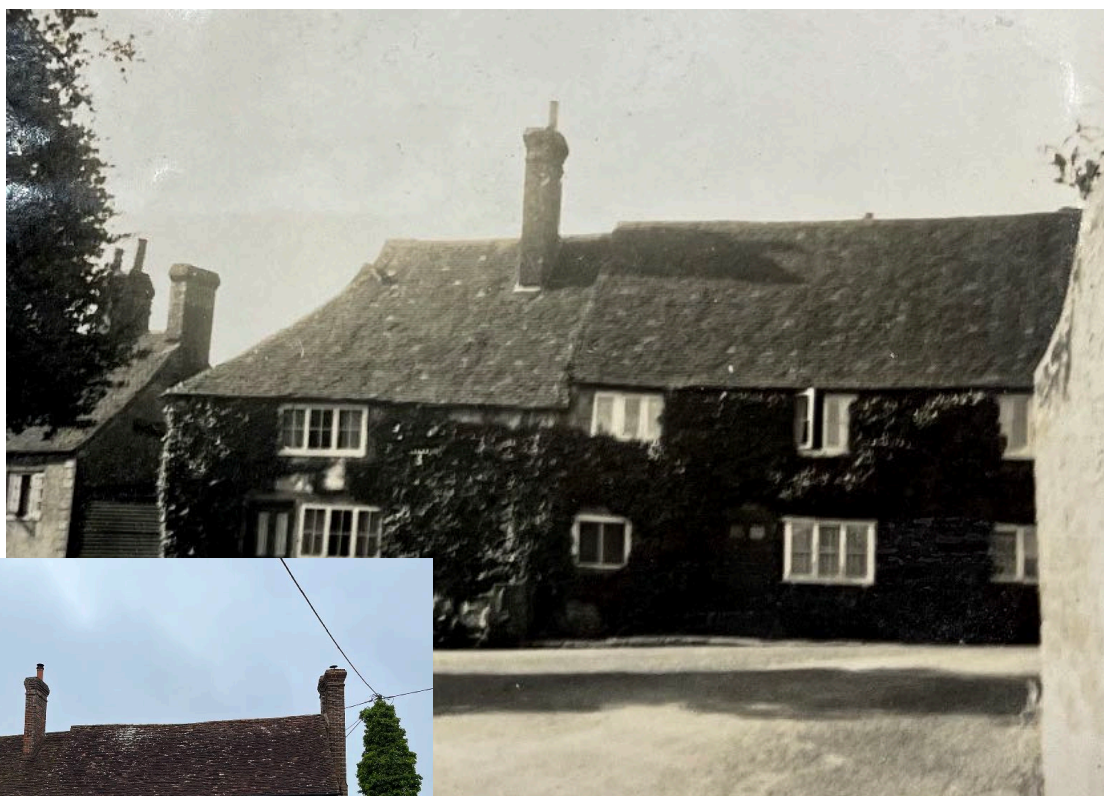
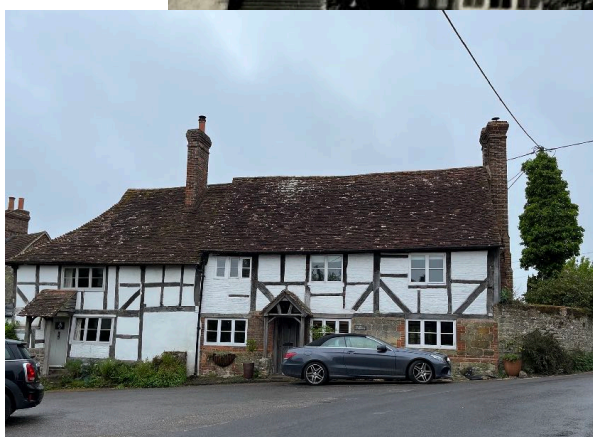
The cottage is three bays wide with exposed timber framing at first floor level with white painted brick infill, and a mixture of red brick and stone facing at ground floor level. The ground floor window to the left of the front door has been enlarged since 1947. The front door is marked by a small, protruding, pitched, timber-framed porch with tiled roof.

Photographs of The Old Nursery (right) and Tudor Cottage (left), both clad with ivy, 1947. And inset, in 2022.

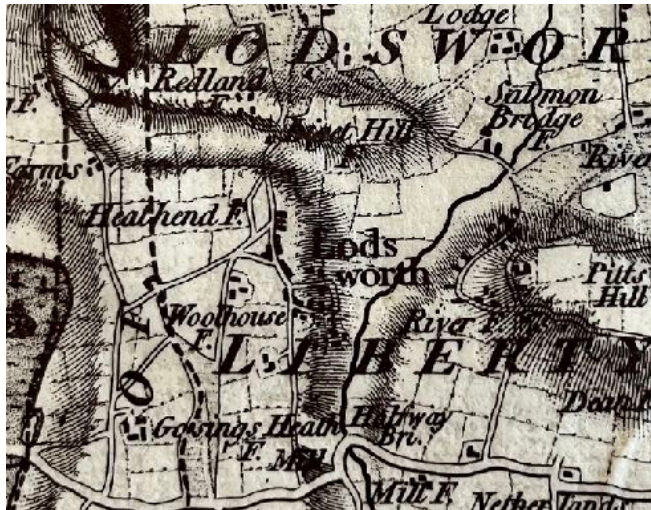
A detail from Gardener & Gream's map of Sussex, 1795. A half century on from Budgen's map, the linear development of Lodsworth had continued. The Old Nursery is identified at the junction, south-west corner of Church Lane. To the right of the 'e' of Woolhouse

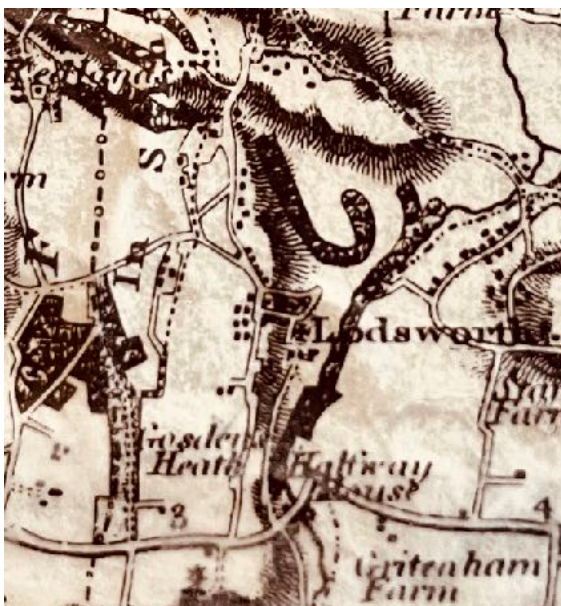
A detail from Greenwood's map of Sussex, 1823. The dwellings on either side of Church Lane are numerous and drawn inaccurately as a continuous block as infill had taken place. Detached buildings continue to stretch northwards along the main route through the village.

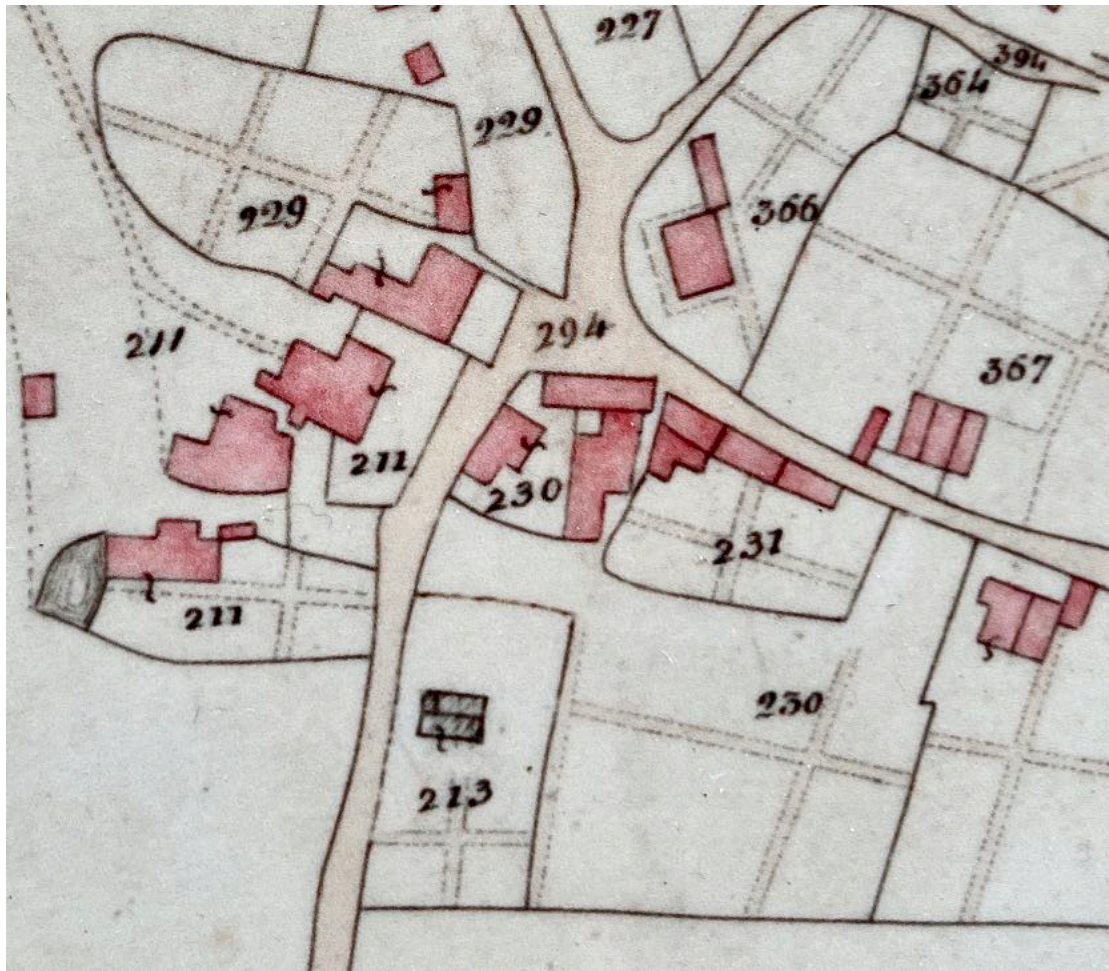
A detail from the Lodsworth Tithe map, 1842.

The free standing inverted 'L' shaped dwelling facing westwards, abutting the road, is now the Workshop/Barn belonging to The Old Nursery. This may have been the butchers shop. The largest building with 'wings' to north and south, shown within plot 230, would be significantly altered/rebuilt with the passing of time. Tithe maps of the 1840s, although important to the historian, are not considered as authoritative as the Ordnance Survey Series of maps from the 1870s and beyond.

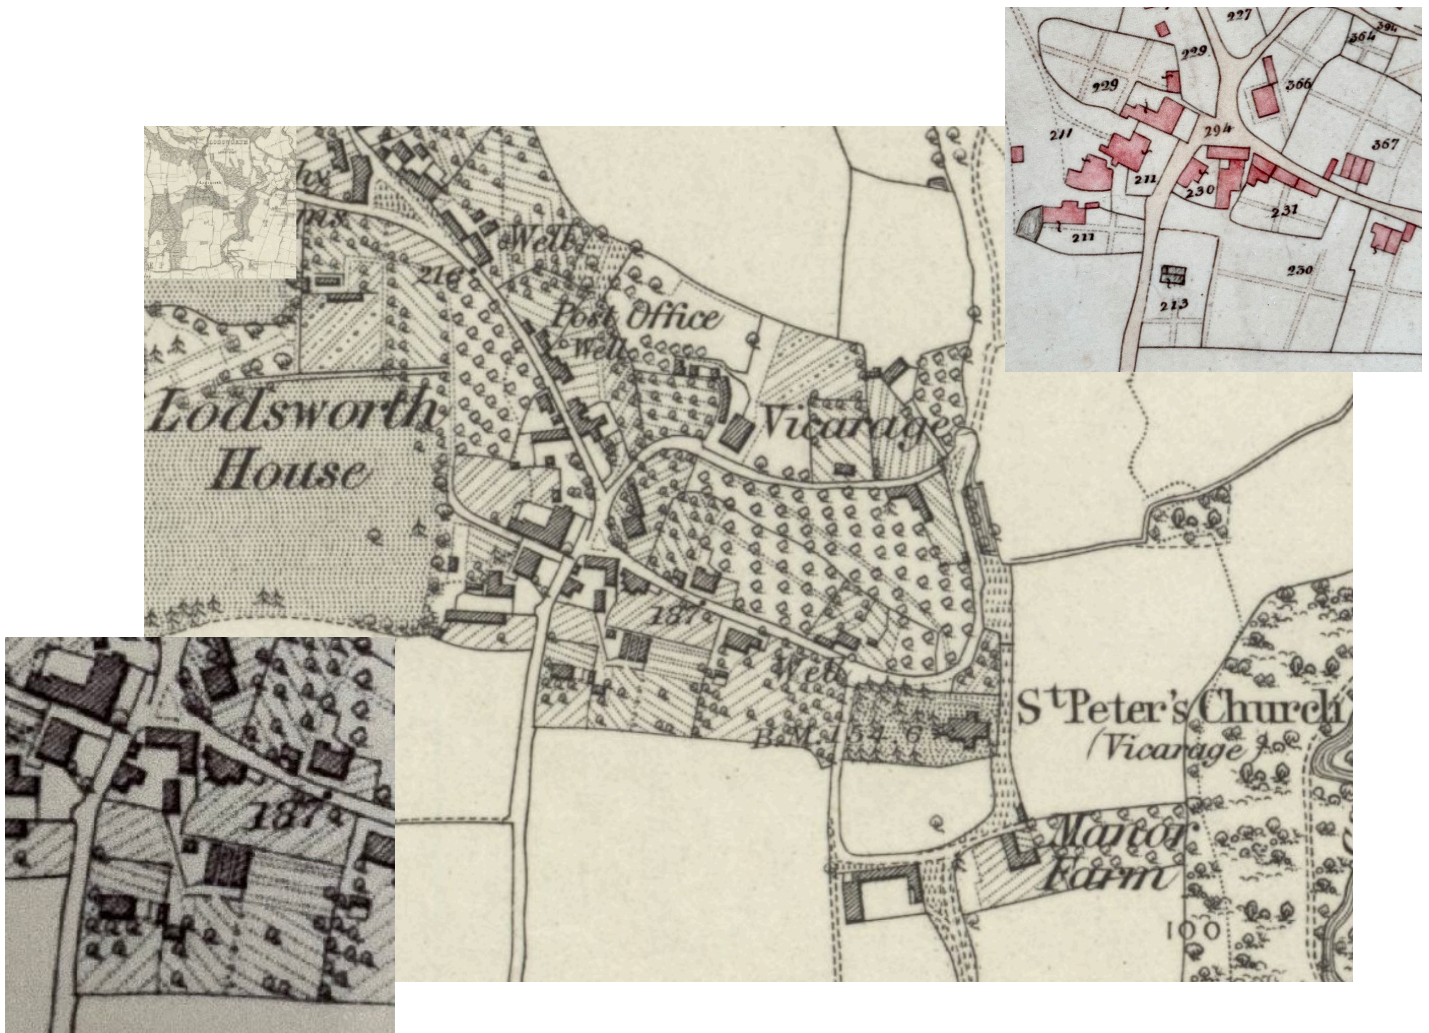
A detail from the 1st edition 25 inch Ordnance Survey map, Sussex XX11.10, 1875.
 Insert bottom left: Small detail OS 1875.
 Insert top right: Small detail Tithe 1841.

A comparison of the Tithe map and the 1st edition Ordnance Survey map indicates changes to the footprint of the properties over the three decades that separates them and the change from butchery to market garden. The dwelling facing Church Lane (The Old Nursery/Tudor Cottage) was now an 'L' shaped building, incorporating part of the largest building with 'wings' shown on the Tithe Map. The remainder of that building had gone and another separate building stood in the garden. The inverted 'L' shaped outbuilding/shop to the west side of the garden, abutting the road, remained unchanged. A small additional outbuilding/shed is shown alongside northwards. Beyond the buildings, on the land belonging to the site, were three rectangular

structures, probably greenhouses, and a small shed. The strip of land that had wrapped around plot 231 (back onto Church Lane) on the Tithe map, had disappeared by 1875. These significant alterations would have been in keeping with the change of business from butchery to market gardening.

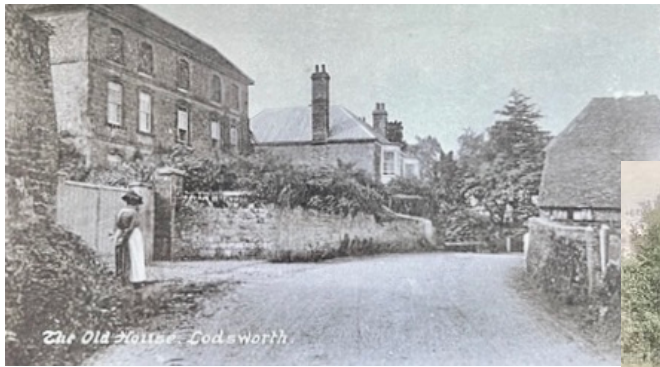
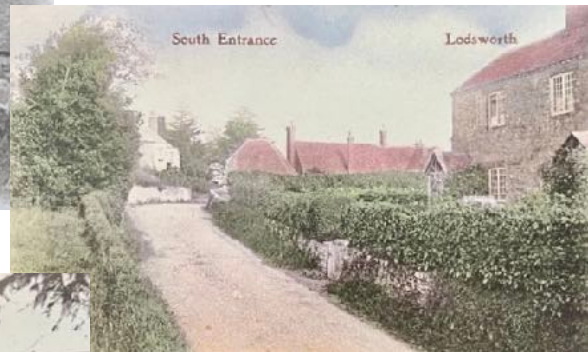
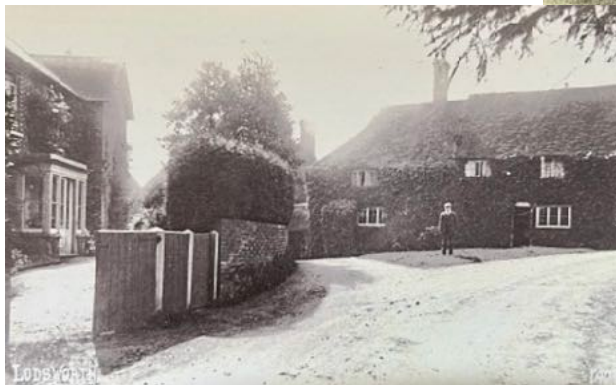
Postcards of Lodsworth showing the south side of the roadside outbuilding belonging to The Old Nursery, c 1910 (top left); the south side of the house and outbuilding, c 1910 (centre, right); and the north facing Church Lane facade, c 1920 (lower left).

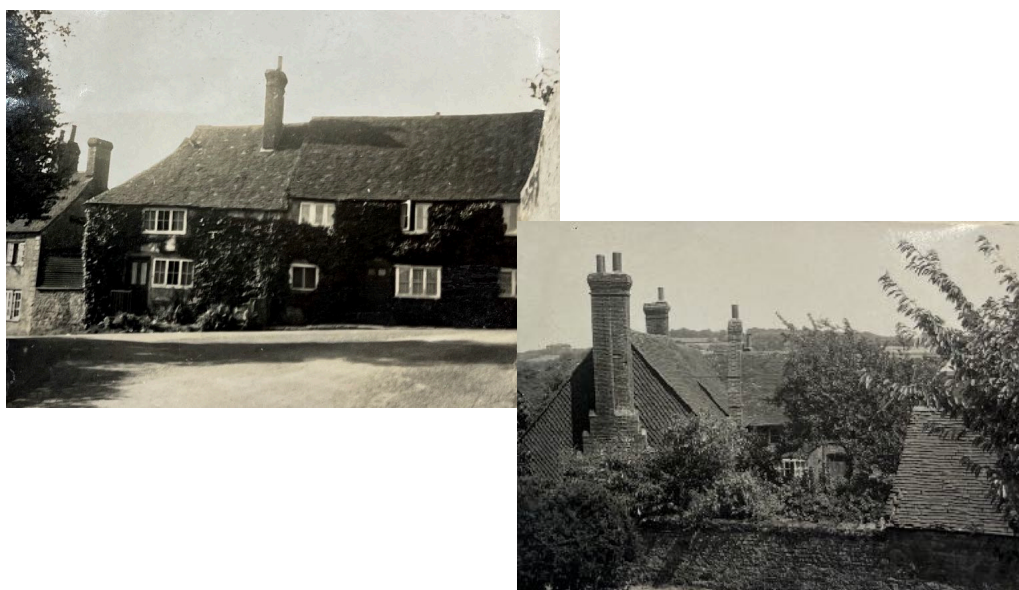
Photographs of The Old Nursery from a Women's Institute 'History of Lodsworth, 1947. (AM21/2/1 West Sussex Record Office)

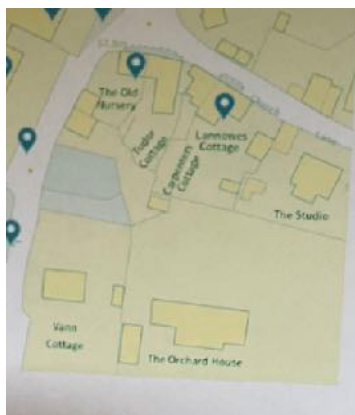
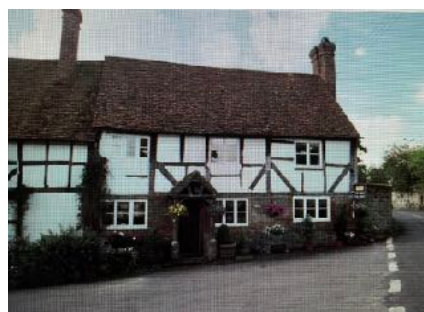
A detail from the OS map for Lodsworth (2022) and an accompanying archive image, 2004. (IOE01/12477/36)

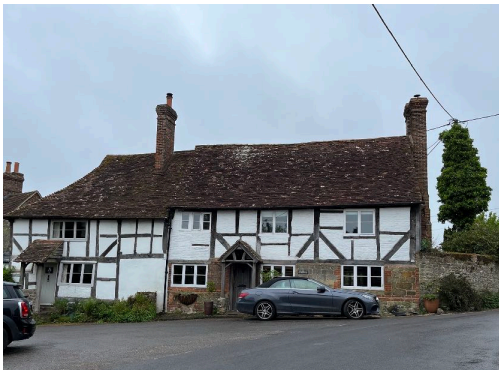
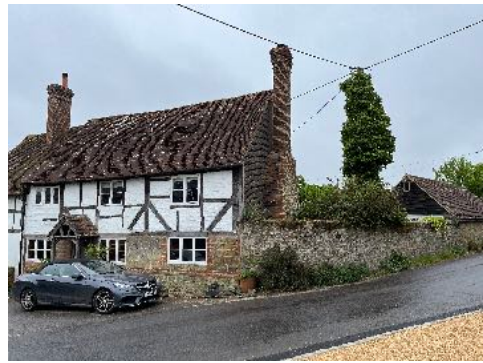
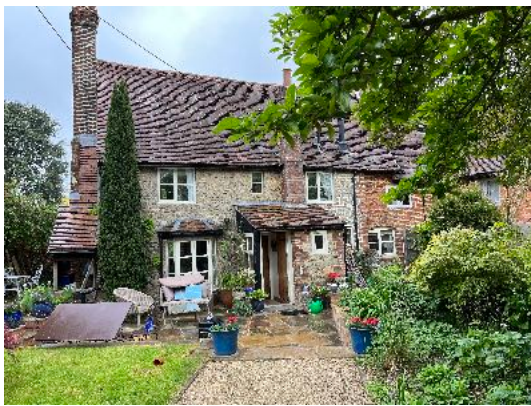
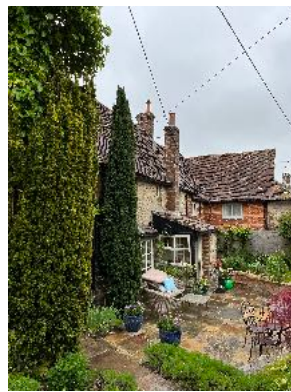
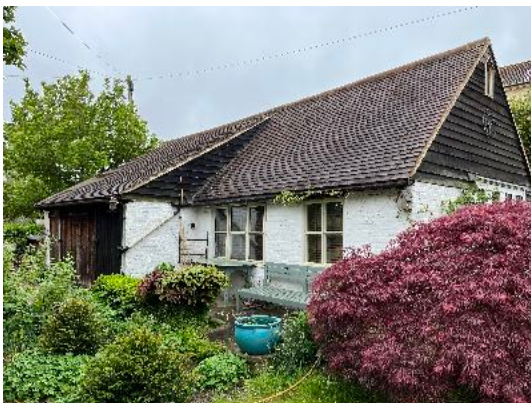
Exterior photographs of The Old Nursery 2022. Front, north facing views (top row). Rear, south facing views (middle row). The Outbuilding/Workshop/Barn, (bottom row).

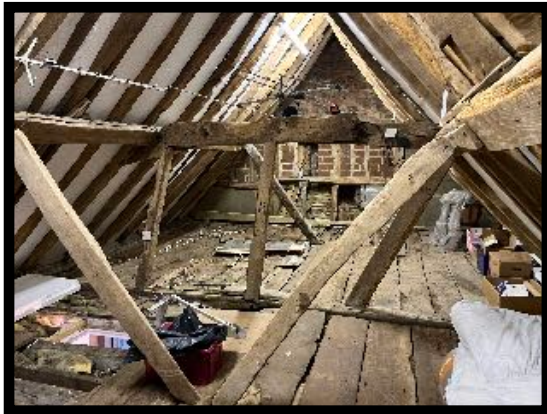
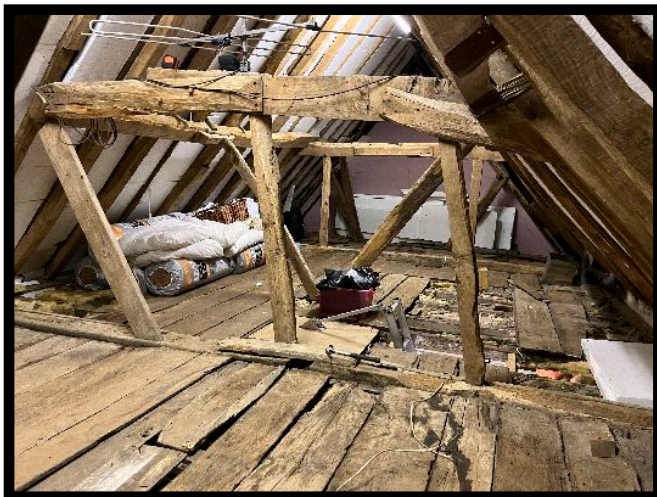
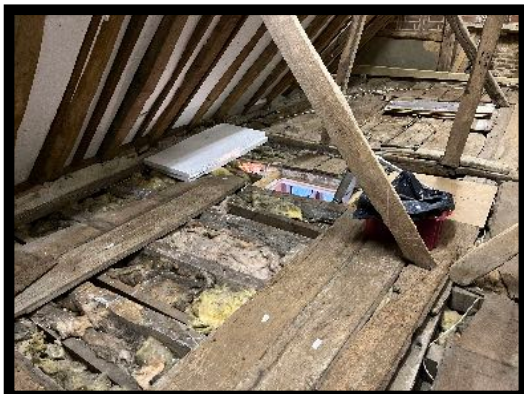
The architectural features within the roof space show a cut tie-beam repaired with supports; rafters of varying age including some modern timbers; floor boards of assorted ages, some missing or cut, some unstable; cross beams of varying ages and condition; brickwork of diverse ages and condition.

Interior photographs of the attic space at The Old Nursery, 2022. View looking westwards(top row). Looking eastwards towards Tudor Cottage (middle row). Present ladder access to the attic (bottom row - right). Chalk marks on joists indicate where a new more adequate access could be created (bottom row-left).

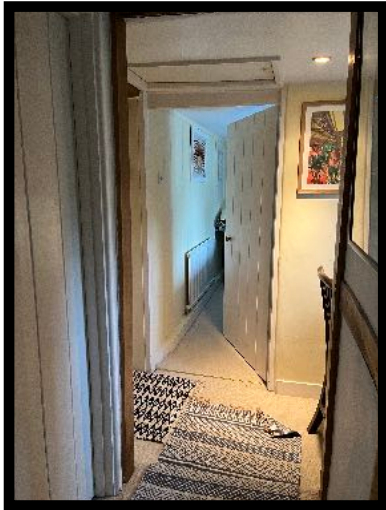
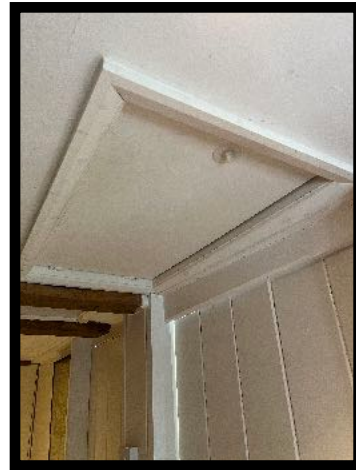
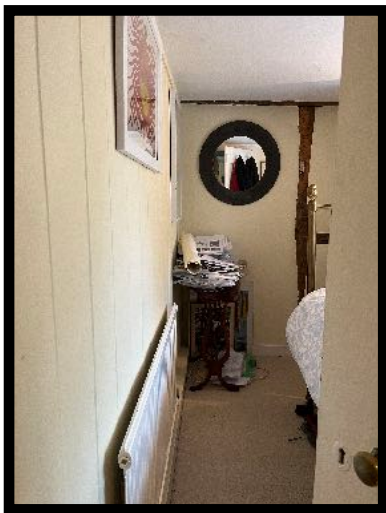
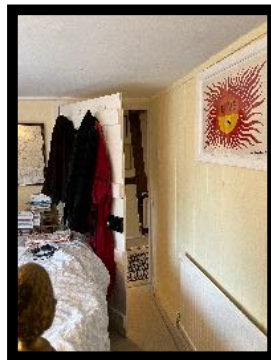
First floor views of The Old Nursery, 2022. Access to the attic space (top row). 'In' and 'out' views of Bedroom 3 from where more adequate access to the attic space could be provided (bottom row). The interior walls of Bedroom 3 are of a modern partition construction.

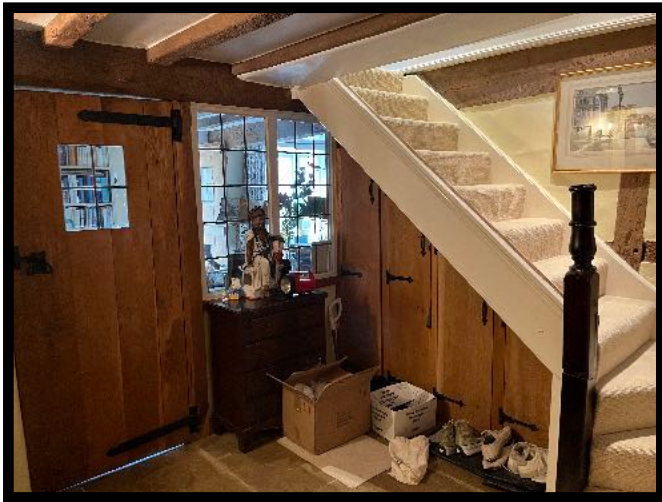
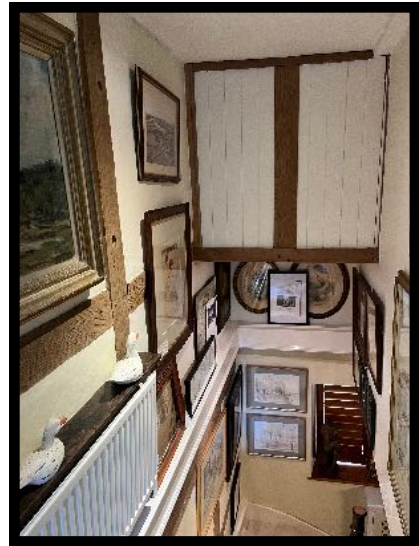
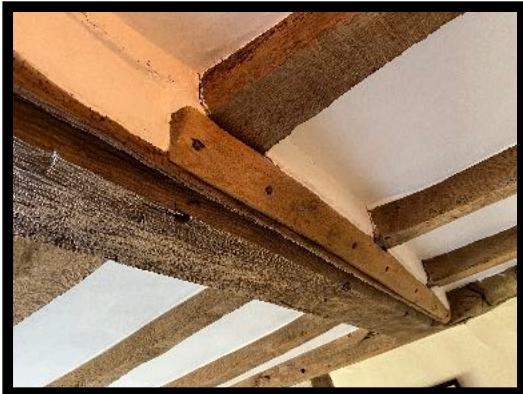
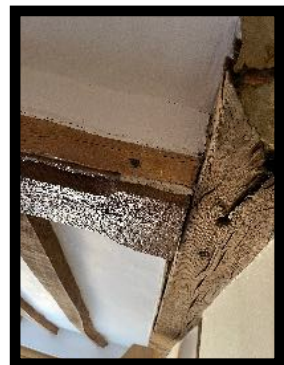
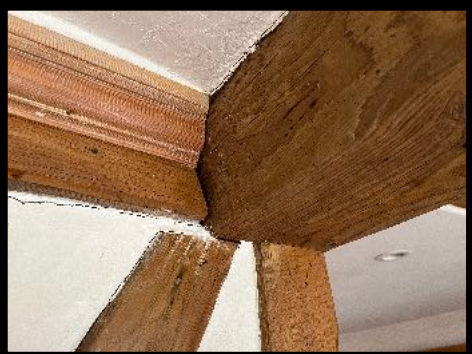
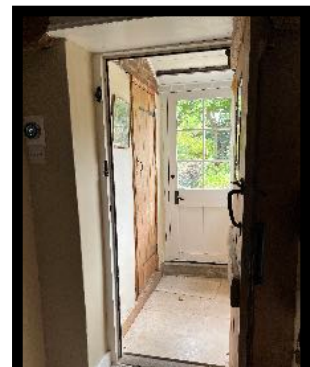
The following range of photographs show architectural features on ground and first floors highlighting the alterations that have happened to the cottage in recent years. Beams have been cut, cupboards have been created with modern materials, a space for a bath created.

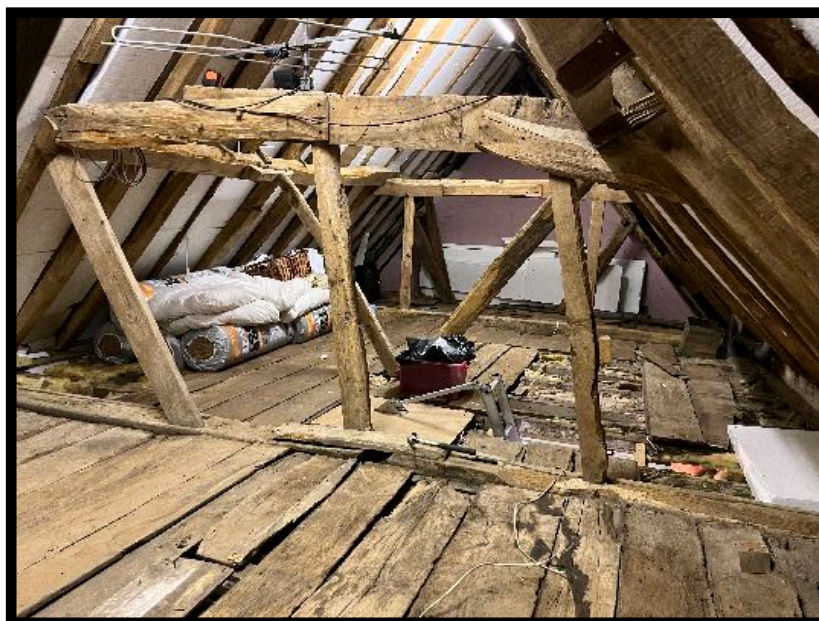
The entire attic space is floored with oak boards, apart from where they have been removed in the last few decades (Photo 1 - below).

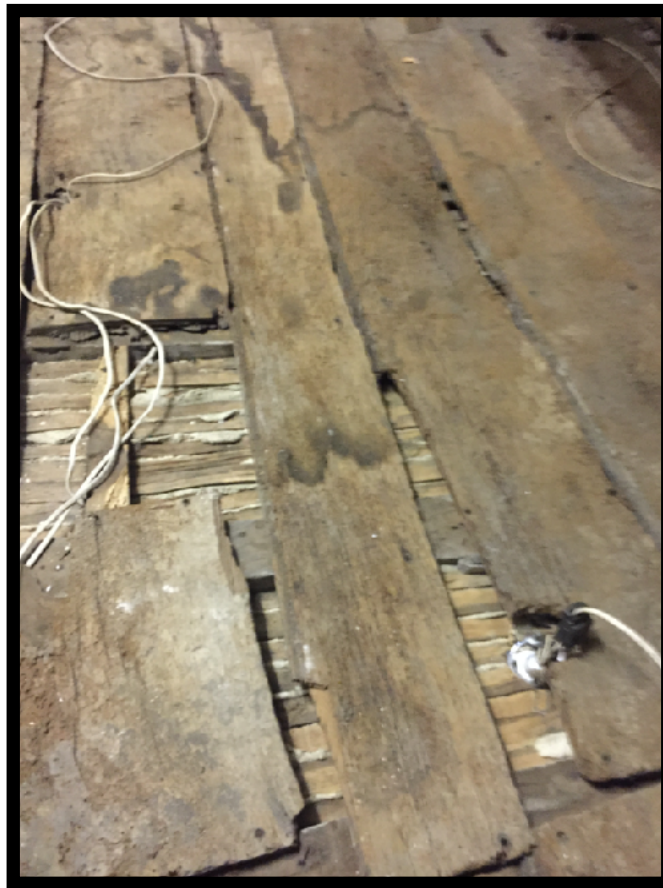
West bay: the boards run east-west and lie directly on the lathes of the plaster ceiling of the room (Bedroom 2) and bathroom below (Photo 2 - below). There is, therefore, no space to insert any modern insulation below the boards.

In the centre bay, the joists are sufficiently deep to allow modern insulation to be inserted between them and below the boards. The boards will then be put back and any damage made good from the boards removed in the past from the east end of the east bay.

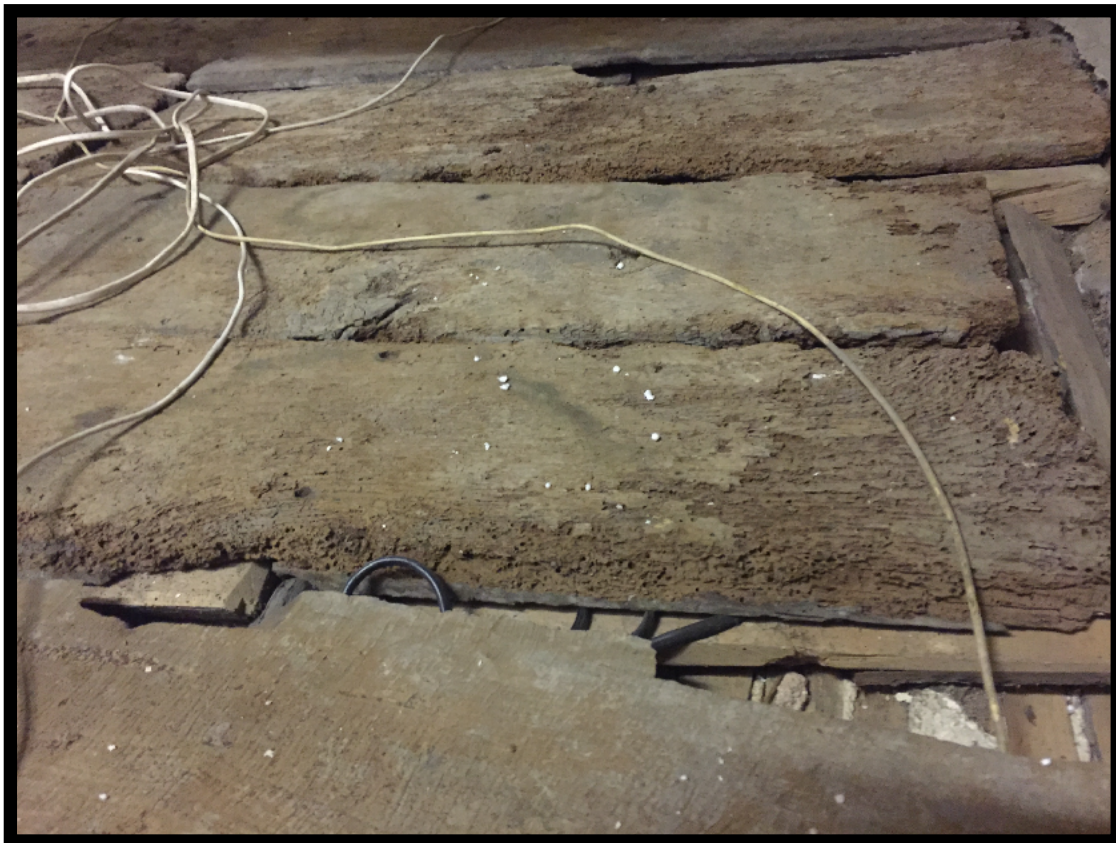
The upper sides of many of the boards have areas where the surface has been damaged. This may have been due to

exposure to the weather with damp and associated moss growth rotting the surface (Photo 3 - above). This has made attack by insects easier. In contrast, the undersides of the boards generally only show insect damage.

At a meeting with a planning official from Chichester District Council in November 2018, it was recommended that the boards should be preserved where possible. It is, therefore, proposed to 'float' a new floor over the west and east bays,

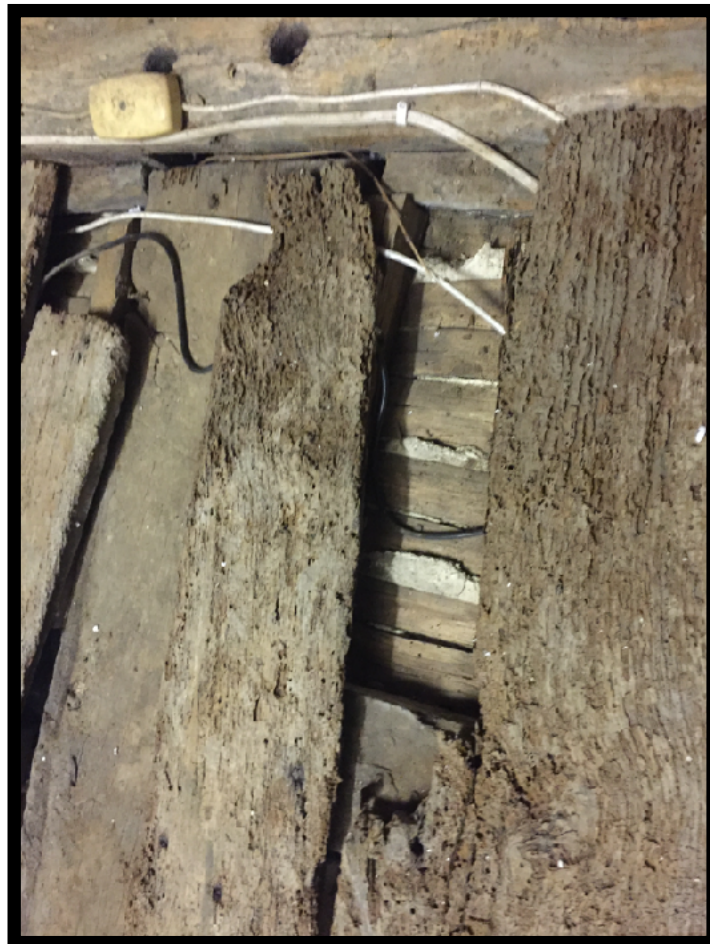
The boards in i. very poor and ii. poor condition cannot support significant weight, eg someone standing on them, as the edges fracture or crumble away (Photo 4 - below).
