HERITAGE STATEMENT

Manor Cottage - Internal alterations

22.01.2024

55 Little Gaddesden, Little Gaddesden, Herts. HP4 1PL.
Historic building recording and analysis of the cottage. Recorded 11 03 2022.

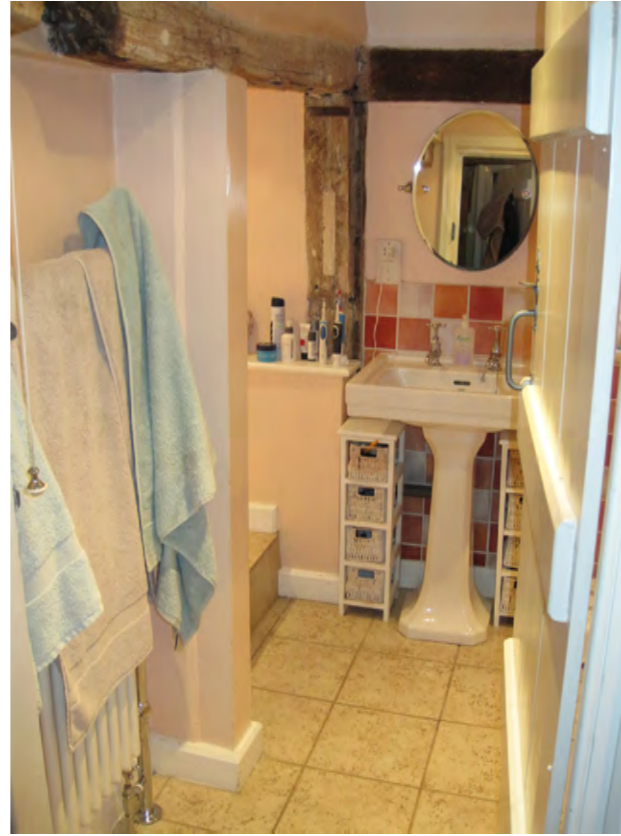
figure 2.1 existing en-suite

2.2 The current arrangement has the bathroom at the first floor, directly at the entrance to the master bedroom.

This en-suite is enclosed with plasterboard partitions, which we propose to remove. All of the original beams will remain untouched and only the 1985 alteration will be removed.

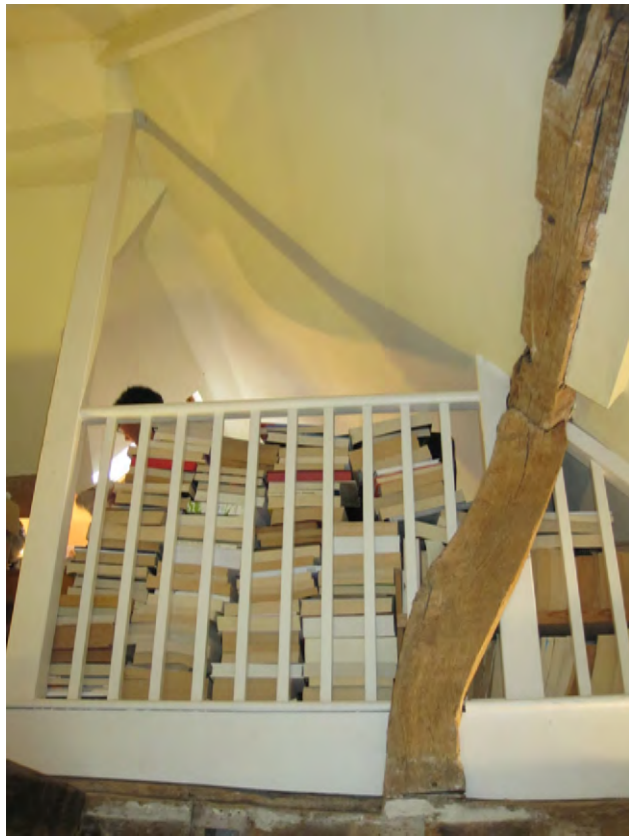
figure 2.3 existing mezzanine

2.3 The mezzanine has probably been inserted in 1985 and is currently used as an office. The proposal is for this mezzanine to be used as an en-suite.

The study mezzanine seems very recent and has a Velux roof light which may be replacement for works done in 1985. Prior to the conversion it is highly likely there was a habitable attic from the C18th onwards.

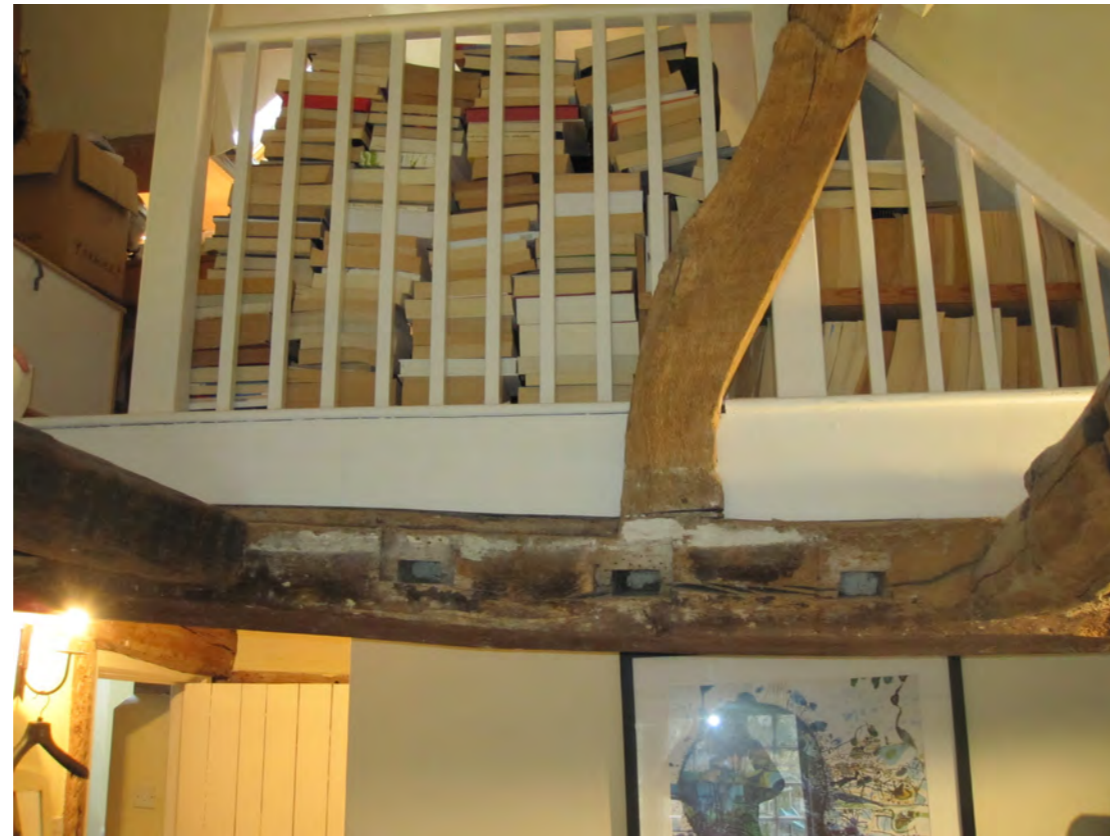
figure 2.4 beams around mezzanine, with plasterboard partition to en-suite below

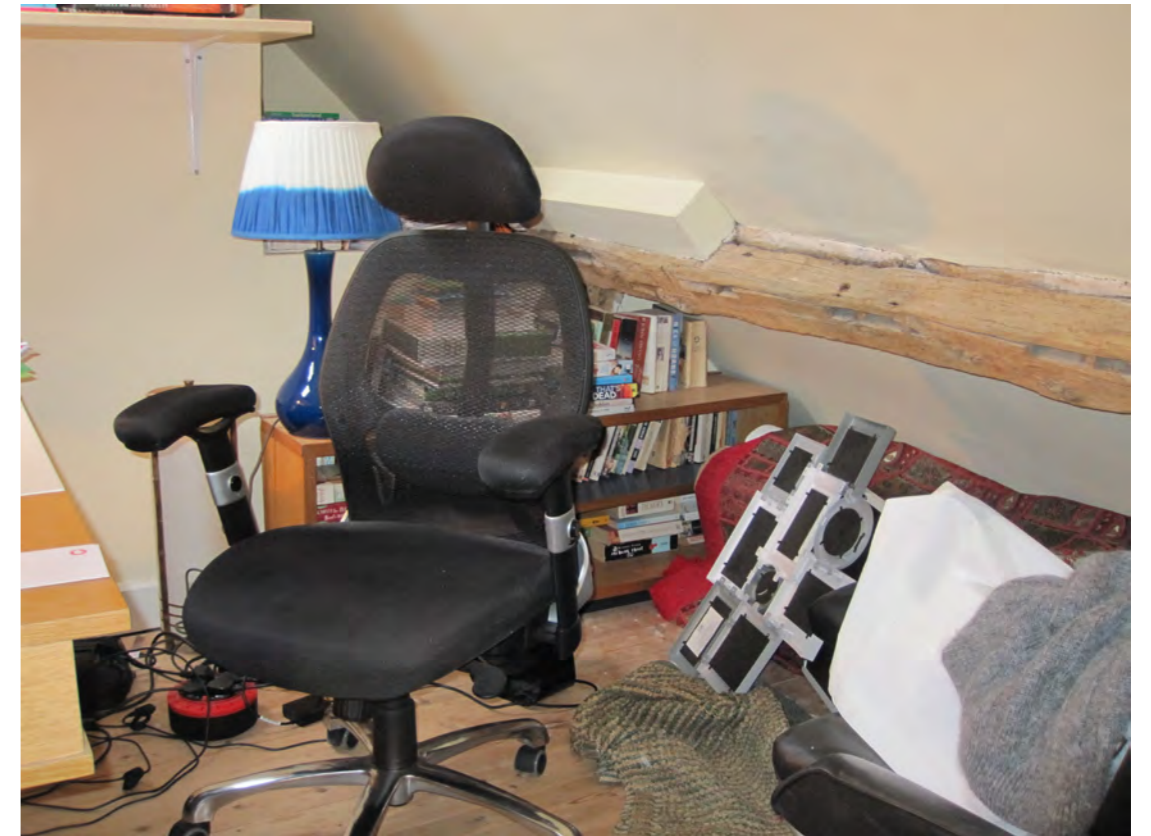
figure 2.5 office on mezzanine

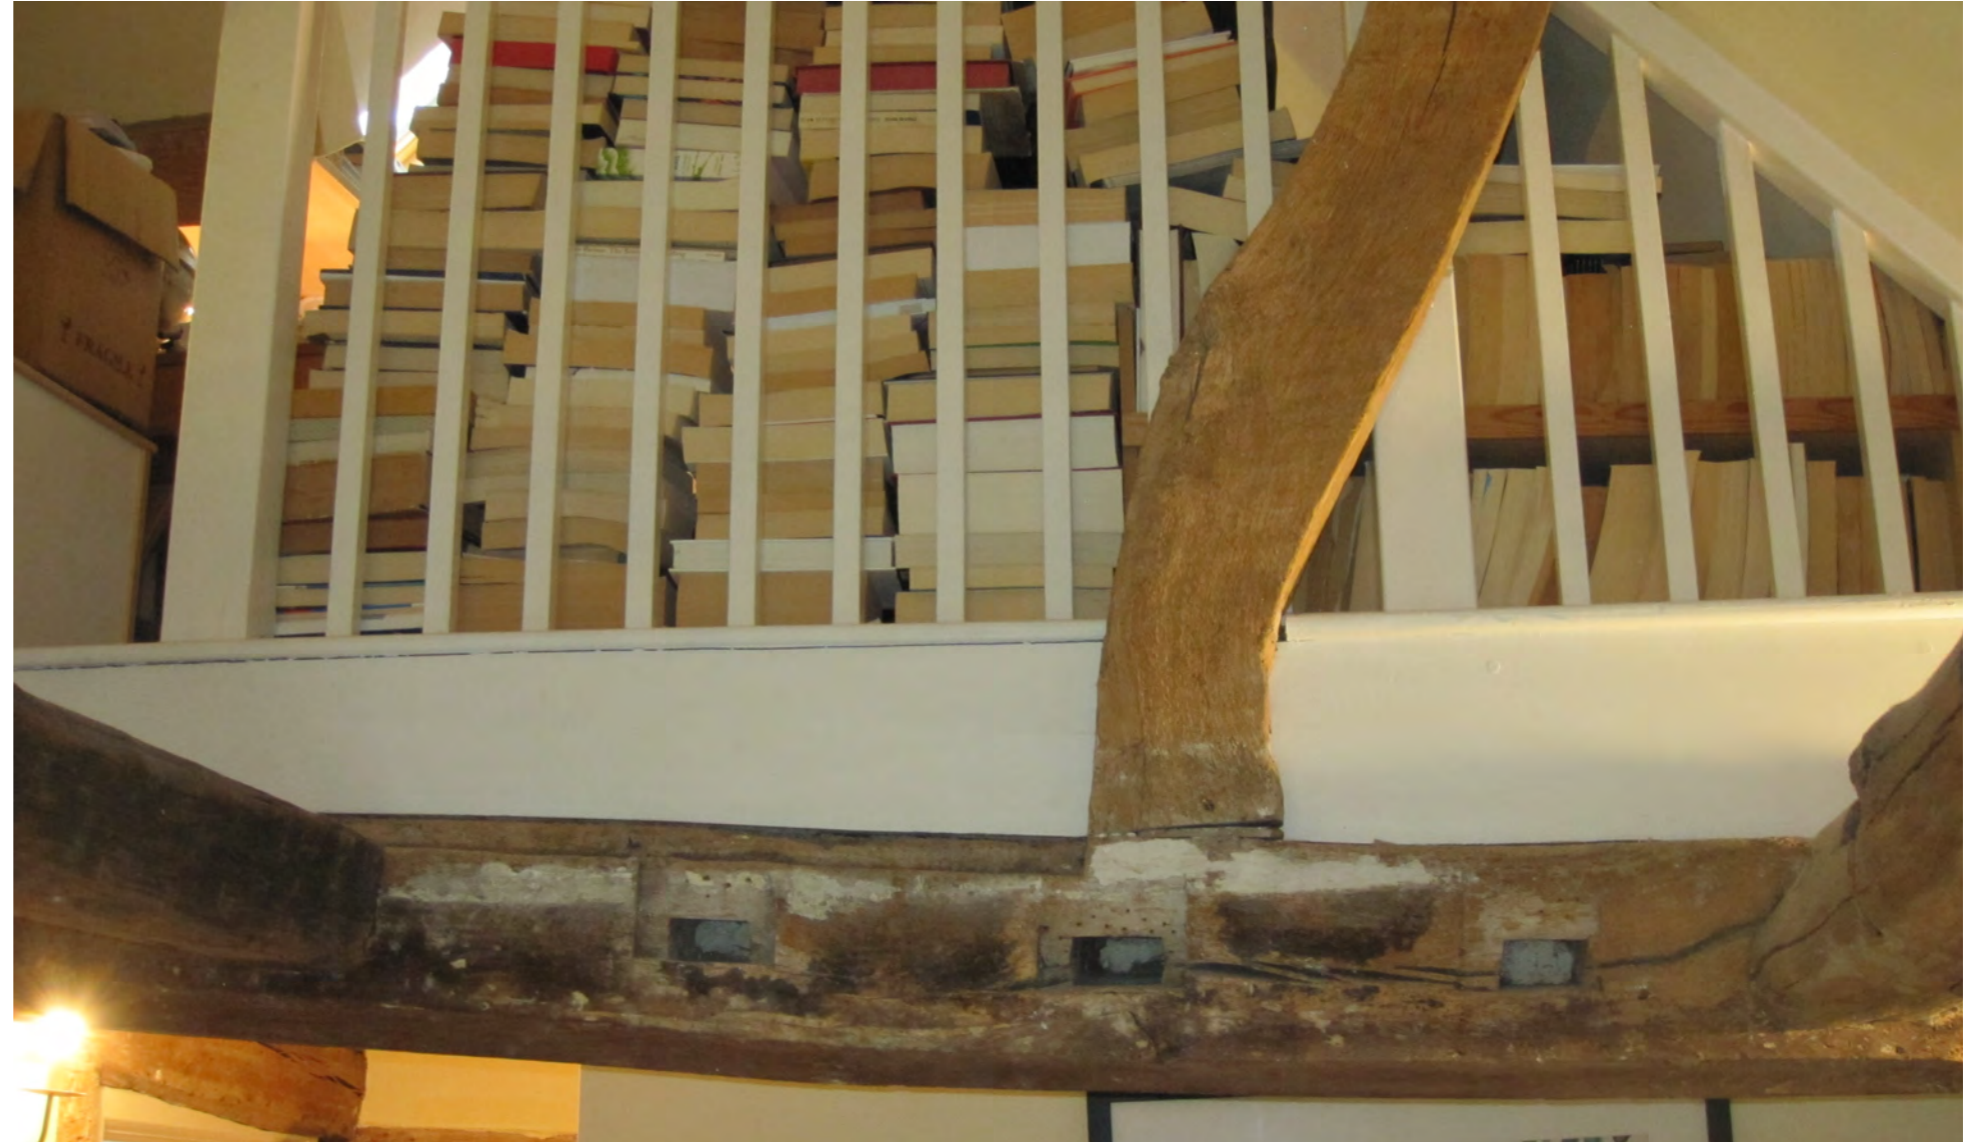
figure 3.1 Mezzanine in master bedroom

The master bedroom [...] occupies the east room of the cross-wing. The frame is difficult to understand. An axial joist with refined entry soffit tenons represents an inserted attic floor that has been subsequently removed and two reused beams inserted as tie-beams as part of a LC20th remodelling to vault the room. The vault carries across to form a mezzanine with small study reached by a ladder stair inserted probably in 1985.

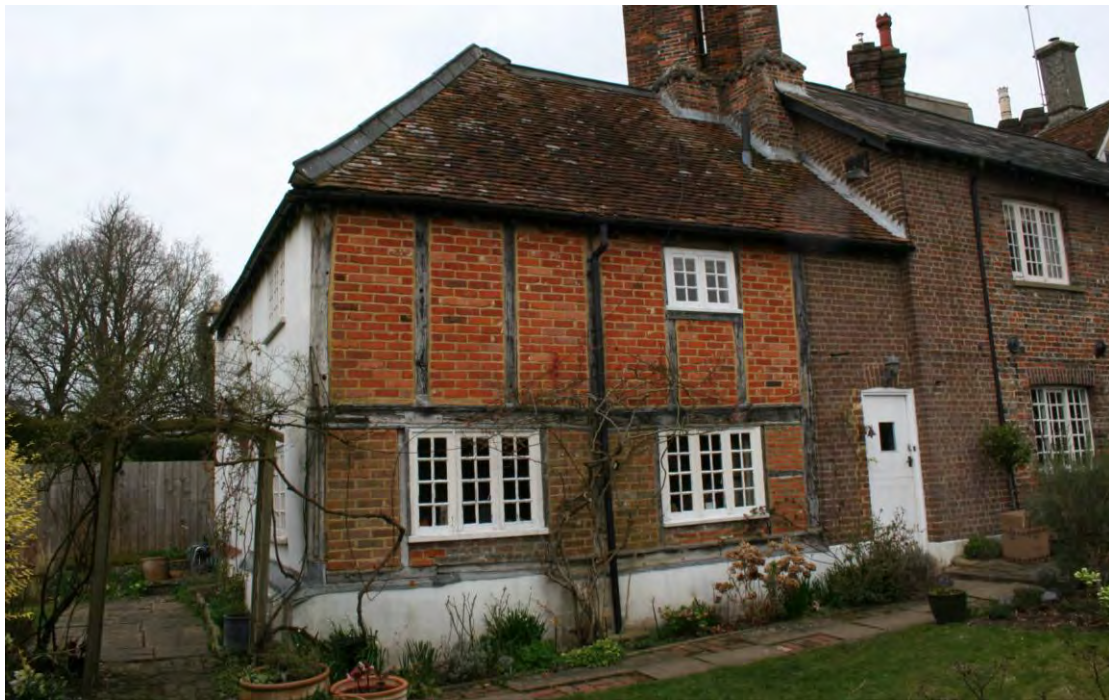
The eastern elevation of the timber-framed cross-wing.

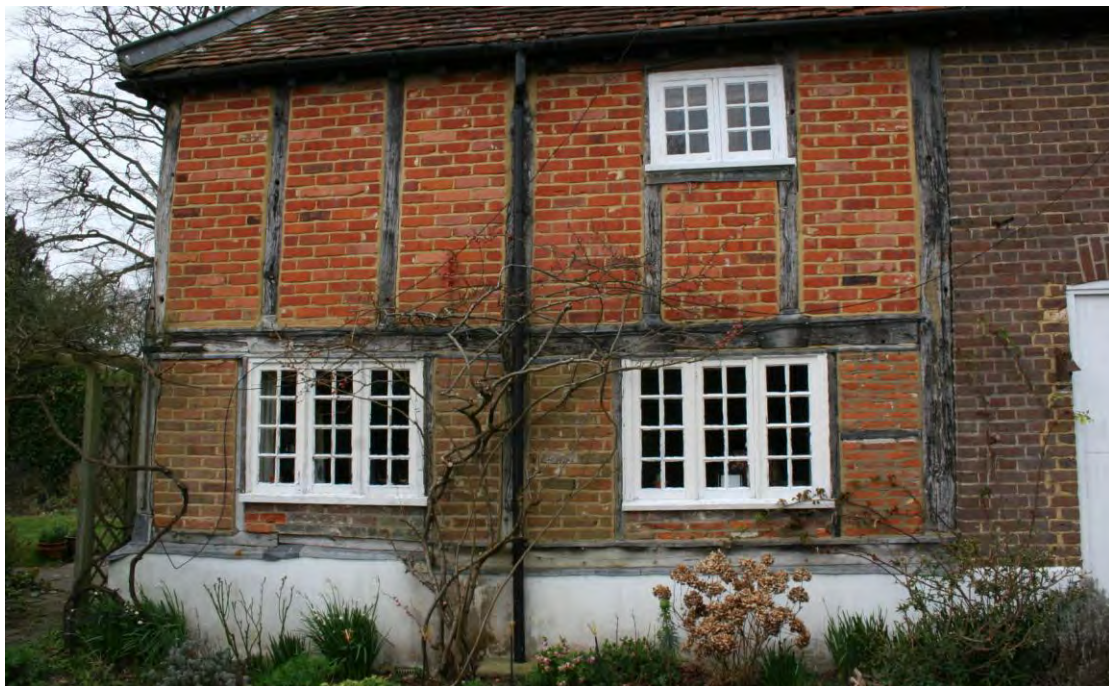
Detail of the LC20th brick panels.

The timber frame has been brick nogged with three sizes of brickwork in the LC20th. The upper register has three panels of 65-70x110x225mm new red/orange bricks. The lower register has three panels of 45-55x110x223-230 mm red/orange bricks simulating 2in Tudors and four panels of LC20th 65x100x225mm buff discoloured orange bricks. All are set in bright sandy cement mortar in stretcher bond. While the principal wide oak timbers are part of a C16th box frame the narrower timbers are put in for the MC20th windows.

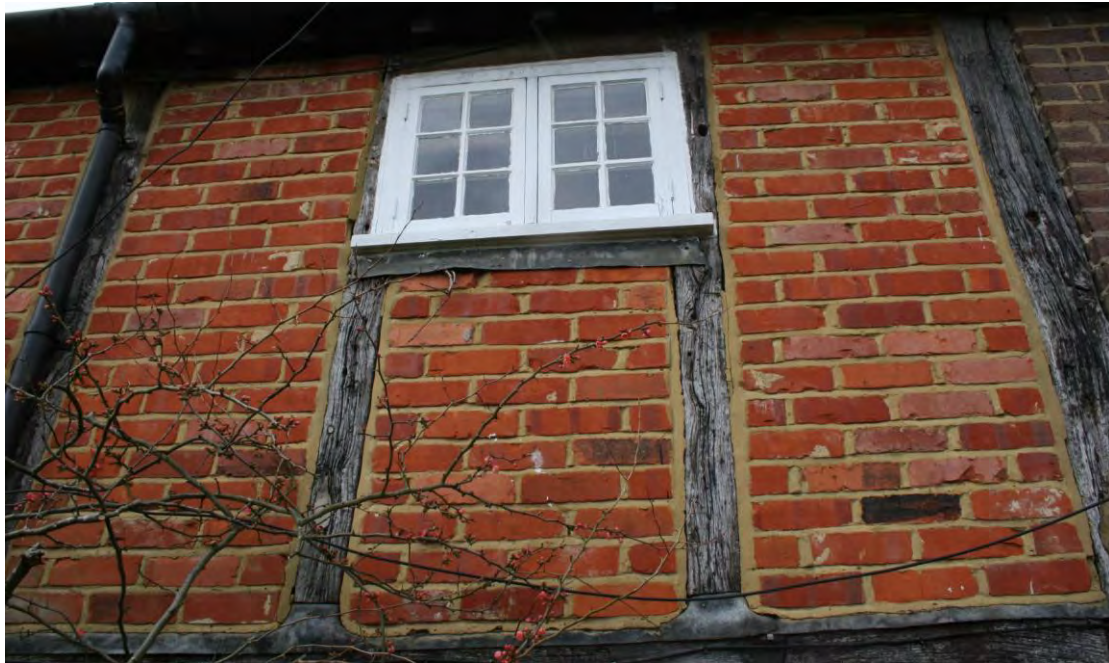
The upper register has LC20th bricks and sandy cement pointing.

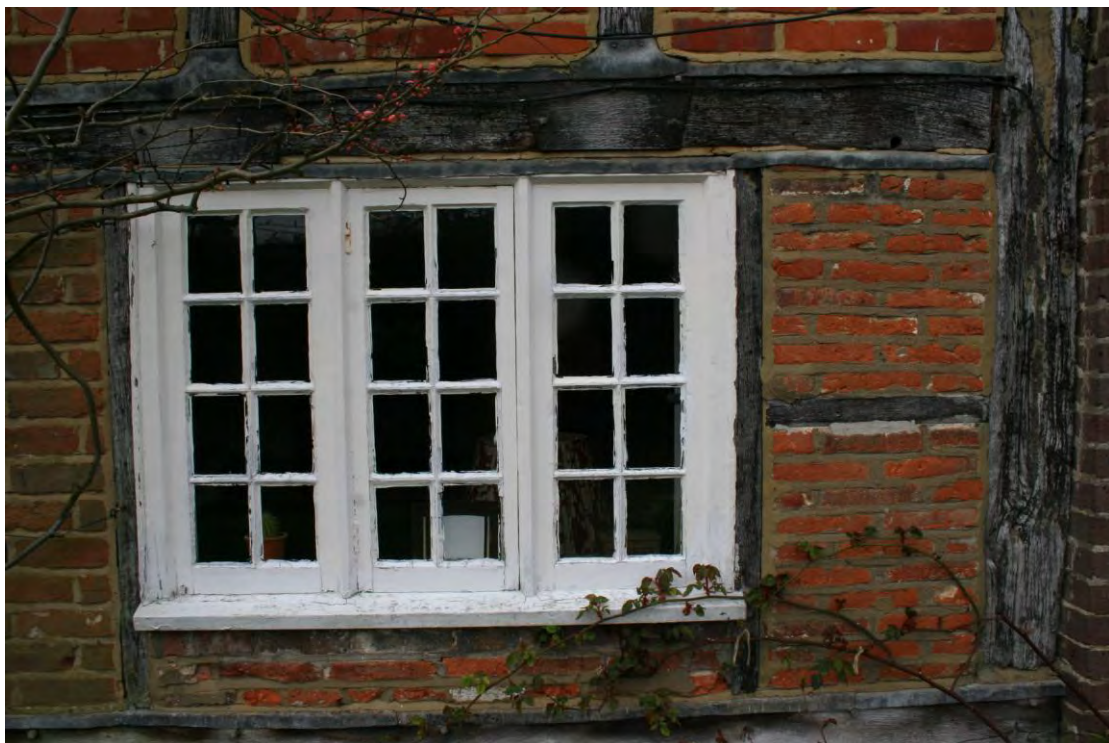
The lower register has thin 'Tudors' as well a larger bricks.

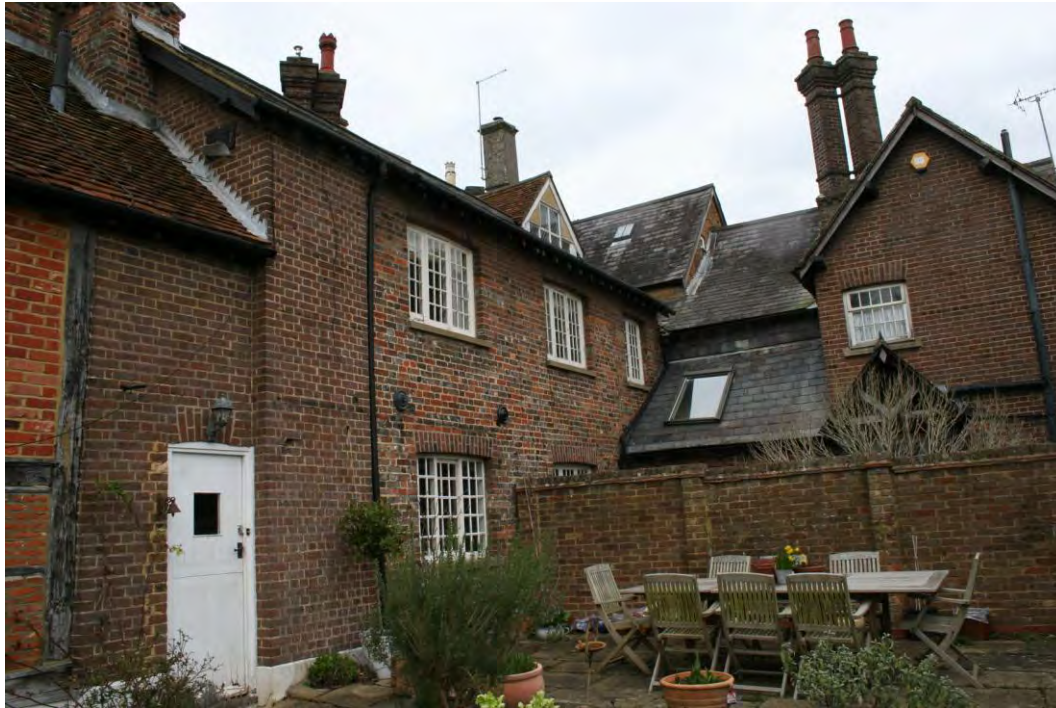
The eastern elevation is divided into a timber-framed range and cross-wing with LC20th brick nogged panels and a brick built Range of 65x90-100x210mm dark brown and over-fired blue bricks. Around the front door is a panel of purple 65x110x225mm London Stocks characterised by large black specks of gasworks breeze.

The eastern elevation of the brick built Range.

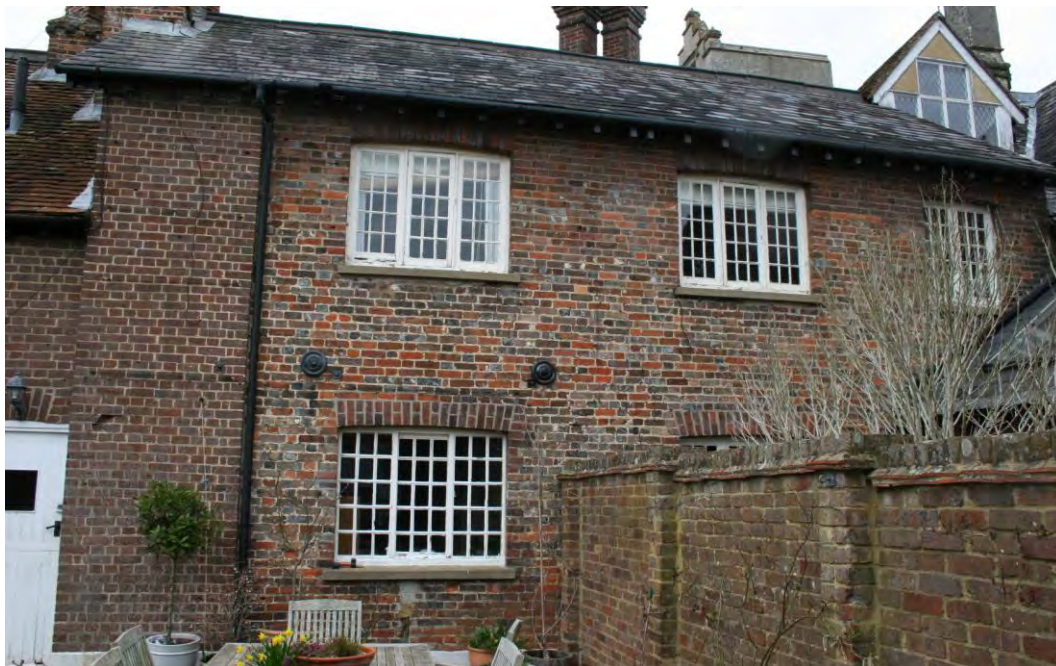
The Range appears to have C18th brickwork with MC19th details.

There is a significant step in the roofline where the timber framed cross-wing is joined to the main Range which appears to have had a MC19th makeover of C18th brickwork. Here the roof is clad with grey slates in contrast to handmade clay peg tiles. Although the brickwork is made from C18th bricks the window openings all have rough gauged arches popularised in the MC19th repointed in grey cement. The windows cills are of sharply cut stone and are likely C20th replacements. The front door is a LC20th split stable door set under a window head and inserted in the brickwork.

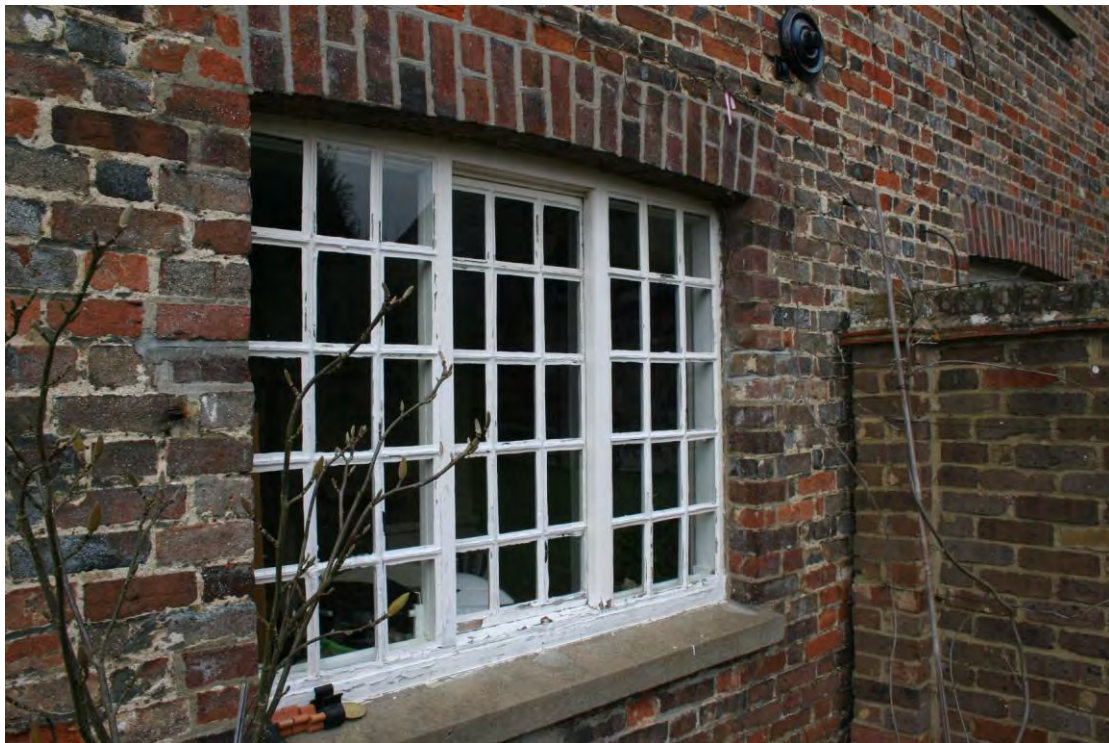
Detail of the horizontal sliding sash.

The windows are all small 15 pane, 3 light casements on the upper floor windows. The Kitchen window is a horizontal sliding sash that appears adapted from a casement. There are pater plates for LC19th or EC20th tie-rods with square headed bolts.

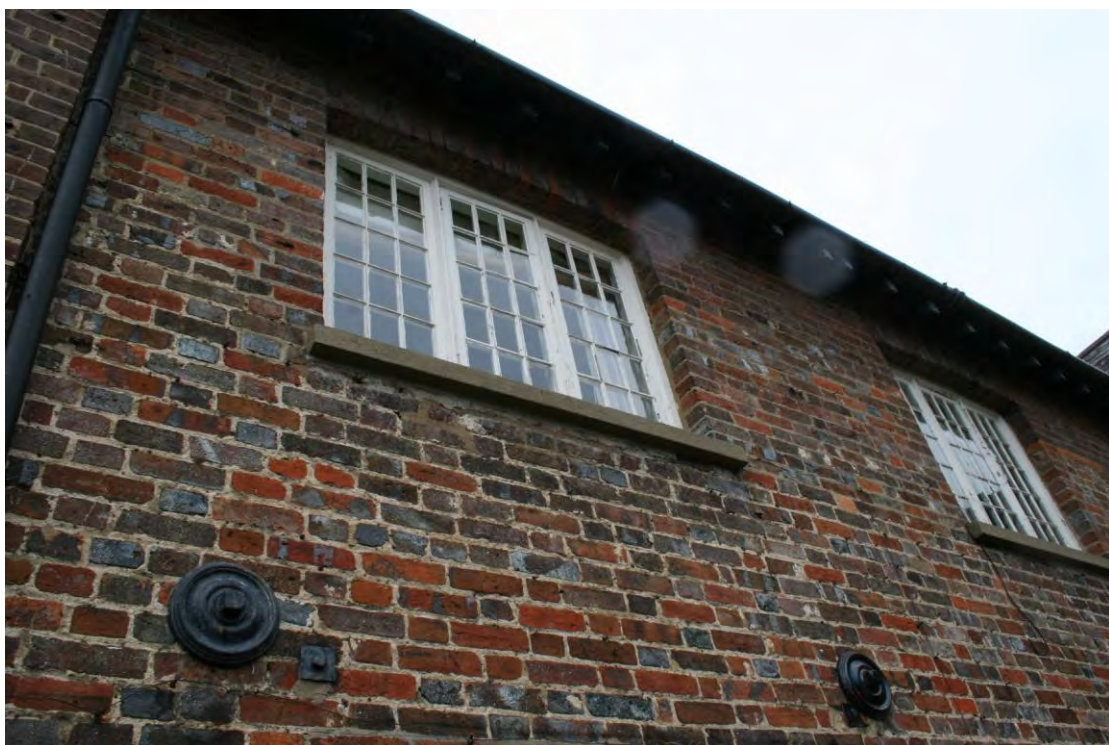
The upper windows and pater plates.

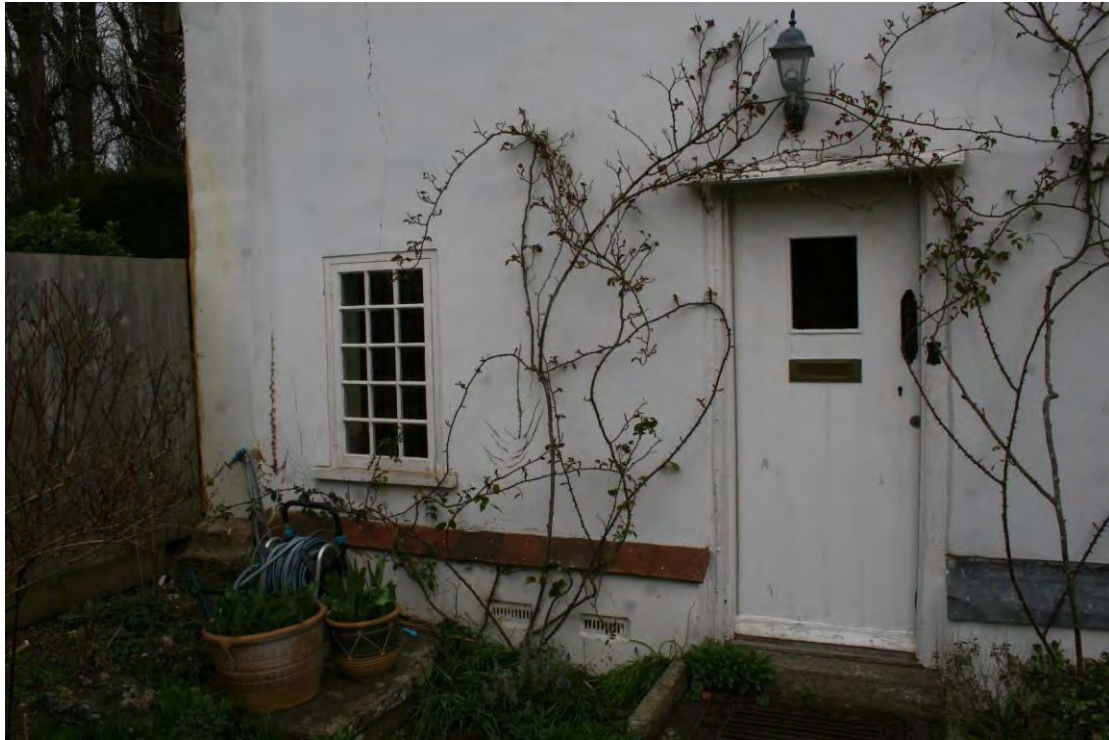
Detail of the plinth, side door and replacement window.

The inserted windows are part of a suite of renovations made to the cross-wing where all the windows on the south and east elevations match as three light casements each with eight portrait panes. The timber frame has been underpinned with a brick plinth that extends far out and is capped with roof tiles and lead sheeting. The wall is skinned with cement render on EML with galvanised drips.

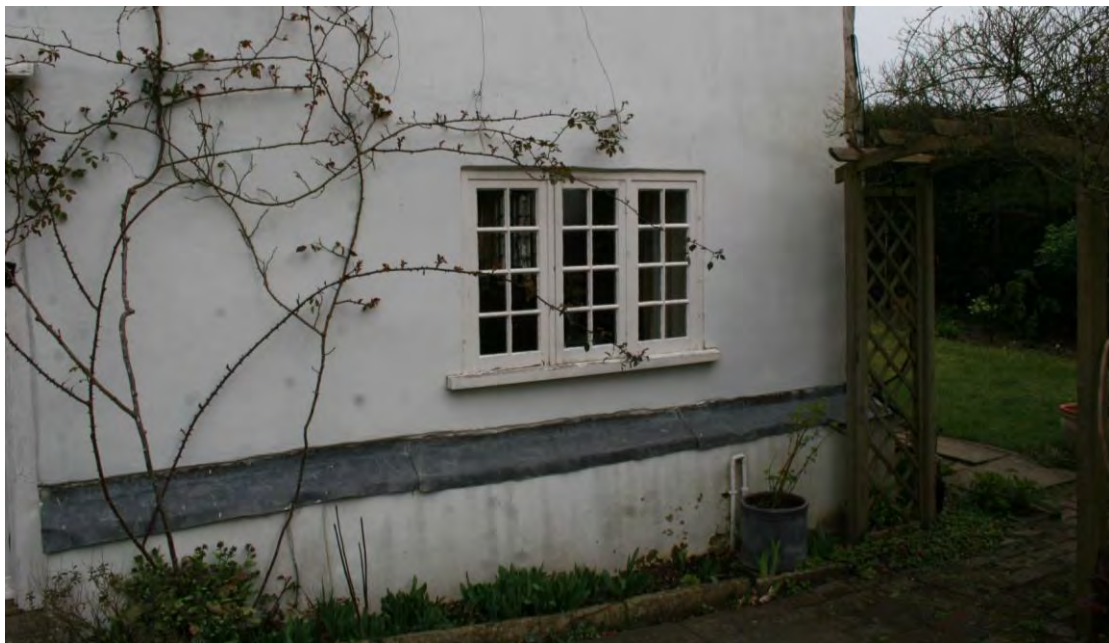
Detail of the inserted window.

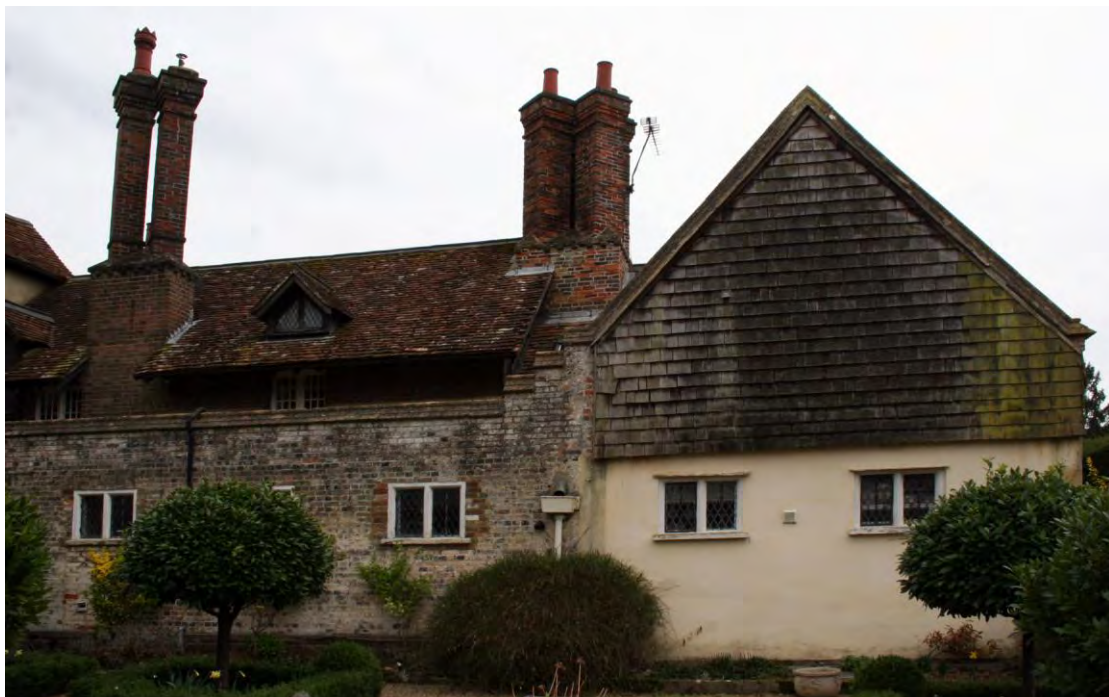
The west elevation of the cross-wing and the Range.

The upper section of the cross-wing has been clad in cedar shingles on softwood battens and several have loosened and fallen. Cedar shingles are attractive to woodpeckers who will damage them. The level of degradation suggests the shingles are no more than 40 years old.

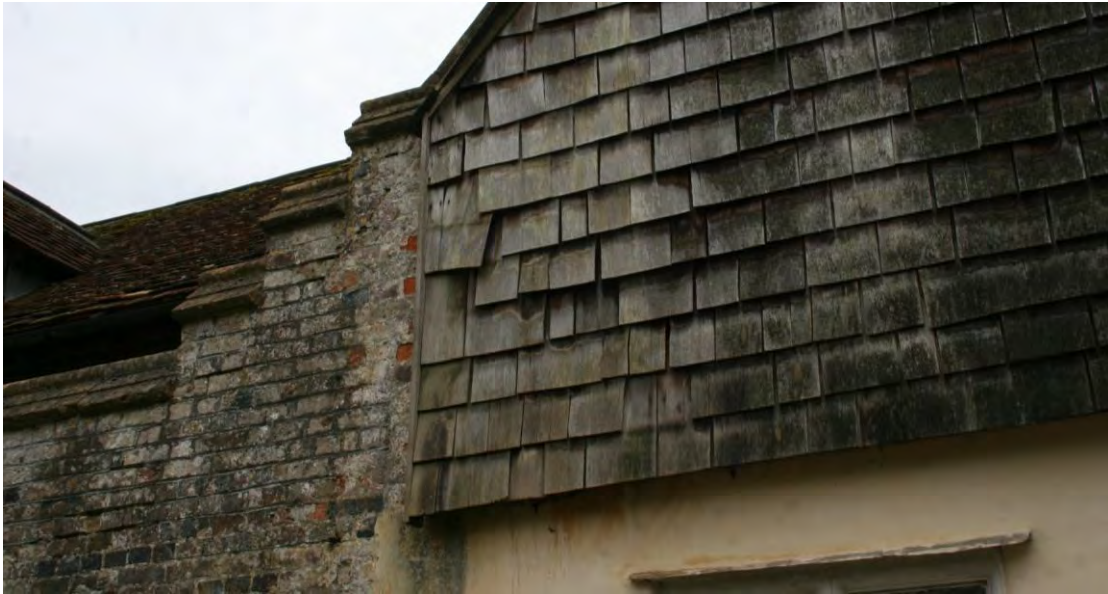
Detail of the shingles.

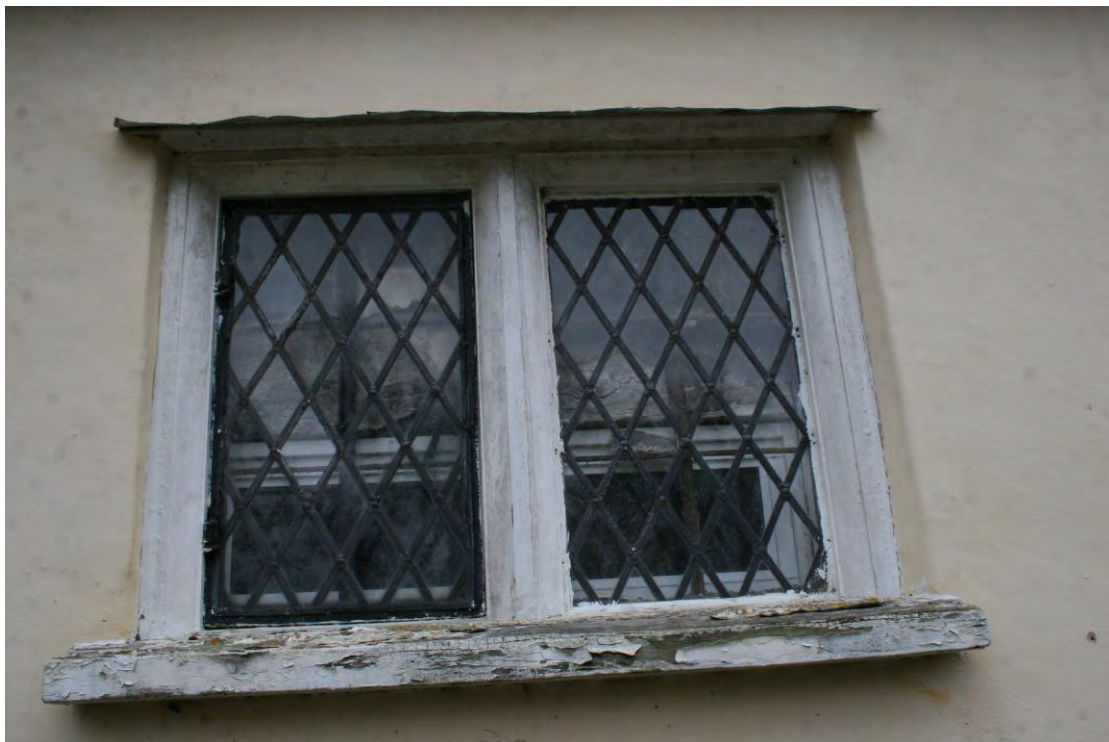
Detail of the southern leaded light window.

The lower register is finished with cement render over EML with lead drips over two twin light casements with leaded light windows. The southern one appears original to the C18th with wrought iron frames and fragile comes with milled glass. The northern one (and three others) appear remade in the MC20th with details typical of the 1930's when leaded lights made a resurgence all over the country. The biggest difference is in the quality of the lead comes and the type of lead welding on the joints which is much more regular.

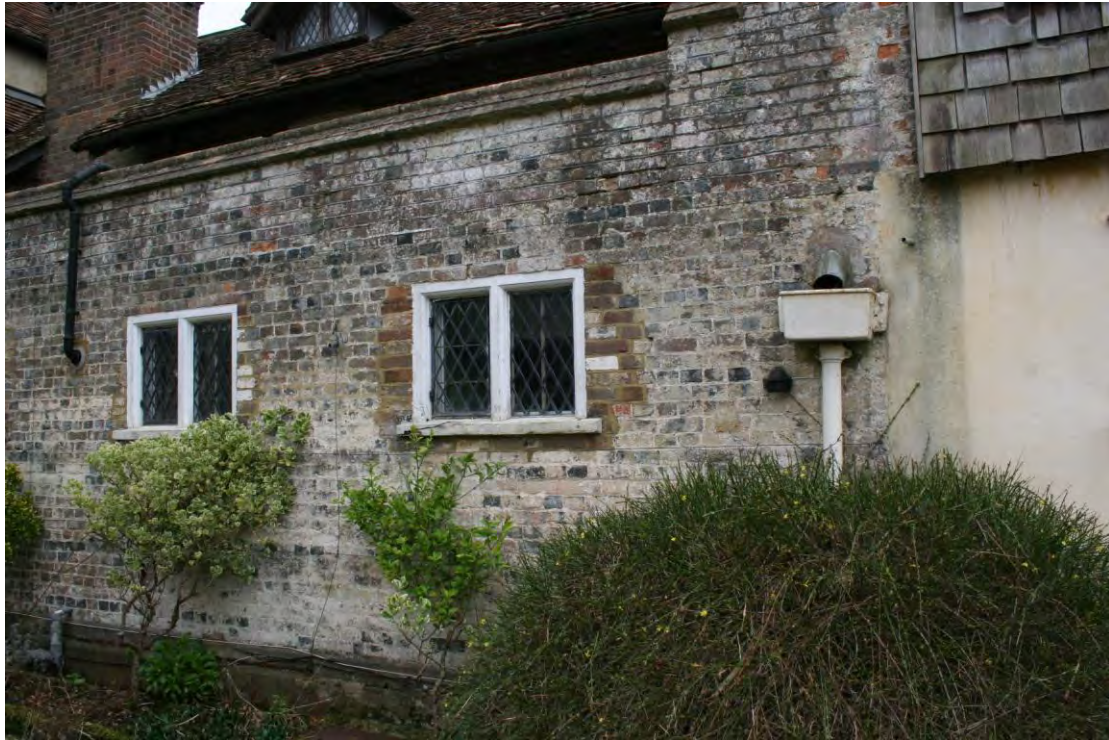
The applied facade to the south elevation. Windows appear inserted.

The southern elevation of the Range has an added facade that forms a service corridor that leads into the main house. There is an awkward junction with the original wall of the Range where small pent roofs have been breached to form openings for the bedroom windows. Here, all the details are quite fresh and the leadwork in the wide rain gully is modern.

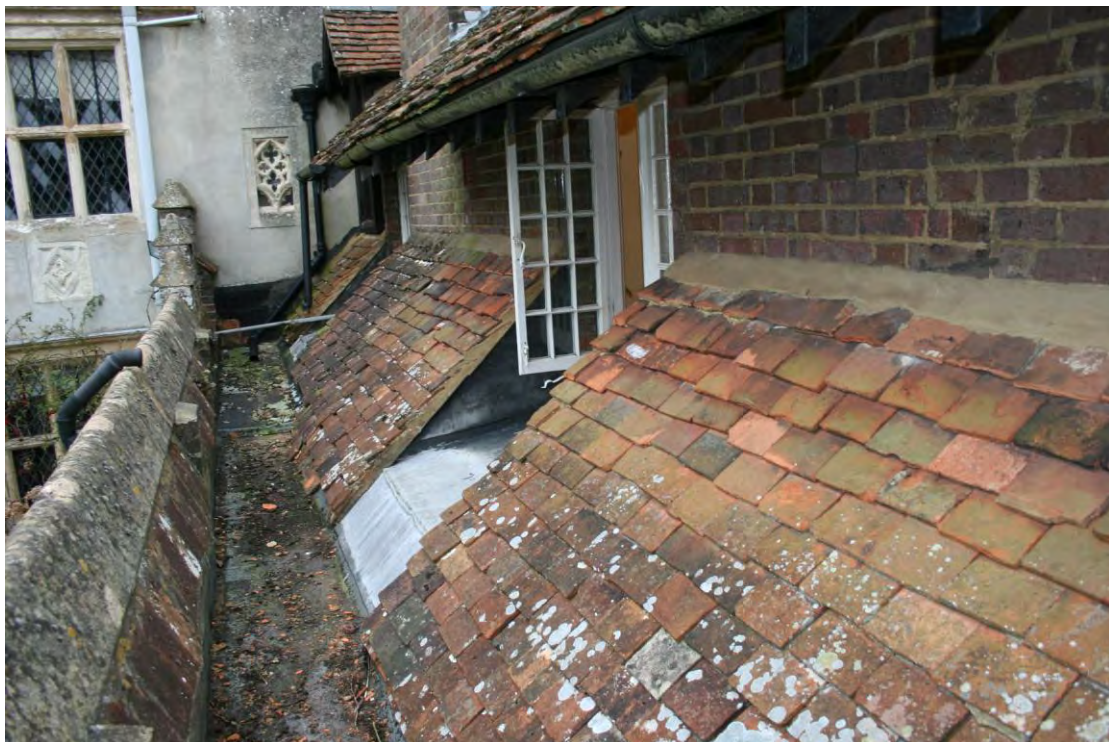
Looking N along the top of the south elevation.

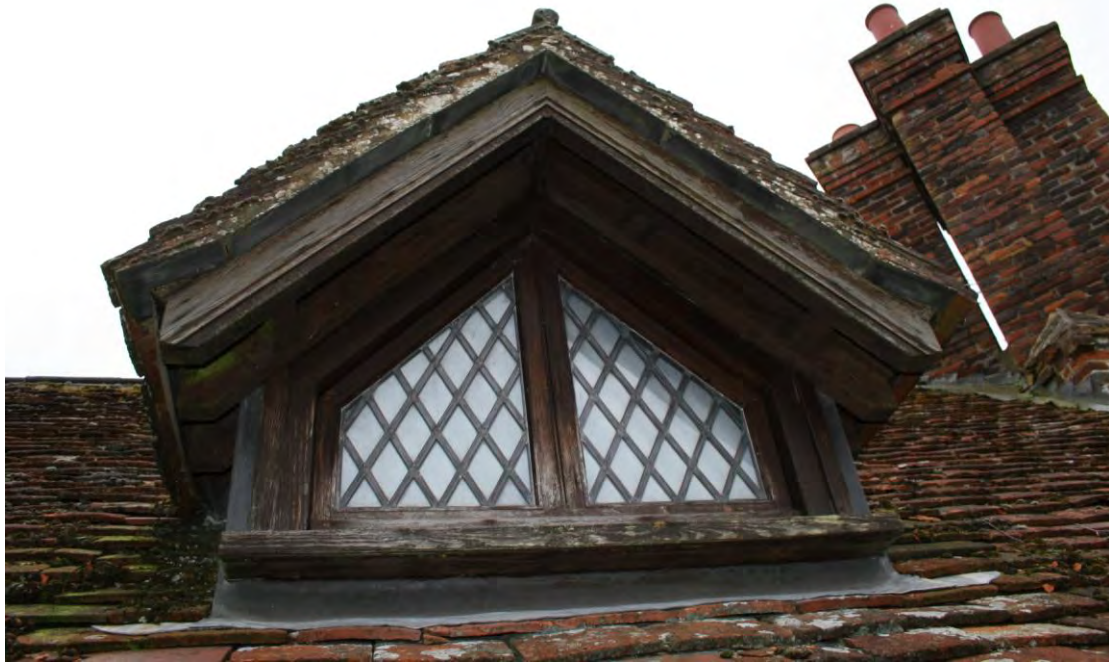
The dormer to the roof space.

There is a LC20th dormer that lights the roof above the bedroom, The leaded lights are more obviously LC20th. There is also a Velux roof light over the Attic Study. The firestack has 2in Tudor style bricks. Four separate chimney shafts have been added in the same size bricks both the stylisation would suggest they are C19th renovations. There are C20th cannon barrel chimney pots. To the north, outside the boundary of the dwelling is another firestack with very tall square shafts built to the same pattern but with the same type of bricks as seen in the walls.

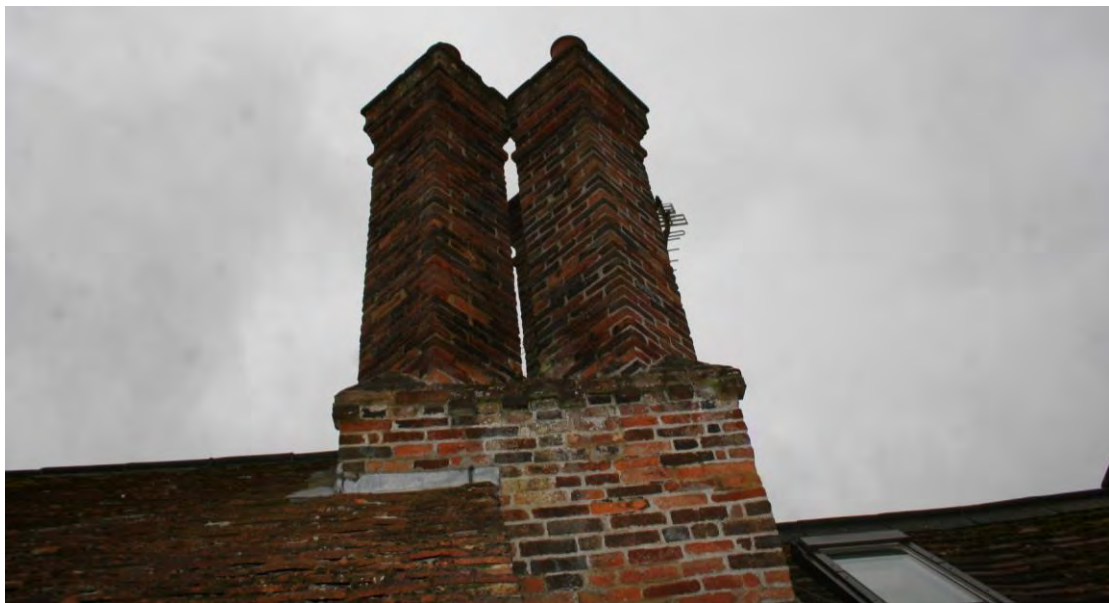
The fire stack divides into four separate shafts.

The position and mass of the firestack would suggest it was put in the building in the M-LC16th. It served two rooms on each floor. Only the basic stack remains, the fireplaces have been removed and the chimney stacks replaced in the C19th.

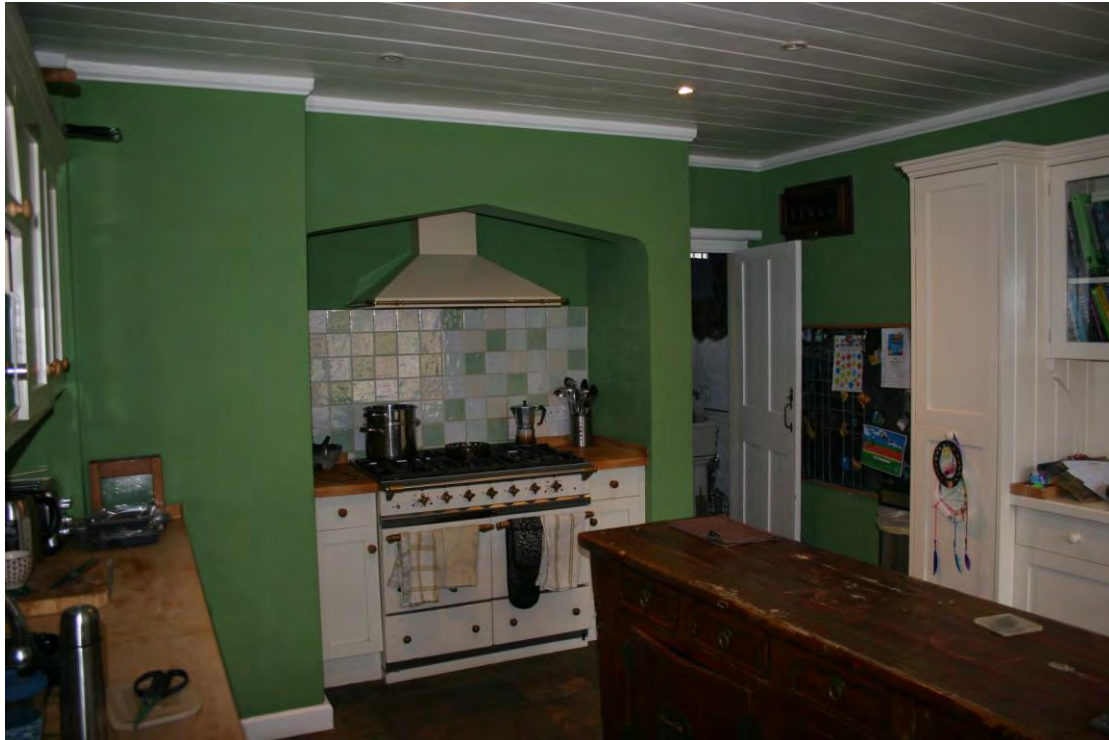
Looking W in the Kitchen. The alcove is described in the renovation plans.

The Kitchen is decorated to recent standards with fitted units, a fashionable Butler (Belfast Pattern) sink and modern appliances. There is an Aga stove set in an alcove described in the renovation plans as a proposed feature to support a beam to support joists. No historic fabric is visible except the horizontal sliding sash window and two Authentic Victorian four panel doors with planed panels.

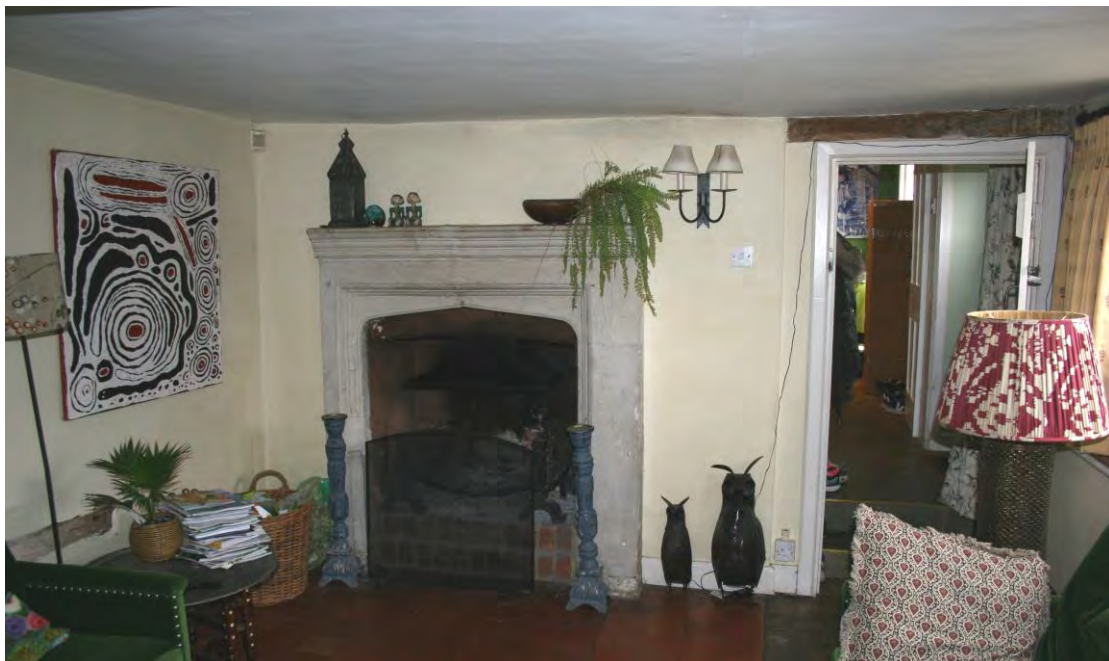
Looking N in the Living Room.

The Living Room displays the storey posts of the timber-frame and a main transverse joist which is inserted as an alteration to the frame. The western end is supported on a new steel bracket, while the eastern end is supported on an applied jowl.

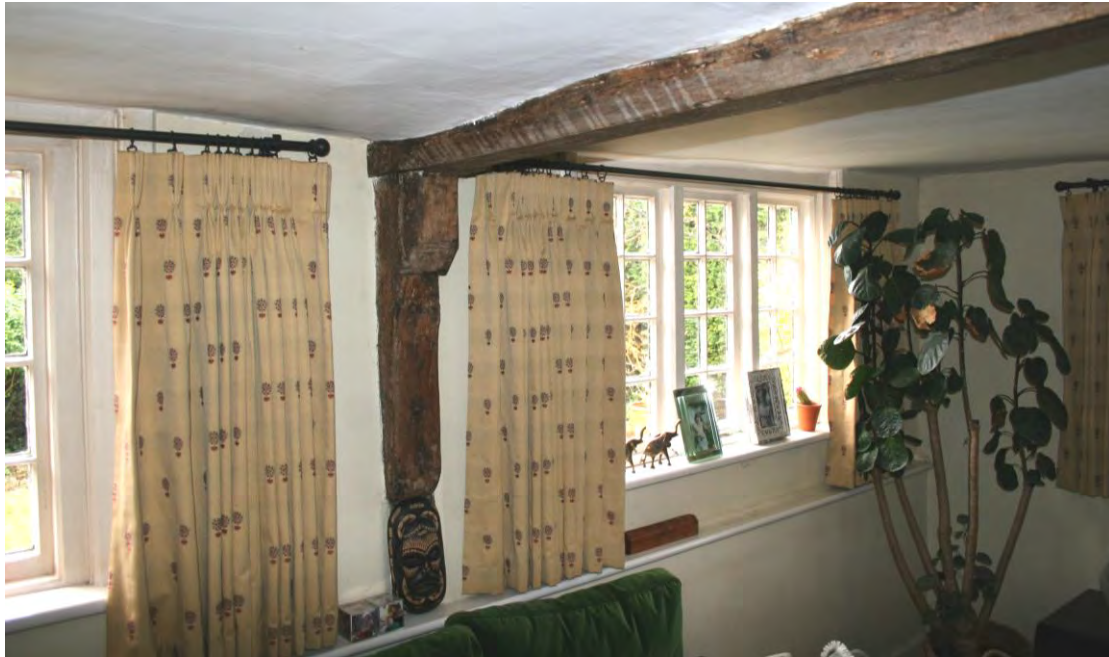
The storey post with applied jowl. Looking SE.
