HERITAGE STATEMENT

Manor Cottage - Internal alterations

22.01.2024

55 Little Gaddesden, Little Gaddesden, Herts. HP4 1PL.
Historic building recording and analysis of the cottage. Recorded 11 03 2022.

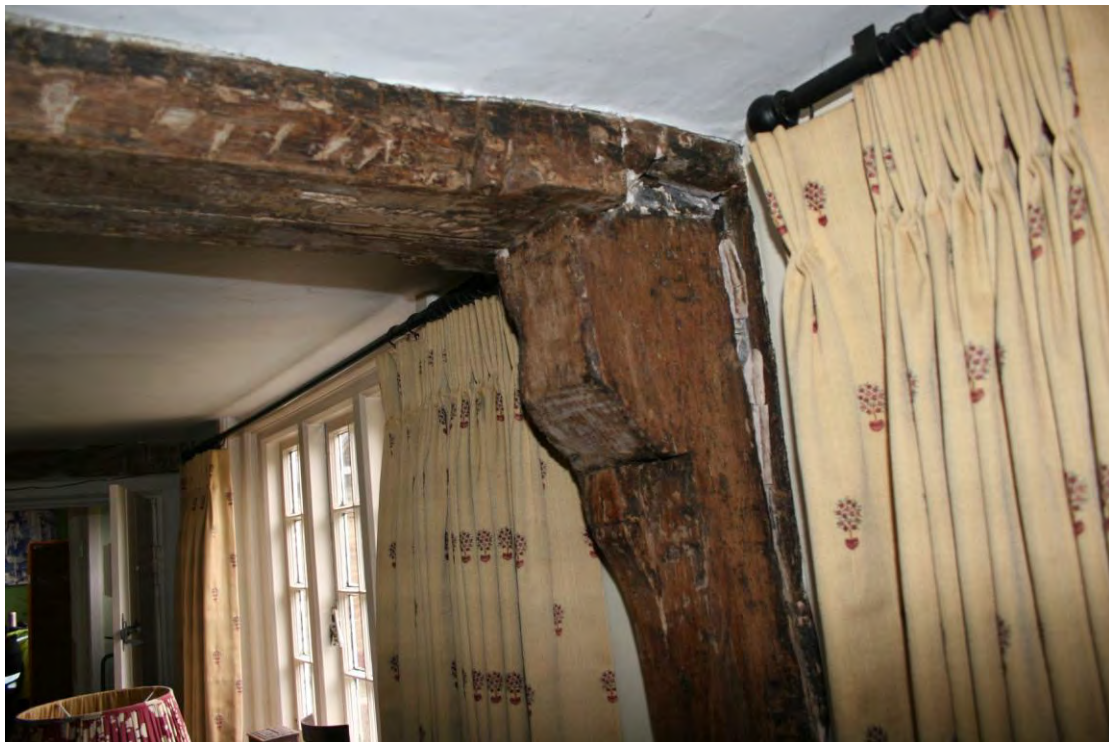
Detail of the applied jowl.

The main joist has deep chamfers with stepped stops with wide single bar. The main joist is not wide enough to span the room and an additional jowl (acting as a corbel) has been fixed with long broaches to make up the shortfall. Originally this would have been the framed wall of a cross-wing. The jowl has been hacked back for a door frame. The main joist was lathed on both sides for plasterwork.

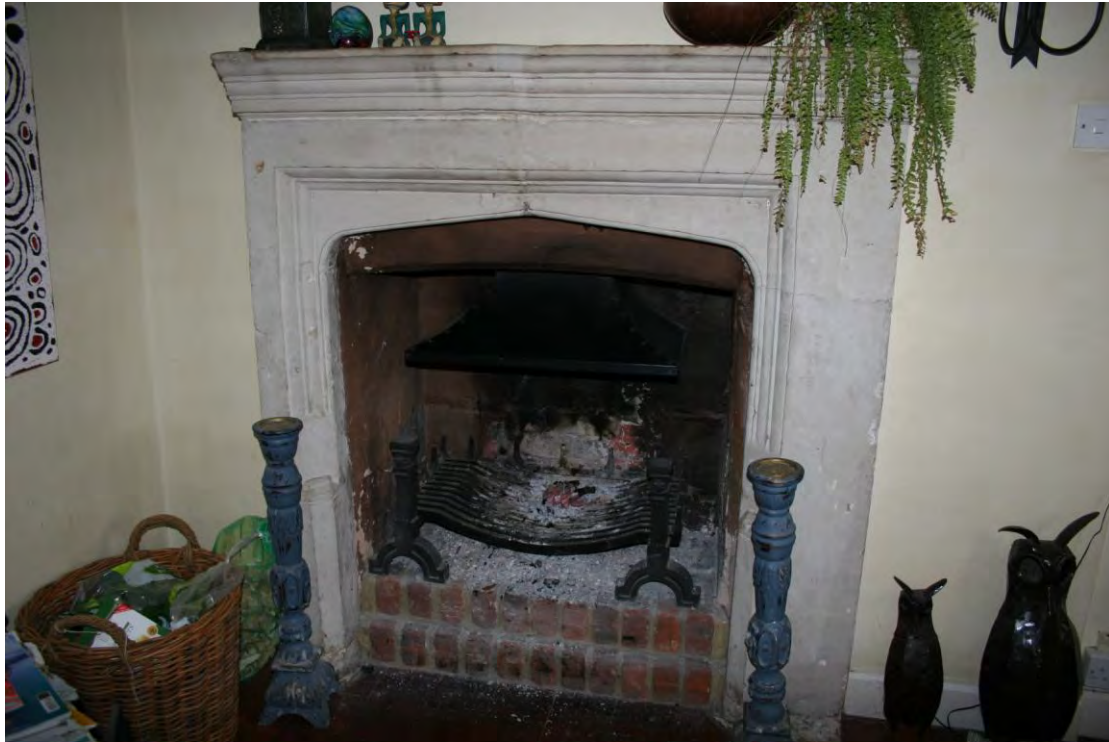
Stone fire surround with cement rendered brick fireback.

There is finely crafted stone fire surround made from sections fixed with wrought iron staples and lime putted joints. The use of a Tudor style four centred arch with a mantel shelf would indicate a MC19th design. The fireback is rendered in refractory plaster over brickwork and may be later still. The hearth has been raised up on MC20th brickwork pointed with grey cement.

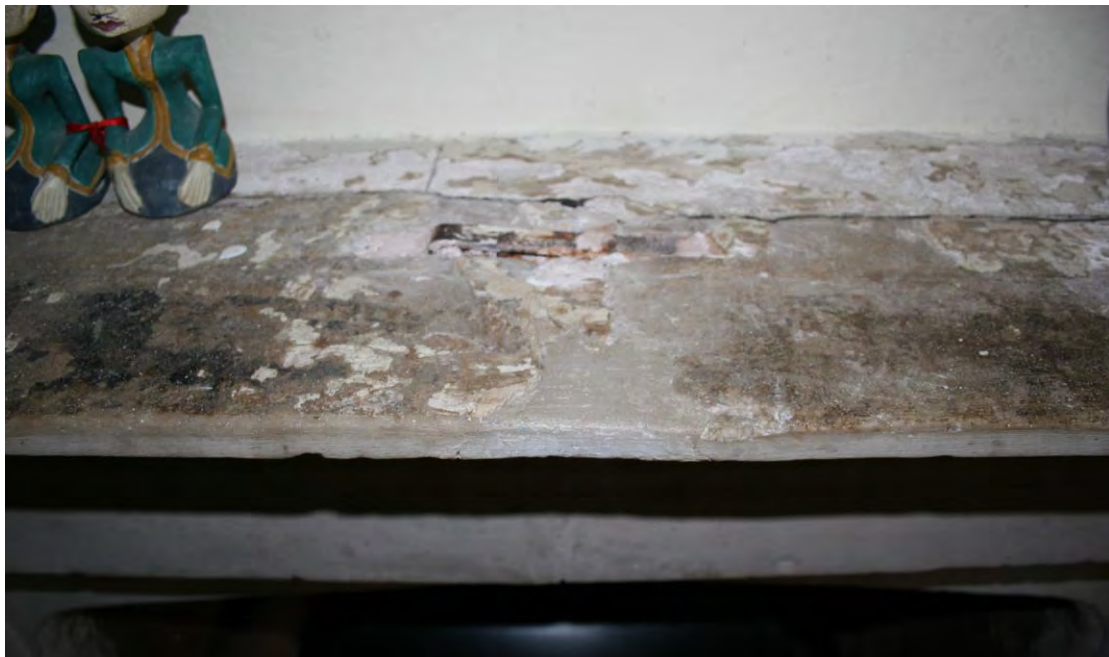
Wrought iron staple securing two halves of the fire surround.

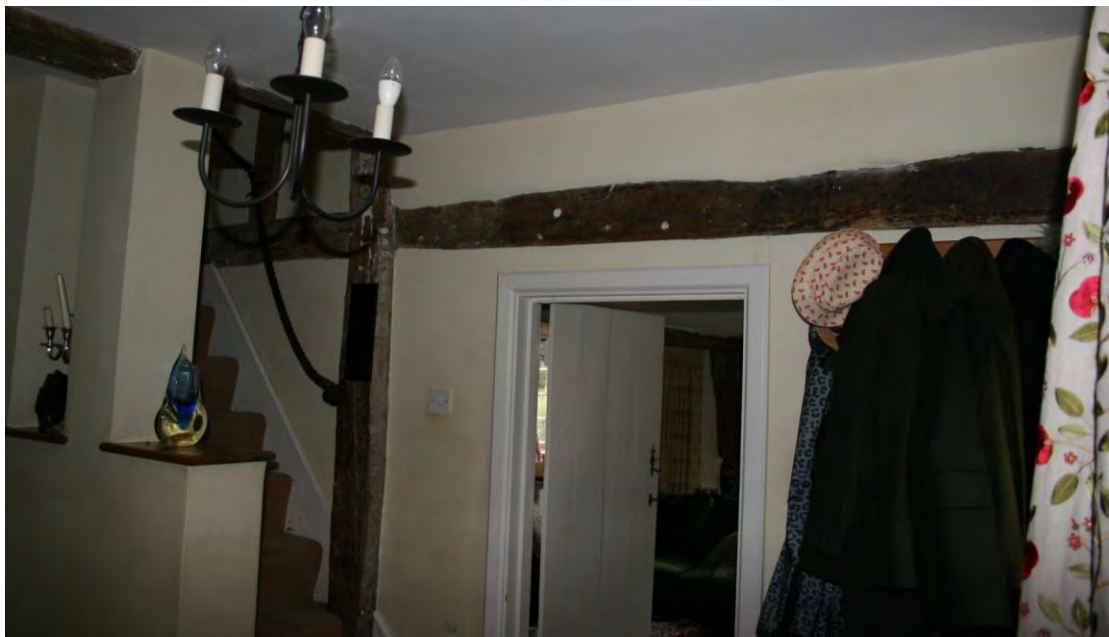
Looking E in the Lobby. The main joist is morticed for a stud wall.

The Lobby occupies one room of the cross-wing. The main transverse joist is morticed for a dividing stud wall and is jointed into the storey posts. The midrails do not follow around at the same height so it is highly likely the frame was jettied to the west and has been remodelled in the Georgian era by under-building the jetty. The leaded light windows in the western wall span both floors which is a more Victorian solution to providing light.

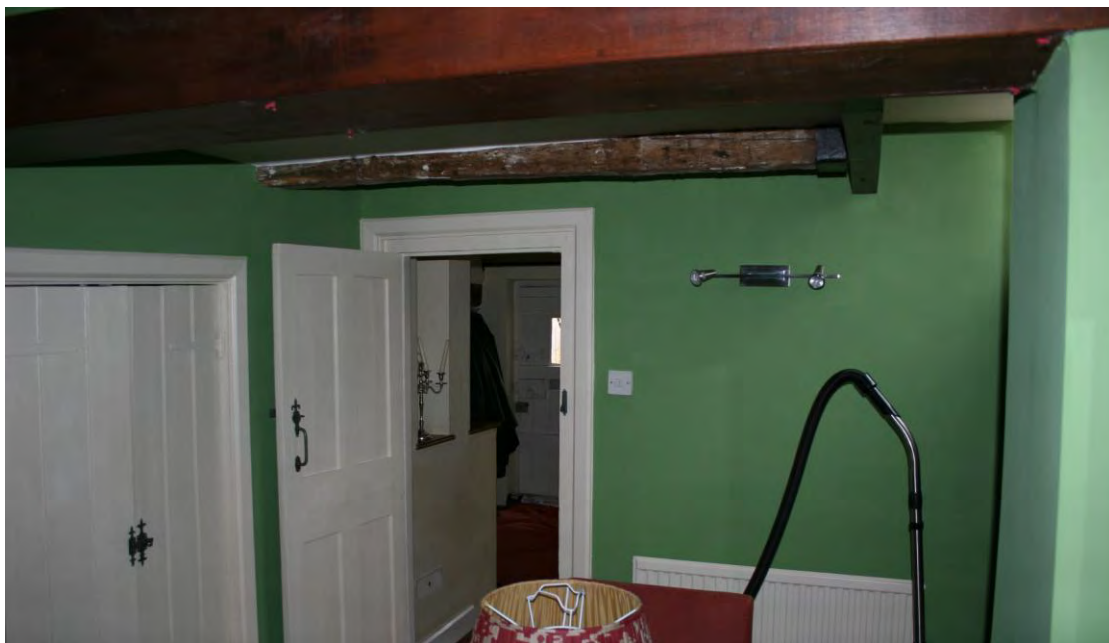
Looking S in the Dining Room.

The Dining Room has an inserted steel frame in the ceiling and the main joist is hidden by box work. It is not obvious why this has been done but is likely that smaller service closets were removed to create the volume of the Dining Room. This is vaguely intimated on the 1985 architect's proposed plan as well as the cutting back of the firebreast.

There is the benefit of having an architect’s plan from 1985 showing some of the proposed works on the Ground Floor. Partitions were demolished and the corner fireplace cut back to form a new Kitchen (now the Dining Room) and steel beams were put in the ceiling. The staircase was changed and the rooms stripped out to reveal the timbers. The ceiling over Bedroom 2 was removed and a mezzanine formed for a study or store. The Ground Floor WC has been relocated to beside the doorway from the south entrance door. The east entrance door was replaced as a split stable door.

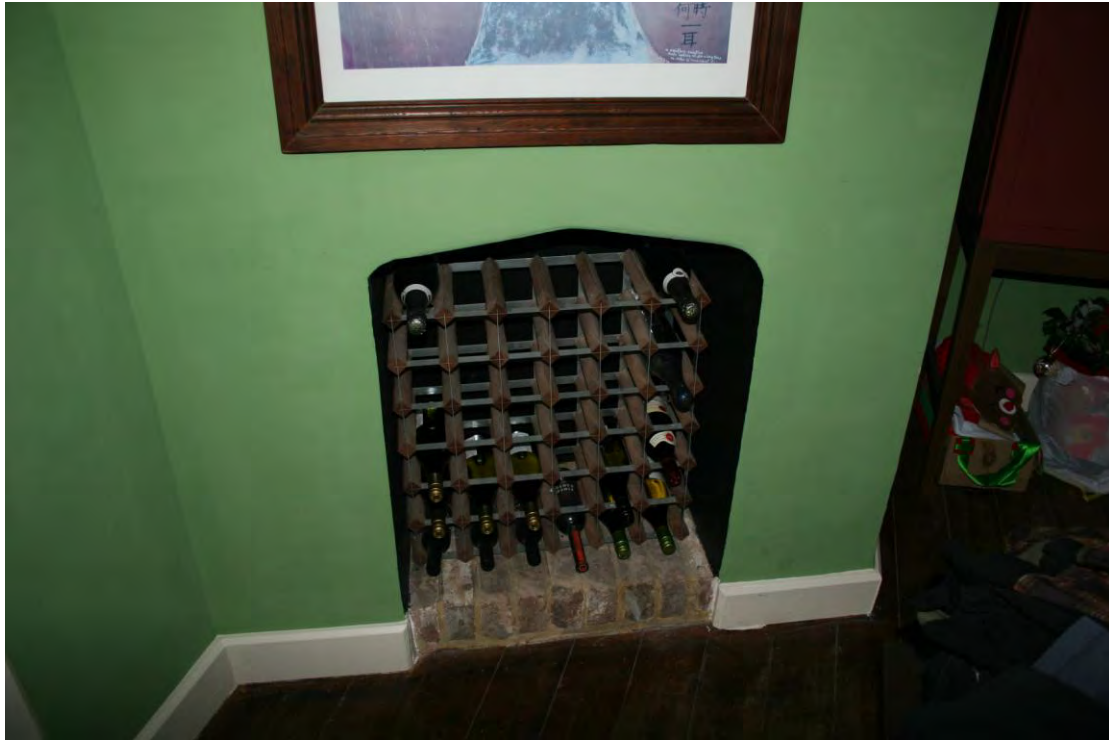
The fireplace has been given a four-centred arch.

There is a fireplace set into a canted firestack attached to the main stack and has been styled with a four centred arch to match that in the Living Room. The flue is now connected to the Aga. Corner fireplaces are typically Victorian and given its position close to a door it was likely for a stove or water heater for the scullery. Its present form dates to 1985 as the drawings propose cutting it back.

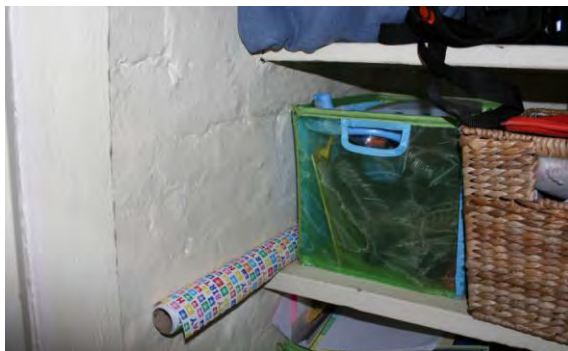
Solid brick wall for the closet.

There is also a brick built closet with C19th black and red triangular floor tiles (set in chequer board pattern) and a well worn timber threshold. It is highly likely the gap between the fireplace and the closet was for the kitchen range and the flue has been removed in C20th alterations to connect the bedrooms above.

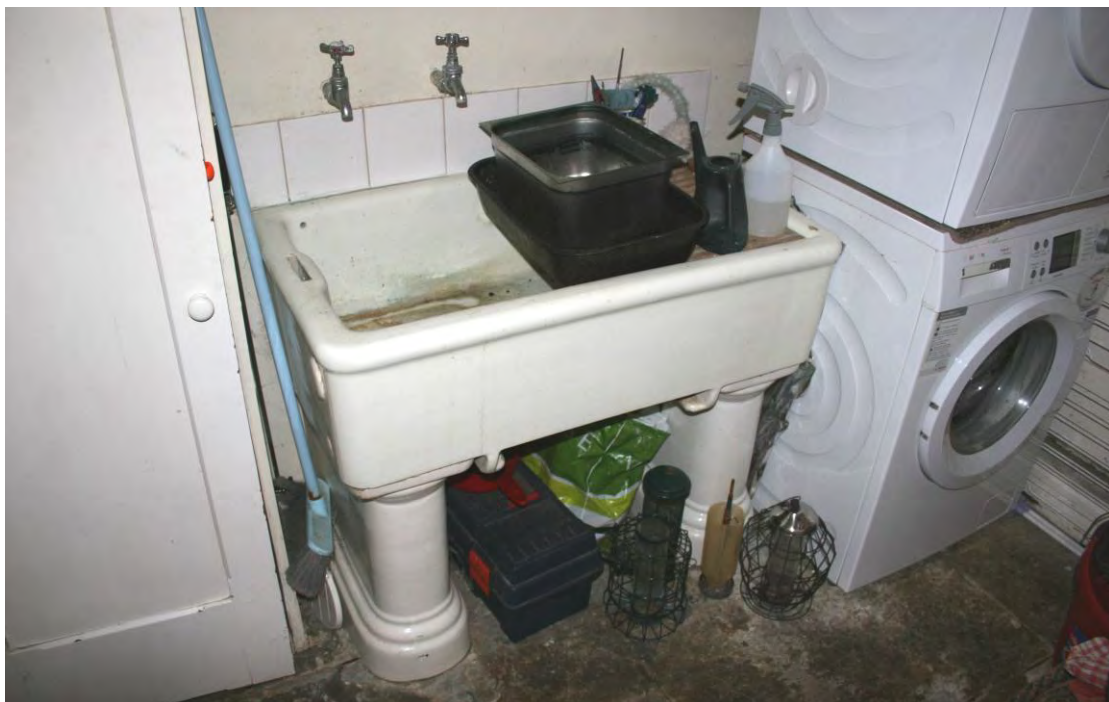
Victorian style butler sink.

The Utility Room has a flagstone floor which are often features of Victorian service rooms but could be earlier. There is a handsome Butler sink with ceramic hollow legs which cleverly hide the supply and water pipes. There is also a pair of runner for a wooden draining board moulded into the underside. This design of white fireclay combination sink and pedestals was on sale in the Nicholls and Clarke Catalogue of 1934.

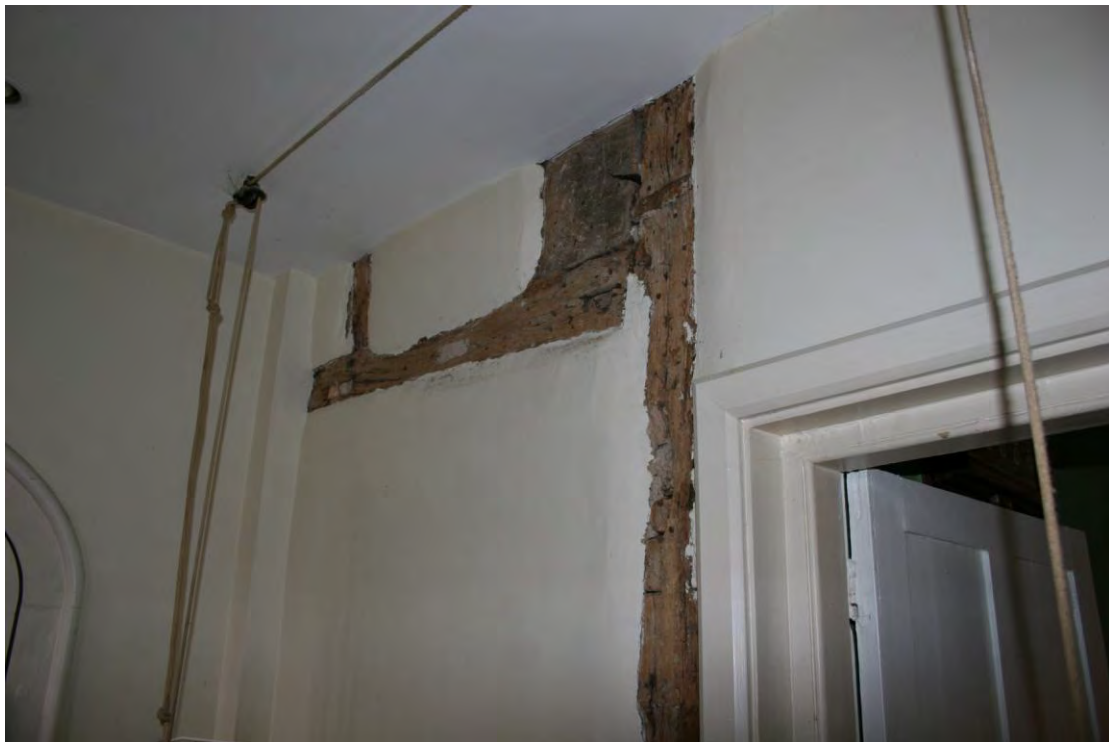
The exposed frame of the early timber range.

An early timber frame is visible in the wall of the Utility Room and Link Room that corresponds with the wall line of the rooms on the First Floor.

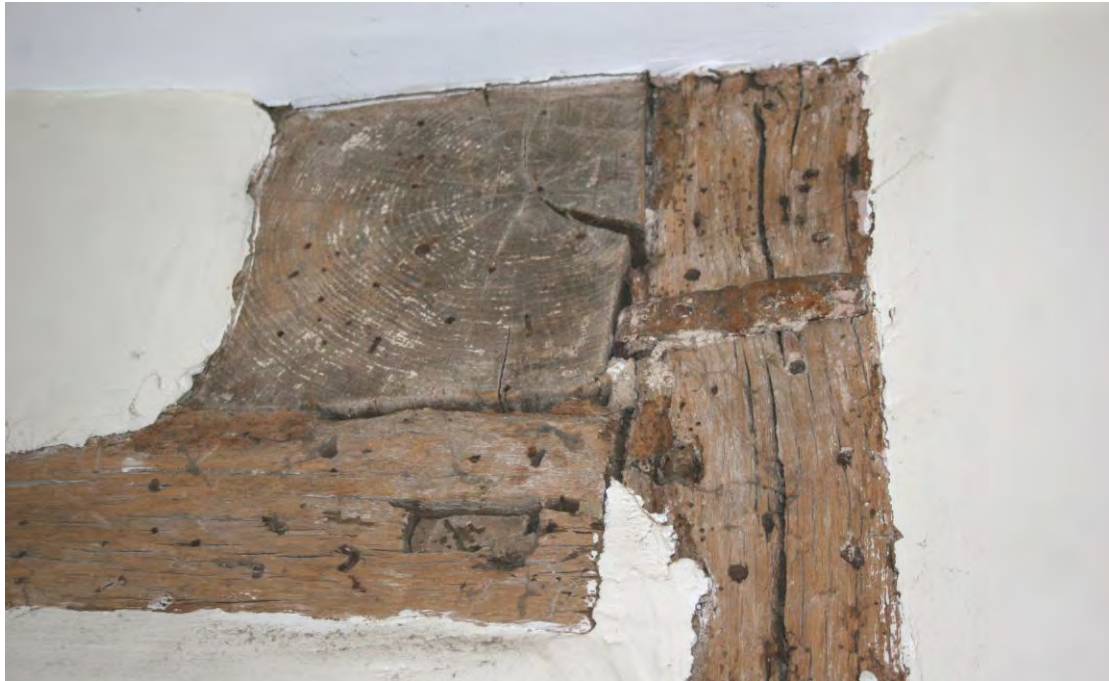
The frame is reinforced with a slender iron joint. Note the sawn off tenon.

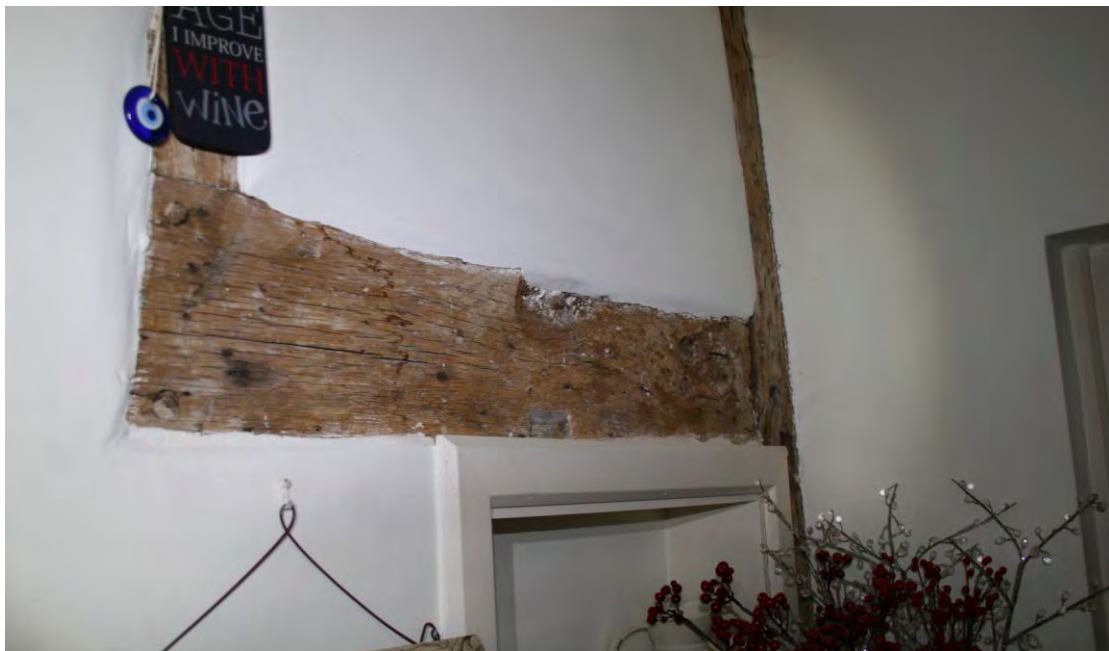
The box frame visible in the Link Room.

The box framing has empty mortices and sawn off tenons for timber structures that have since been removed in favour of the service passage that now contains the Utility Room, Link Room and Dining Room.

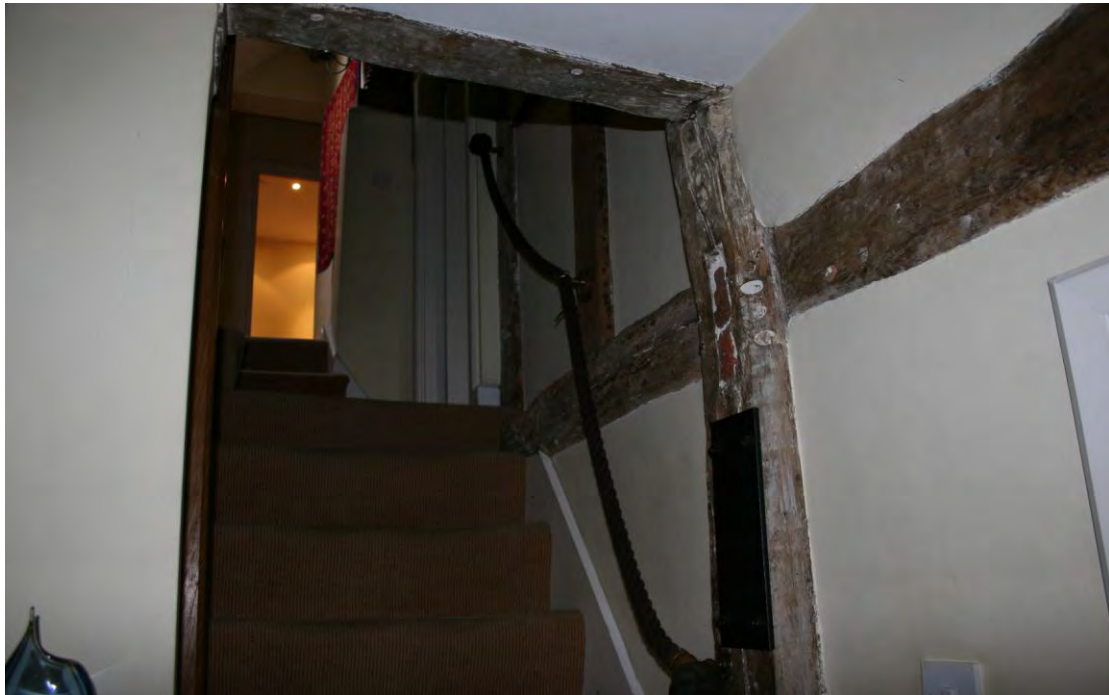
The foot of the stairs. Note the brick filled mortice and steel plate.

While the present staircase appears LC20th there is evidence the cross-wing midrail was cut, raised and reused to create an opening for the foot of the stairs. The midrail mortice was filled in with Georgian style bricks and plastered over. The redundant mortices were also filled with white lime mortar. The removal of the plaster in the LC20th revealed a weakened storey post which now has a large steel plate.

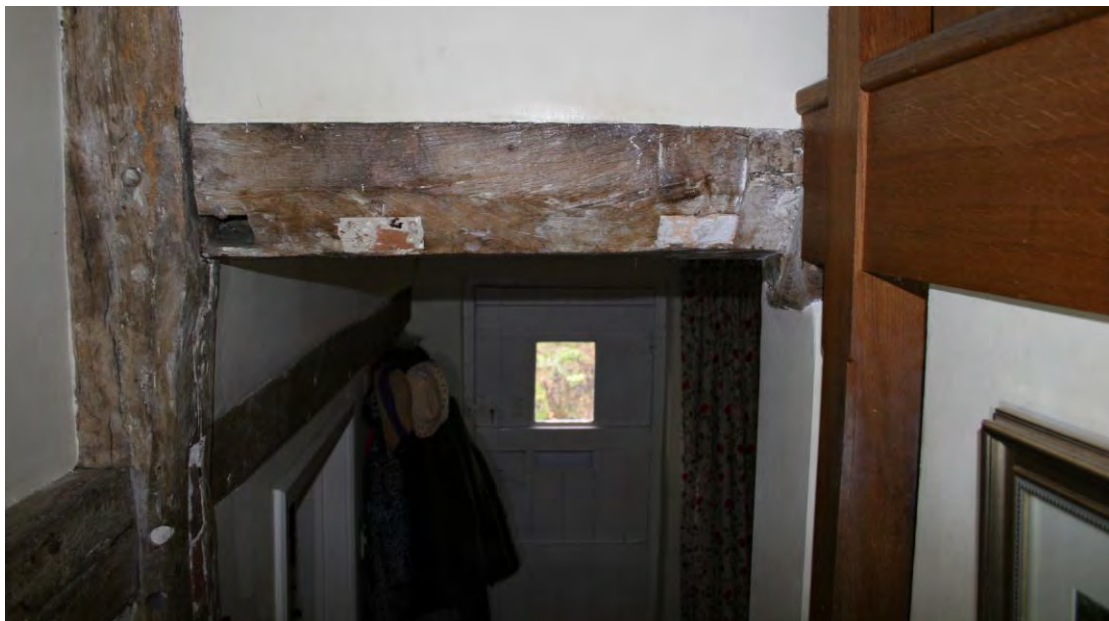
The midrail has been raised to insert the stairs.

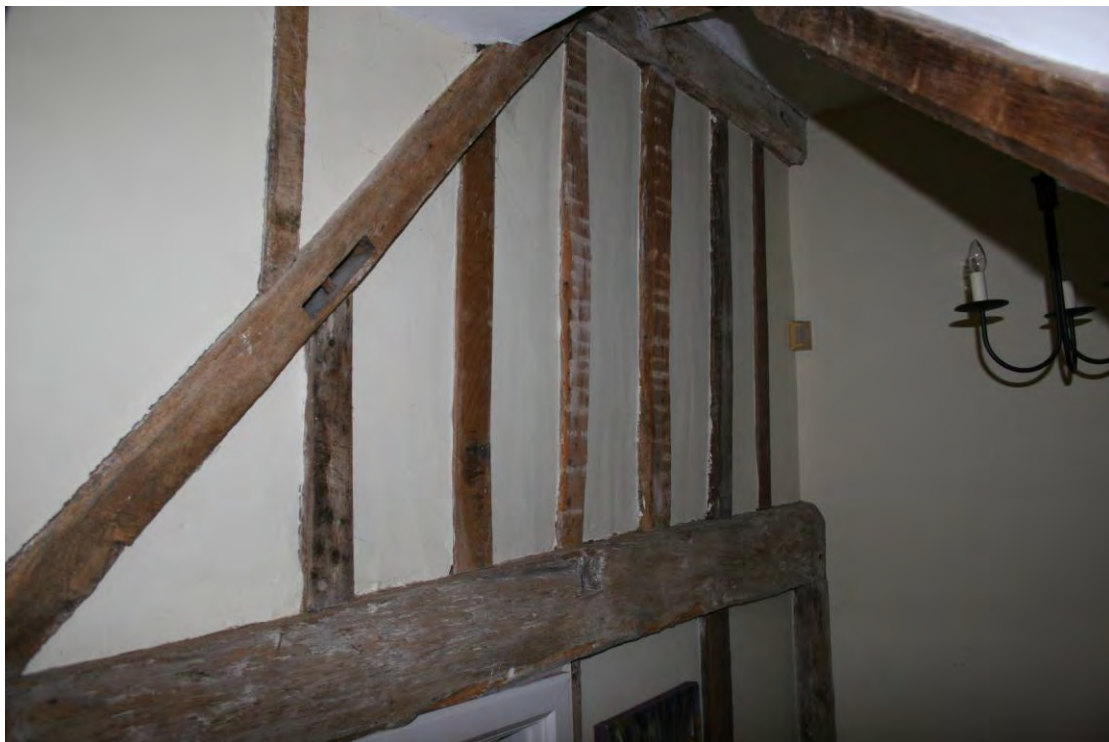
Exposed reused timbers over the stairwell.

The partition wall over the stairwell has reused oak and elm scanting studs peppered with nails and striped with lime for Georgian plaster. High up is a collar for a clasped side purlin roof to the cross-wing roof. The principal rafter is morticed for a butt purlin which has been removed.

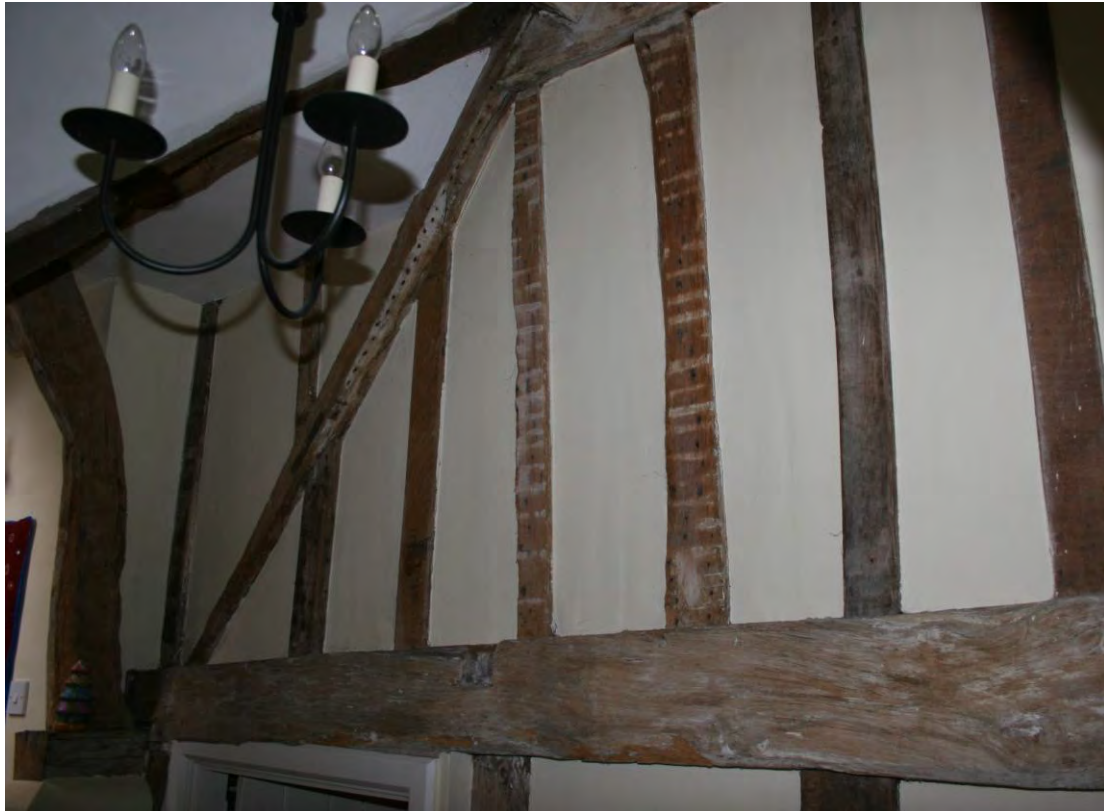
The principal rafter and tie-beam looking NW.

The roof structure can be seen continuing into Bedroom 1 from the Landing above the stairwell. This shows a frame for a clasped purlin roof. The room has been modernised with a casement of four narrow lights to give borrowed light to the Landing.

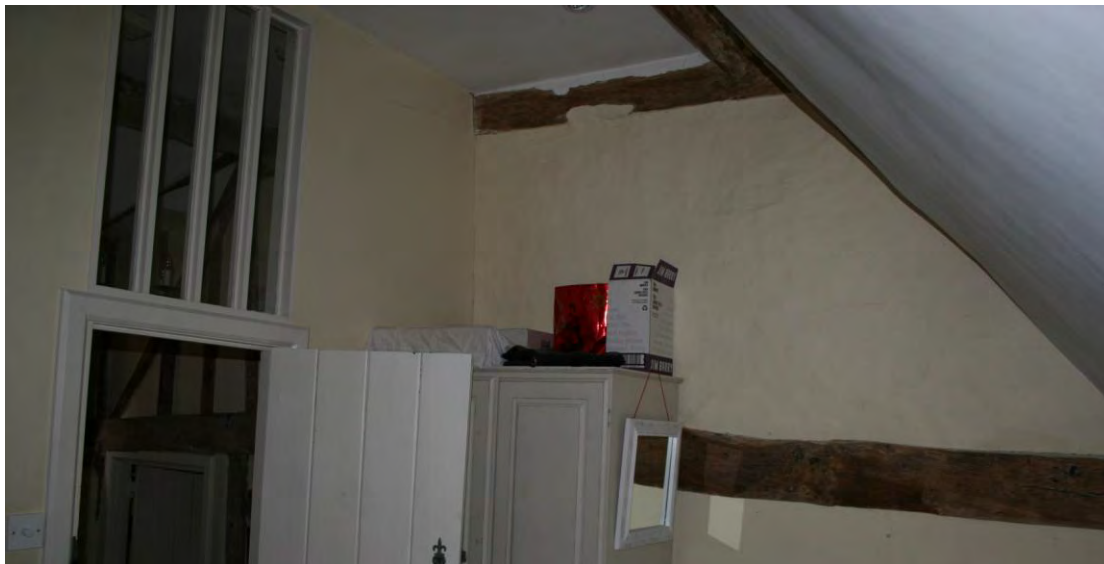
The continuation of the collar and tie-beam seen in Bedroom 1.

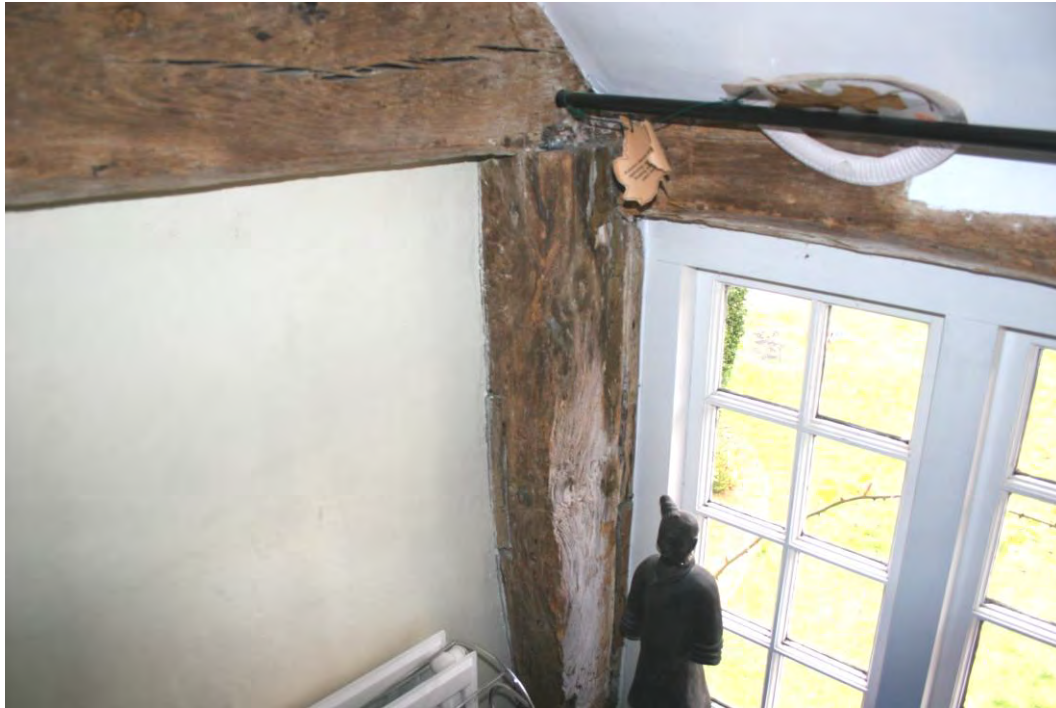
The jowled storey post on the end of the tie-beam in the south wall.

The exposed frame has storey posts with swept jowls, cambered tie-beams and curved spandrels in the corners. The tie-beam is braced with a curved spandrel rising from the corner post. The corner post is braced with a curved brace rising up from the midrail. These features are sunken into the rendering as part of a LC20th interpretation of the original finishes which would have been wattle and daub panels.

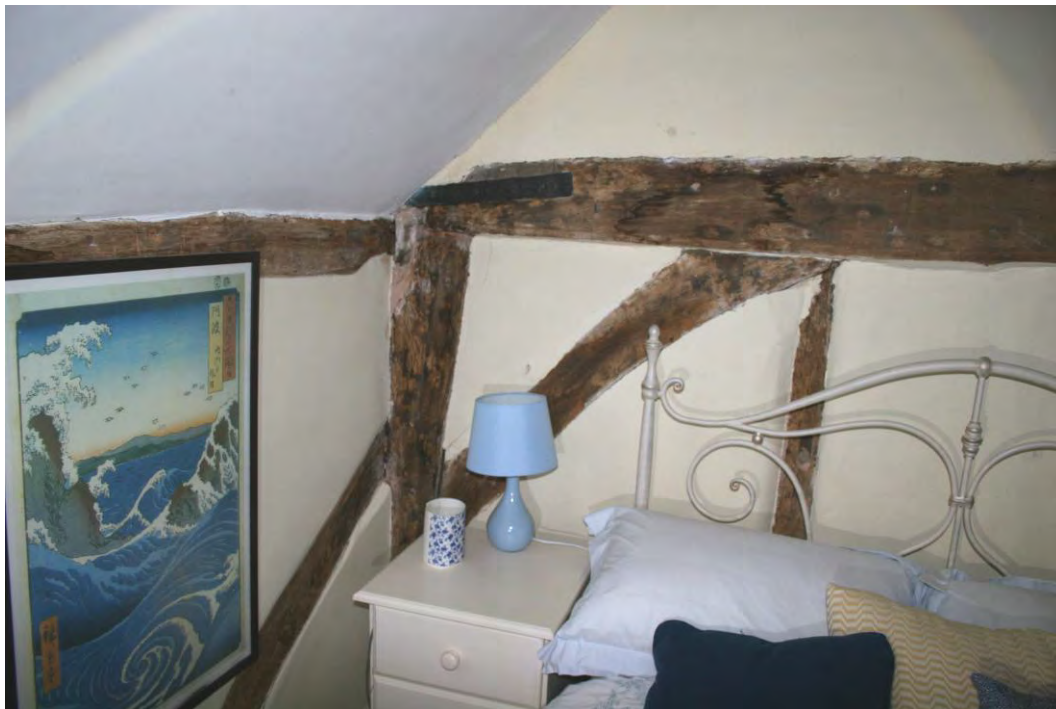
The storey post, tie-beam, spandrel and top-plate in the south and west walls.

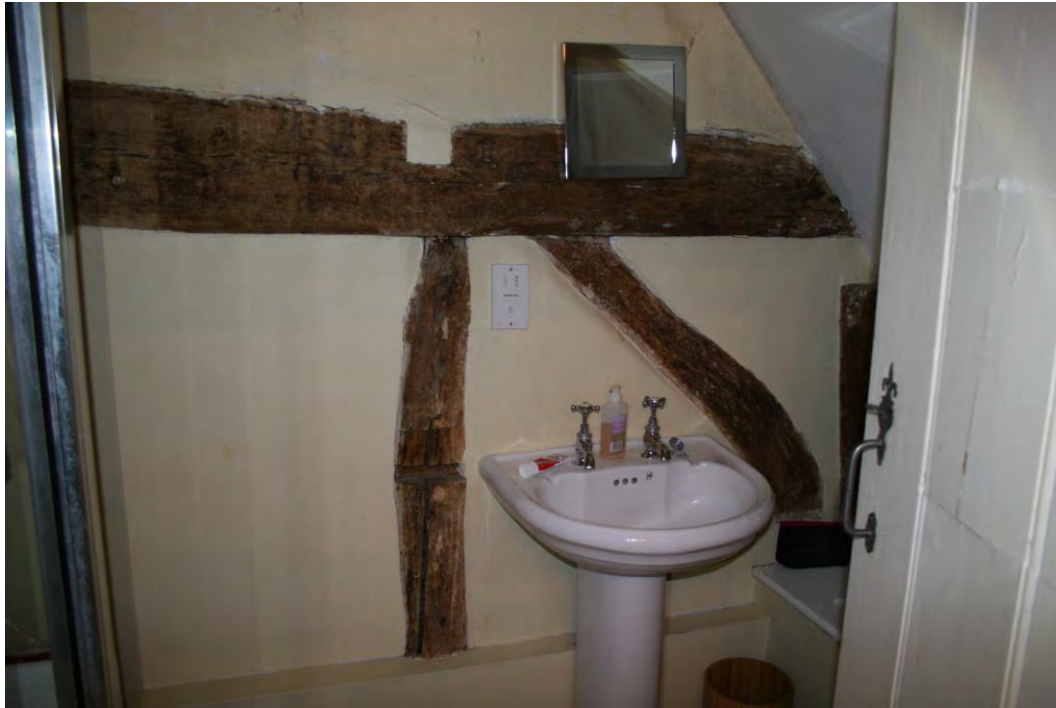
The north end of the tie-beam in the western wall seen in the Bathroom.

The frame continues in Bathroom 1 where the tie-beam, corner post, spandrel and studs are visible. The north top-plate has been removed in the bathroom and the sawn off end can be seen on the Landing placed under a curved support (often called a shore). This would have been done in the LC20th. Nearly all of the north side of the cross-wing has been deleted. More of the cross-wing frame is visible in Bedroom 2.

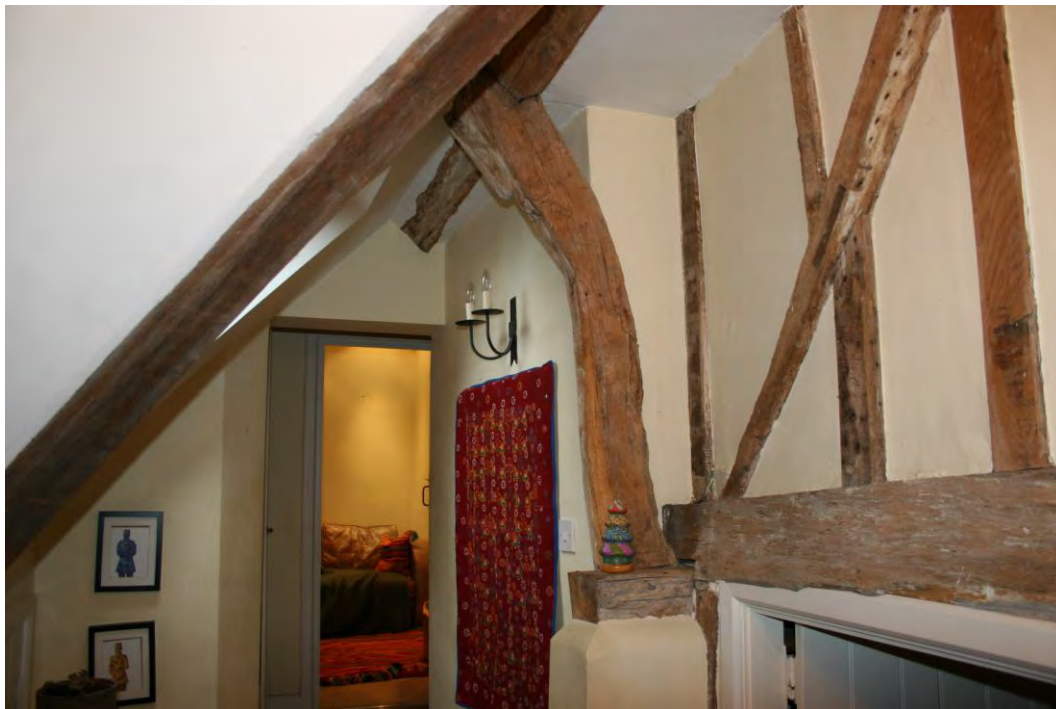
Looking N on the Landing, The cut off top-plate can be seen under the curved shore.

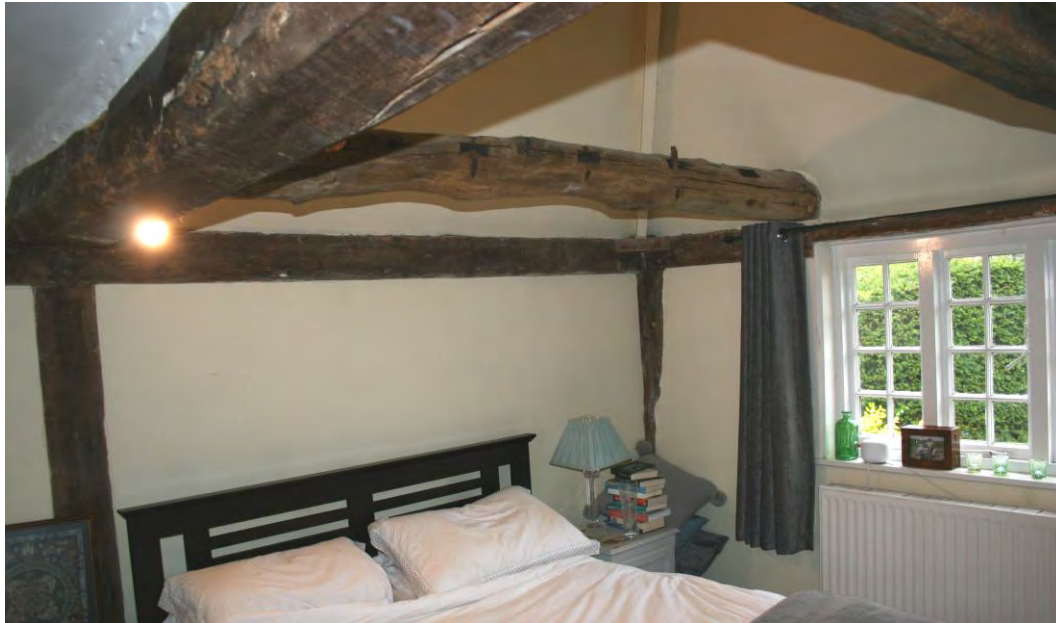
Looking E in Bedroom 2. A fake frame has been affected.

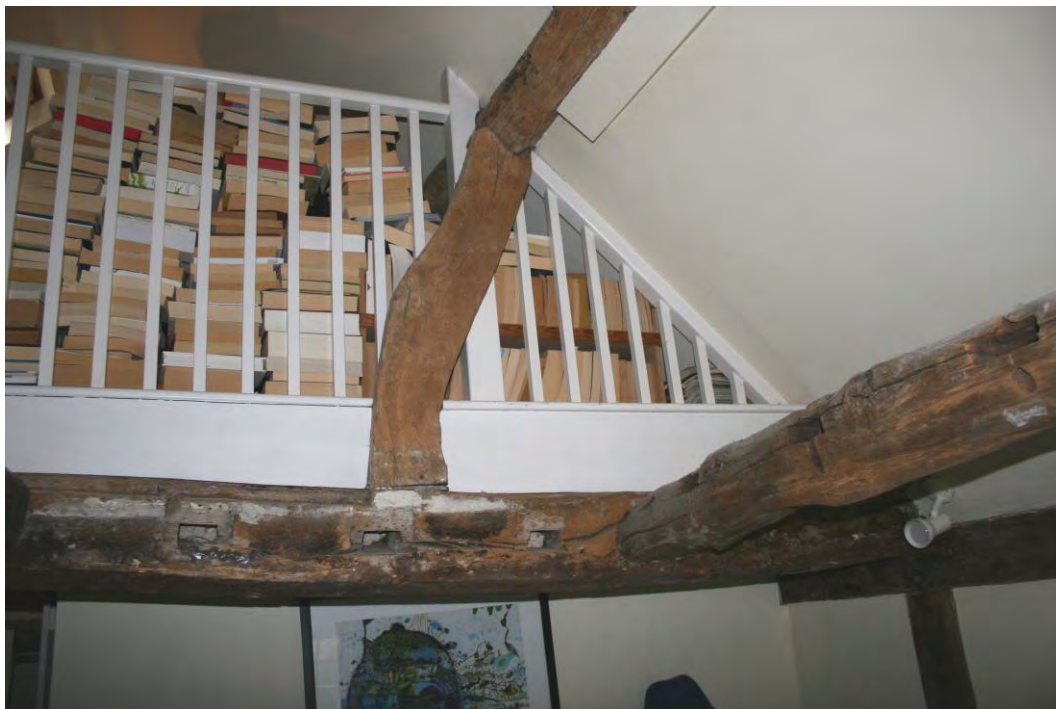
Looking N in Bedroom 2.

Bedroom 2 occupies the east room of the cross-wing. The frame is difficult to understand. An axial joist with refined entry soffit tenons represents an inserted attic floor that has been subsequently removed and two reused beams inserted as tie-beams as part of a LC20th remodelling to vault the room. The vault carries across to form a mezzanine with small study reached by a ladder stair inserted probably in 1985.

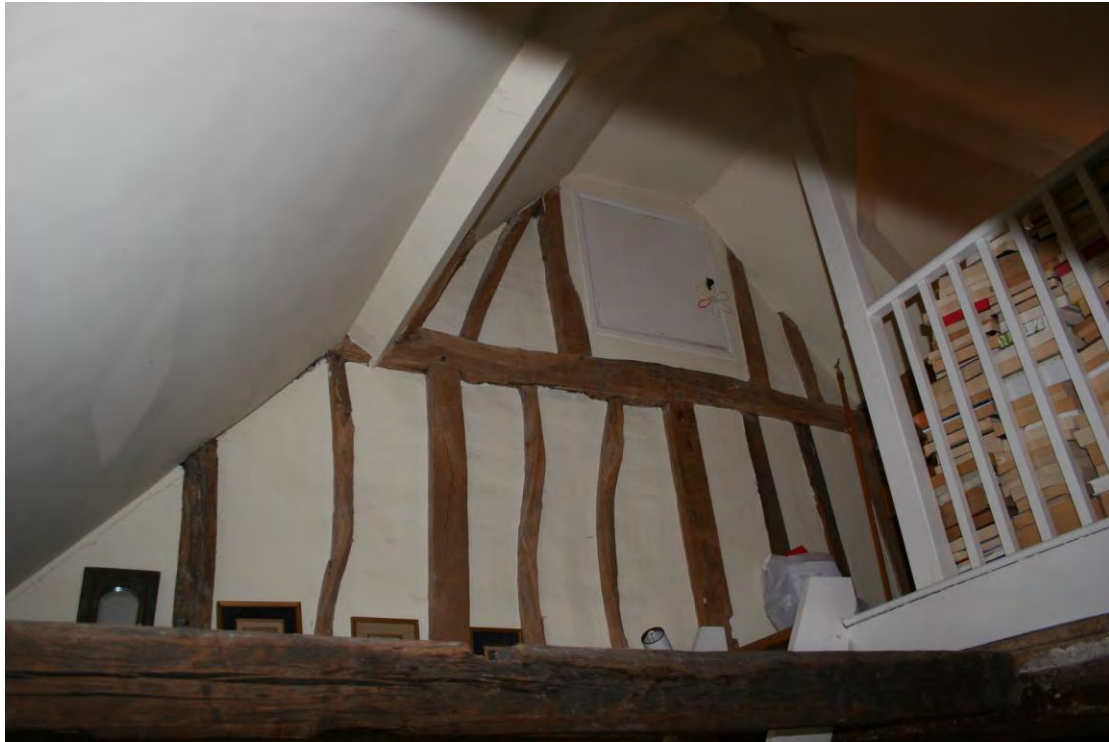
Looking up at the partition wall with the landing. The box frame has added scantling studs.

The partition wall has box framing with added interstitial scantling studs for later lath and plaster. In the loft space the flat paired rafters are nailed on the soffits for riven laths fixed with wrought iron lath-nails of which small sections have been left in situ as souvenirs.

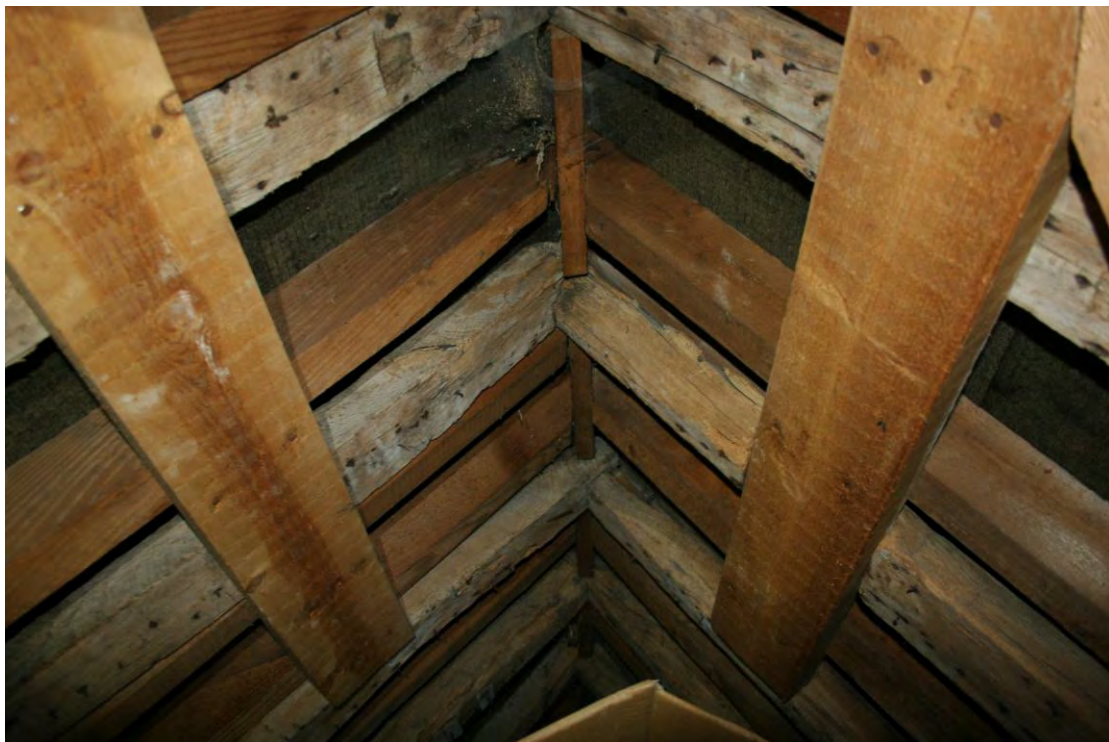
The apex of the cross-wing roof with modern reinforcement. Looking W.

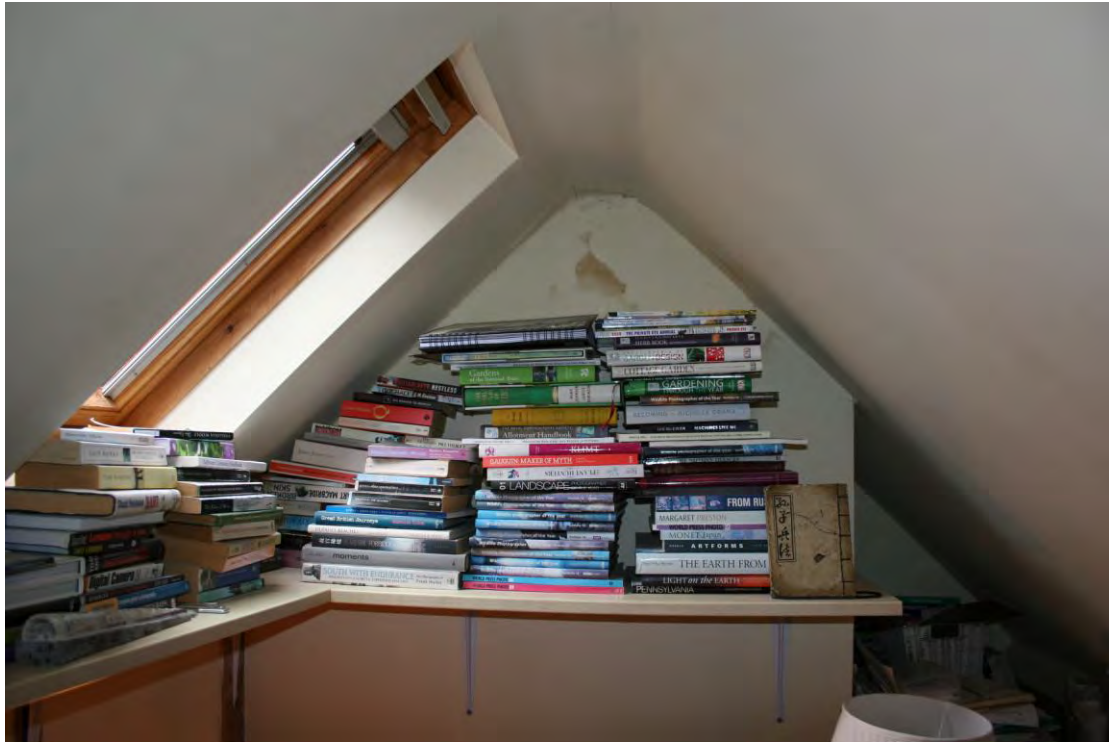
The study mezzanine looking N.

The study mezzanine seems very recent and has a Velux roof light which may be replacement for works done in 1985. Prior to the conversion it is highly likely there was a habitable attic from the C18th onwards.

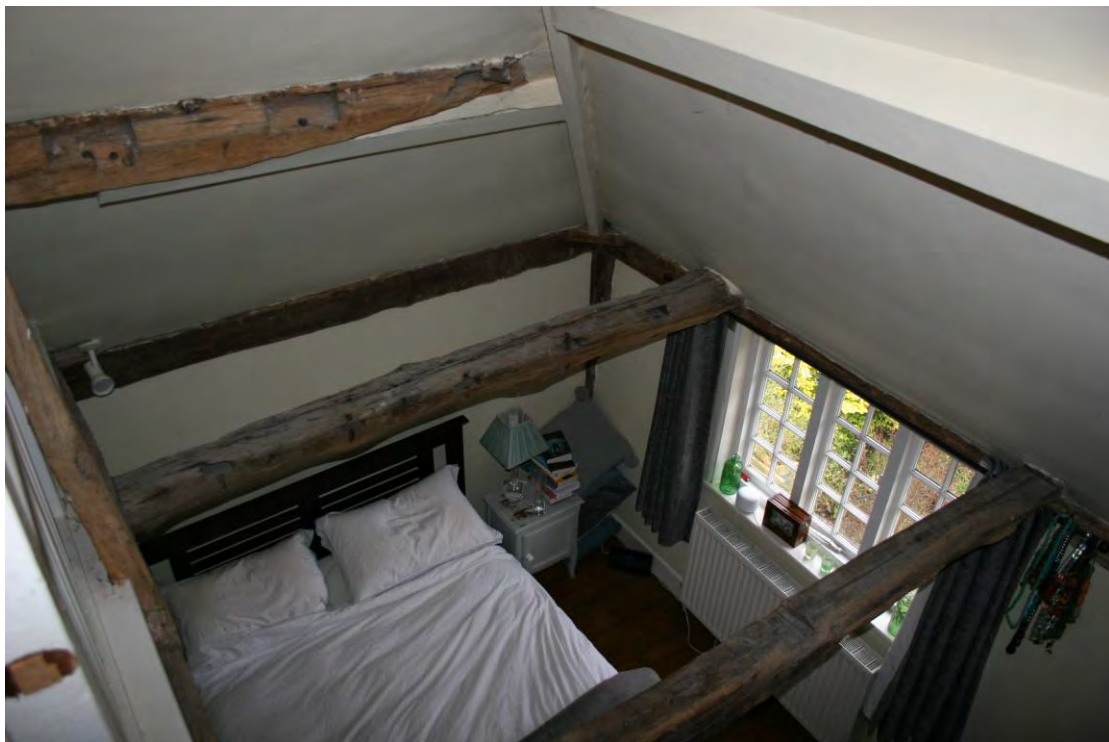
Looking down on Bedroom 2.

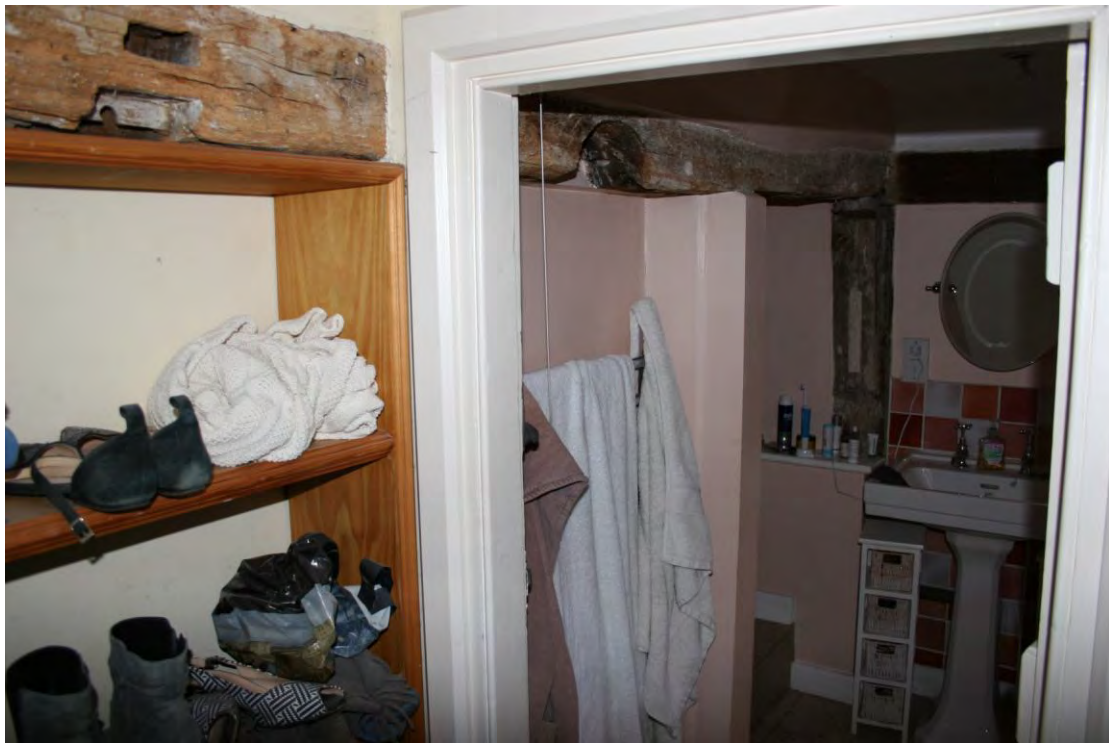
Looking E into the Bathroom 2.

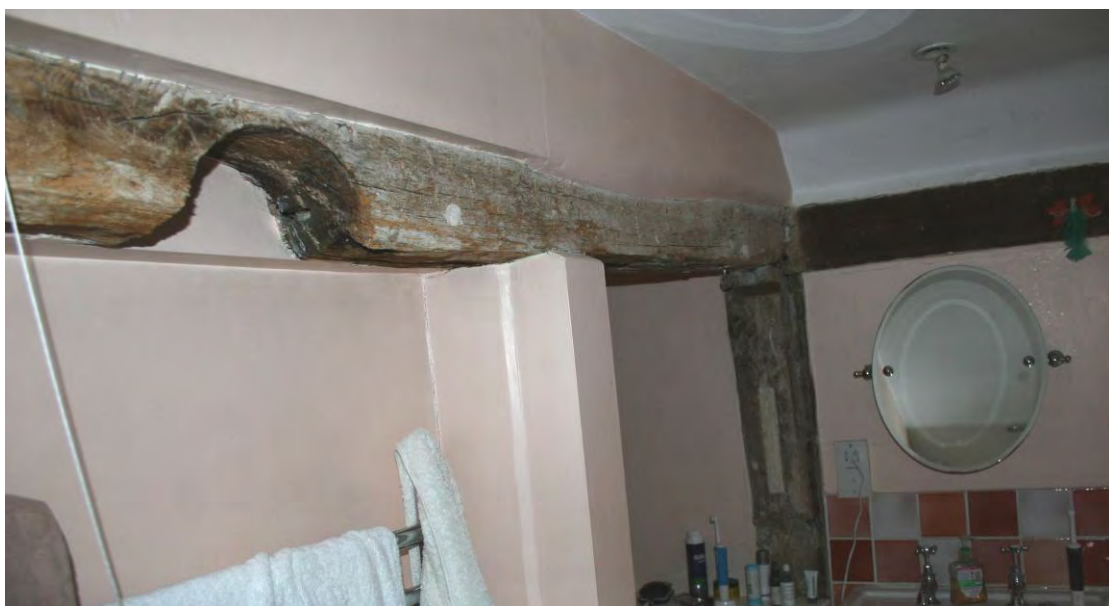
The top plate has a recess for a boiler flue.

The top-plate of the north frame of the cross-wing passes into Bathroom 2 where it meets the storey post. The mortice for the spandrel has been filled with lime mortar. There is a large semi-circular cut out in the top-plate with signs of scorching which indicates it was used for a boiler or stove flue. The main stack is buried in the wall below.
