HERITAGE STATEMENT

Manor Cottage - Internal alterations

22.01.2024

55 Little Gaddesden, Little Gaddesden, Herts. HP4 1PL.
Historic building recording and analysis of the cottage. Recorded 11 03 2022.

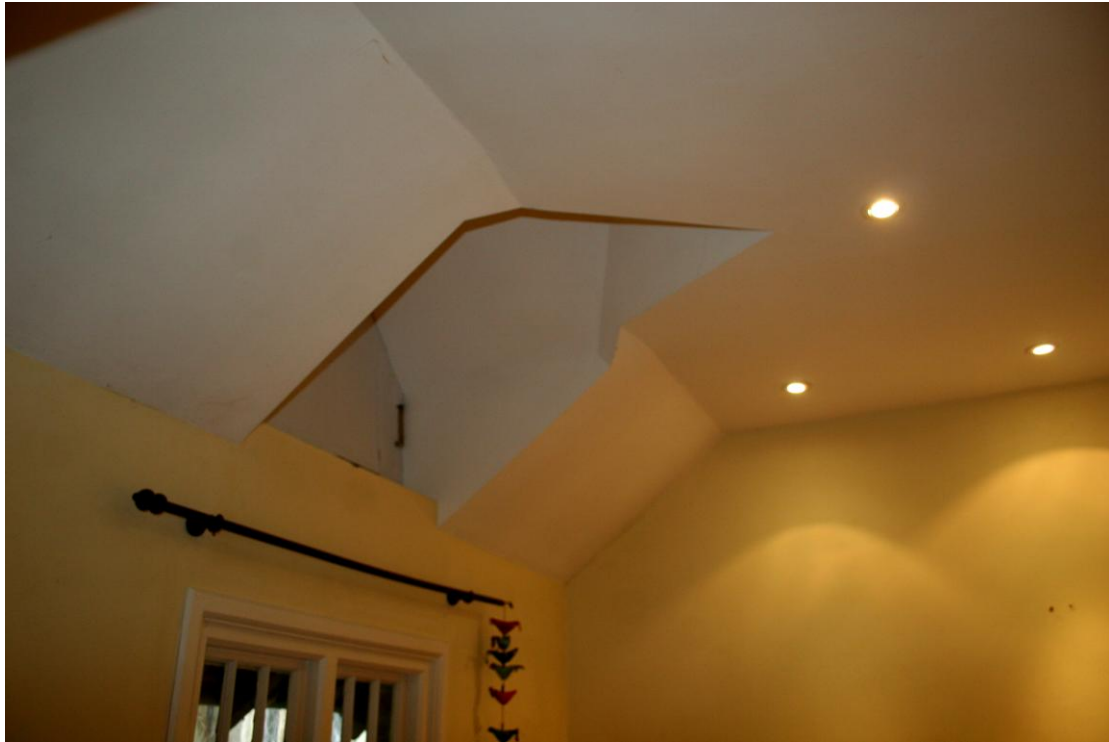
The ceiling of Bedroom 3.

Bedroom 3 does not display any historic fabric and all the finishes appear LC20th or later. The window is placed to be used as an exit onto the roof to maintain the gutter. The window has fine astragals and LC19th or EC20th latch and window stay.

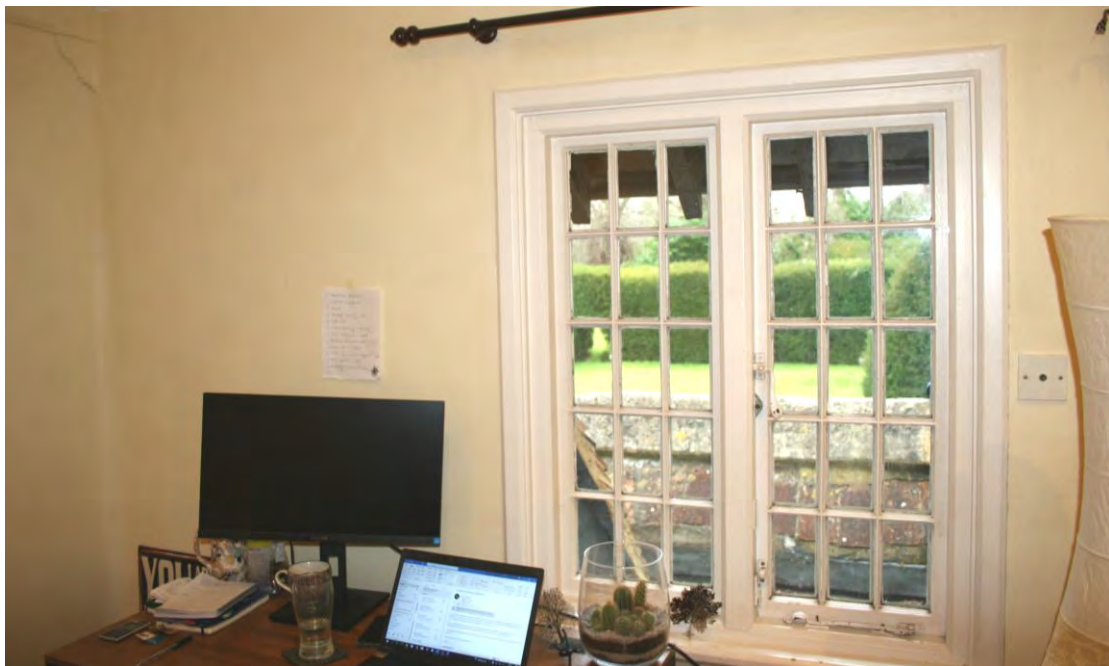
The window in Bedroom 3 allows access to the roof gutter. Looking W.

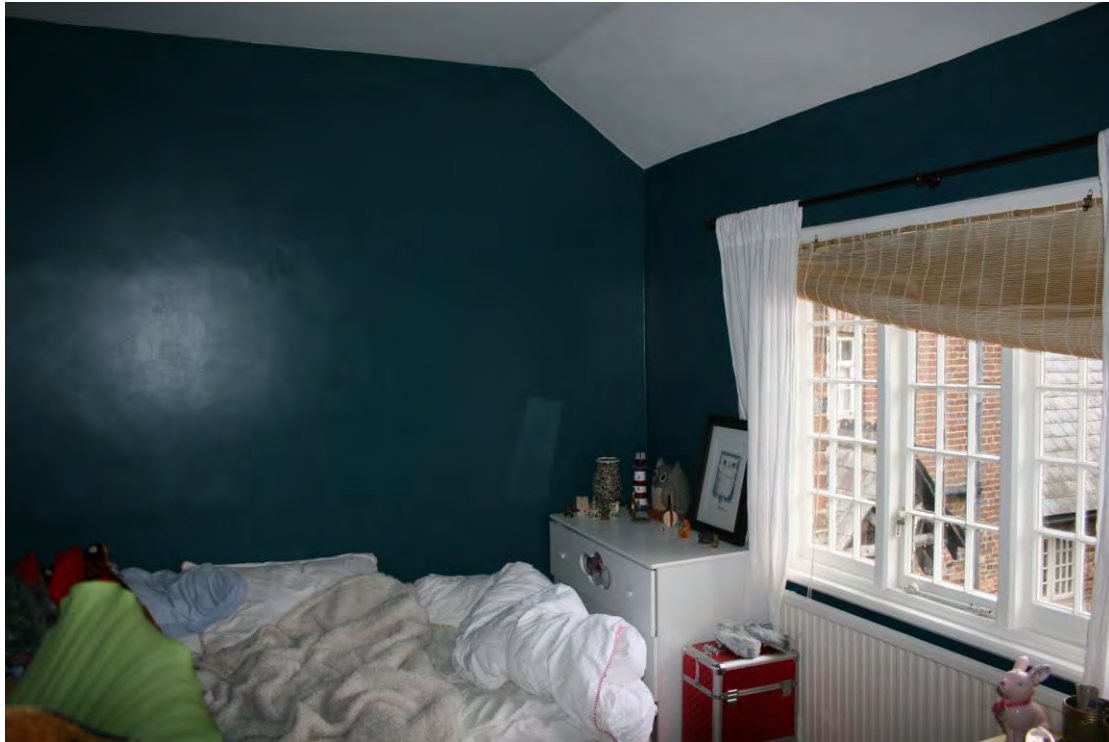
Looking N in Bedroom 3.

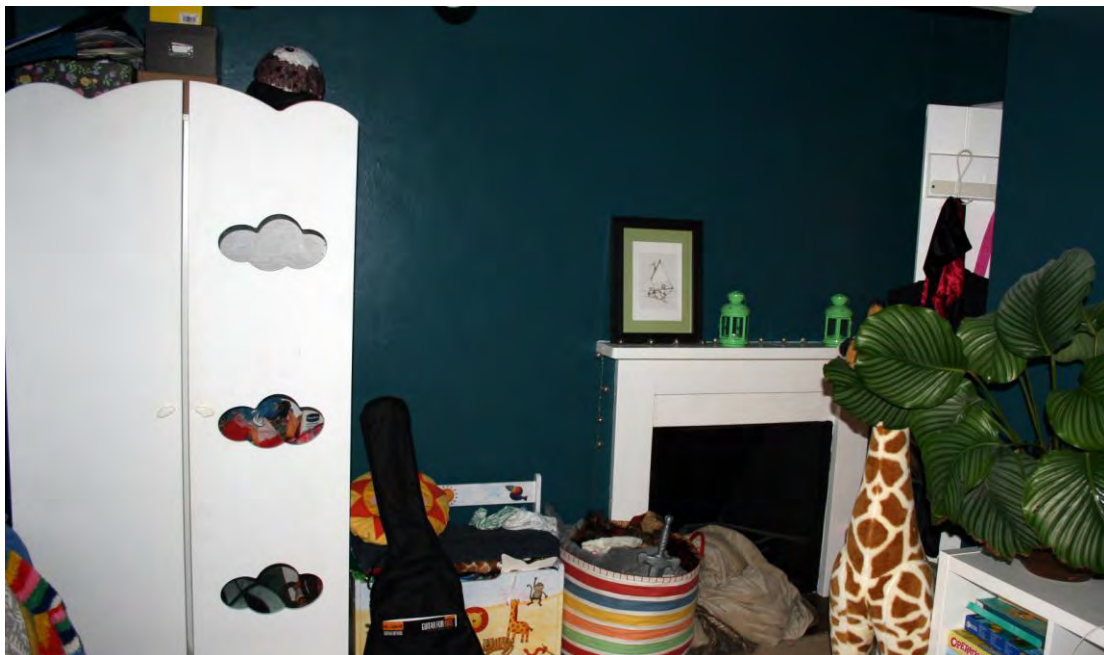
Looking S in Bedroom 4.

Bedroom 4 does not display any historic frame because the outer wall is replaced in brickwork. There is a fire surround with cast iron grate and brick fireback that is too close to the partition wall to be practical so the partition wall must be a M-LC20th insertion.

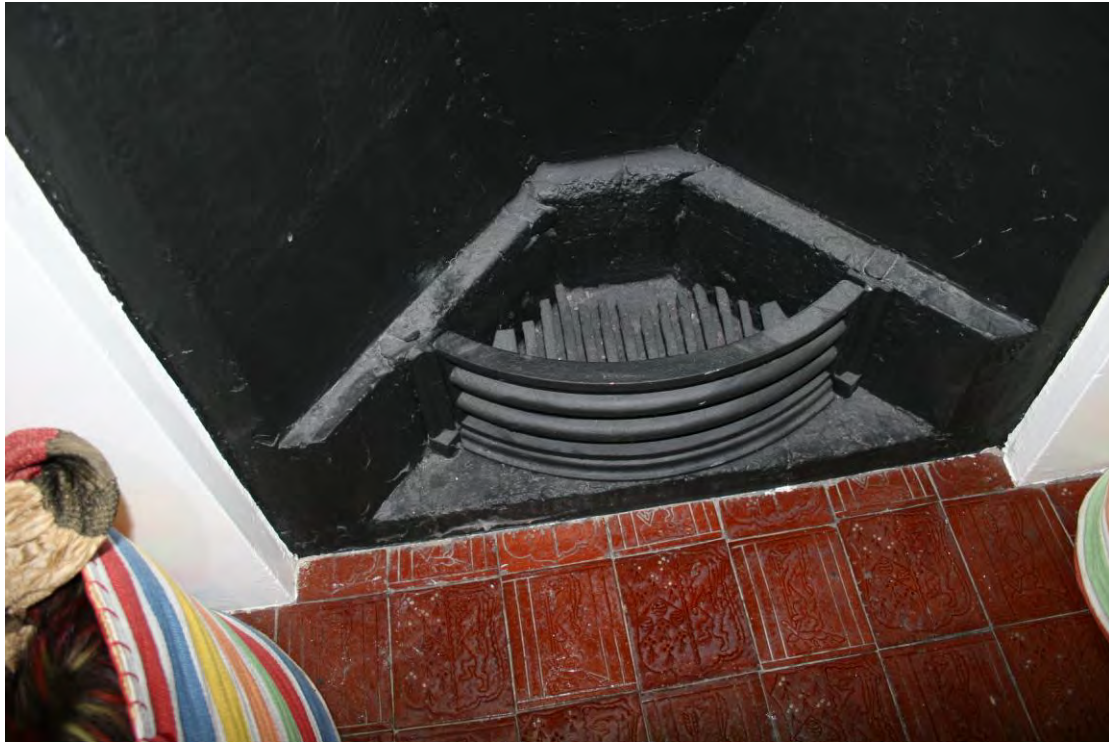
The tiled hearth and coal grate.

The tiled hearth and coal grate with firebrick back appear LC19th or EC20th. The tiles depict a rampant lion with a coat of arms or with a long arrow and are not all the same size and vary in colour. Some have been cut into quarters. There is a deep section machined timber tie-beam secured with bolted wrought iron plates supported with a small corbel.

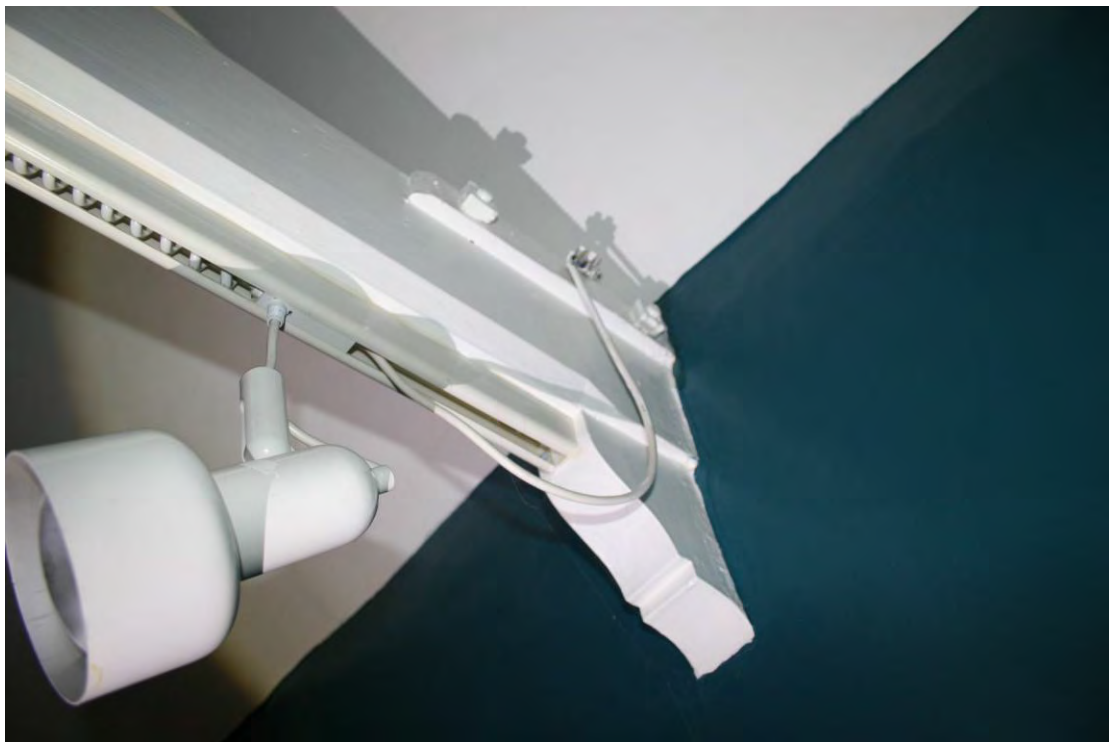
Wrought iron strap on a deep section joist.

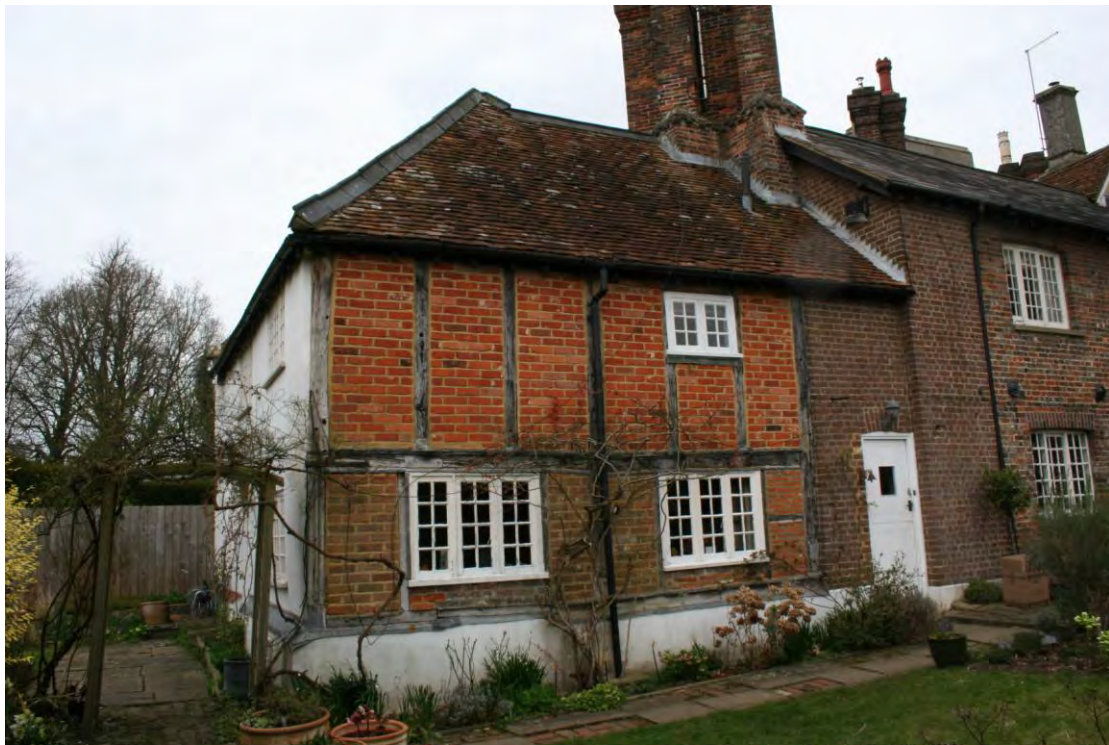
The east elevation of the cross-wing.

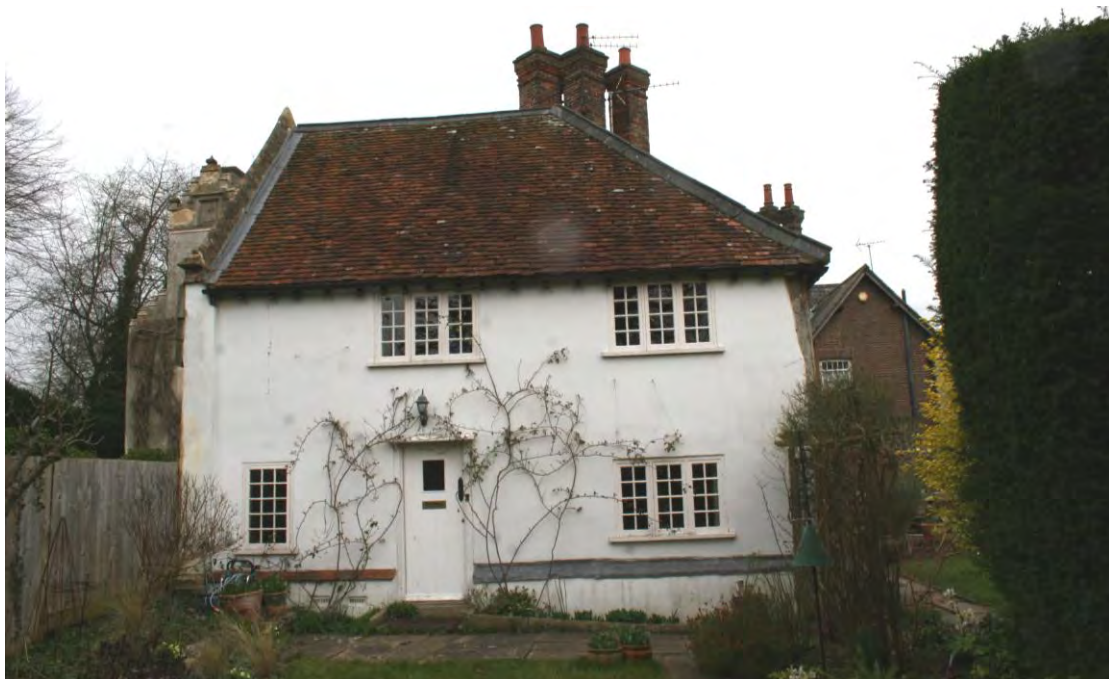
The south elevation of the cross-wing.
