BAT, BARN OWL AND NESTING BIRD SURVEY

3 WINDMILL LANE, LAUNCESTON, CORNWALL

January 2024

Wheal Grey Ecology Ltd

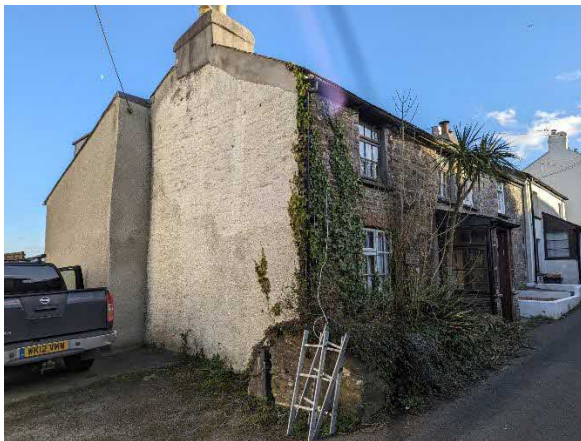
The building subject to this survey is a two storey semi-detached stone built cottage with a pitched roof covered with natural slate which extends down to 1st floor level to the rear. Recent building work to the house has been carried out with a new large dormer having been constructed into the rear slope of the roof and the roof having been recovered with the ceilings on the 1st floor in the front section of the house having been taken down. The new dormer on the rear of the building has been constructed to raise the ceiling height in the rear 1st floor bedroom and in the stairwell. This dormer is built from timber studworks and has been clad on the exterior with hanging slate. The dormer has plastic sheeting closing the window apertures. The building has a rendered gable end to the north with a chimney built into the wall and is attached to the neighbouring property to the south, see Photos 1 and 2.

Photo 1. Showing the front and northern gable end of the house

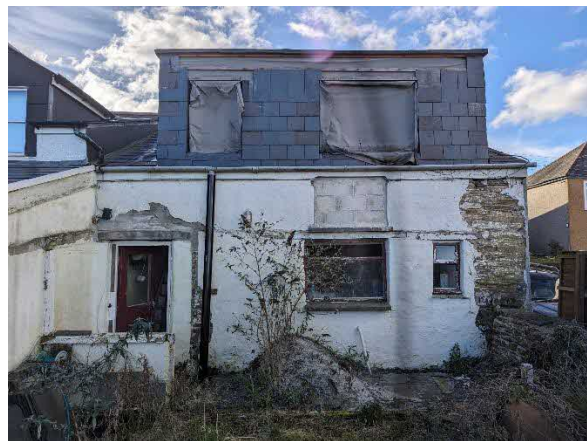
Photo 2. Showing the rear of the house and new dormer from the east

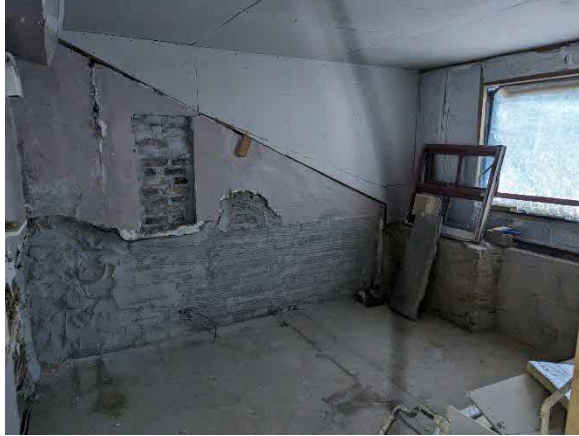
Internally within the new dormer the walls and underside of the roof have been lined with plasterboard but not finished with the rooms on the 1st floor over the front part of the house having large holes in the ceiling but the rafters are still covered with fiberglass insulation, see Photos 3 and 4. The roof void of this house extends over the roof void of the attached cottage with no fire partition. The building has not been lived in for number of years with the interior of the building being all open and having been stripped back.

Photo 3. Showing the interior of the new rear dormer

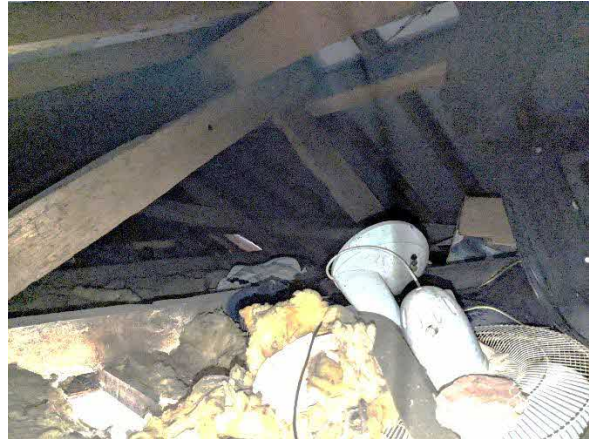
Photo 4. Showing the roof void

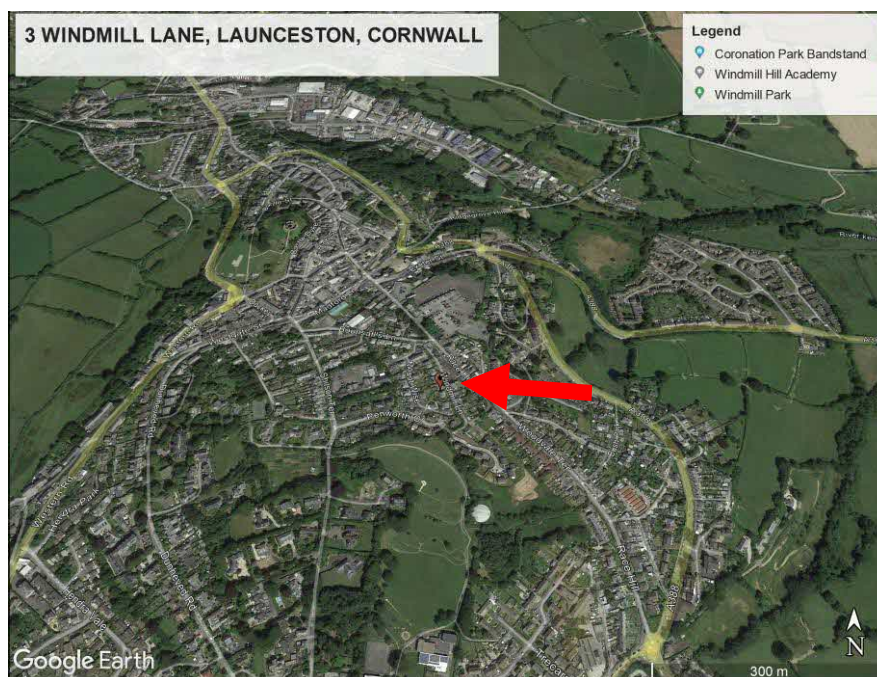
The building is located within the town of Launceston, to the south of the town centre, and is surrounded by houses with small gardens and street lit roads with the ground dropping away steeply to the east. A short distance away to the south is Coronation Park, a large open green space lined with trees with Windmill Hill School to the west, which is also lined with trees, see Figure 1.

Figure 1. Google Earth image showing the location of the property (shown by the red arrow) and surrounding landscape

The property is surrounded by houses with small poorly vegetated gardens but there are open areas and lines of trees nearby and represents moderate quality urban bat foraging habitat. The gardens are likely to be used by the bat species more commonly found in urban environments including Common Pipistrelles.
