HISTORIC BUILDING RECORDING AT
“SNUFF MILL WAREHOUSE”
6 PARK LANE.
BEWDLEY
WORCESTERSHIRE

Historic building recording at “Snuff Mill Warehouse” 6 Park Lane. Bewdley Worcestershire

20th September, 2021

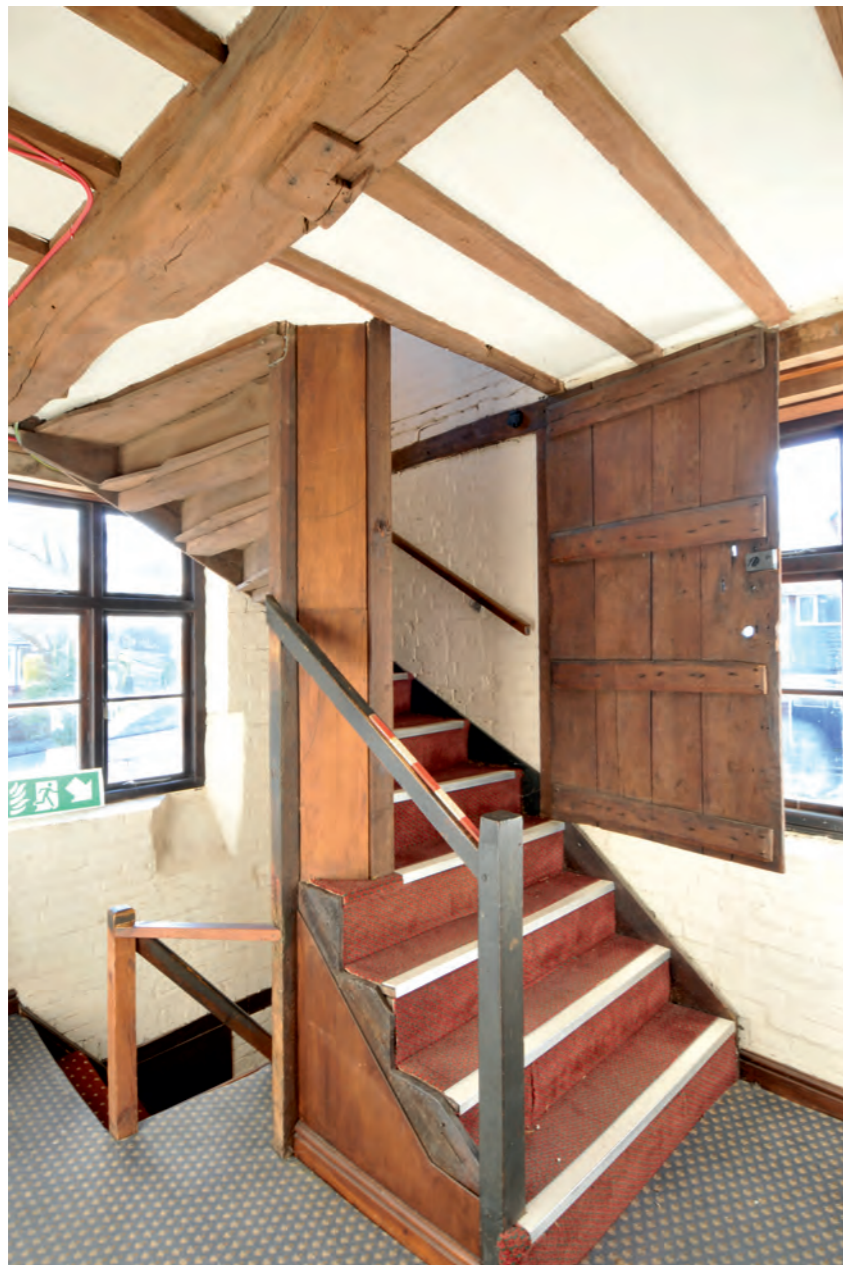
Stair at first floor level, with rehung door from elsewhere in the building

6.3.1 All of the first floor was accessible, the building at this level being a single large open space with modern plasterboard and stud partitions. The stairs in the south west corner appear to be of early-mid 19th Century origin - a re-used plank and batten door has been added part-way up the flight. The floors are fully carpeted but appear to conceal primarily historic planking. The ceilings are modern plasterboard with exposed tie beam soffits and some exposed joisting. There is some residual evidence of probable drive shafting, being characteristic spike marks and staining on the sides of the tie beams, together with one remaining example of a probable shaft hanger (Fig xx) There are, on the upper part of the northern wall clear areas of wear suggestive of belt driven machinery or some other repeated stroke action – these are unlikely to be 18th Century, as no evidence of motive power is currently visible, but given the loss of many of the ancillary buildings there is some possibility that a horse powered gin (or “ginny ring”) was available in the later 18th Century.

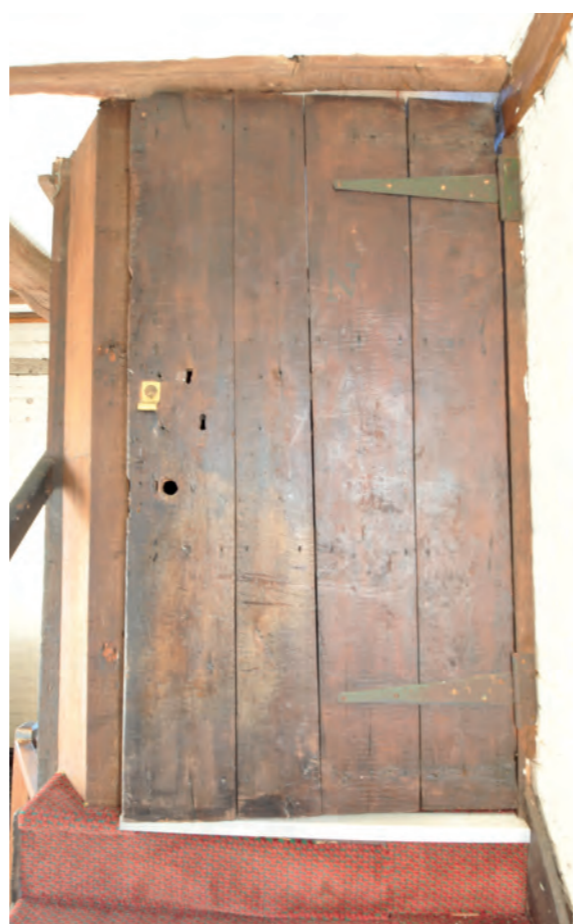
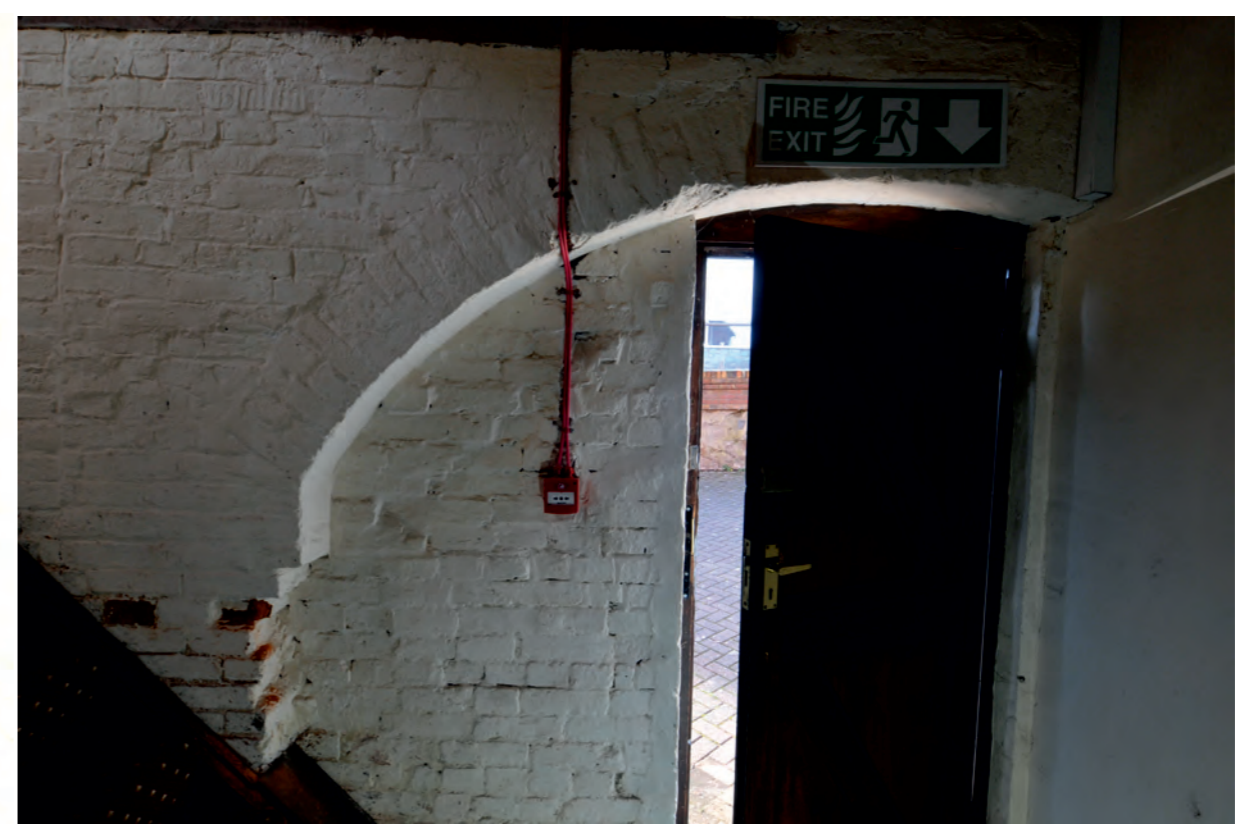
Arch interior of ground floor entrance door - the arch is a secondary insertion cut through a original window opening, the infill of the arch is again later than the arch

6.2.2 The southern elevation has an enlarged doorway opening at ground floor level – the present opening appears to have replaced a centrally positioned doorway and a window opening to the east. The heads of both openings are still discernible, as is a break in the platt band/string course directly over the central doorway. The platt band also terminates just short of the two storey block indicating that that structure was contemporary with Block 1. The large opening has modern wooden doors and panelling of late 20th C date. The south facing windows at this level are modern softwood transom windows with side opening casements broadly replicating the original fenestration. Blocked window openings on the northern elevation indicate that the fenestration of the southern elevation was largely mirrored on the northern elevation. This would have made the original building well lit and well ventilated prior to construction of Block 2. Stairs to the first floor appear to be modern.

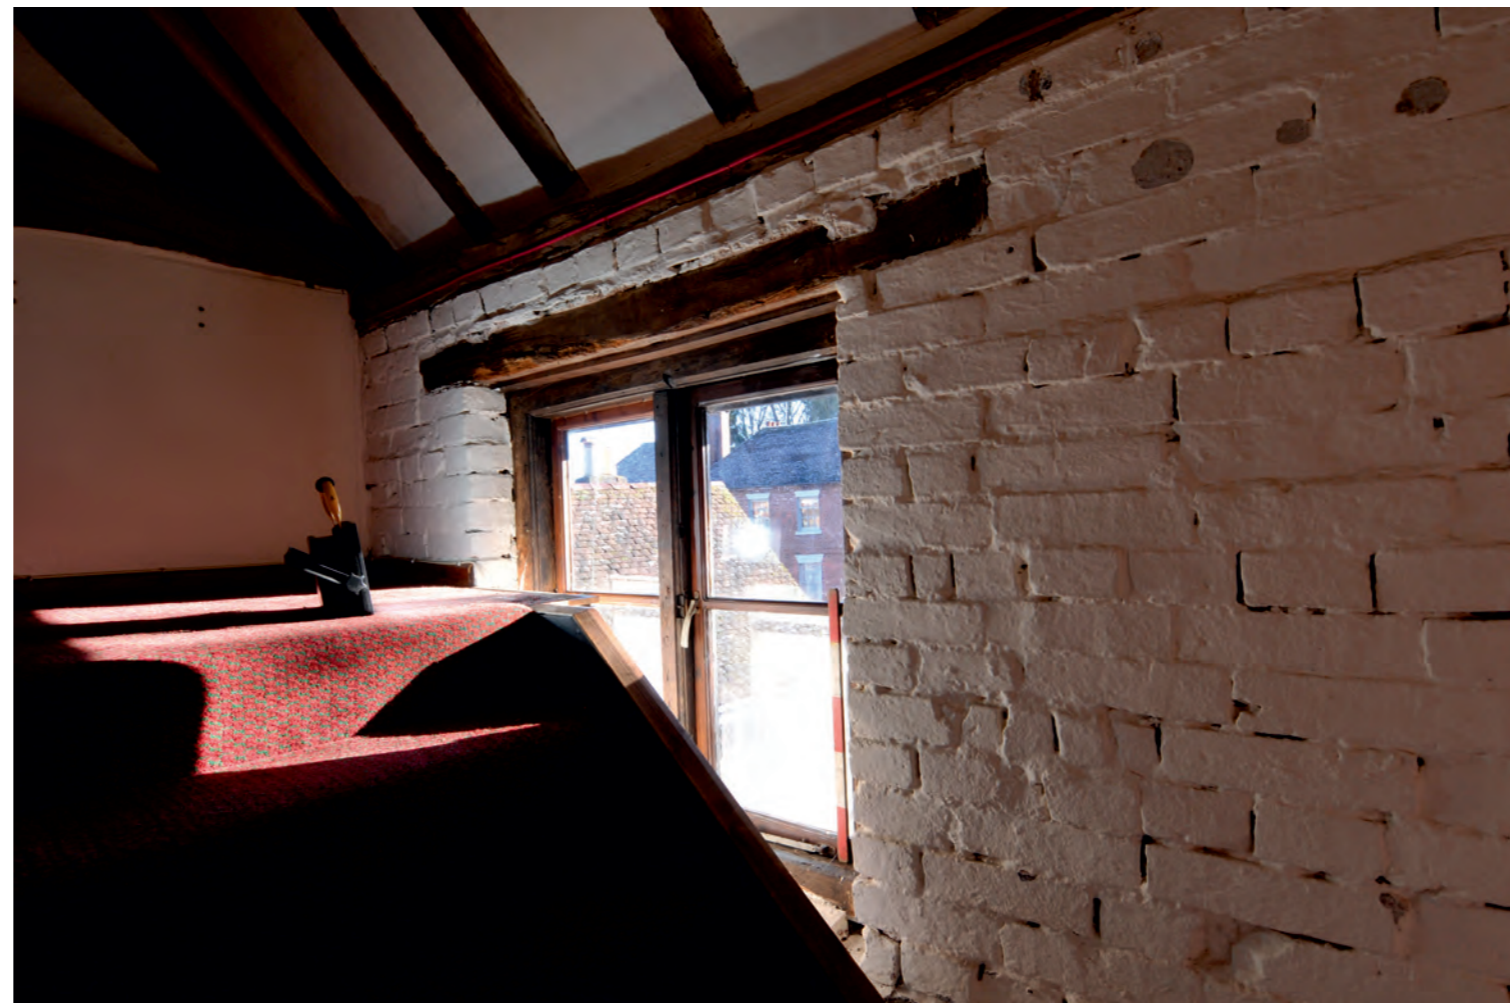
Probably original early 19th C wooden casement window frame, replaced side opening casements

6.3.2 The first floor south and west facing windows, with one exception, appear to be modern approximate replicas of transom windows with side opening casements. The exception is a probably early 19th C transom frame second from the west on the southern elevation. The opening casements have been replaced but it would appear that this frame was retained as an exemplar of the original window form. The former window openings on the original northern elevation are mostly visible as patches of brick blocking beneath the original heads.

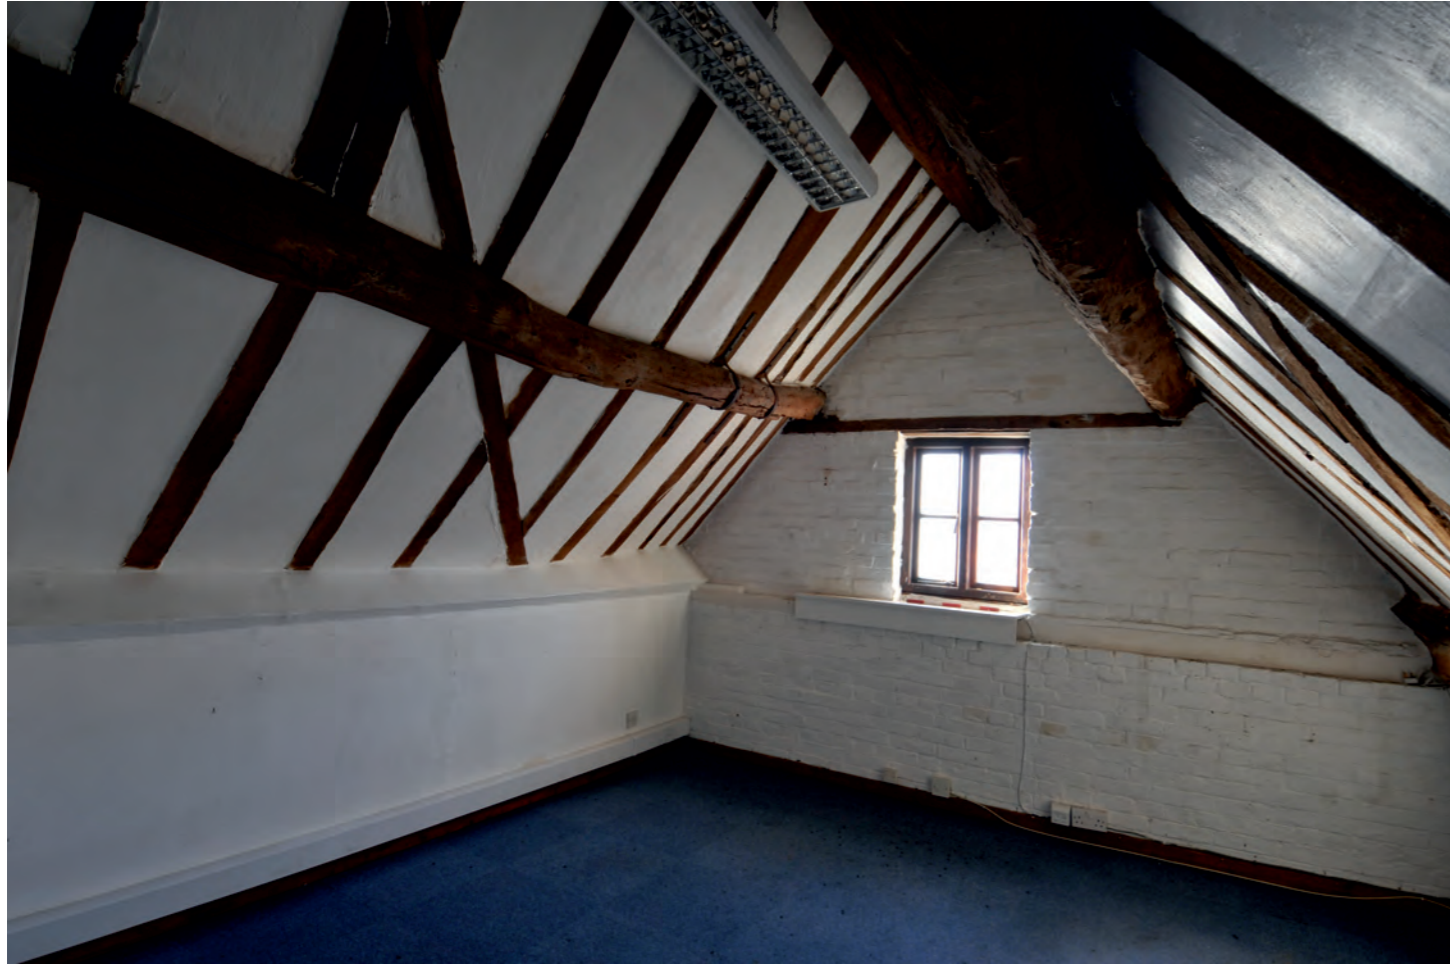
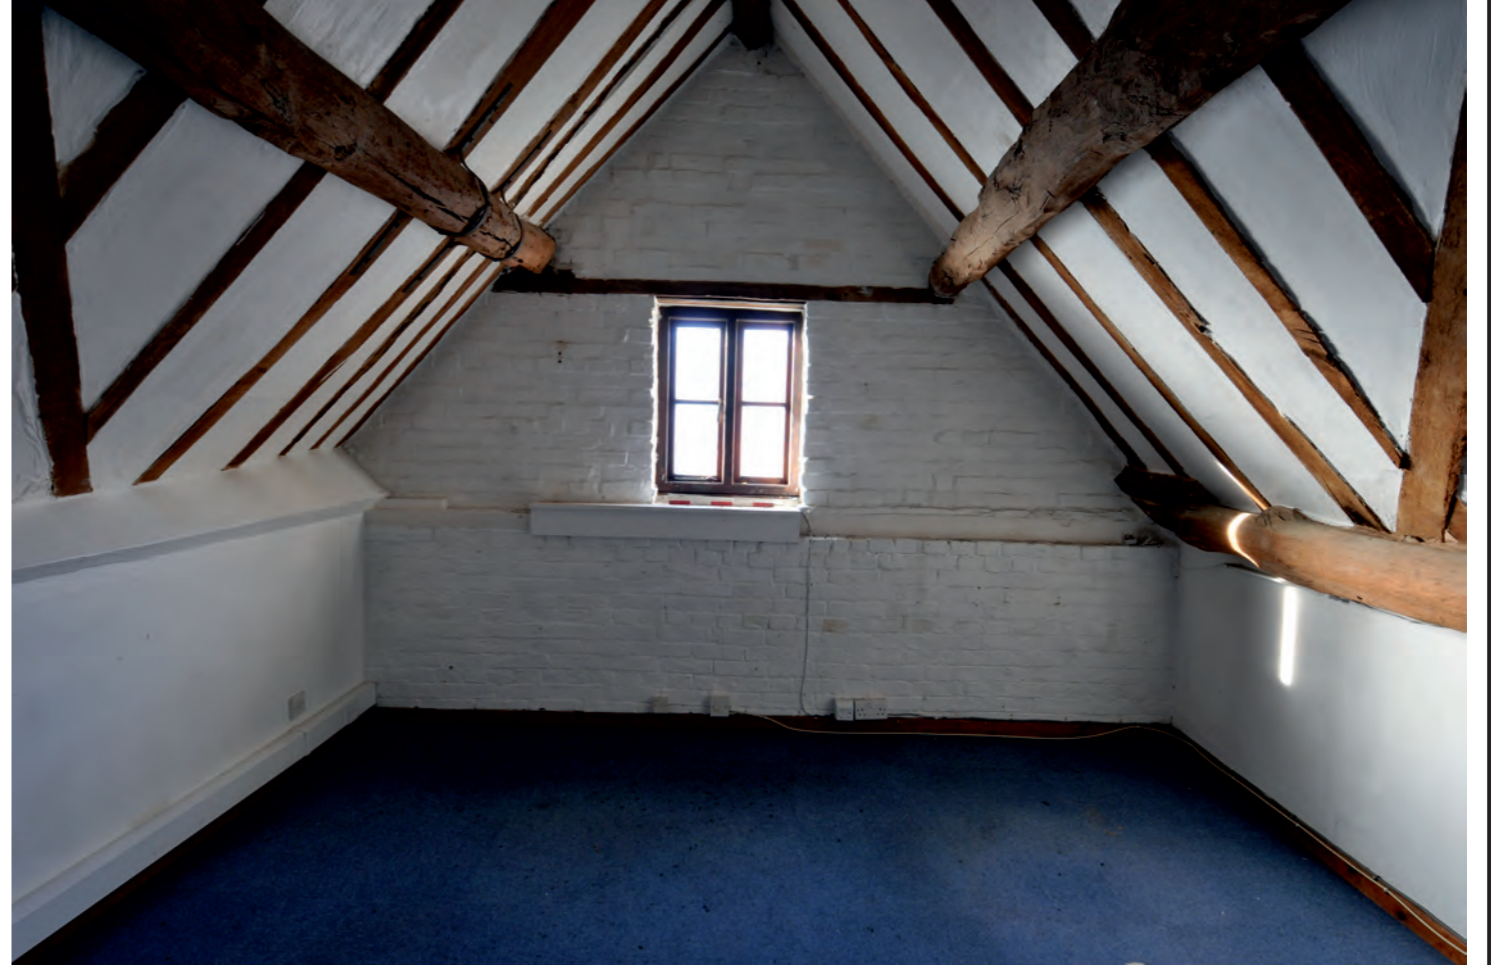
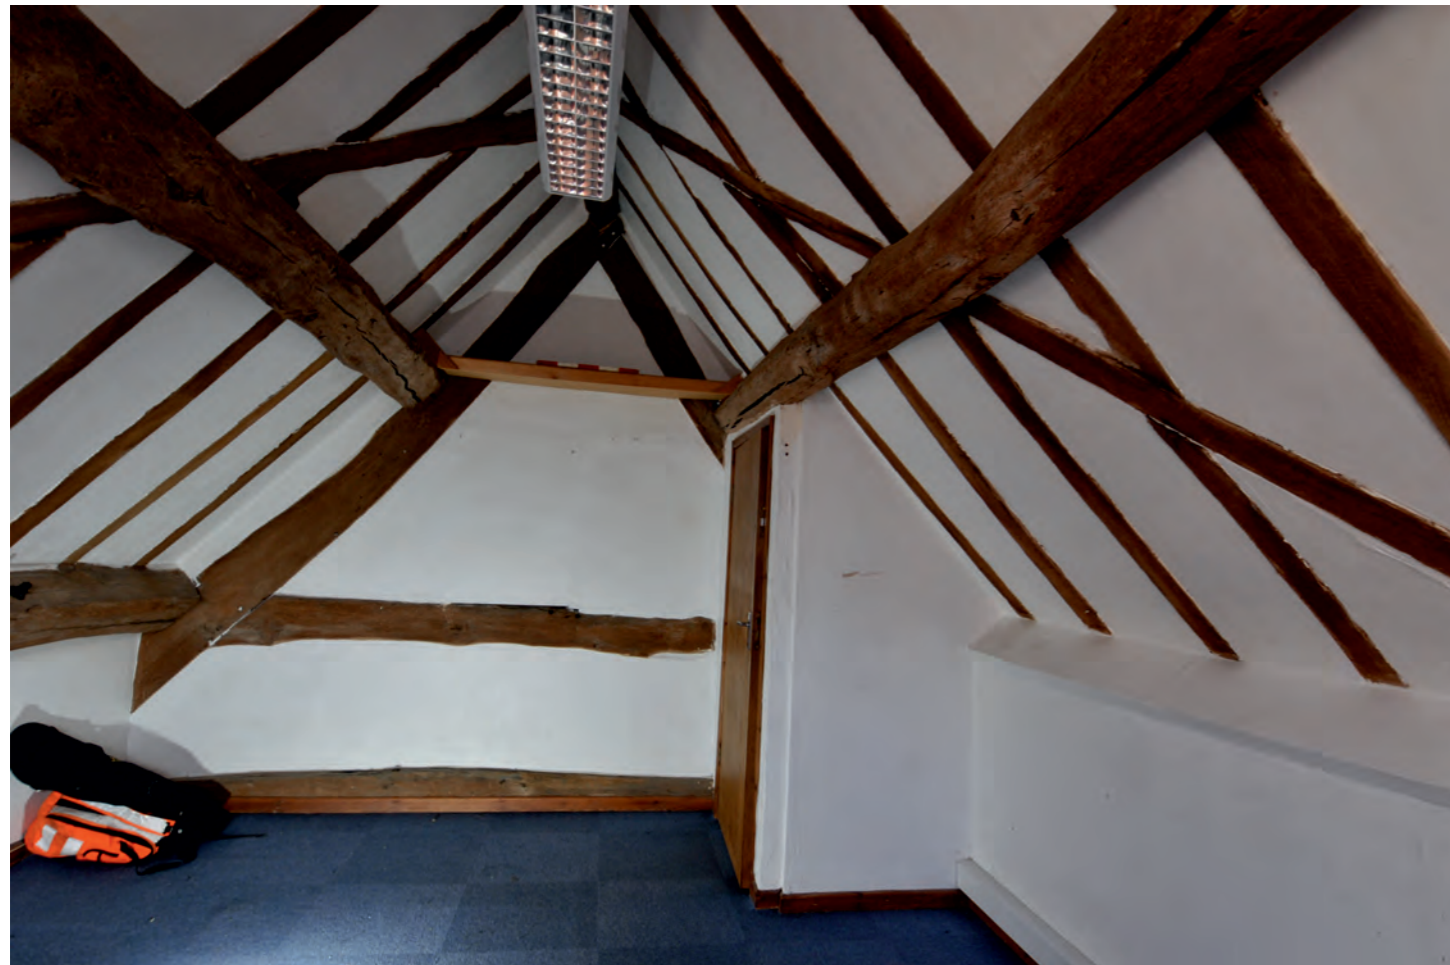
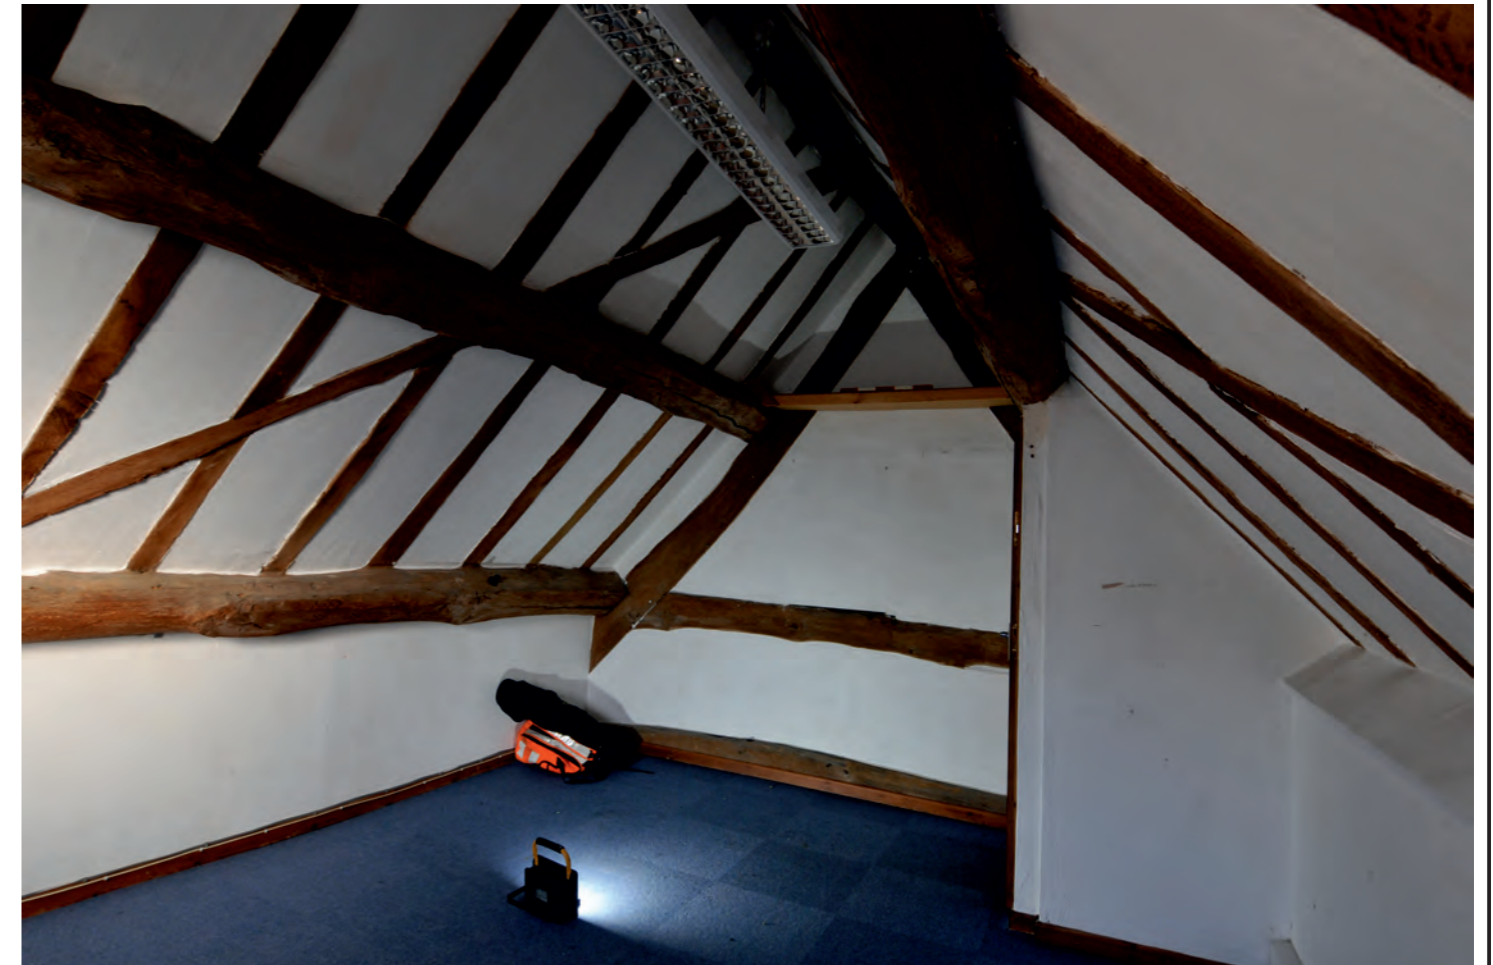
Block 1 - attic level room and west side of truss 1

Eastern face of truss 1

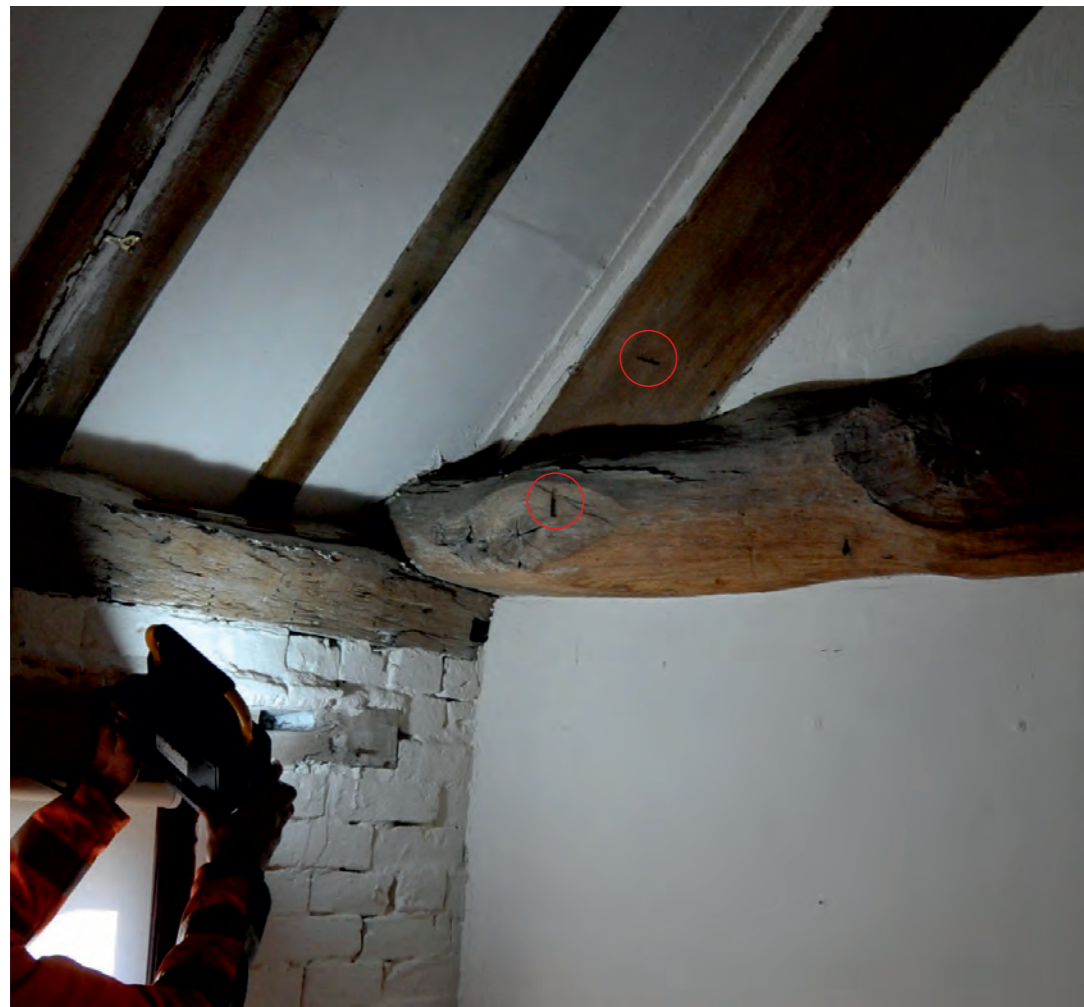
Assembly marks I - I

Assembly marks II-II

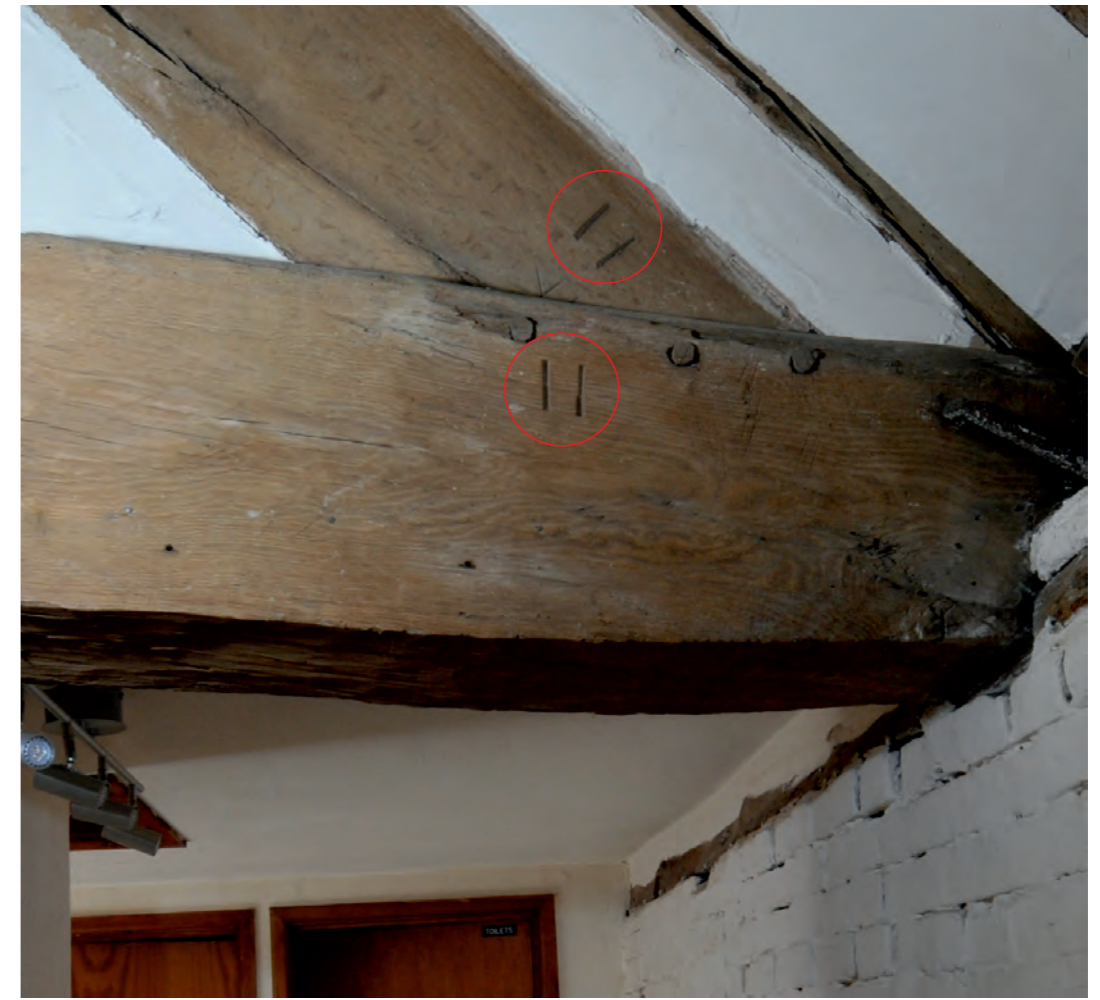
Western face of truss 1

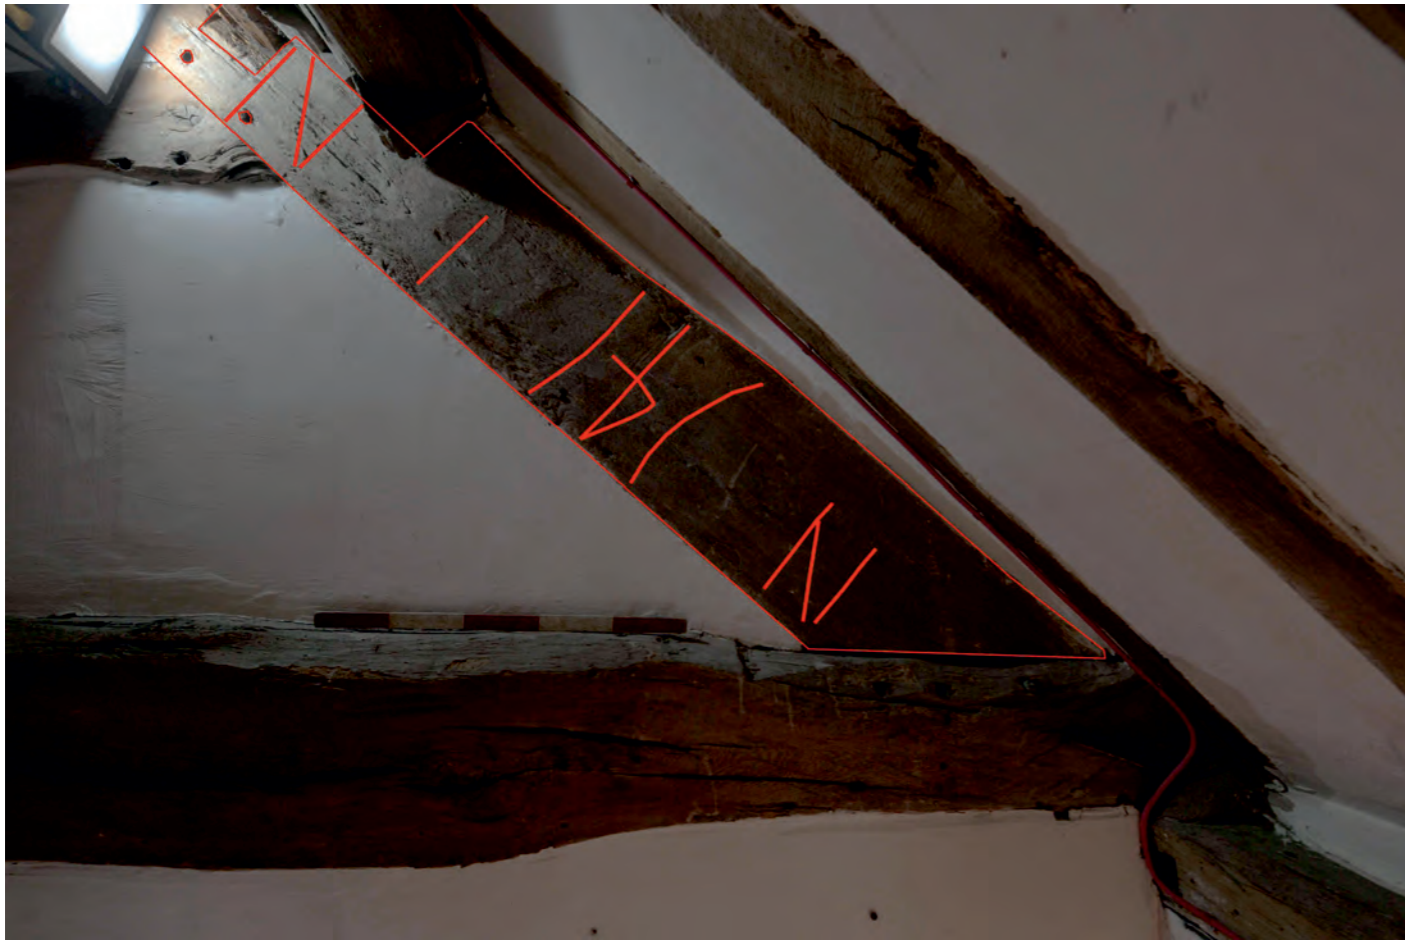
Truss No. 1 - detail of assembly marks and Baltic timber importers marks (probably North Prussian oak) on southern end of truss

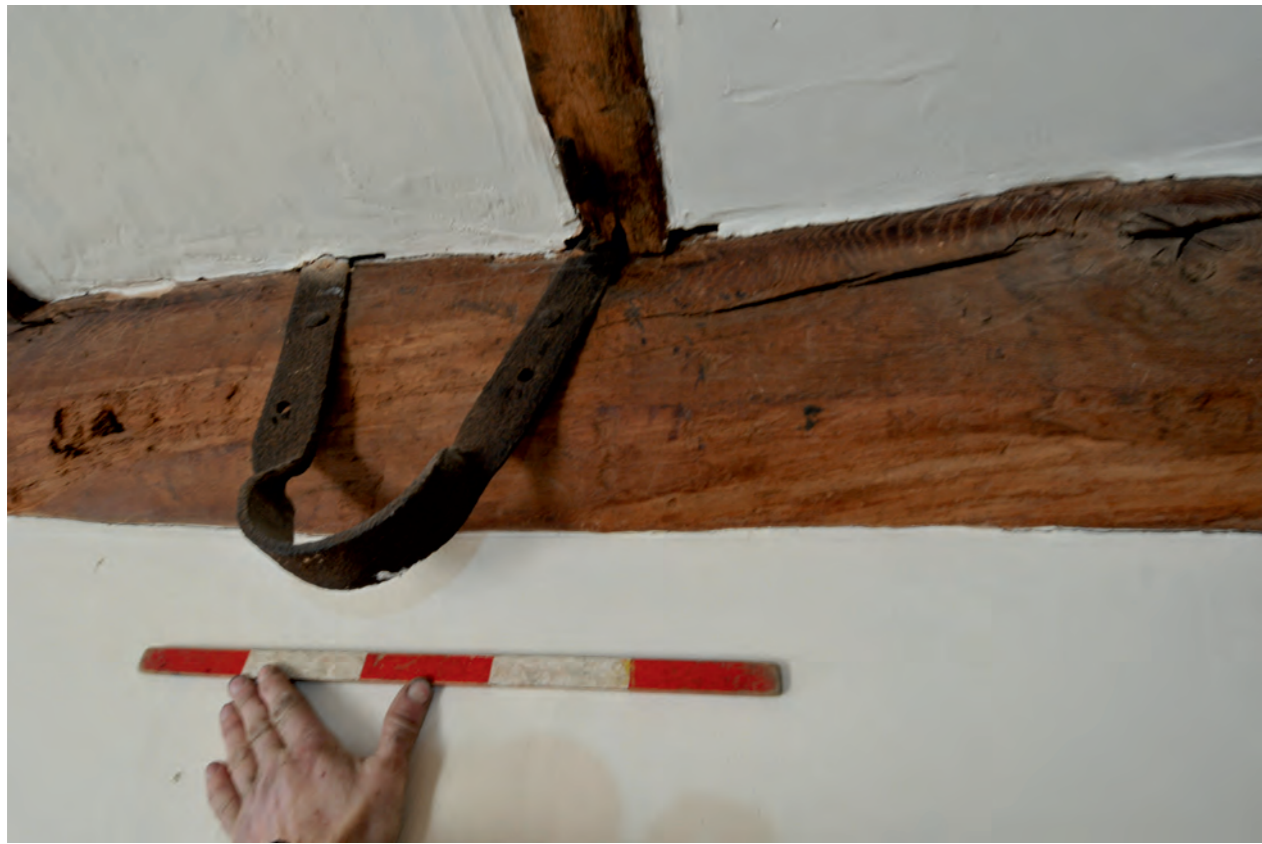
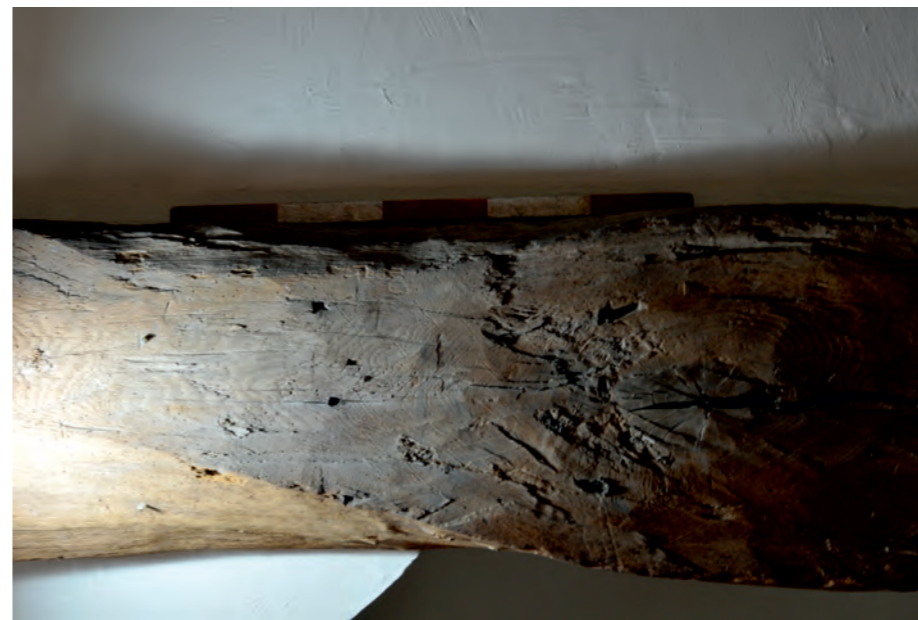
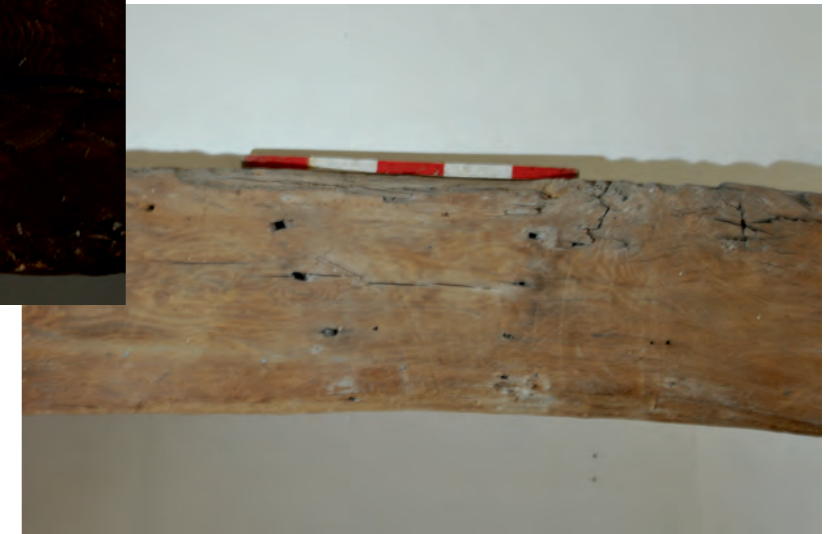
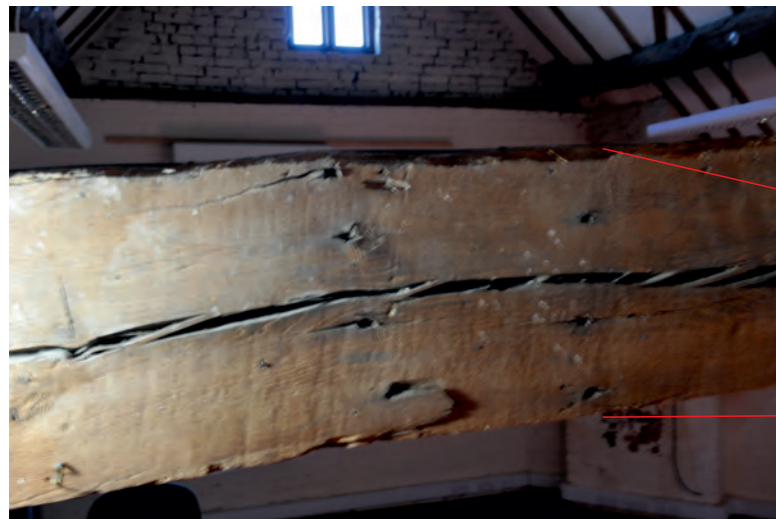
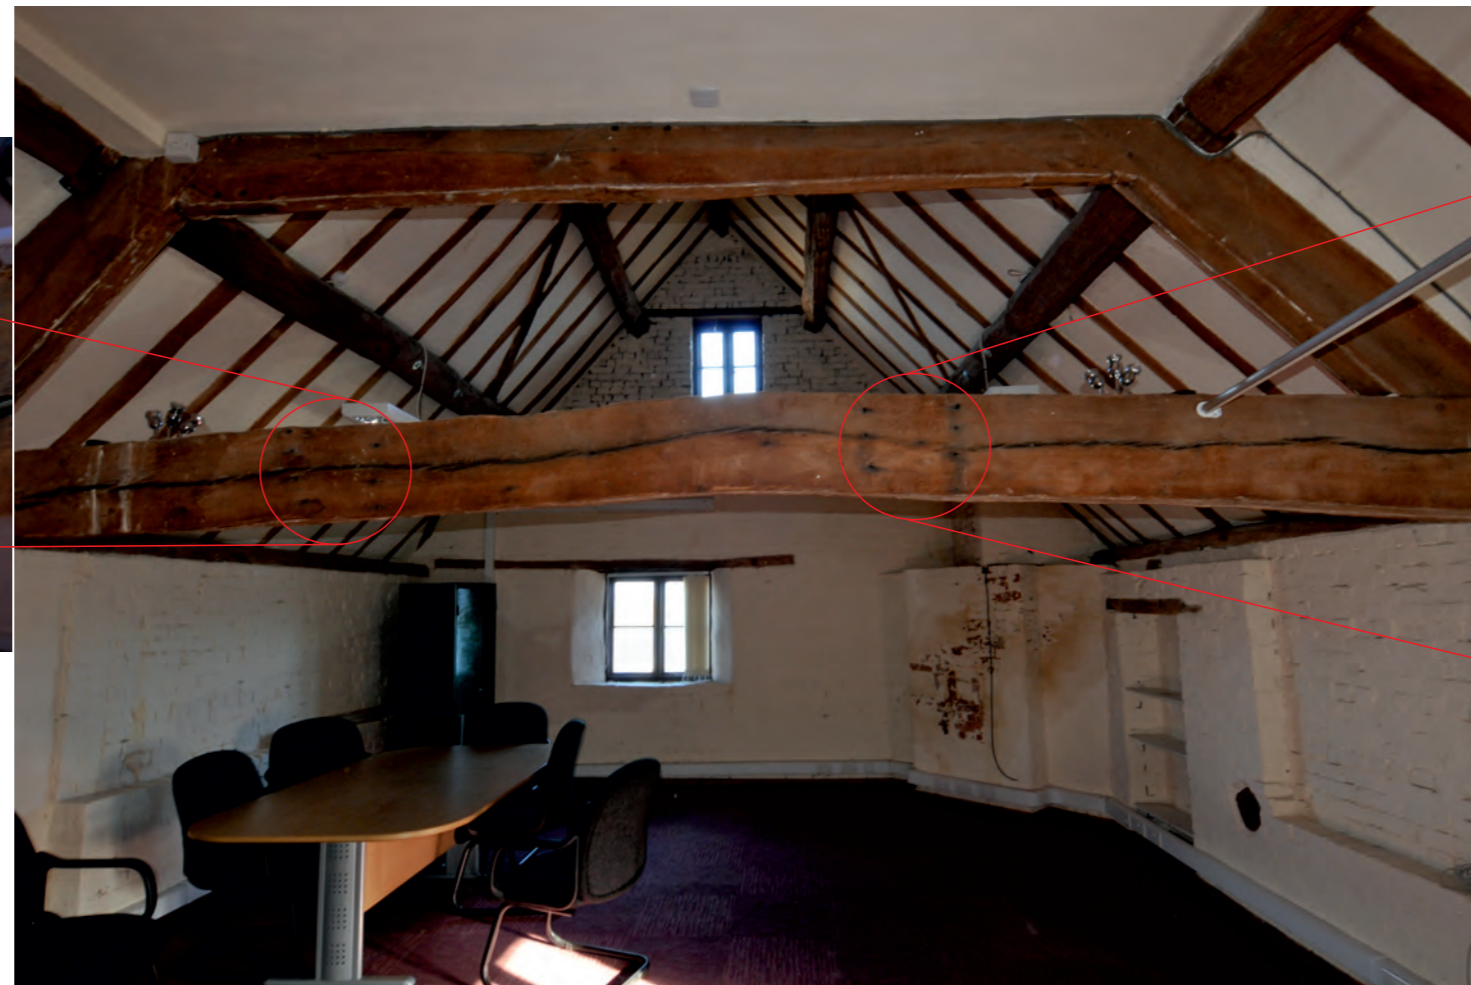
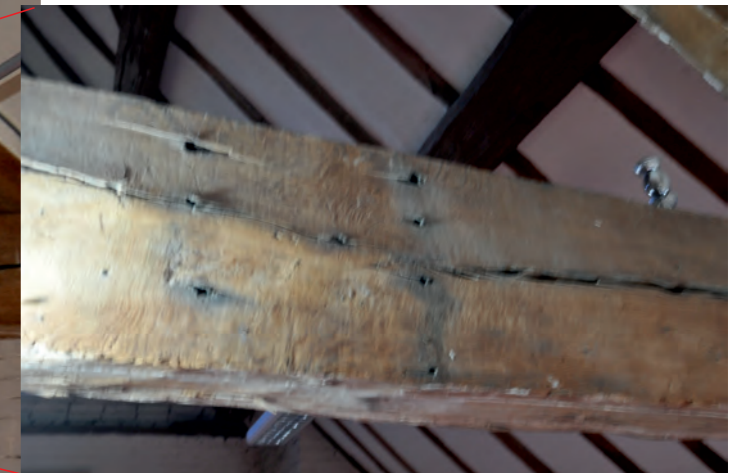
First floor Strap hanger

Truss 1 Scar of strap hanger

Scar of strap hanger

Truss 3 view facing east

Figure 9: Evidence of removed strap hangers relating to rails or horizontal drive shafting hung from tie beams - the sole surviving hanger appears to be of 18th or early 19th C date, and the spike fixings suggest similar dates for all.

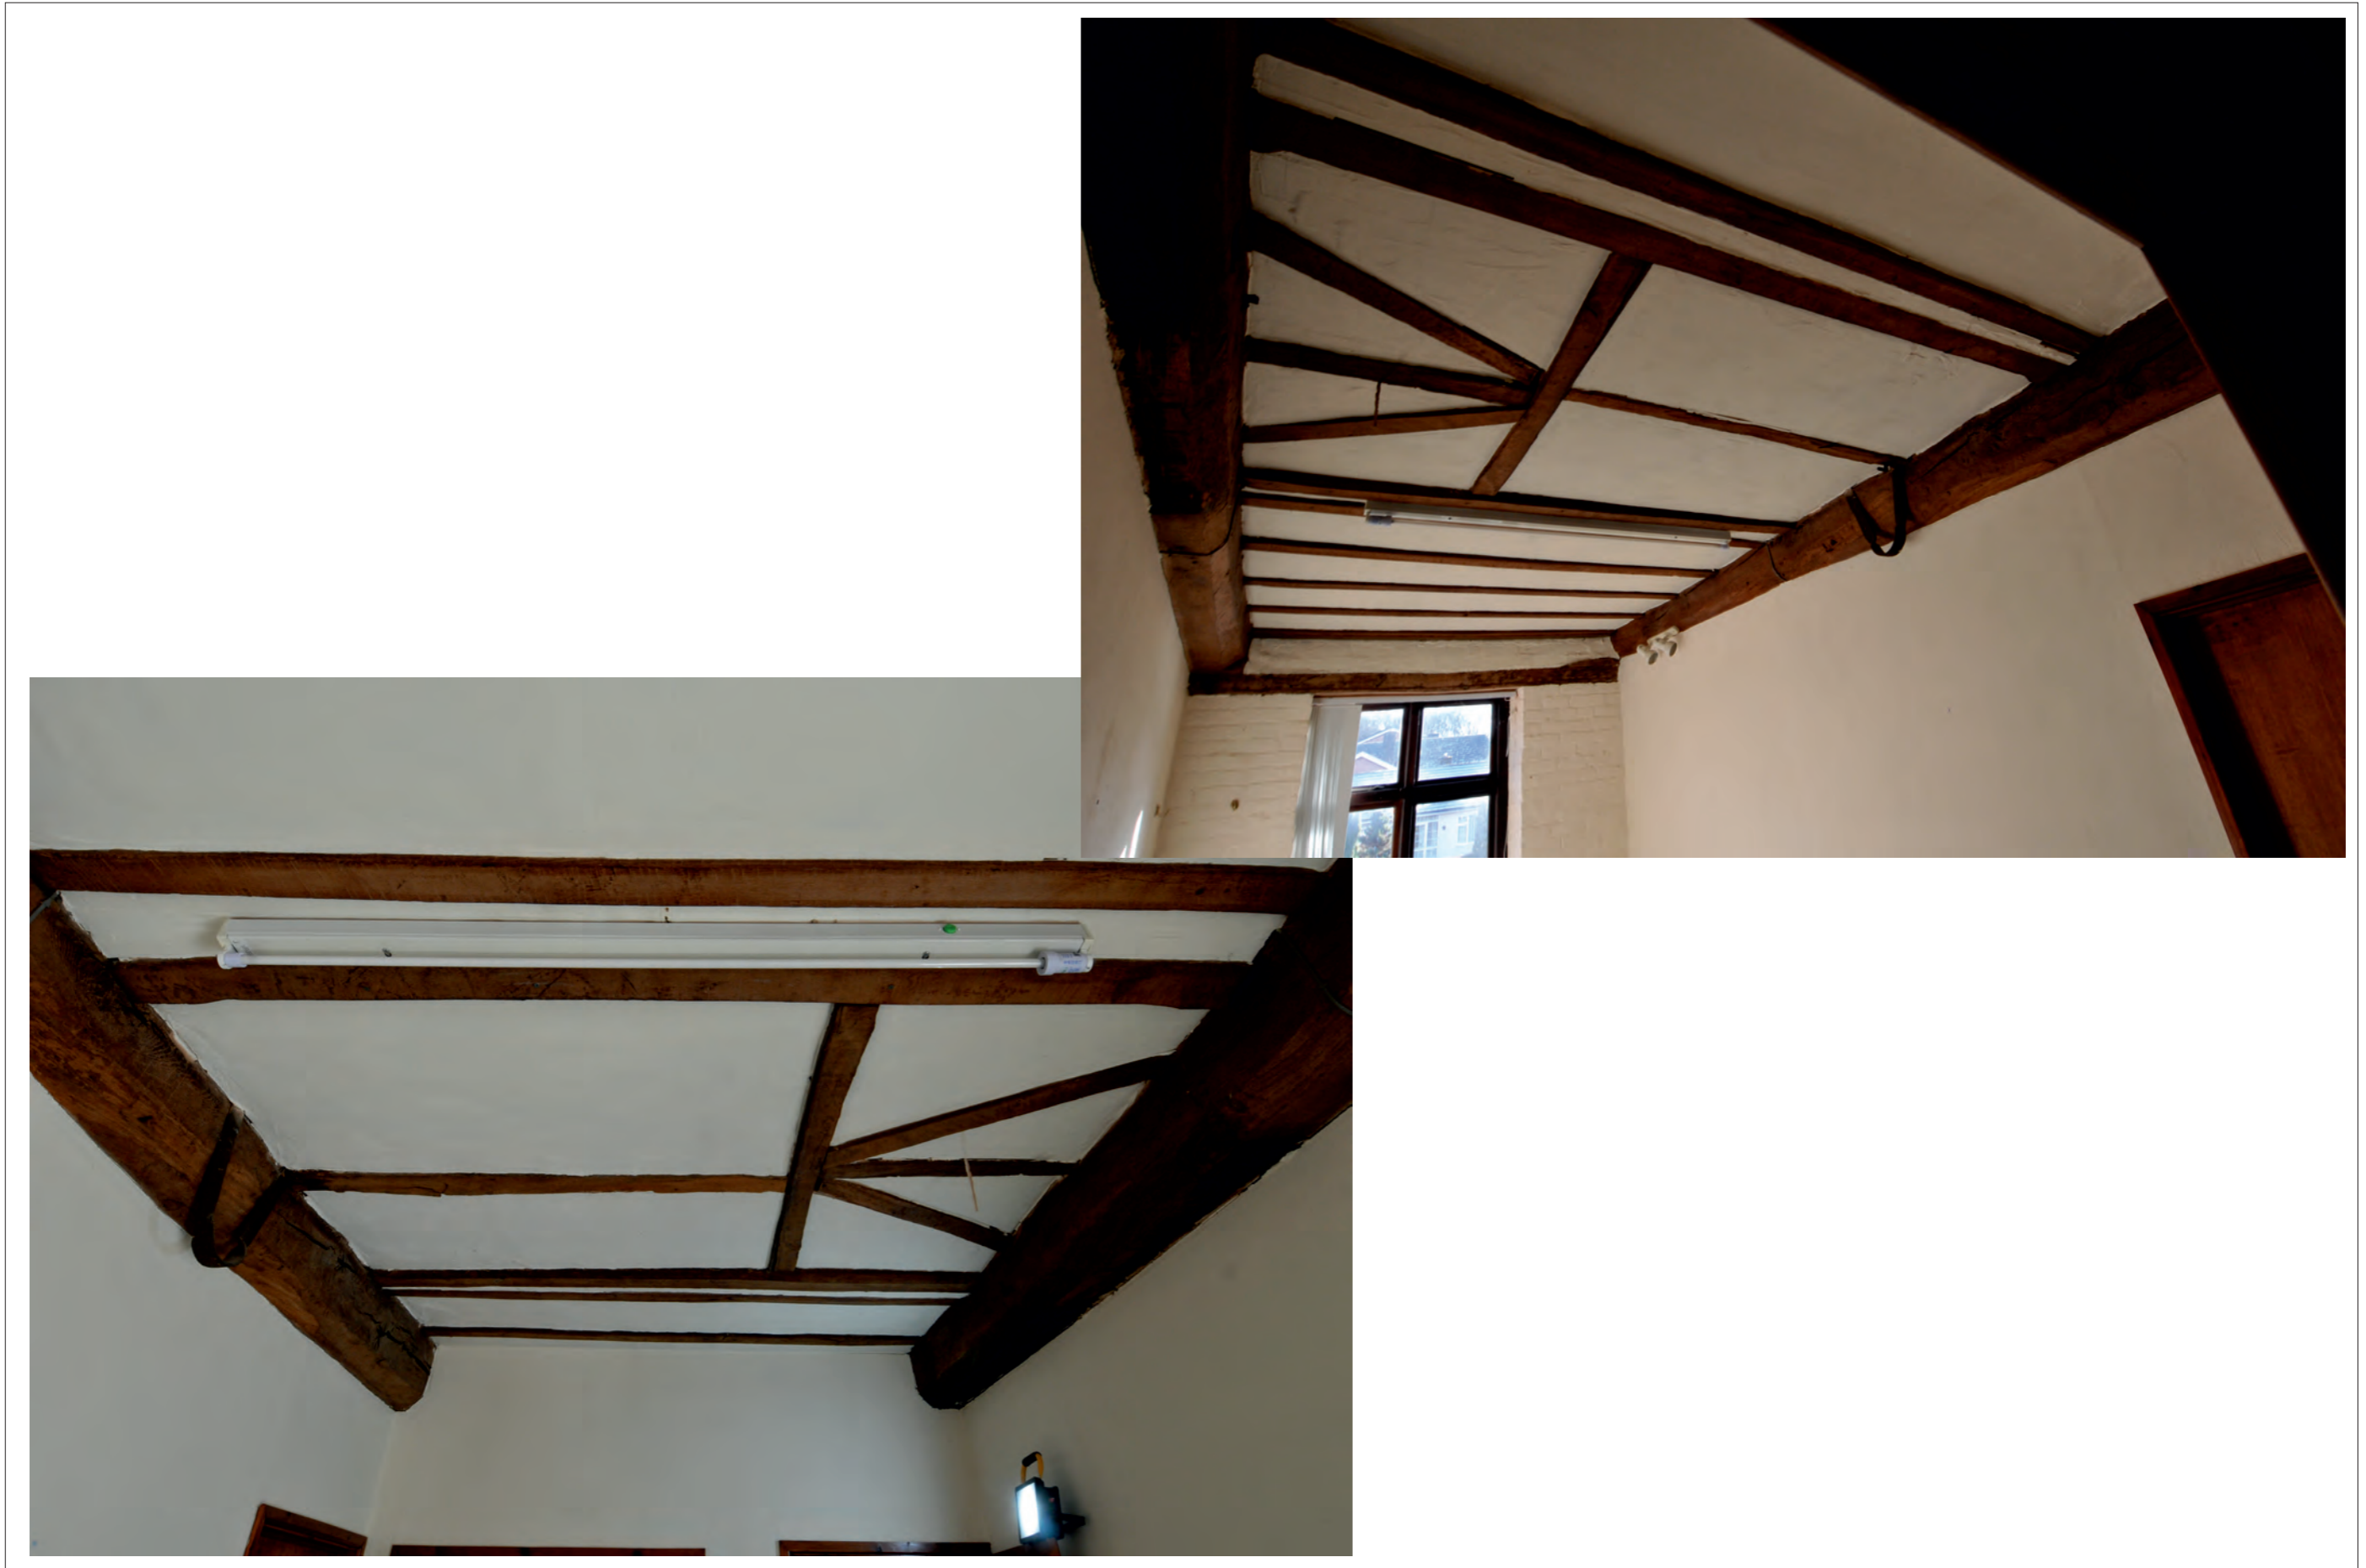
Figure 10: Probable former floor trap door location - note strap hanger
