HISTORIC BUILDING RECORDING AT
“SNUFF MILL WAREHOUSE”
6 PARK LANE.
BEWDLEY
WORCESTERSHIRE

Historic building recording at “Snuff Mill Warehouse” 6 Park Lane. Bewdley Worcestershire

20th September, 2021

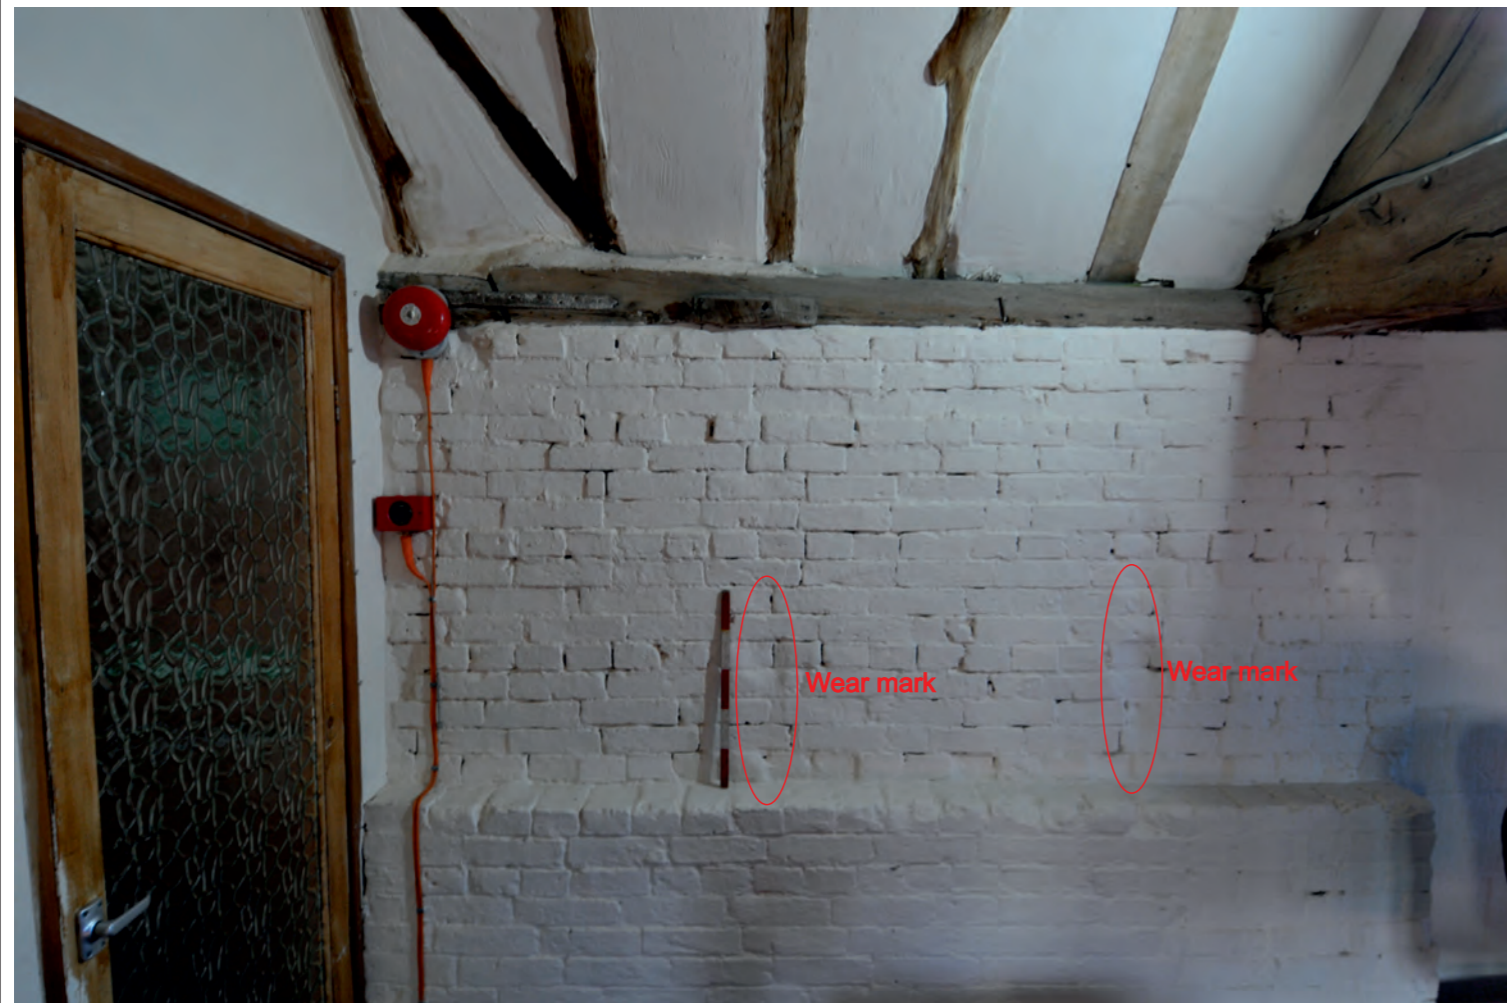
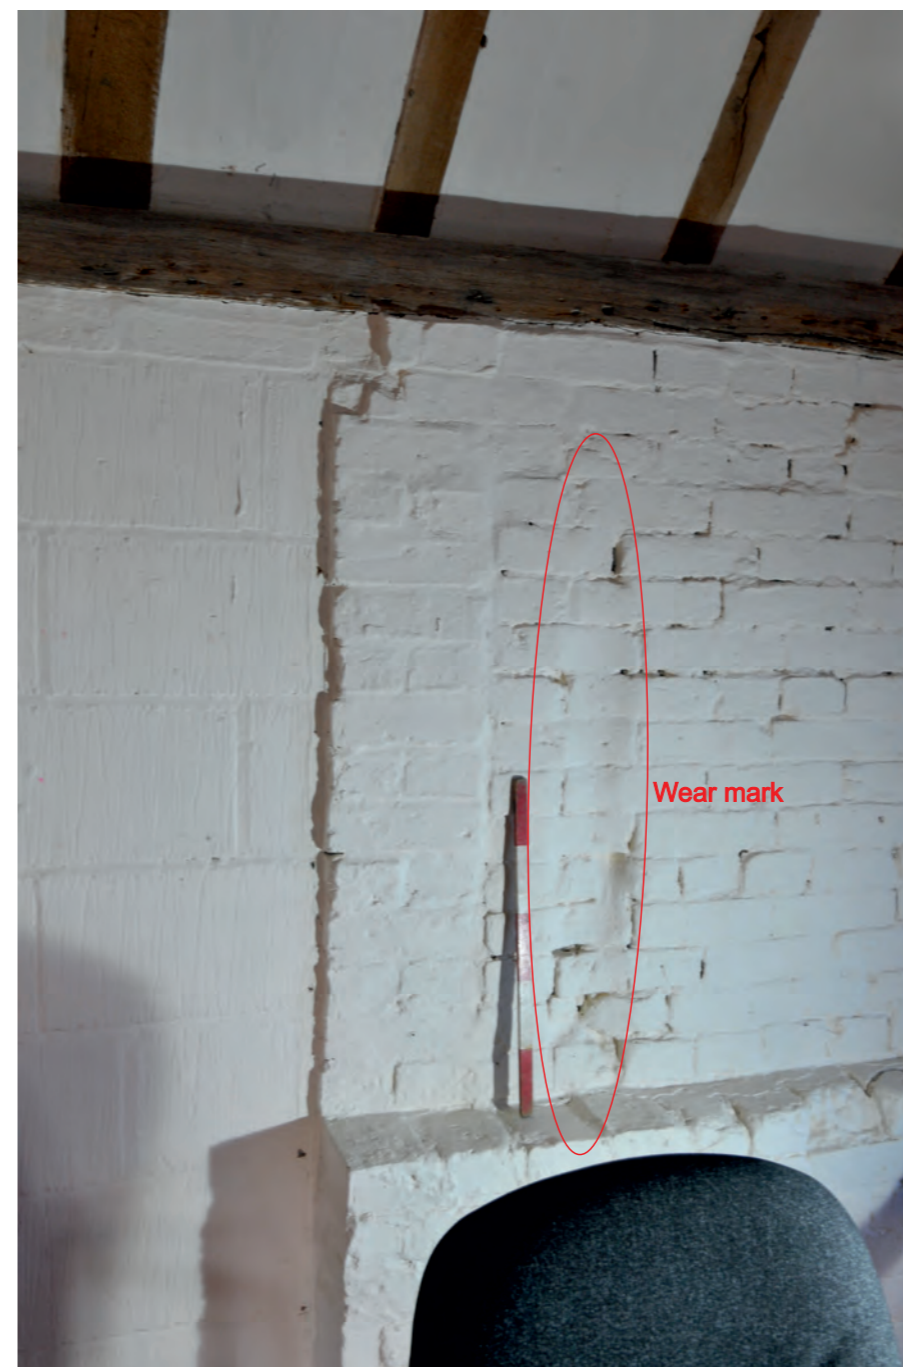
Wear marks relating probably to former belt driven machinery on upper floor, interior of northern wall of Block 1

Figure 11: Wear marks probably caused by adjacent belt driven machinery rubbing against brickwork

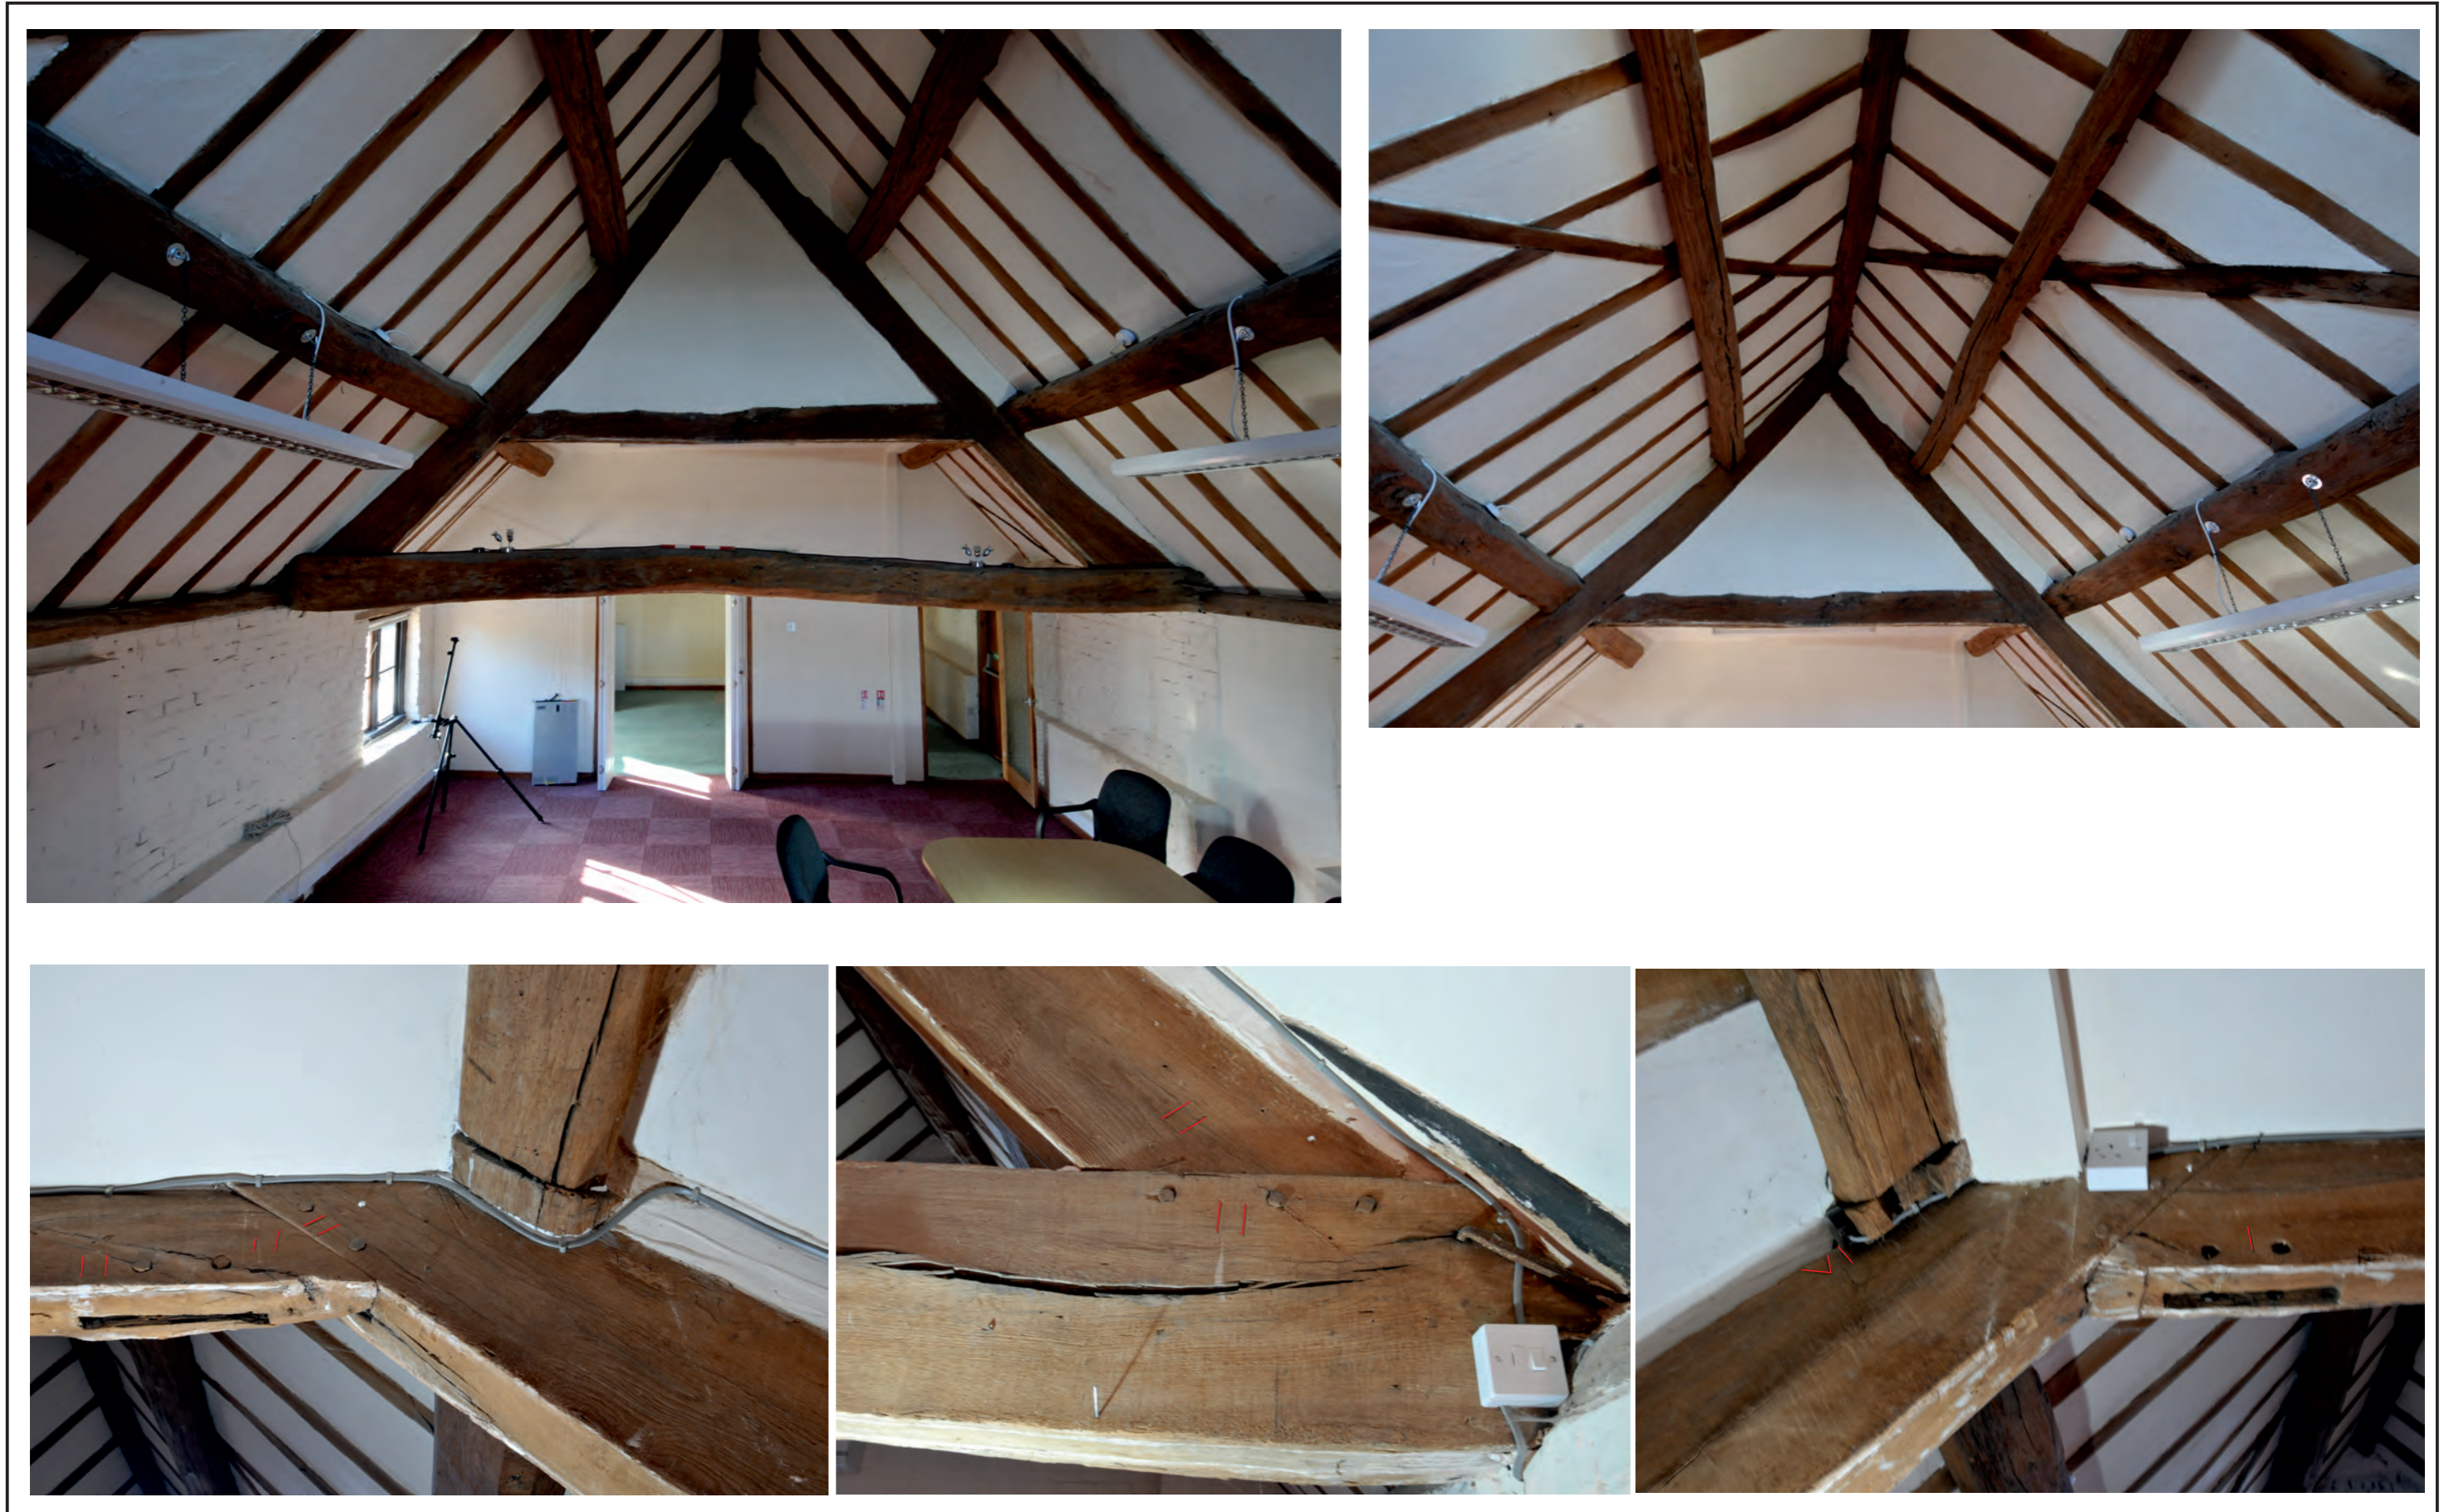
Figure 12: Truss 2, with details of assembly marks on western face. Note that the queen strut mortices on the collar have no corresponding mortice on the tie beam.

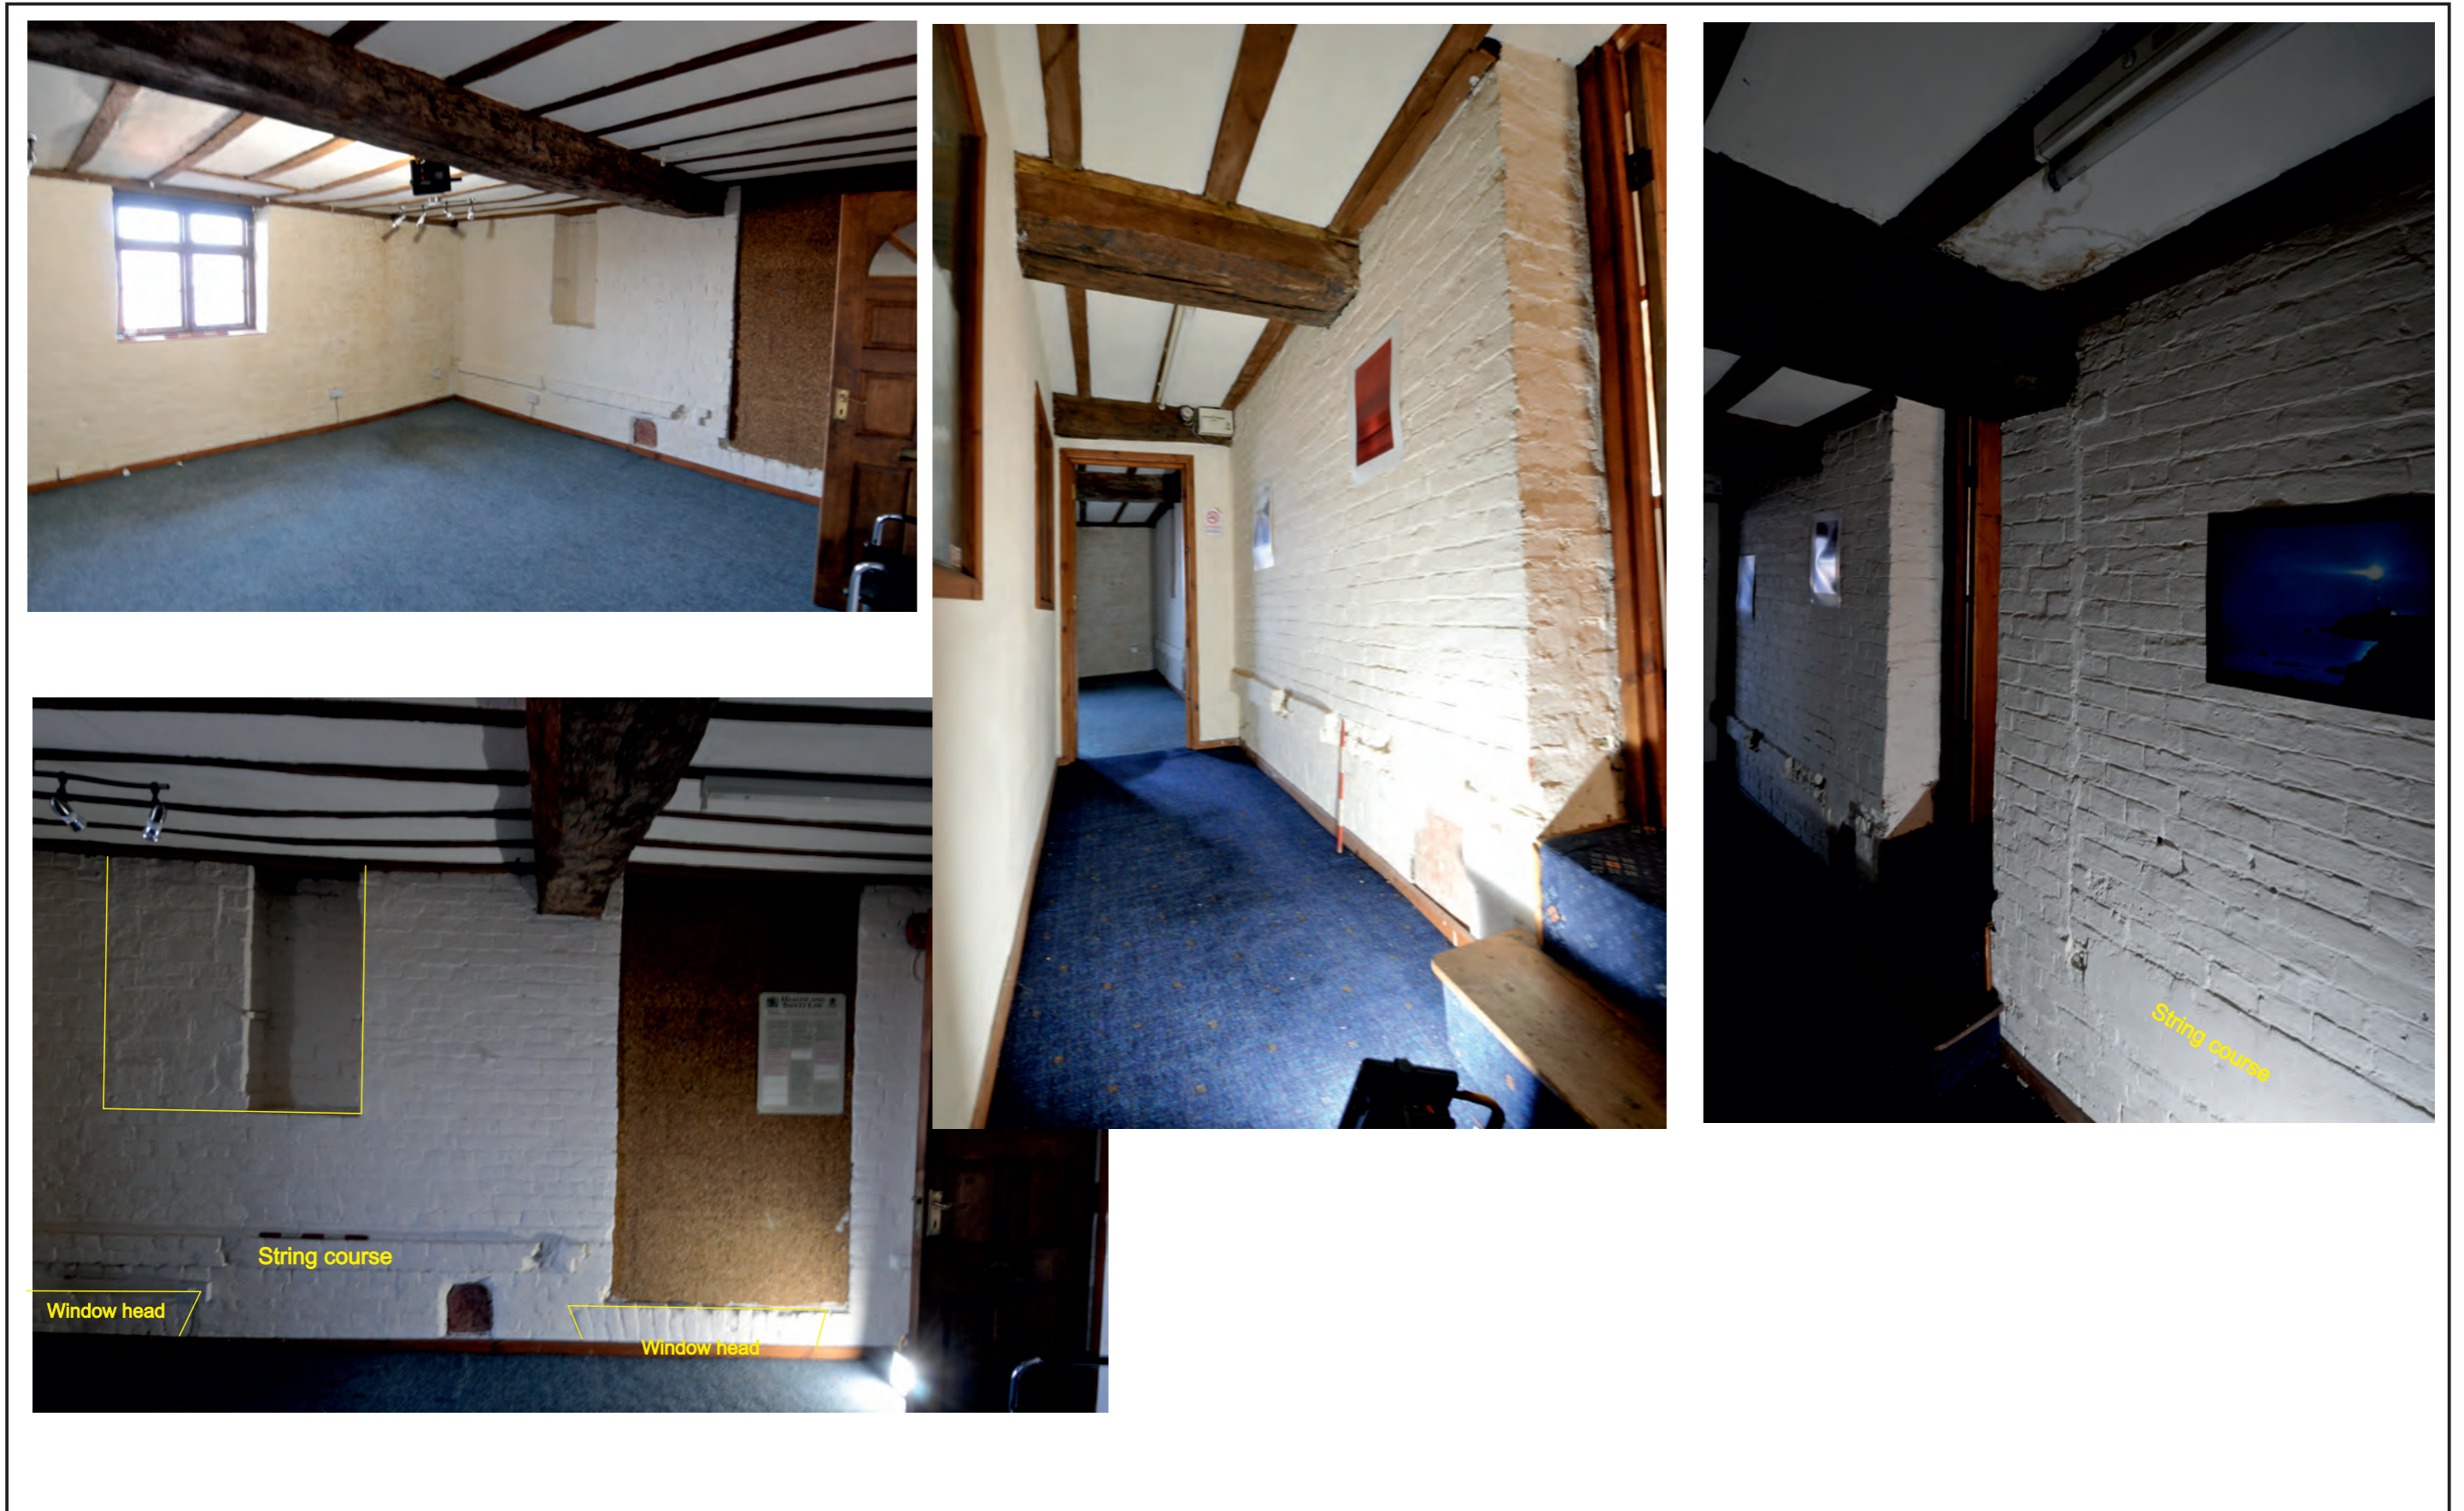
Figure 13: Northern wall of Block 1, visible from within Block 2, showing former string course and heads of blocked ground floor north facing windows

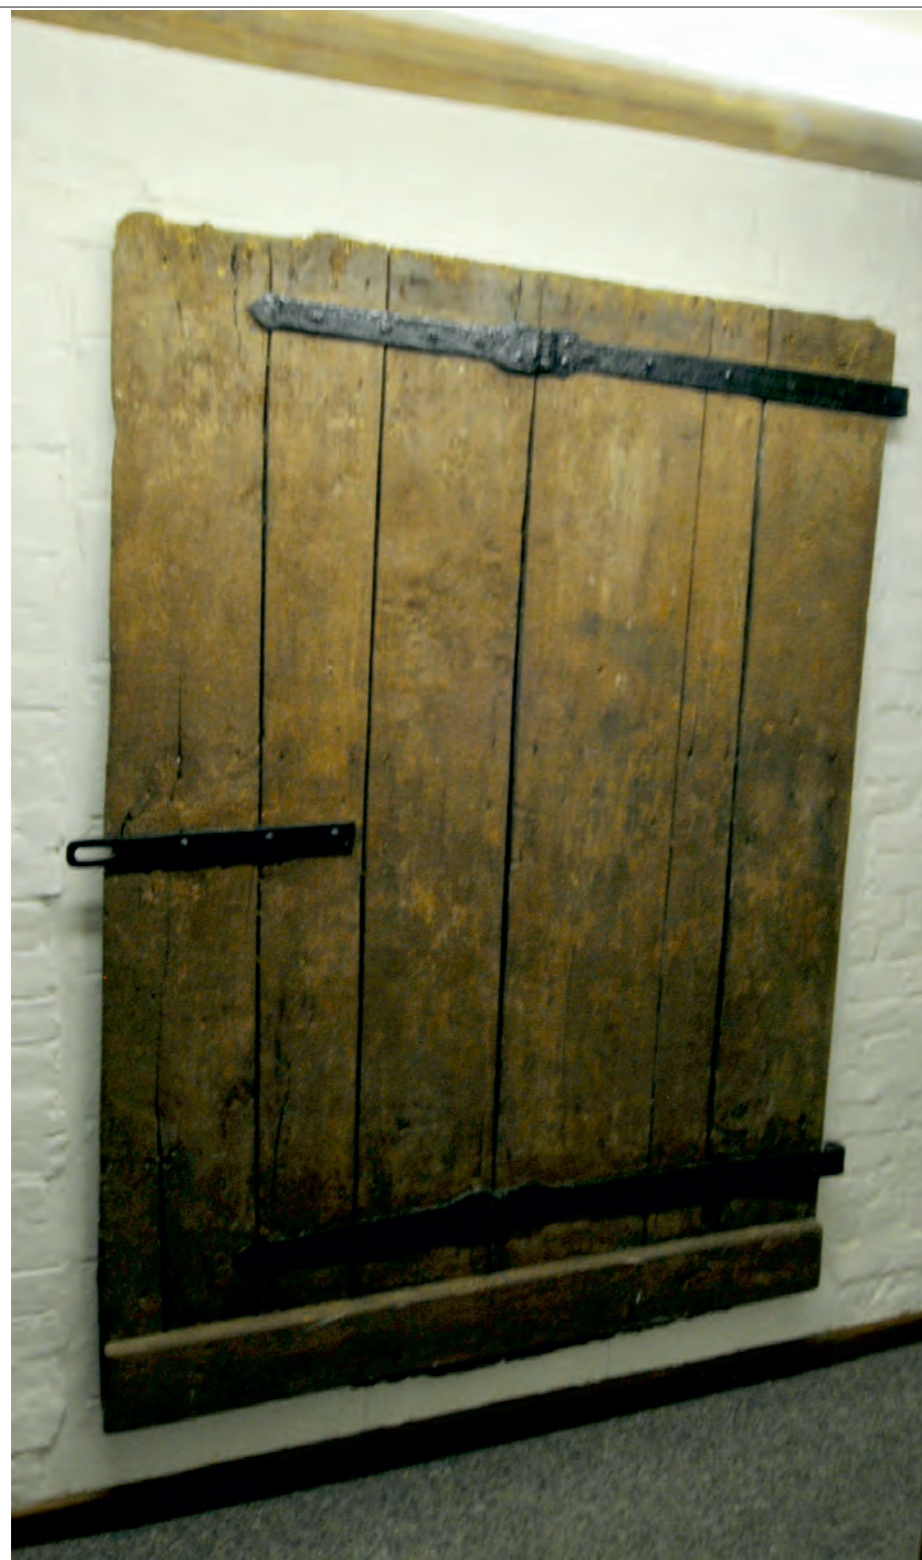
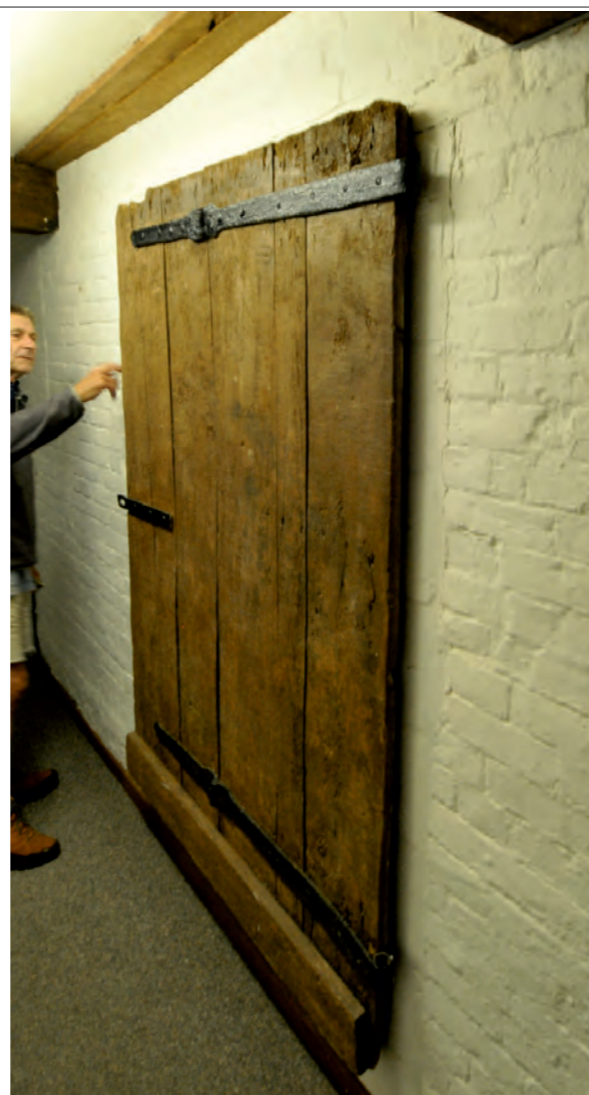
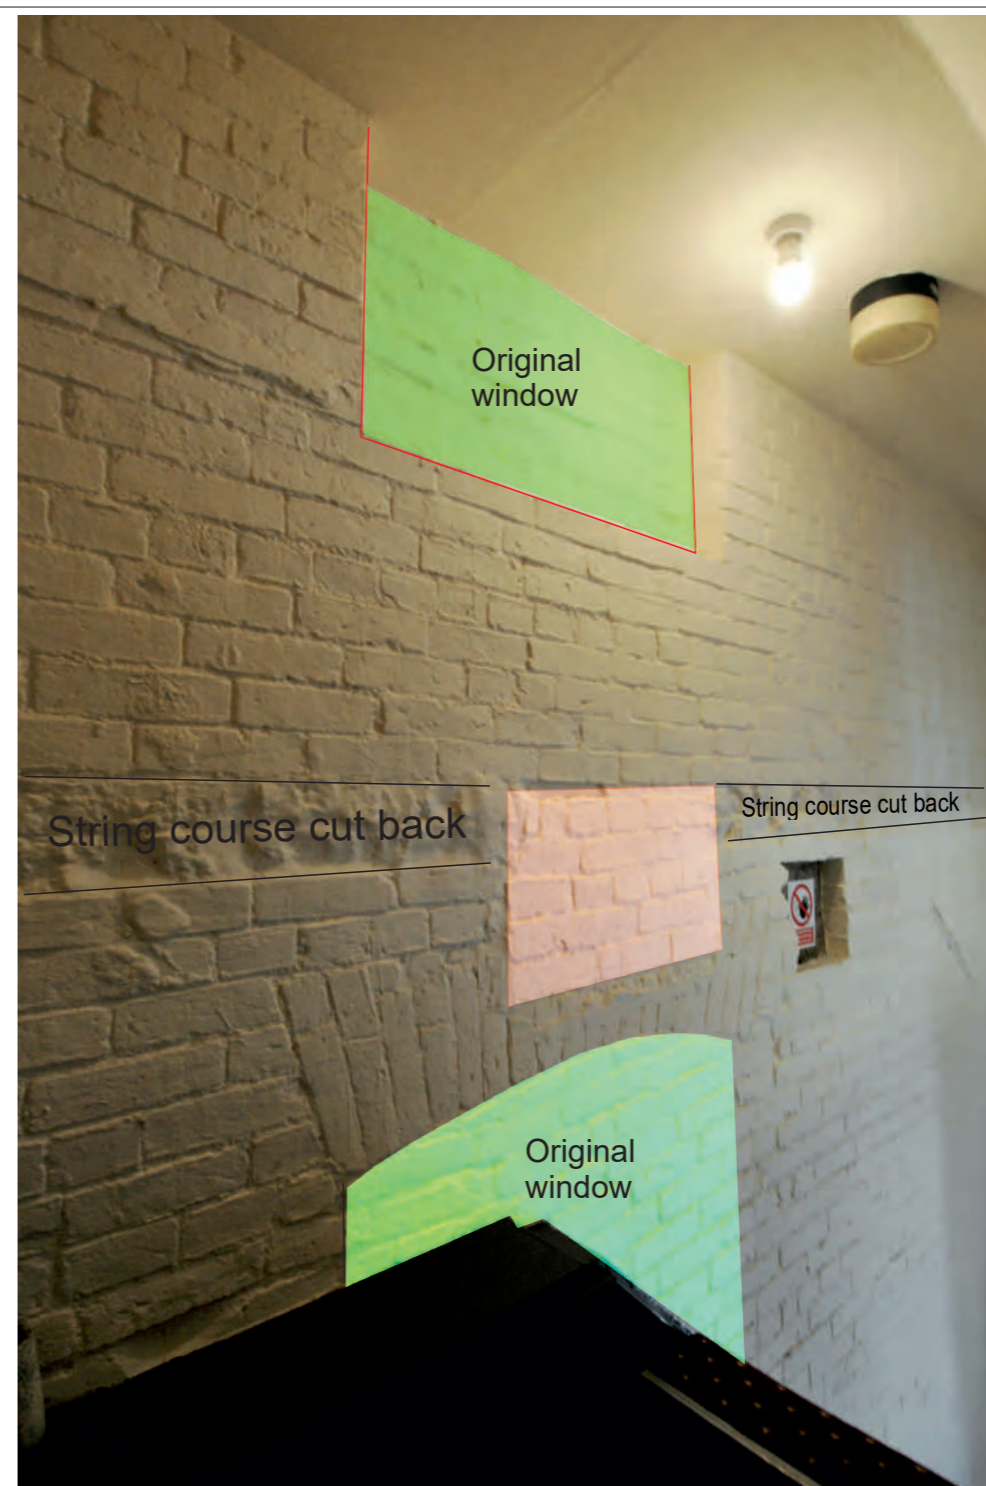
Ground floor window head and sill of 1st floor blocked window openings of Block 1

Figure 19: Block 2 corridor - detail of salvaged door and blocked window openings on north side of Block 1

- 7.4 The fenestration is all recent, though in original window openings on the upper levels. The blocked former arched openings have been noted above – within the building there is an early 19th C arched folding double door retained as a decorative feature (Fig 19) – this appears to have been originally fitted to the first floor entrance.

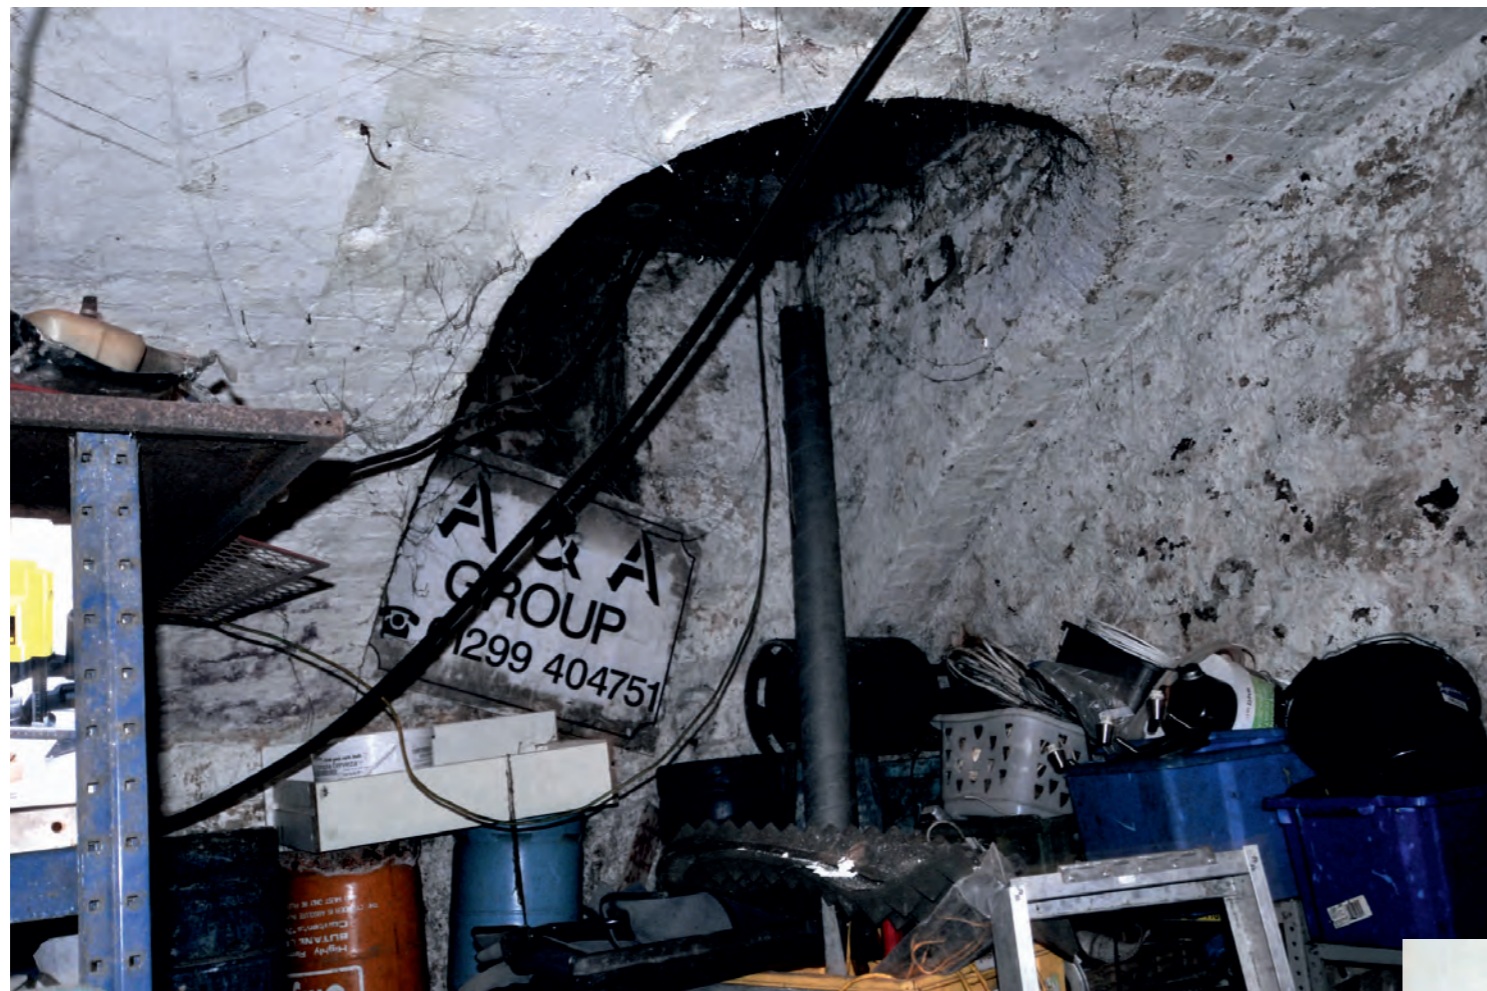
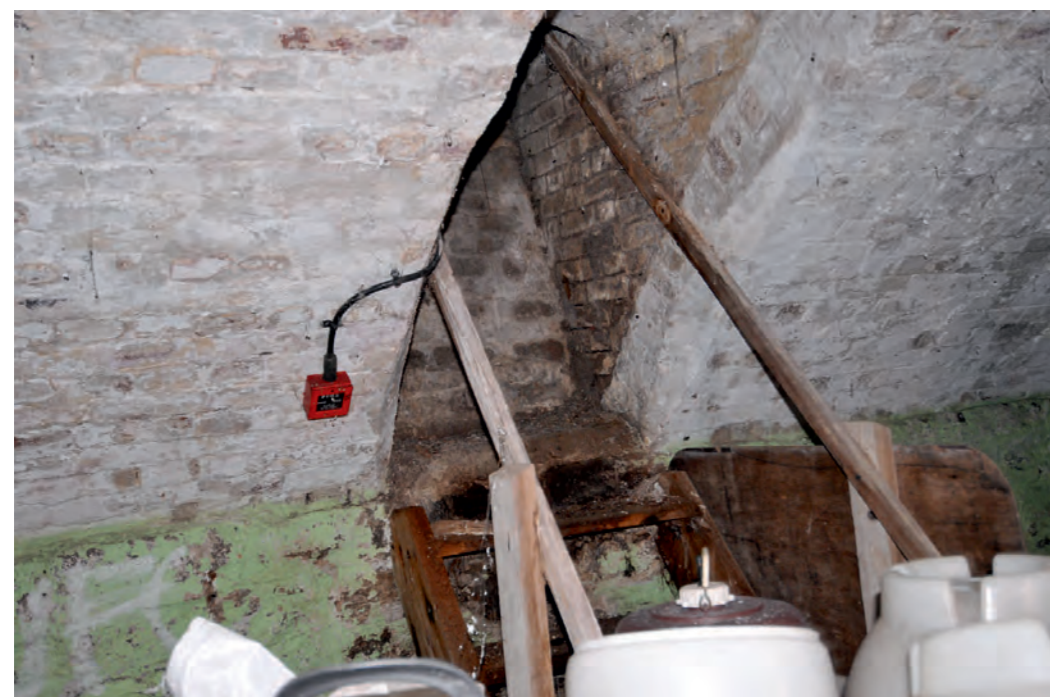
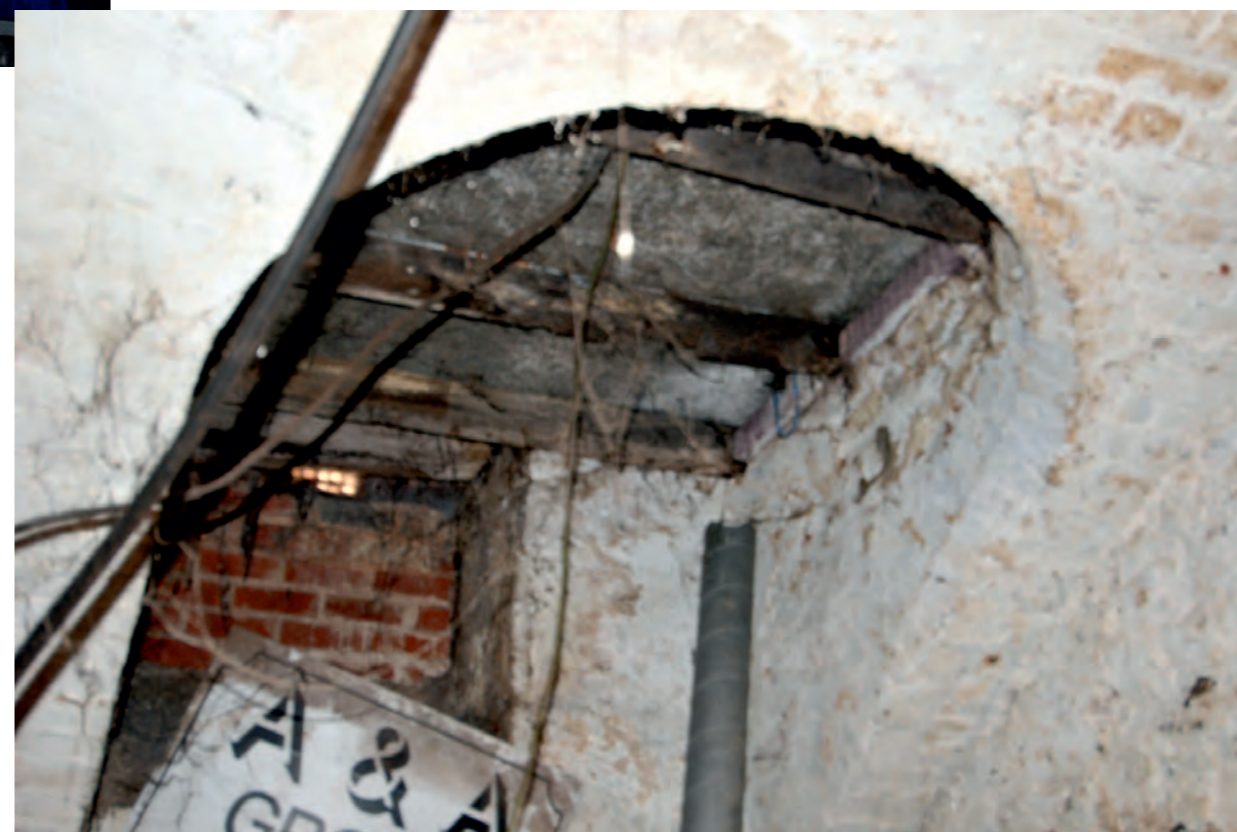
Figure 21: Cellar details

Internal drop close to south-western corner of cellar - partially beneath present stair of Block 1

Blocked former entrance

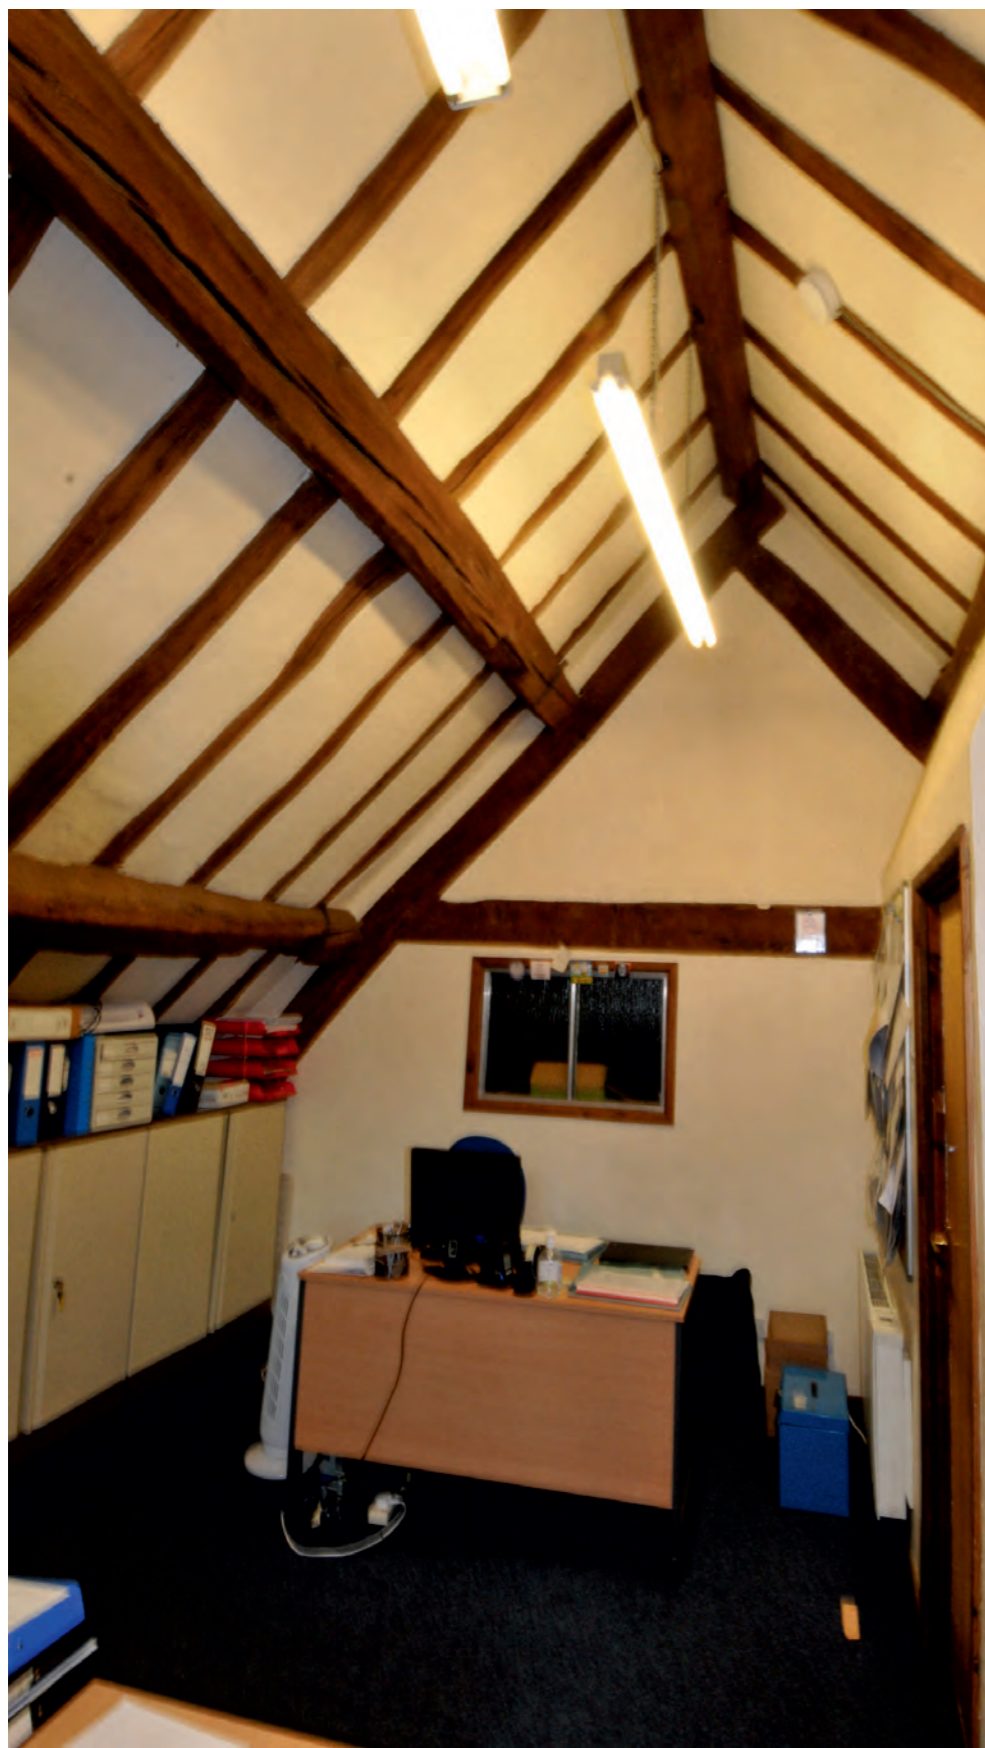
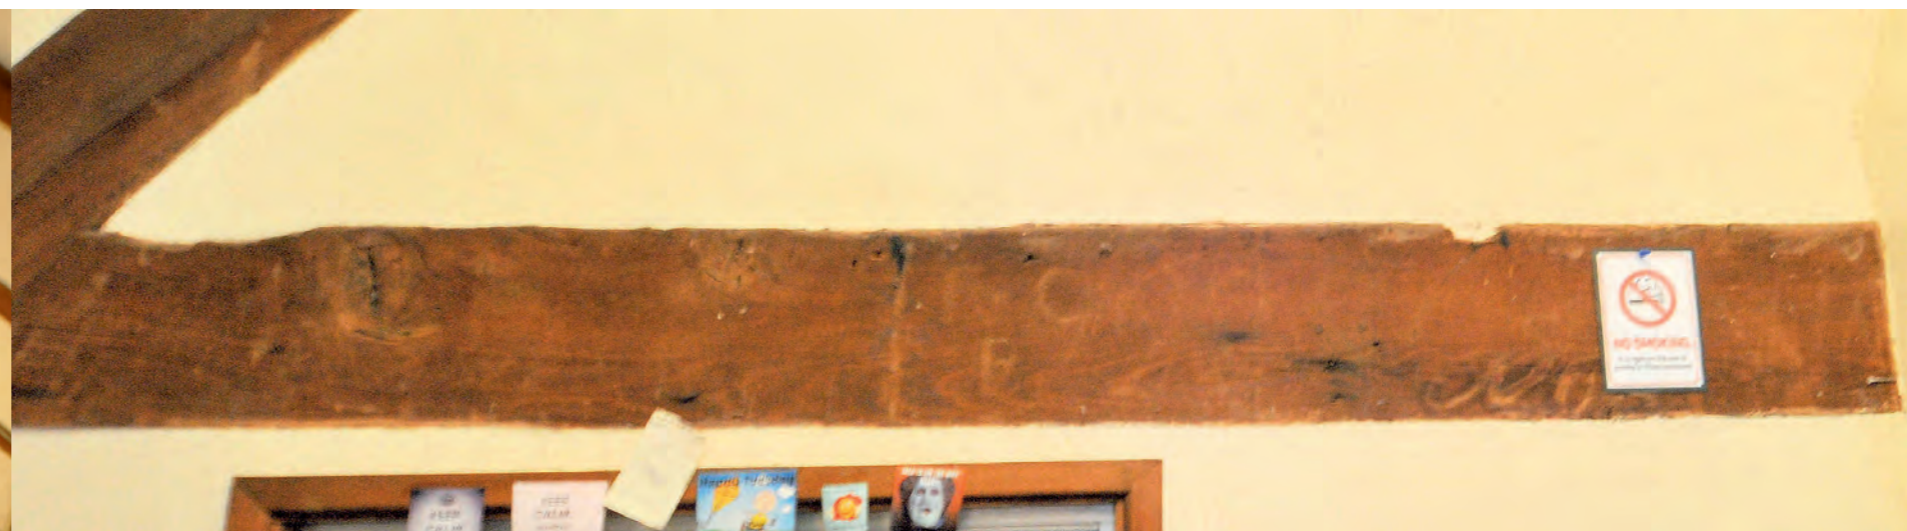
Detail of 19th C. inscription on tie beam

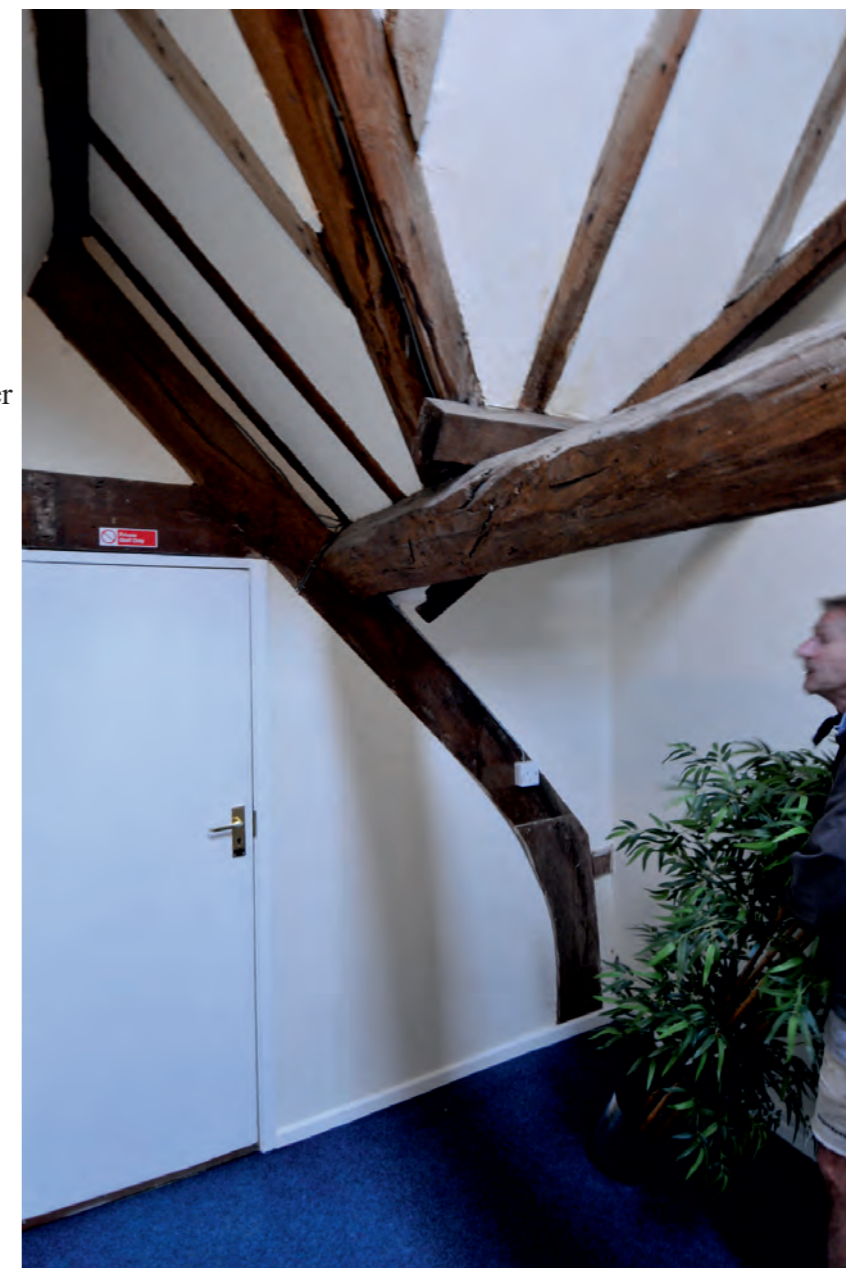
Haunched principal rafter of Block 2 roof truss

Figure 22: Details of Block 2 roof structure
