Dilapidated Farm Dwelling / Horse Stable
Existing single story farm dwelling is currently used as a horse stable.

CLIENT:	Ms Lee
ARCHITECT:	Target Carbon Management

SITE:	An Teachin Hawley Rd, Dartford		
TITLE:	Existing Brick Stable / Structure		
SCALE:	DATE:	DRAWN:	CHECKED:
1/100@A3	04.03.21	WRJ	//
PROJECT NO:	DRAWING NO:	REVISION:	
2118	P_104	/

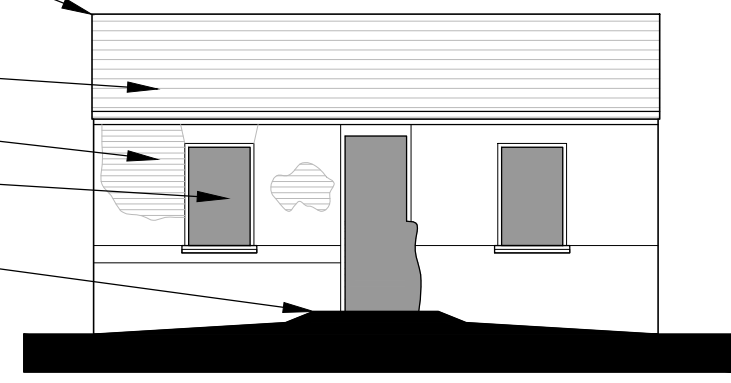
South Elevation
1:100

Clay Tiled Roof Finish

Solid Masonry Wall with rendered finish
Rendered finish failing

Fenestration and Doors
missing

Loose poured Concrete forms ramped threshold

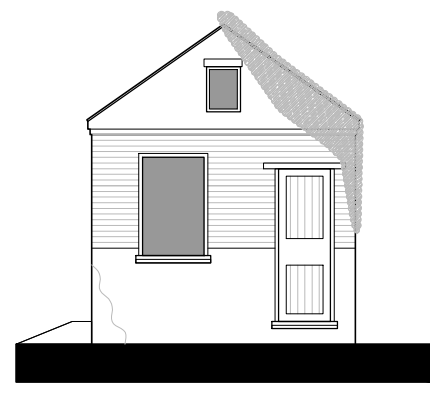
East Elevation
1:100

Overgrown vegetation masks over 30% of structures elevation
