PRELIMINARY ROOST
APPRAISAL

23 PLYMOUTH ROAD, BARNT GREEN
B45 8JF

Date: 23rd October 2023

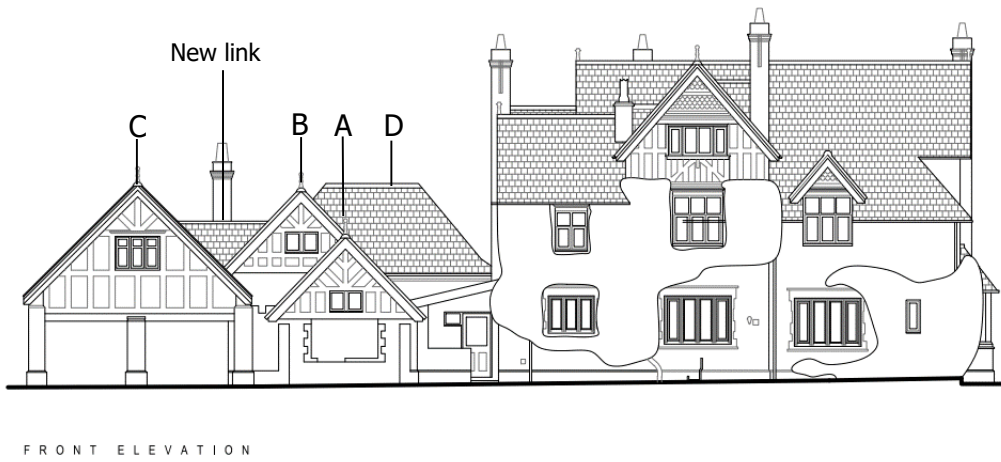
Figure 3.1

3.1.1 The building proposed to be removed comprised two sections (A, B), each with a pitched roof clad with clay plain tiles, and recently these had been re-roofed when an extension was constructed that adjoined the coach house at the south east elevation (C). As a result, the roofs were in a well-sealed condition and showed no PRFs. A and B each had windrows to the north east gables. The extension work was incomplete and the front of A and C were open which offered direct access for bats and birds to the interior of the structures. The rear south west of C was also open, and the gable was constructed of glass, and this included a gaps where the unit had not been sealed which also offered access for bats to the interior of the structure.

3.1.2 Inside the A and B it could be seen that the roofs were vaulted and had been recently lined with a breathable roofing membrane and the spaces were well-lit via the windows the north east gables. The ridge boards of each supported a significant amount of cobwebs which suggested that no bats had disturbed these features recently. The floors were boarded, and this supported dust that had settled over the last few years, although no evidence of bats was present on this or at the interior of the structures. B and C were linked together with a new flat roof construction, to make the space between A, B and C contiguous. The link was clad with clay hanging tiles, and these were well-fitted and sealed and showed no PRFs. C, which had been constructed within the last four years had a new roof supported by light weight timber trusses and this roof was lined with a breathable roofing membrane. No evidence of bats or breeding birds was present at the interior.

<p>Photo 1 North east gables A, B, C</p>	<p>Photo 2 South elevation C, D</p>
<p>Photo 3 New roof section A with cobwebs at ridge</p>	<p>Photo 4 Interior roof section C</p>

4.3 Currently, no further bat surveys are recommended (refer to 4.3 for potential future survey), although a methods statement (Appendix 1) will be followed prior to demolition and re-roofing to prevent any ingress by bats to the structures A, B and C and to safeguard any bats that may potentially ingress the gaps beneath tiles on structure D.

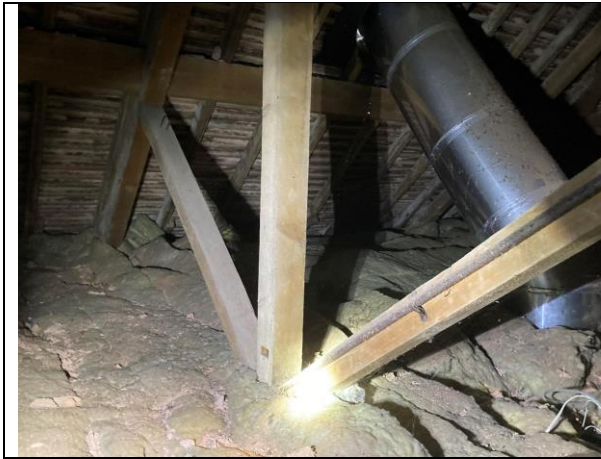
3.1.4 Inside the roof void it could be seen that the roof was original. The roof, typically of 1920 houses unlined, giving an uninterrupted view of the roof construction, and the tile joints were torched (filled with lime mortar) although this had crumbled away in many areas. Cobwebs hung over the full depth of the roof void and across the entire extent of the void. The floor was covered with fibreglass insulation which appeared to have been in place for many years, and this was covered in a thick layer of dust and detritus, although there was no evidence of bats at the floor or anywhere else within the void.

Photo 5 Loft floor section D dust-covered

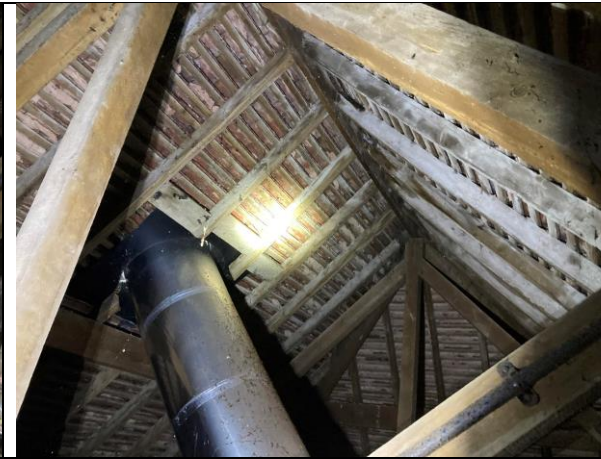
3.1.3 To the rear south west elevation was a two storey section to the house (D) which had a hipped roof clad with clay plain tiles and this included a roof light to the south west hip. The roof was in poor condition and showed many gaps beneath tiles because of this which offered potential access point for bats to the roof interior.

Photo 6 Section D unlined roof

4.2 The roof of D was in poor condition with tiles raised that would allow bats access into the roof, however no evidence of this was present and it is considered that the building has potential for occasional opportunities use by crevice-dwelling species such as pipistrelle bats.

- Prior to destructive works to the roof of D, a licensed bat worker will carry out a check for bats of the roof interior. Should evidence of bats be encountered at this time, work will stop and further bat surveys of the Site will be undertaken between May and August to characterise the roost. In such a scenario it is likely that an EPSL application would need to be made to Natural England before works could commence.
