Preliminary Investigation Report

Proposed Development

Kestrel Way, Luton

Site: Kestrel Way, Luton
Document Title: Preliminary Investigation Report
Document no.: STU5850-R01 Rev A
Date: February 2023
Client: Luton Borough Council
Issuing office: Soiltechnics Ltd
Cedar Barn, White Lodge, Walgrave, Northampton. NN6 9PY
Tel: 01604 781 877 E-mail: mail@soiltechnics.net

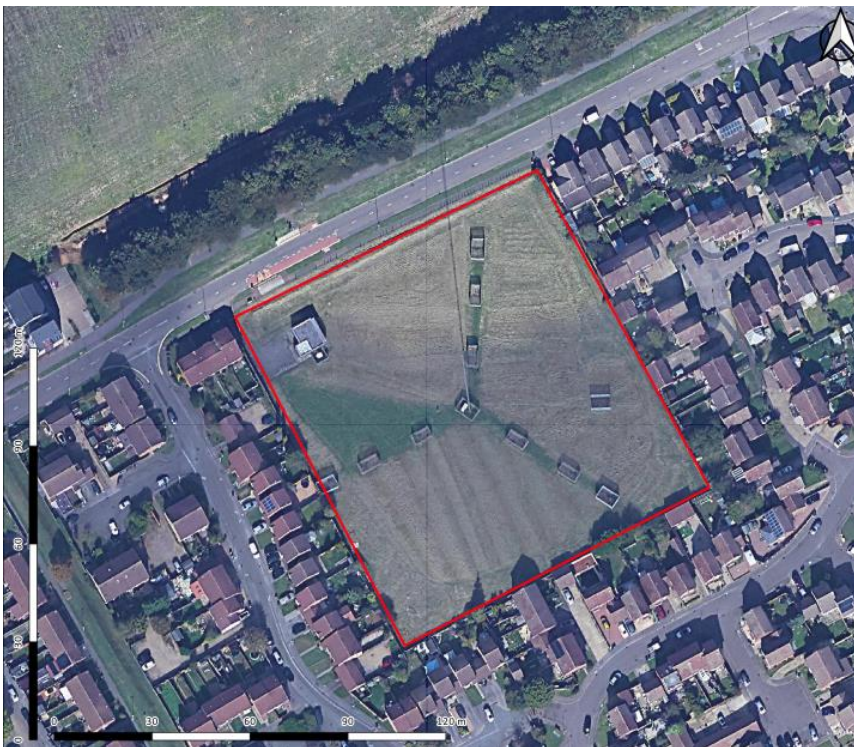
Figure 2-A: Aerial photograph and approximate site boundary

2.2.2 An aerial image showing the approximate site boundary is presented below, followed by a table summarising the key site features. A site plan is provided within Appendix A.

2.2.3 Due to the sensitive nature of the site, we were requested not to complete a site inspection and therefore this assessment is undertaken using readily available aerial photographs and street views.

Theme	Feature
Current site use	The site is currently a grassed area occupied by a central telecommunication mast. The site appears to be accessible to the general public.
Local area land use	Two storey residential properties lie to the west, east and south. Undeveloped land present to the north of the site, beyond Kestrel Way.
Topography	The topography of the surrounding area generally falls gently to the northeast. On site topography appears relatively flat.
Buildings, surfacing and other permanent features	A radio mast is present in the centre of the site with surrounding fenced off tension cables. A small brick building, likely housing the equipment cabinets and satellite associated with the mast, is present in the northwest of the site with a small area of hardstanding allowing vehicular access. The remainder of the site is covered in grass.
Boundary features	The site boundaries to the west, east and south are defined by timber fencing and brick walls of adjacent houses/garages. The public pavement running along Kestrel Way forms the northern boundary, though a shallow ditch and wooden posts run parallel to the pavement, just inside the site.

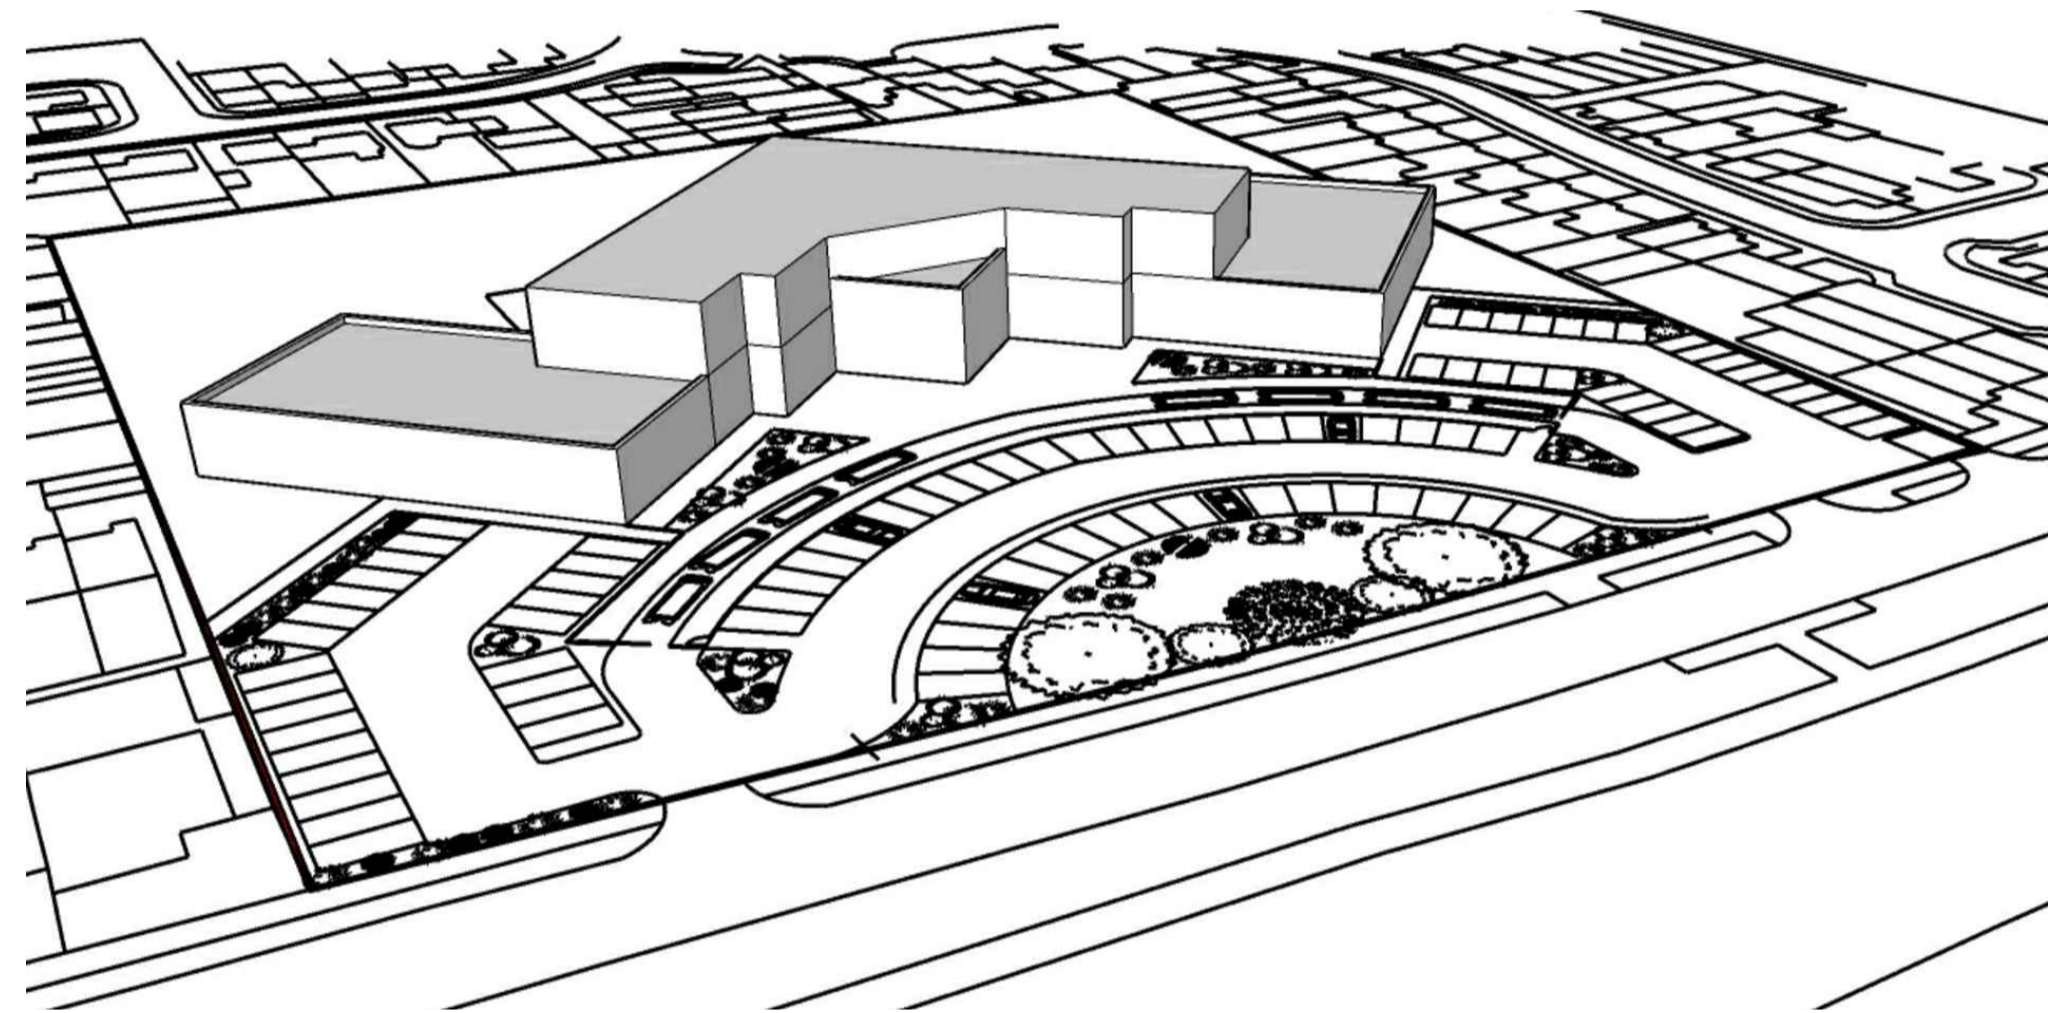
Sketch Mass Model
Scale NTS@A1

- Key:
- SEND School facilities
 - Resource Centre facilities

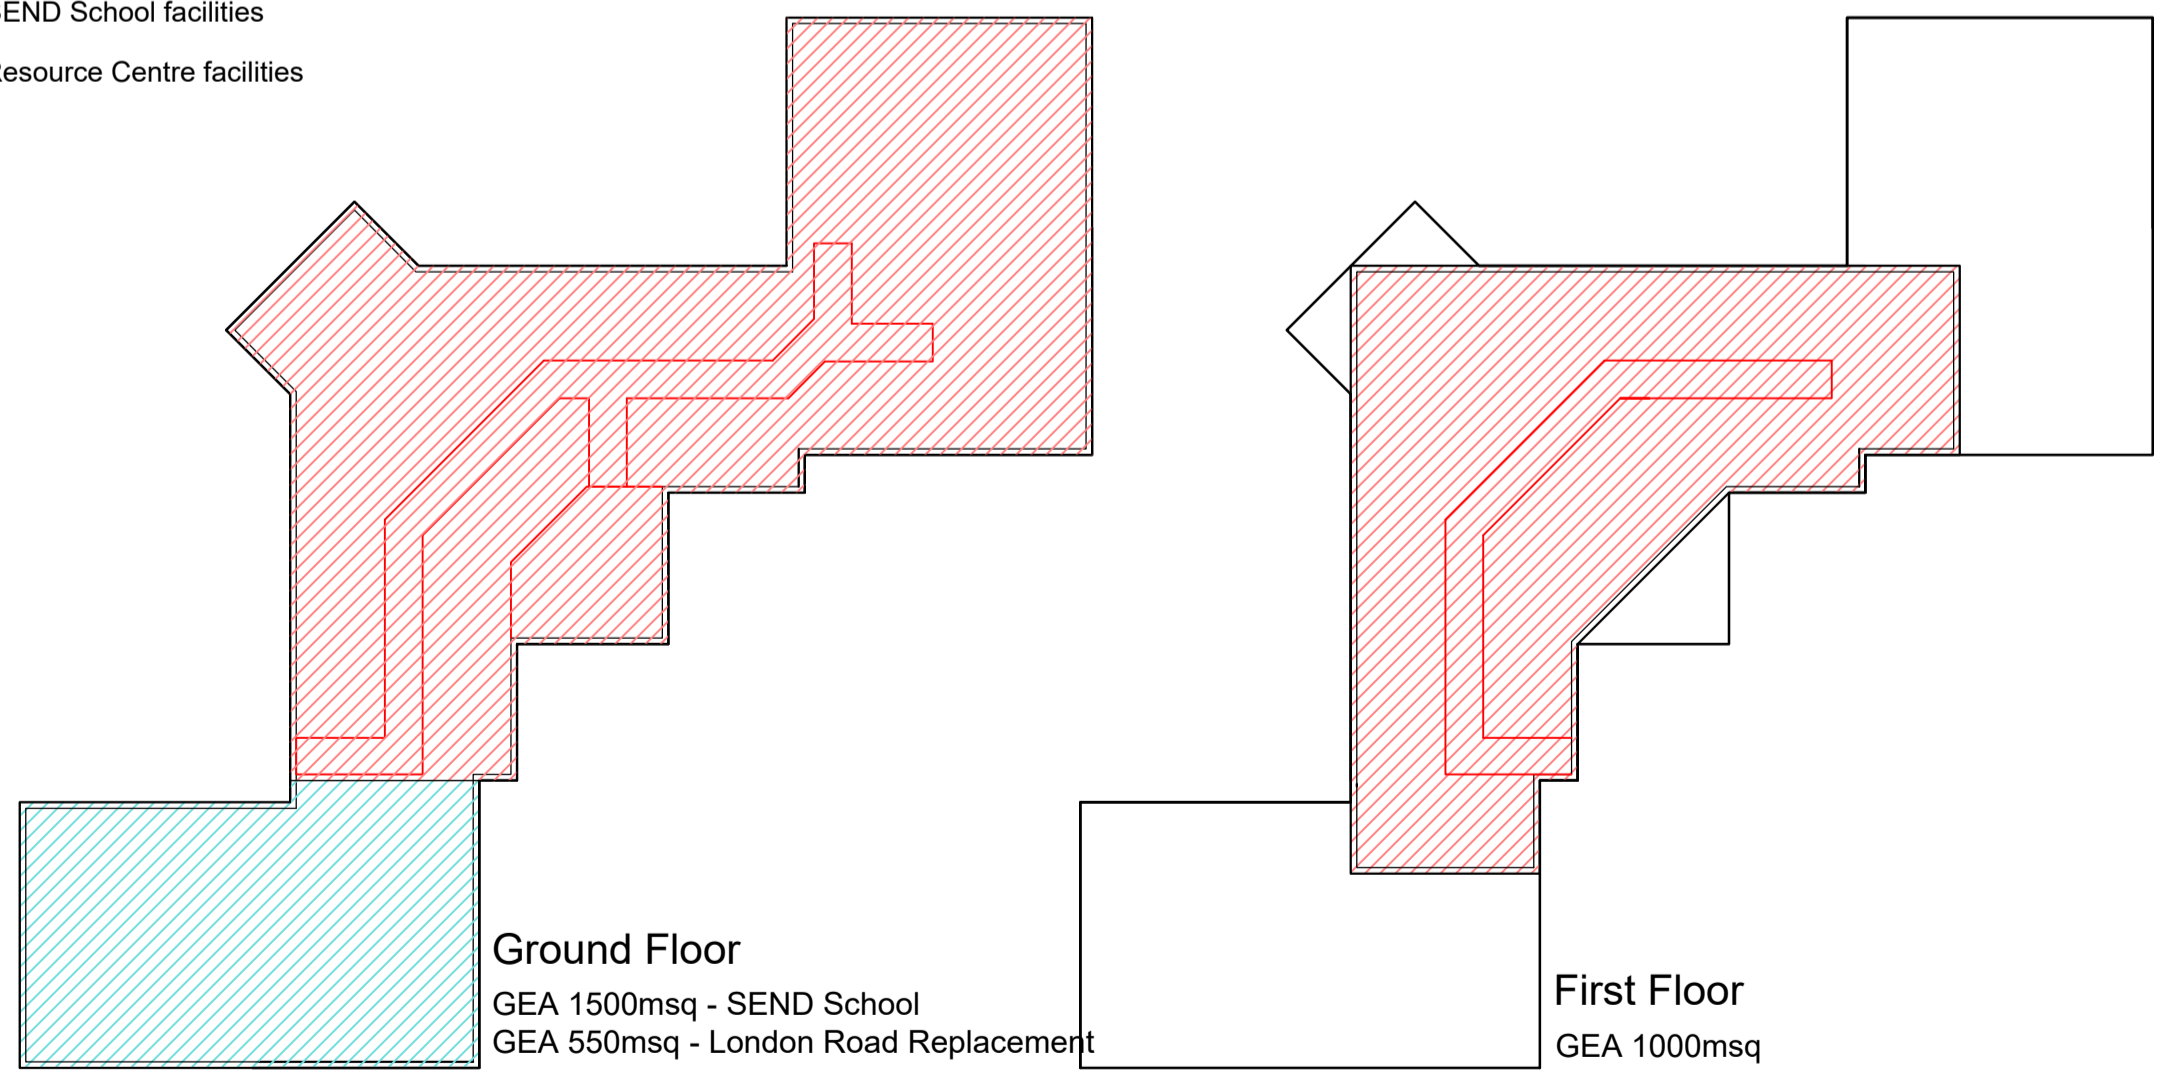
Proposed building footprint
Scale 1:500@A1

Ground Floor
GEA 1500msq - SEND School
GEA 550msq - London Road Replacement

First Floor
GEA 1000msq

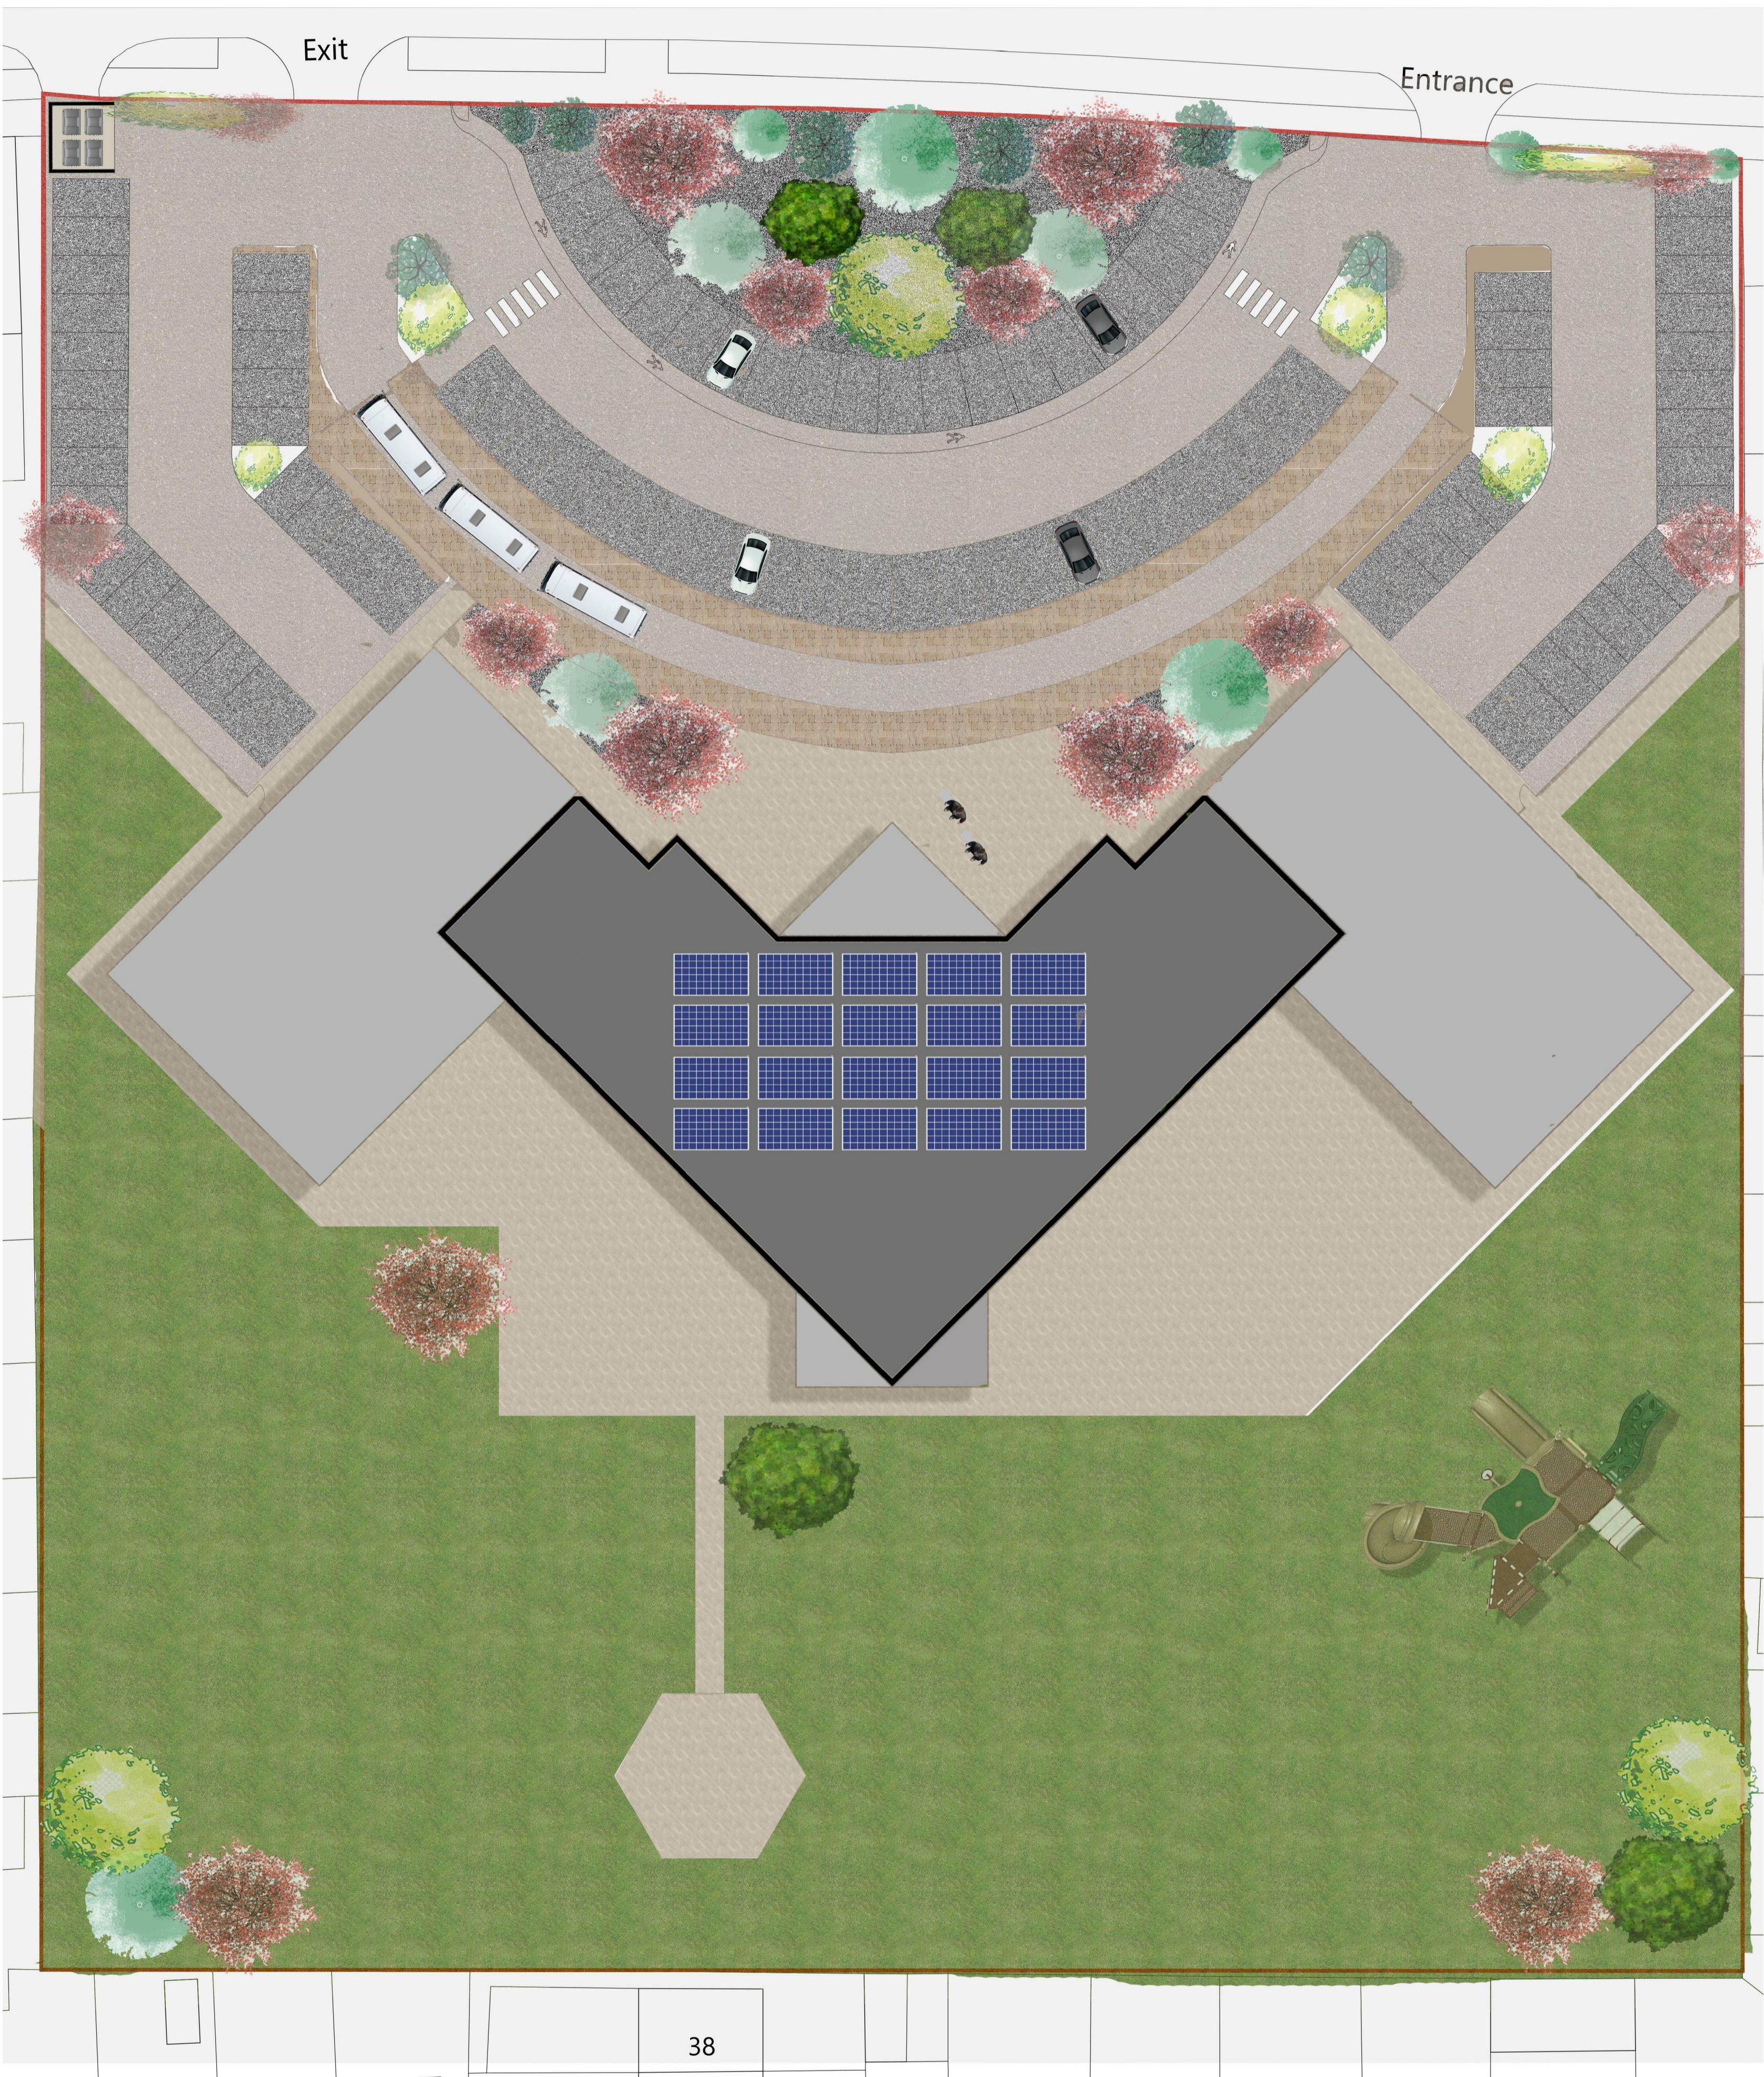
Proposed site plan
Scale 1:250@A1

1.1.1 It is understood that the development will comprise the construction of a new two storey school with associated grassed play area, soft landscaping and a car park. A drawing of the proposed development is presented within Appendix A.
