THE ARLEY CONSULTING COMPANY LIMITED

67 & 69 Deardengate, Haslingden, Rossendale, BB4 5SN
Planning Refs 2023/0368 & 2023/0488

Background

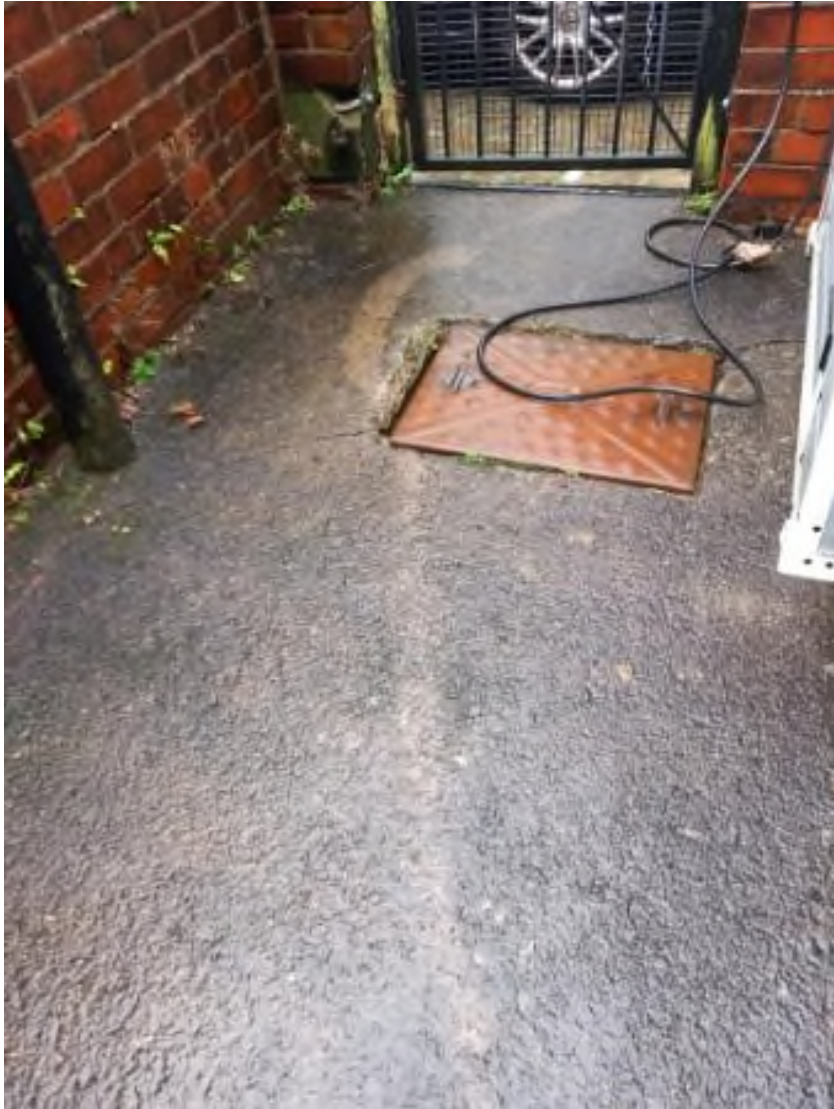
Photograph No 5: View of Concrete Surfacing in Rear Yard

The small external yard areas are surfaced with concrete and there is no realistic possibility of these being converted to gardens for the residents of the flats. They will remain as access to the buildings.

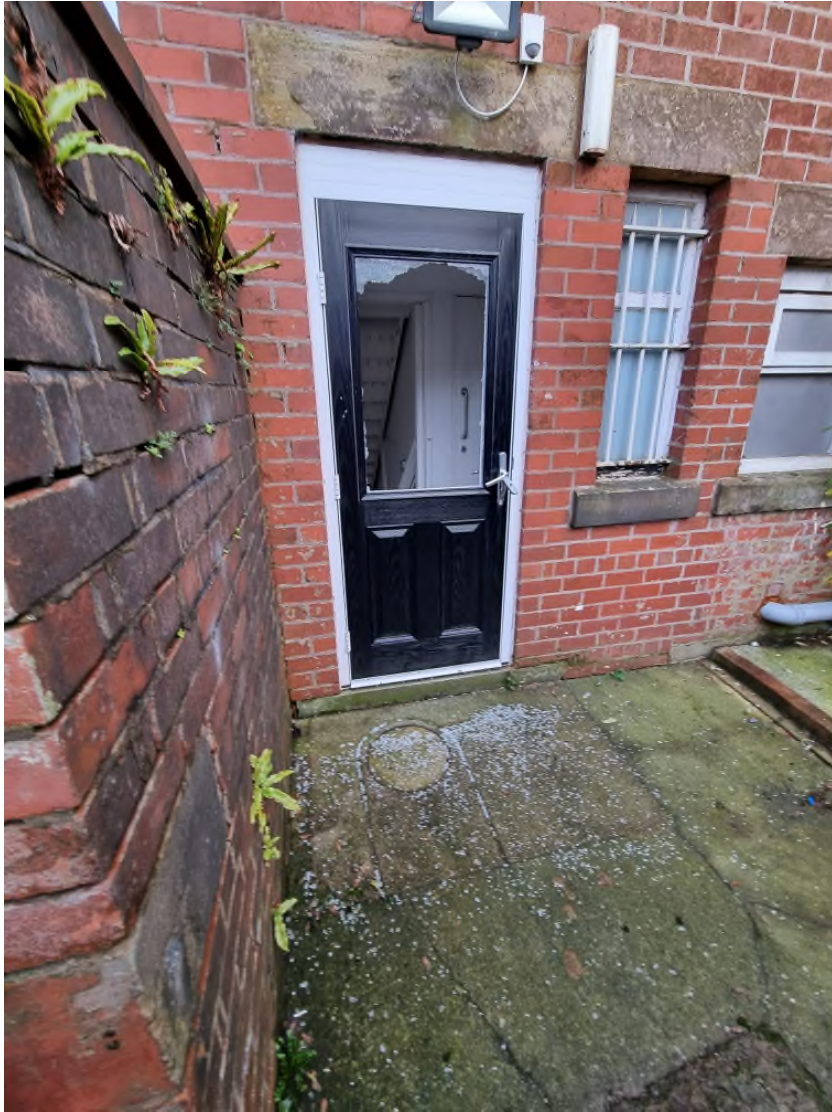
Photograph No 7: View of Concrete Surfacing in Rear Yard
