Brick Wall at Sun Court, 12-16 Bridge Street, Hadleigh

(Suffolk HER HAD 046)

Historic Building Record

January 2024

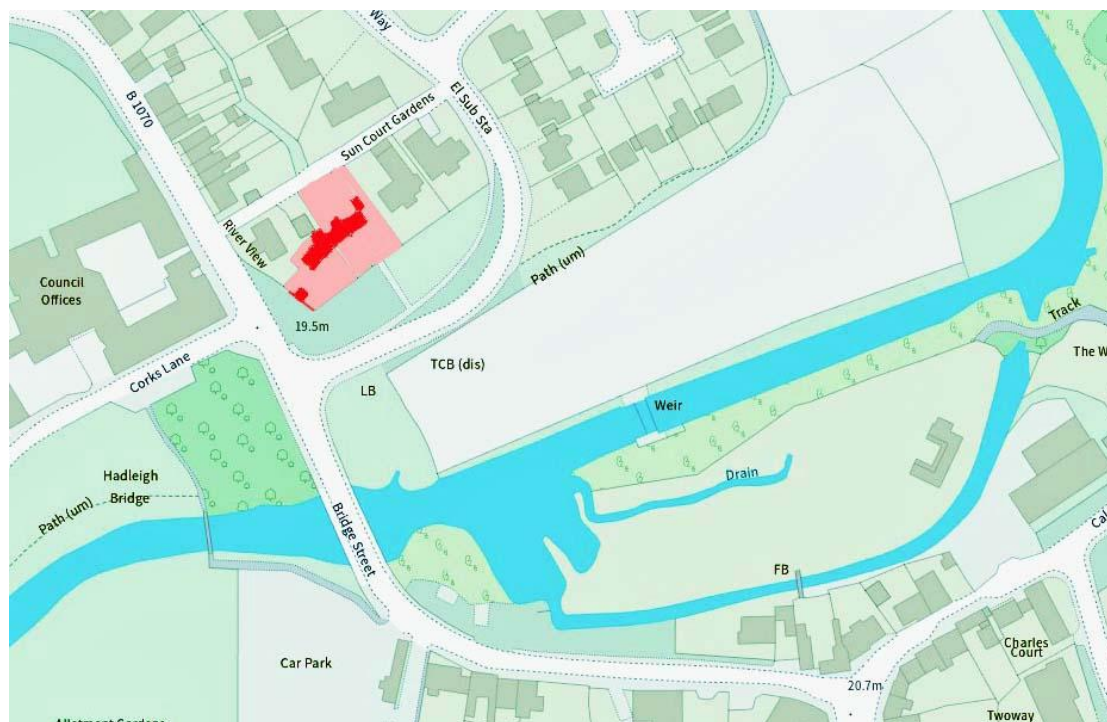
Figure 2. A current site plan highlighting the sub-divided grade II*-listed house and its gardens in dark and light red respectively. The historic wall adjoining the former waste land to the south-west is also highlighted in dark red.

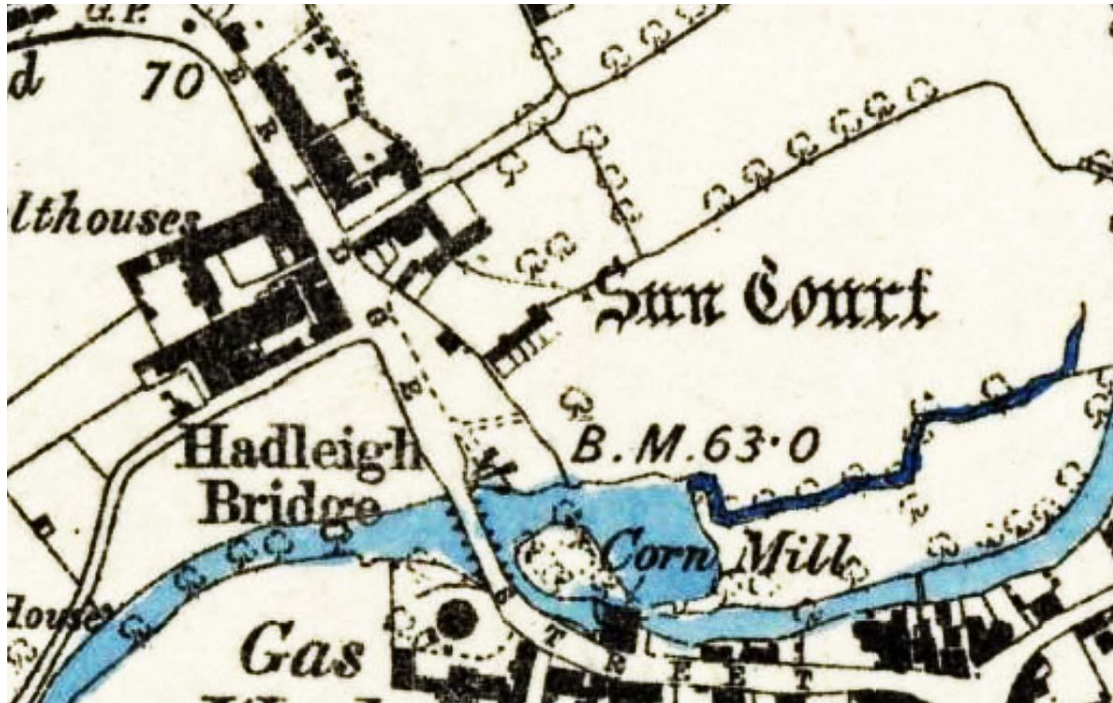
Figure 4. The six-inch Ordnance Survey of 1884. The two single-storied sheds in figures 8 and 9 had been added to the western gables of both the house and barn since 1839 along with an additional structure to the east of the barn. The site of the 20th century council offices was occupied by a range of malthouses.

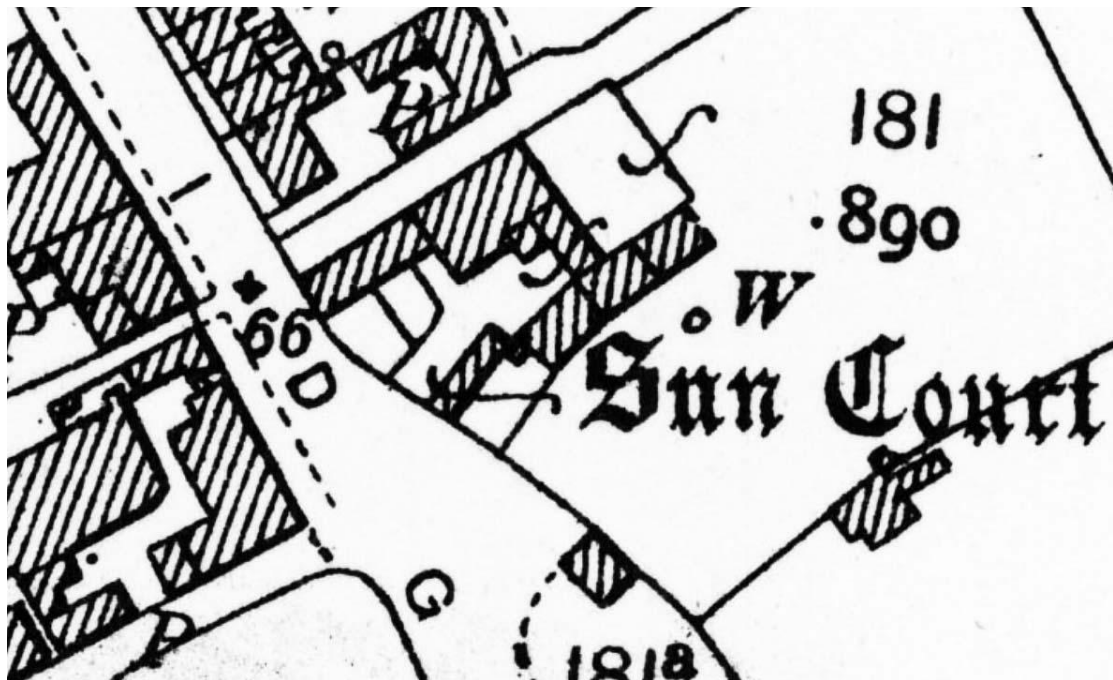
Figure 5. The highly accurate Second Edition 25 inch Ordnance Survey of 1902, which clearly shows the change of orientation between the western cottage (no. 12) and its two neighbours at nos. 14 & 16. A narrow shed connected the former's north-western corner to the road and adjoined a yard defined by a boundary wall projecting from the south-western corner of the house. This southern boundary wall was also shown in 1839, dividing the yard from the garden, and a short section still survives (section 8 in figure 11 and illustration 20). The main entrance of the barn is likely to have faced the field track on the north, with the central projection in 1839 forming a lean-to rear porch.

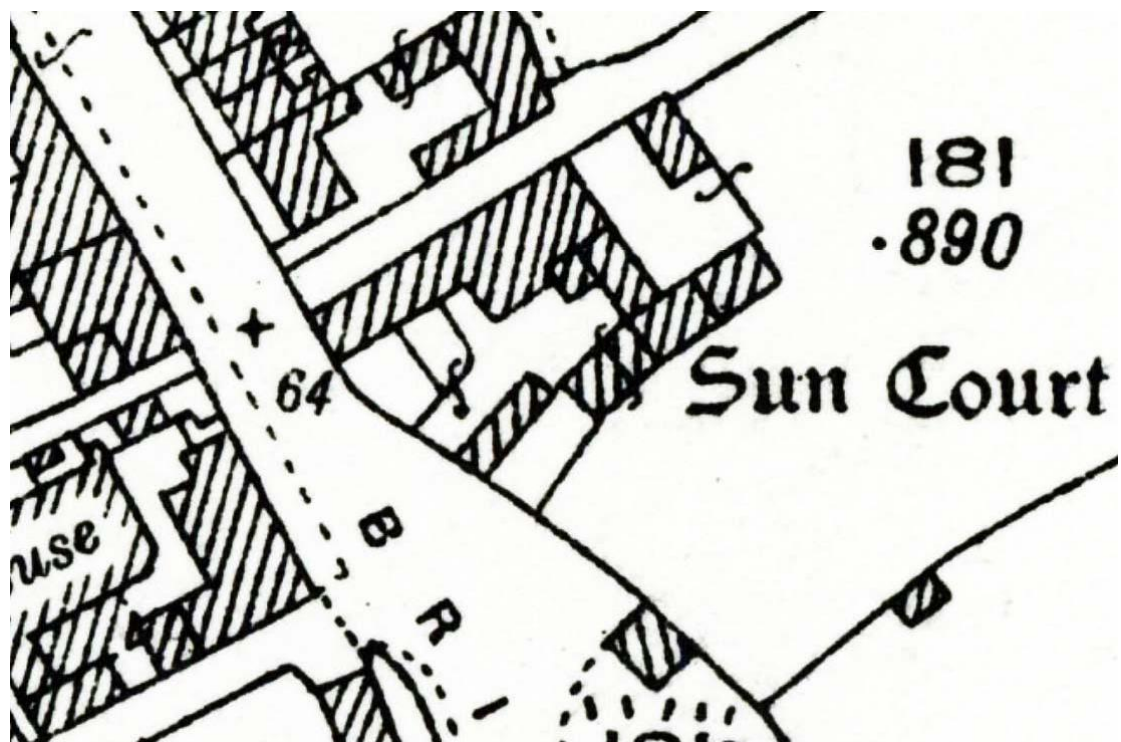
Figure 6. The 25 inch Ordnance Survey of 1924. A new shed had appeared to the east of the large barn but the layout was otherwise unchanged since 1902. The various yards and sheds flanking the barn to the north of the house are likely to have contained cattle and other animals in the usual manner – despite the fact that one shed adjoins the central cottage. The small shed coloured orange in figure 11 did not exist at this date but must have been built soon afterwards in the north-western corner of the large garden to the south of the house.

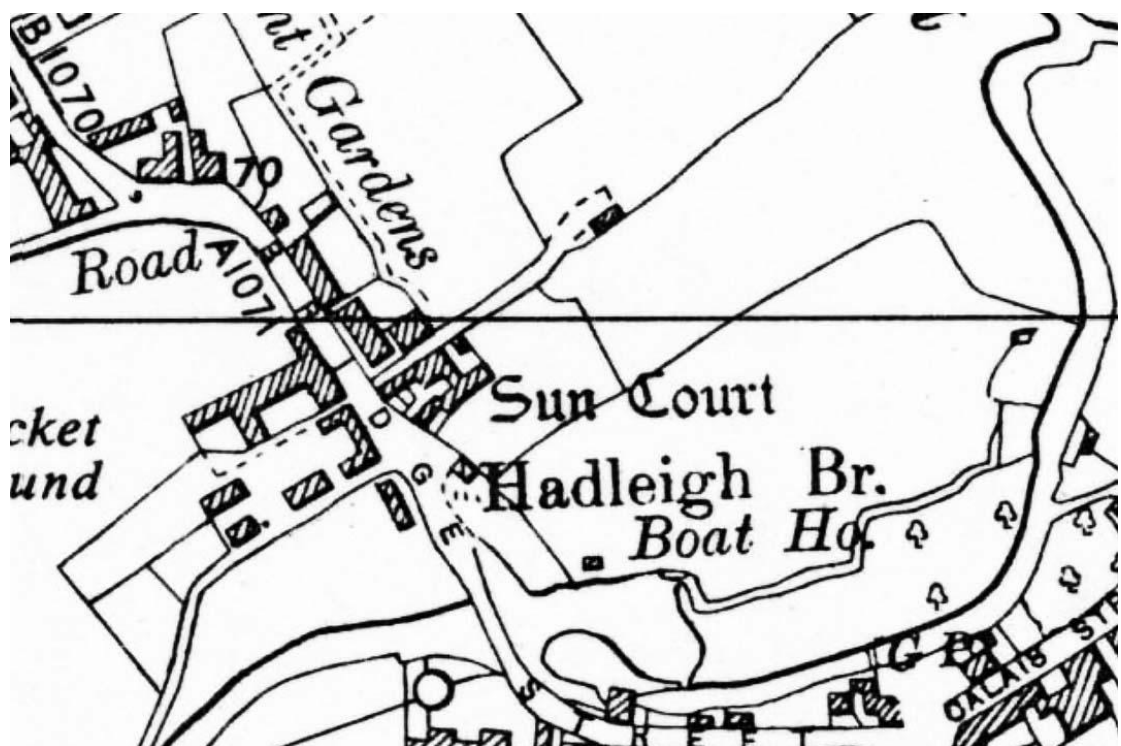
Figure 7. The six-inch Ordnance Survey of 1957, showing little change since the 1880s (although smaller additions such as the garden shed may have been omitted).

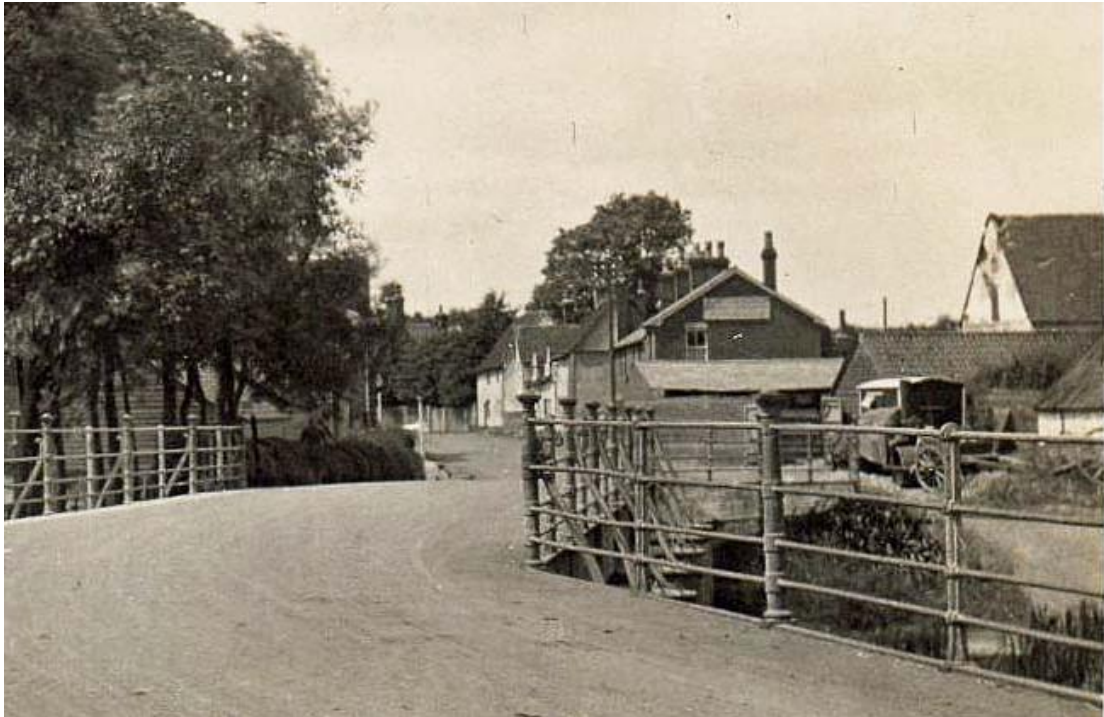
Figure 8. An early-20th century photograph looking north from the bridge with the mid-19th century single-storied pantiled shed that adjoined the north-western corner of the house visible to the right. The western gable of the demolished barn can be seen in the rear to the right with another single-storied shed connecting it to the road in the centre. A gap flanked by doors in the wall between these sheds resembles the entrance to a cattle yard. The surviving wall buttress lies to the right of a parked wagon or van that hides the position of the present access to no. 12. The corner of the detached mid-19th century shed on the waste ground is just visible to the extreme right.

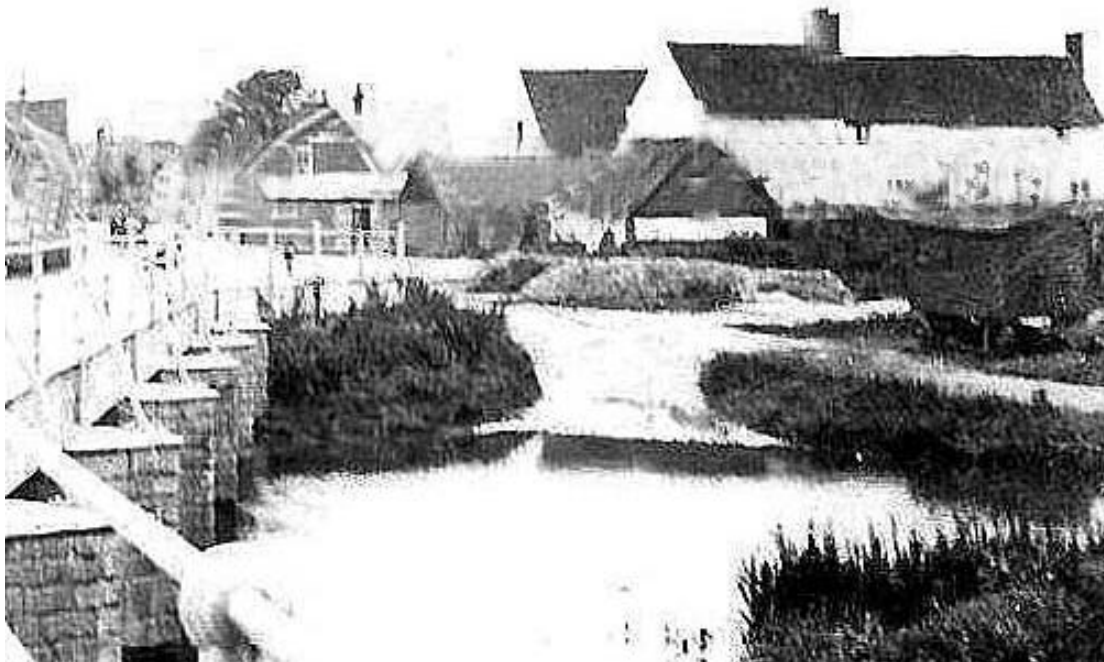
Figure 9. A similar early-20th century view to that in figure 8, showing the house to the right with the large demolished barn in the rear. A mobile shepherd's hut lies on the waste ground to the right and the house is partly obscured by the detached shed that appeared against the wall between 1839 and 1884. This shed has also been demolished.

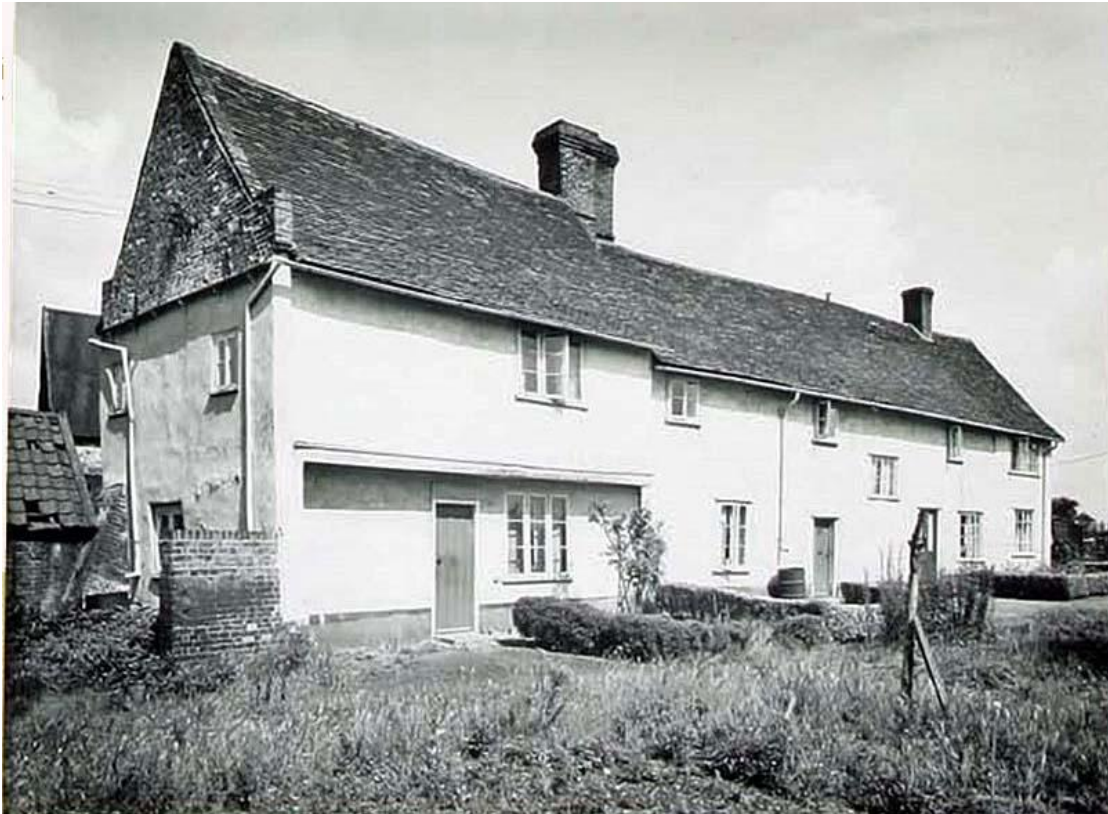
Figure 10

The house from the south in 1962 (Historic England archive). The tall roof of the historic barn is still visible to the left of the brick gable, as is the pantiled single-storied shed (the southern wall of which still survives as shown in illustration 4). This shed appears to adjoin a demolished brick buttress supporting the north-western gable of the house, matching that of the roadside wall. The short section of brick wall attached to the gable's south-western corner has also been demolished but formerly continued to the road and its western end has been incorporated into the garden shed (section 8 in figure 12 as shown in illustration 20). This house was not inspected internally and its development is a matter for speculation. At first glance the jettied range to the left represents the rebuilt parlour of an older house to the right, but the change of orientation may be significant: it could instead have formed the rear range of a Tudor courtyard (as the name Sun Court suggests), with the lower right-hand section added later. The brick gable may have been added when the street range was demolished in the late-17th or early-18th century.

The National Monuments Record includes a number of external photographs taken in 1962 such as that in figure 10, but there are no internal views showing the staircase and panelling and the inspector's terminology suggests the existence of these features was based on hearsay. The property was first listed in 1950 but this entry is likely to have been revised in the 1970s before internal inspection was required in the 1980s. Only 5.8% of listed buildings are awarded stars to indicate their 'particular importance' and 'more than special interest', and it is not clear why this example was included in the category on the basis of an apparent rumour. It was not inspected internally for the purpose of this report and it is not known whether the reputed staircase or panelling survives. The section that now forms no. 12 to the west of the principal chimney is jettied to the south and is slightly taller than the rest in a manner that usually indicates the addition of a new enlarged parlour of the late-16th or early-17th century to a slightly earlier hall and service range. The building's scale is more typical of a farmhouse than the high-status gentleman's residence suggested by local historians, as is the close proximity of the demolished threshing barn on the north. It may have been larger initially, perhaps possessing an additional front range which would explain its recessed position with respect to the street. The southern jetty may have faced a rear yard, as the name

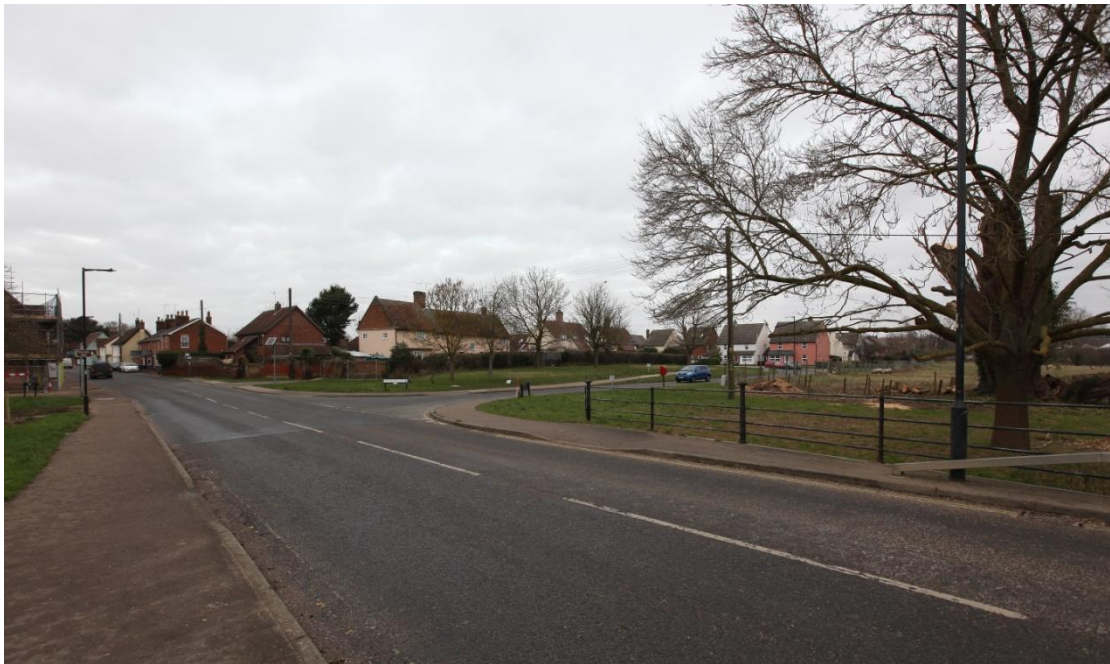
Illus. 1. A general view from Hadleigh Bridge to the south showing the remnant of waste ground between the highway and the meadow on the right. 12-16 Bridge street lies in the centre beyond the recent road known as Ann Beaumont Way leading to the modern housing development visible in the rear to the right.

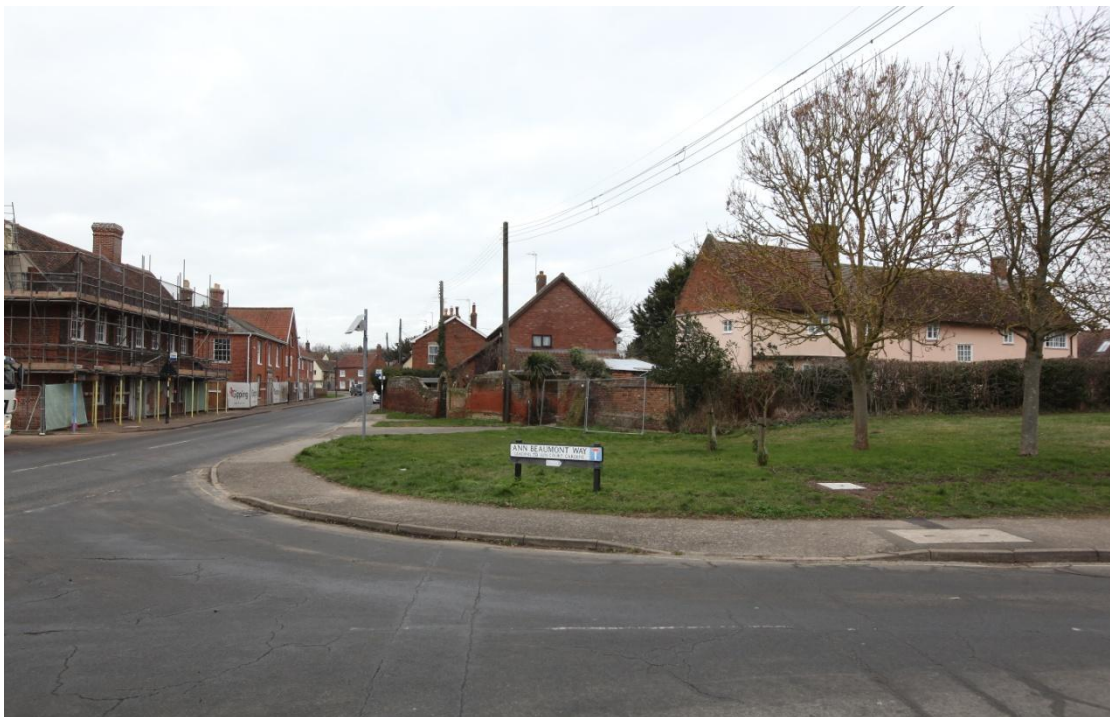
Illus. 2. The house and wall from Ann Beaumont Way to the south with the former council offices to the west of Bridge Street on the left. As the sign notes, Ann Beaumont Way leads to Sun Court Gardens. The public land in front of the house to the right was formerly part of its garden as shown in figure 3, and the course of the demolished section of boundary wall is indicated by the marked change between the flat grassland of the waste in the centre and the sloping ground of the former garden to the right.

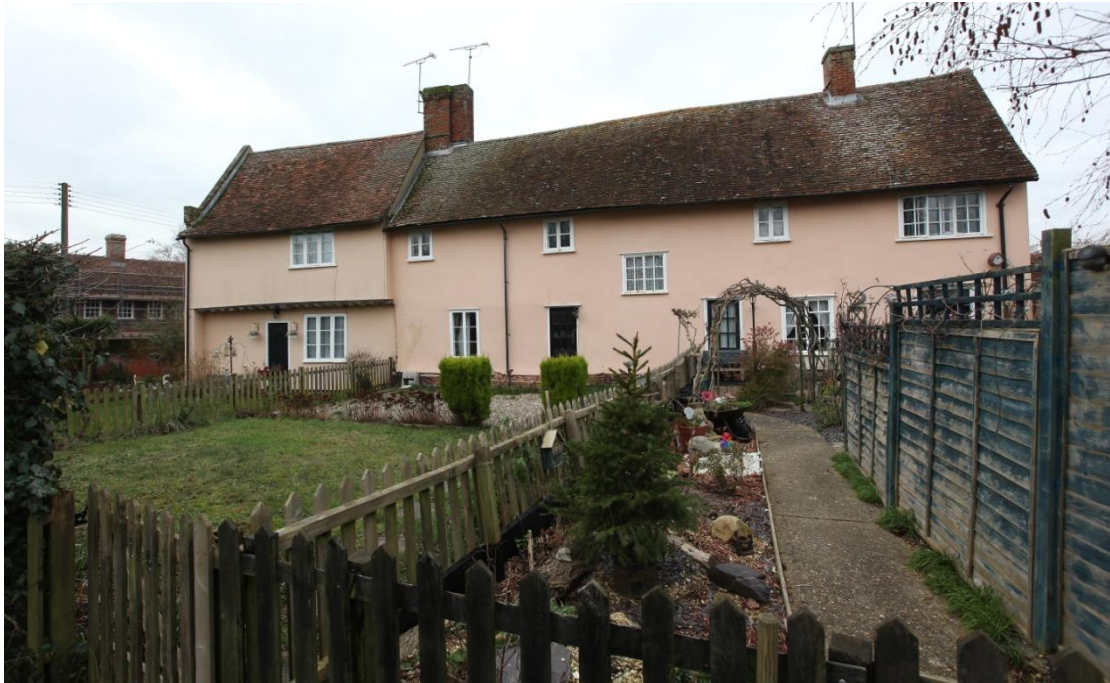
Illus. 3. The southern facade of the house, with nos. 14 and 16 to the right and the taller jettied range of no. 12 on the left. The gardens are now divided by fences but were formerly a single, larger garden separated by the brick boundary wall from the waste ground against the road. No. 12 was built either as the rear wing of a demolished house on the street to the left or as the new parlour of an older and lower house on the right.

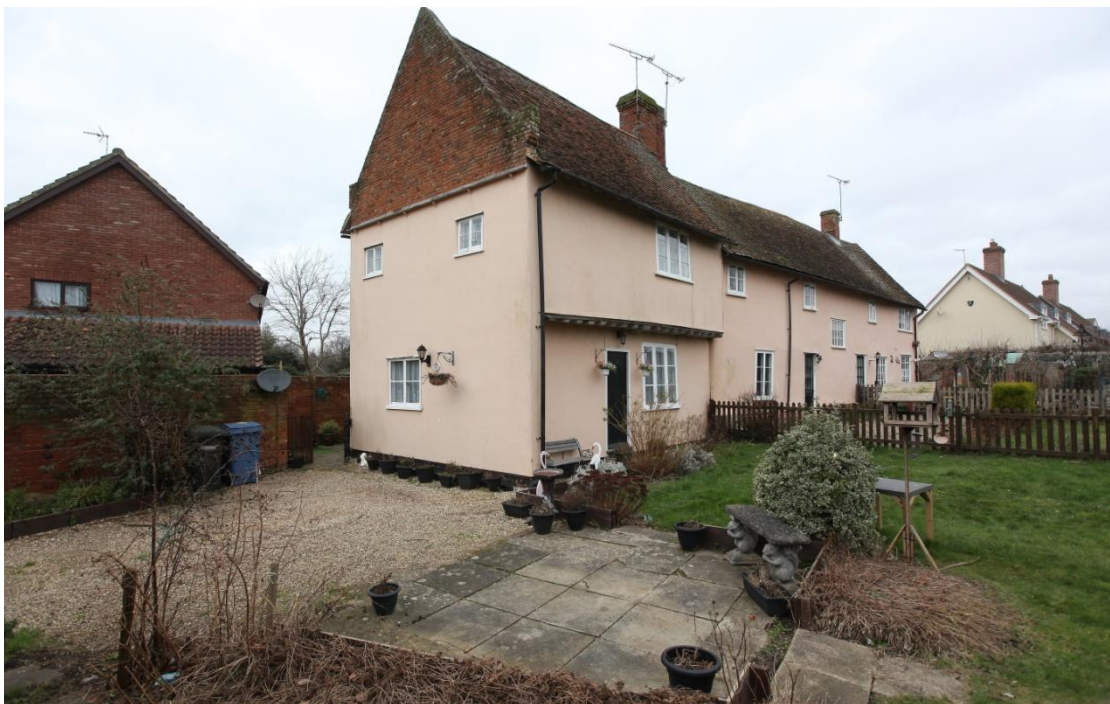
Illus. 4. The house from the south-west showing the slightly different axis of the two-bay jettied range at no. 12. This may have resulted from a desire to enlarge the rear courtyard of a demolished principal house in the foreground. The boundary wall to the left survives from the mid-19th century single-storied shed shown in figures 8-10 which served the animal yard on the site of the modern house beyond. It has been cut on the right to create the present rear access to the no. 12. The latter's 'eared' brick gable may have survived from the 17th century but has been rebuilt in recent years.

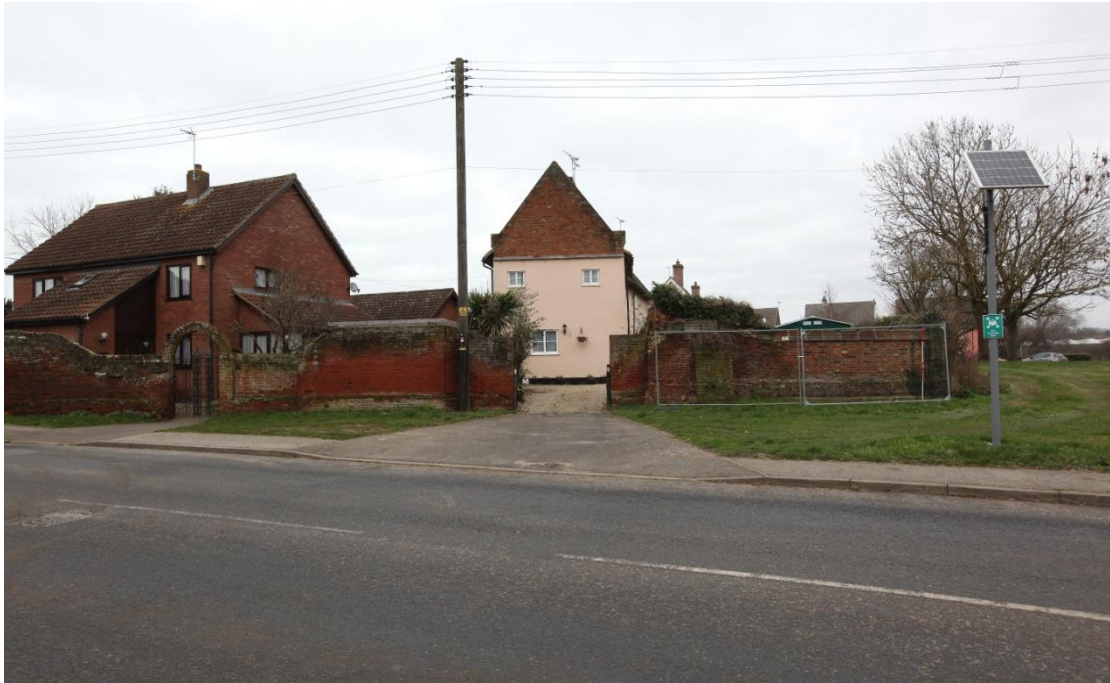
Illus. 5. The house from Bridge Street to the south-west showing the angle of the boundary wall that divided the property and its southern garden from the triangular area of waste ground separating both from the highway. The tall, Monk Bond wall to the left of the telegraph pole survives from the mid-19th century pantiled shed and now defines the garden of the modern house known as River View. The lower section of the latter's wall on each side of its arched entrance gate is modern and replaced the apparent yard entrance in figure 8.

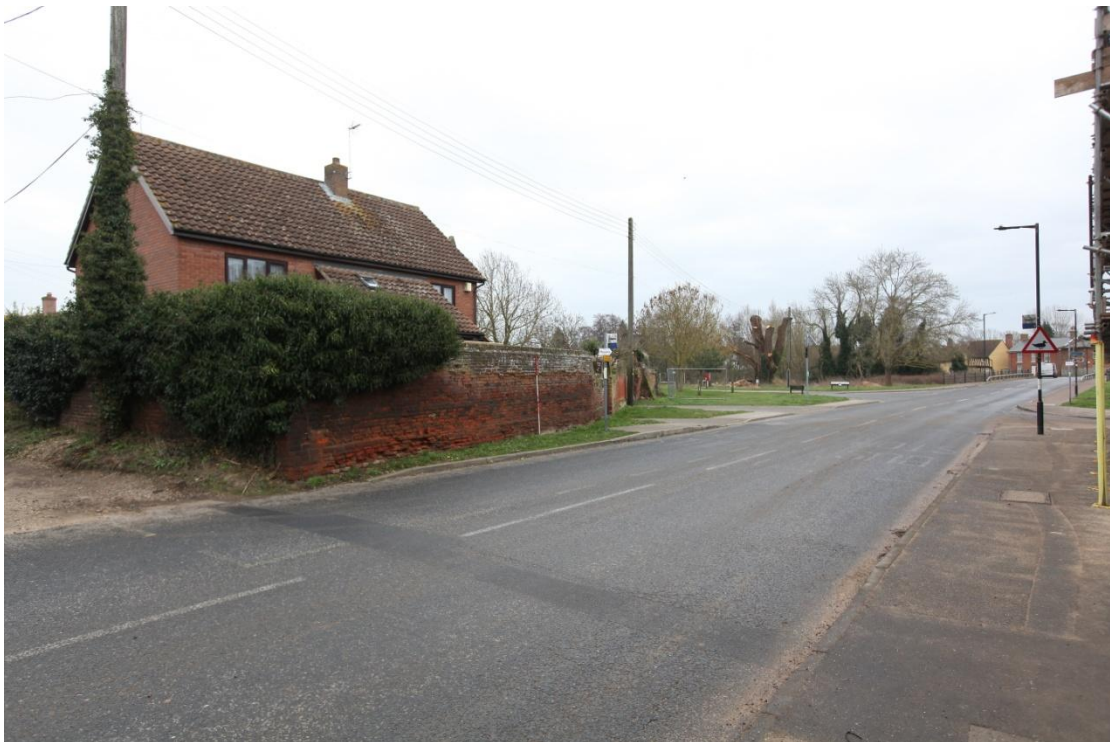
Illus. 6. Bridge Street from the north showing the marked change in angle of the farm yard wall that now belongs to River View. The demolished barn adjoined the field track on the left known today as Sun Court Gardens.

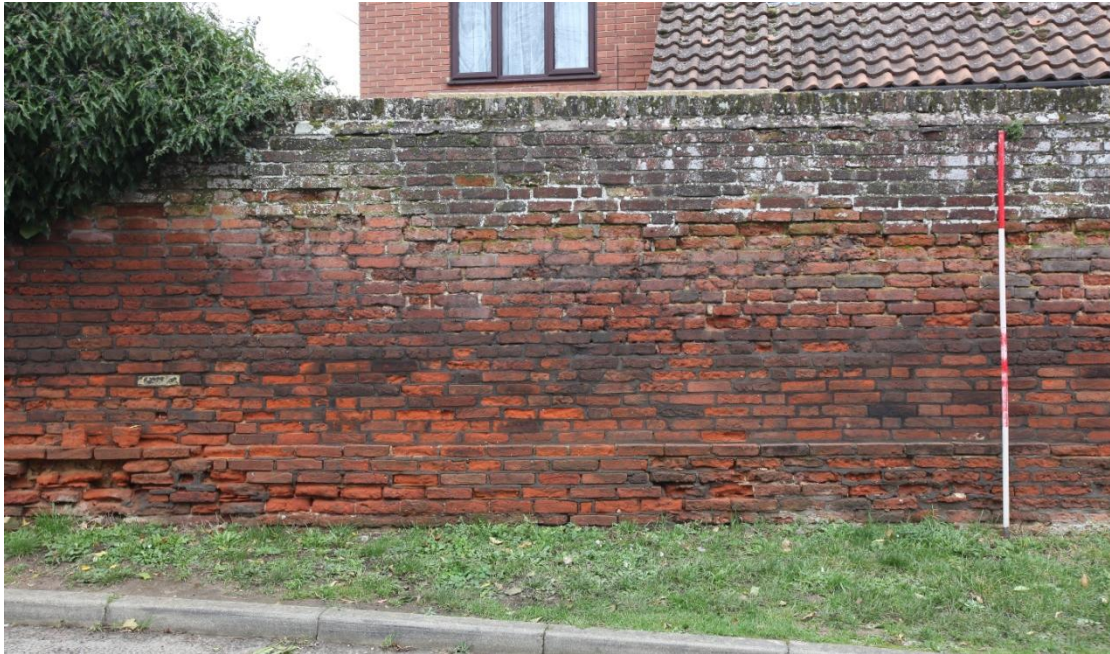
Illus. 7. The roadside wall of River View consists of similar narrow bricks to those of 12-16 Bridge Street, but the bonding differs and it was probably rebuilt as part of the new animal yard in the 19th century. The plinth lacks chamfered plinth bricks and consists chiefly of stretchers while the rest is a random mixture of bonds. It has been heavily repointed and partly rebuilt using a hard cement mortar which has exacerbated the process of decay.

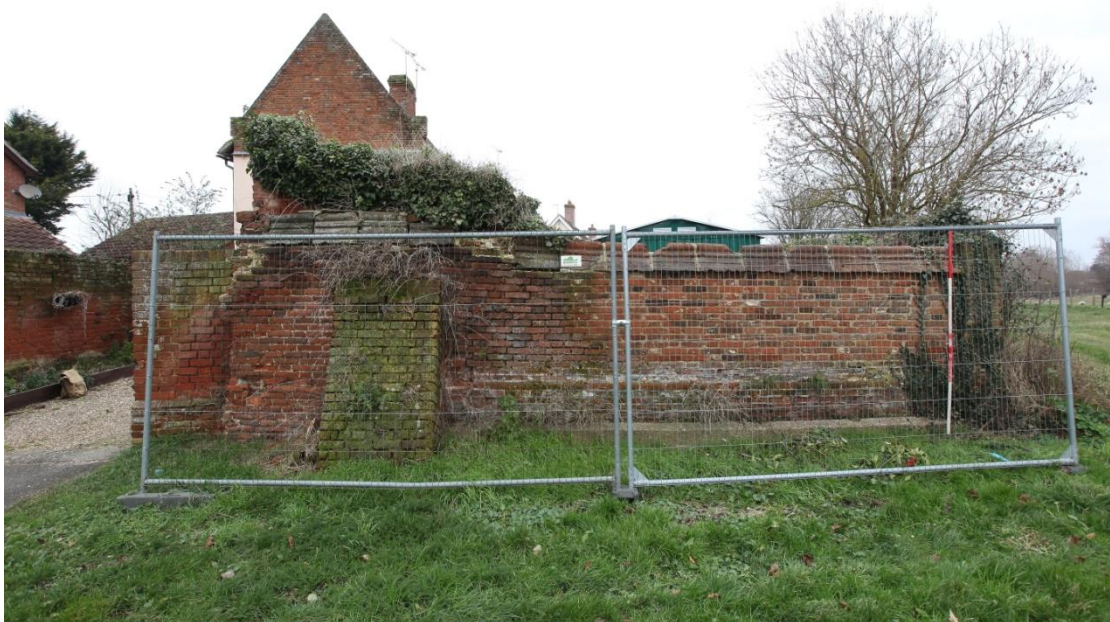
Illus. 8. The garden wall of no. 12 seen from Bridge Street to the south-west. The lower section to the right is lighter in colour and represents a recent reconstruction using old bricks on an earlier plinth but retains the impressive original coping tiles. It terminates in a new pilaster to the right but once continued further as shown on the historic maps. The section to the right of the 19th century buttress is laid in Flemish Bond and is likely to date from the 18th century while the section to the left is more random and may date from as early as the 16th century. The short section adjoining the entrance to the extreme left was rebuilt in the mid-19th century and matches its Monk Bond counterpart to the north of the entrance.

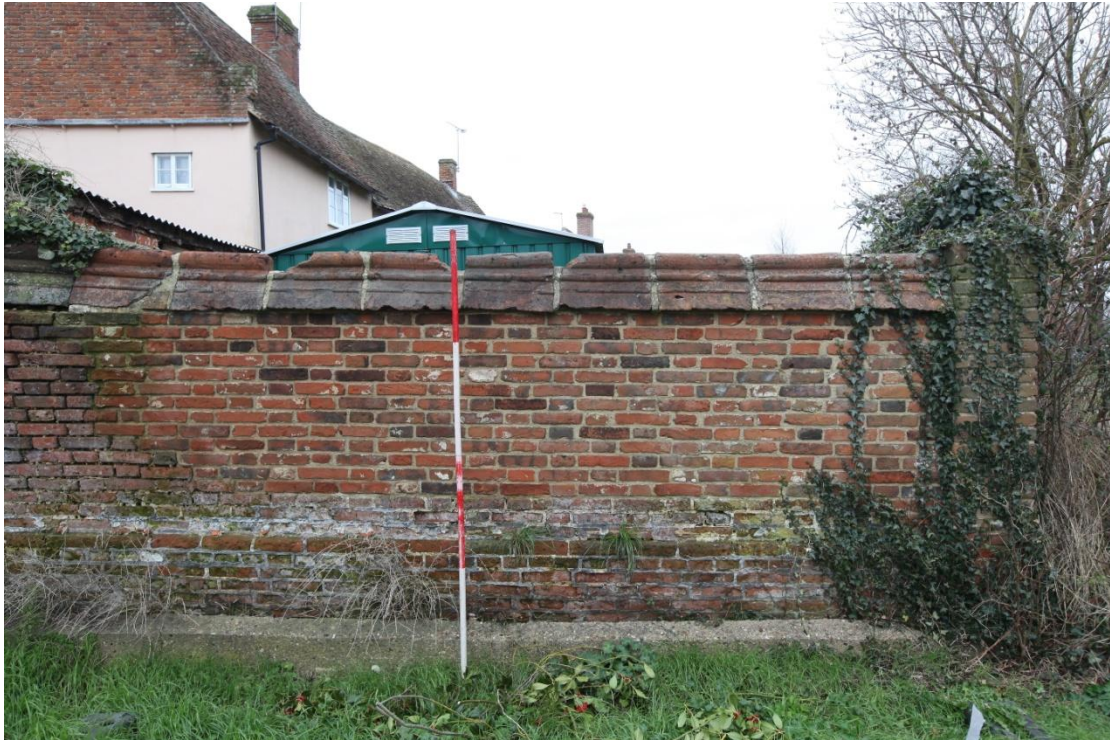
Illus. 9. A detail of the southern section of the wall in illustration 8 which has been entirely rebuilt in recent years using a patchwork of re-used bricks laid in a light-coloured cement mortar imitating lime (section 5 in figure 12). The terminal pilaster to the right is also modern, but the plinth survives at least from the 19th century and consists of stretchers with a single course of headers below the plinth. The coping tiles have also been re-used.

- 5 A recently rebuilt section consisting of miscellaneous re-used bricks of varying sizes laid in Flemish Bond on the surviving stretcher plinth of section 2 (illus. 9). The terminal post or pilaster to the south is also part of this phase and the wall previously continued against the garden shown on the historic maps which was reduced to accommodate the new housing development reached from Ann Beaumont Way. It rises to 66 inches or 1.7 m in height excluding the coping tiles which were re-used from the previous wall.

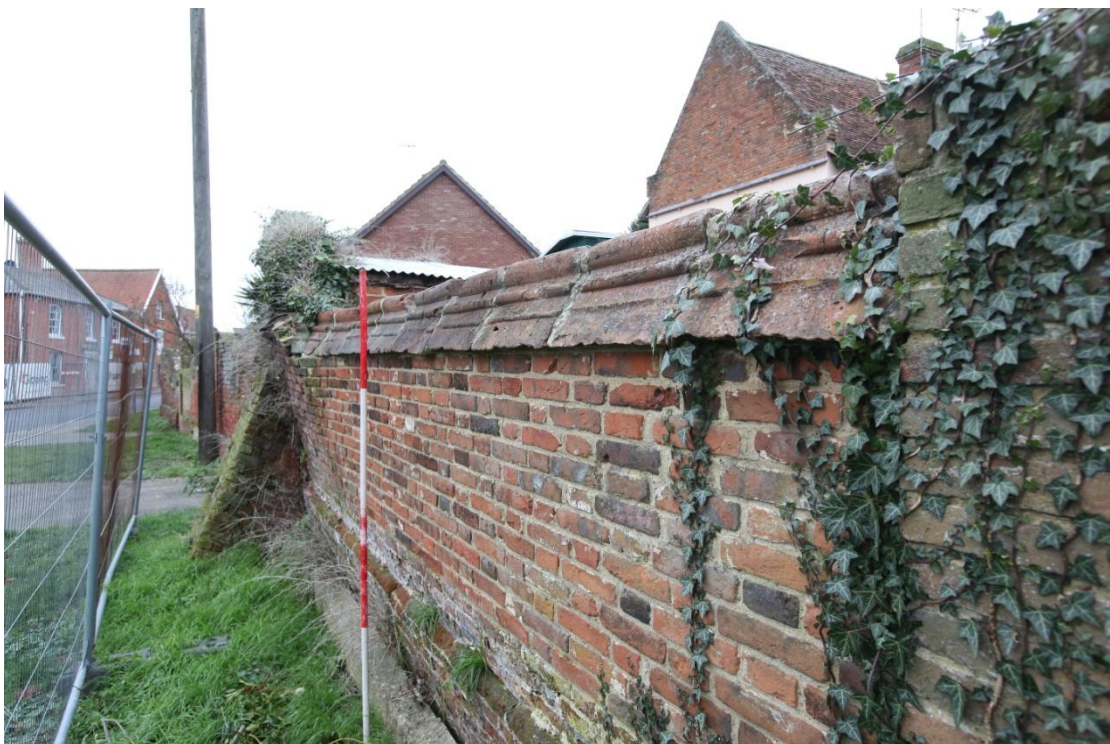
Illus. 10. The rebuilt section of wall from the south (5) showing its slight lean supported by the buttress and caused by the weight of the 20th century garden shed and the much higher ground in the garden to the east (producing a differential of some 0.75 m).

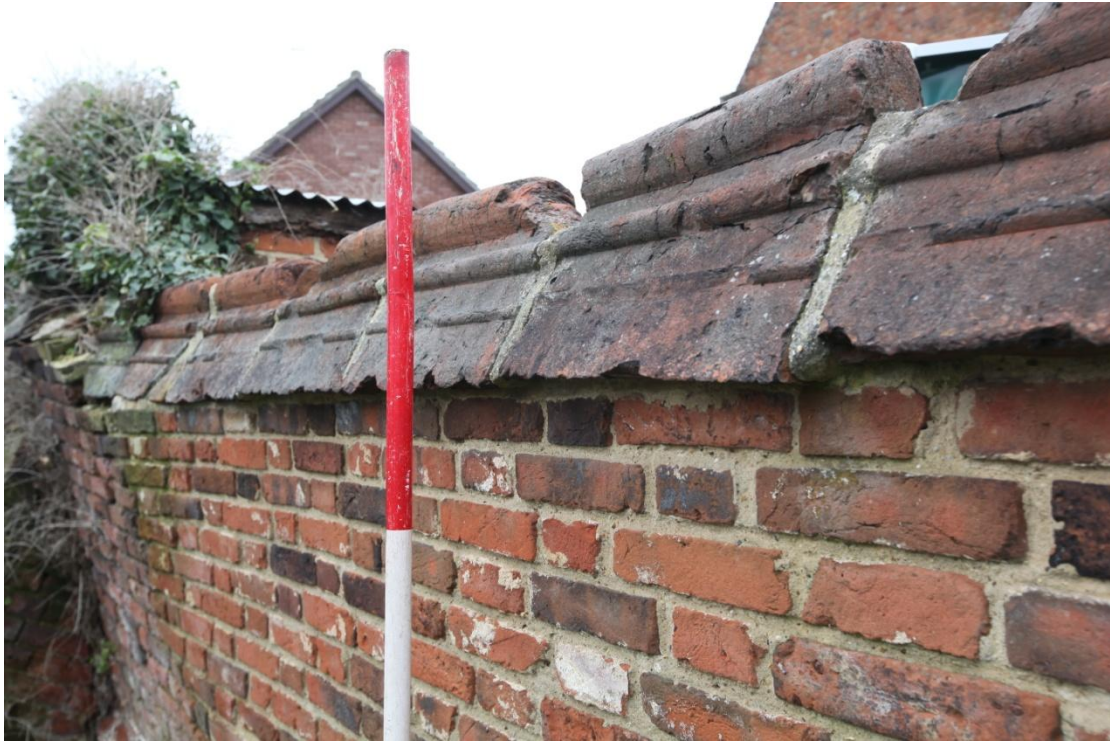
Illus. 11. A detail of the coping tiles in illustration 10 showing their two horizontal ribs of different sizes (6 in figure 12). These impressive features are difficult to date closely but may be as early as the 16th century and are unlikely to be any later than the 17th.

- 6 **An impressive series of triangular terracotta coping tiles spanning the 14-inch wall and rising to 12 inches in height with a broad roll moulding at the ridge and two narrow roll-mouldings to each side (illus. 11, 19 & 24). The upper side moulding is 3 cm in width and the lower 2 cm. These tiles may be as early as the 16th century and are unlikely to post-date the 17th but are difficult to date closely. They were re-used at a lower level on the recently rebuilt section of wall (5).**

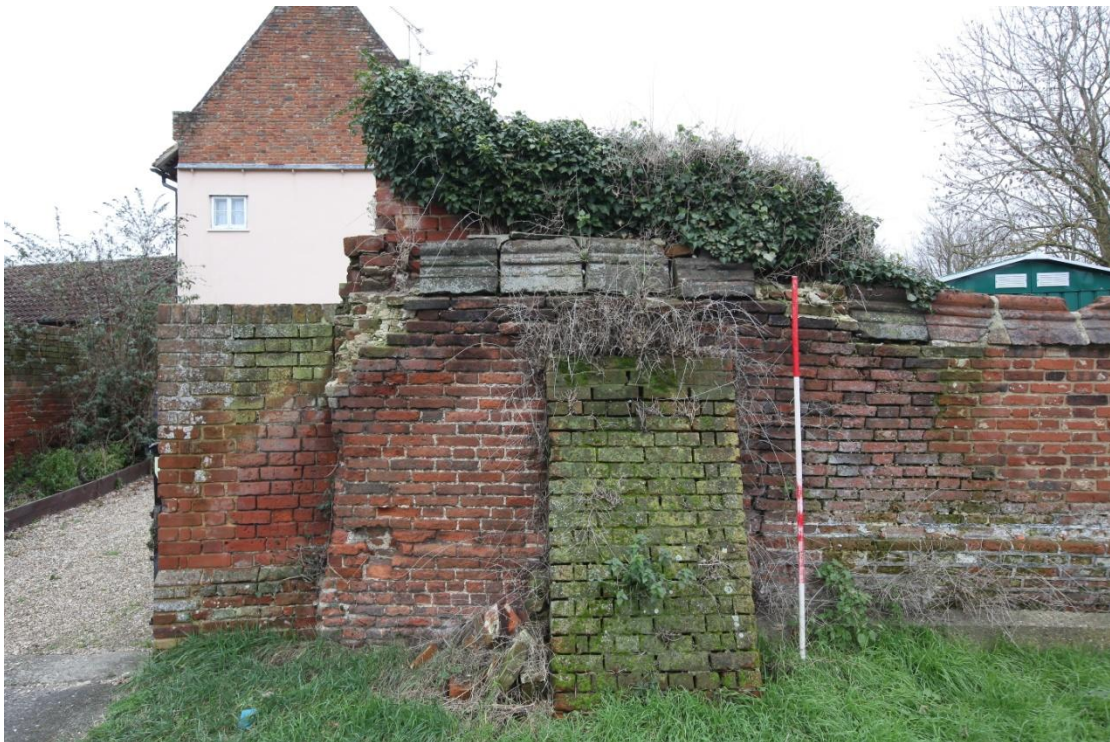
Illus. 12. The large 19th century buttress (3) pre-dates the overgrown 20th century brick garden shed which overtops the wall at this point. The coping tiles probably indicate the wall's original height of 8 ft or 1.2 m, which is taller by three courses than the rebuilt section (5) to the right.

- 3 A substantial 19th century buttress of 3 ft or 0.9 m in width consisting of uniform red bricks of 2.5 inches by 9 laid in English Bond as shown in illustration 12 (6.5 cm by 23). This is visible in the early-20th century photograph in figure 8 and a similar buttress adjoined the north-western corner of the house in 1962 as shown in figure 10. It presumably supports and conceals a junction between sections 1 and 2 that may be more apparent in the garden shed to the east which was inaccessible at the time of inspection. This buttress was necessary to inhibit the westward lean of the two sections which does not appear to have increased since its construction.

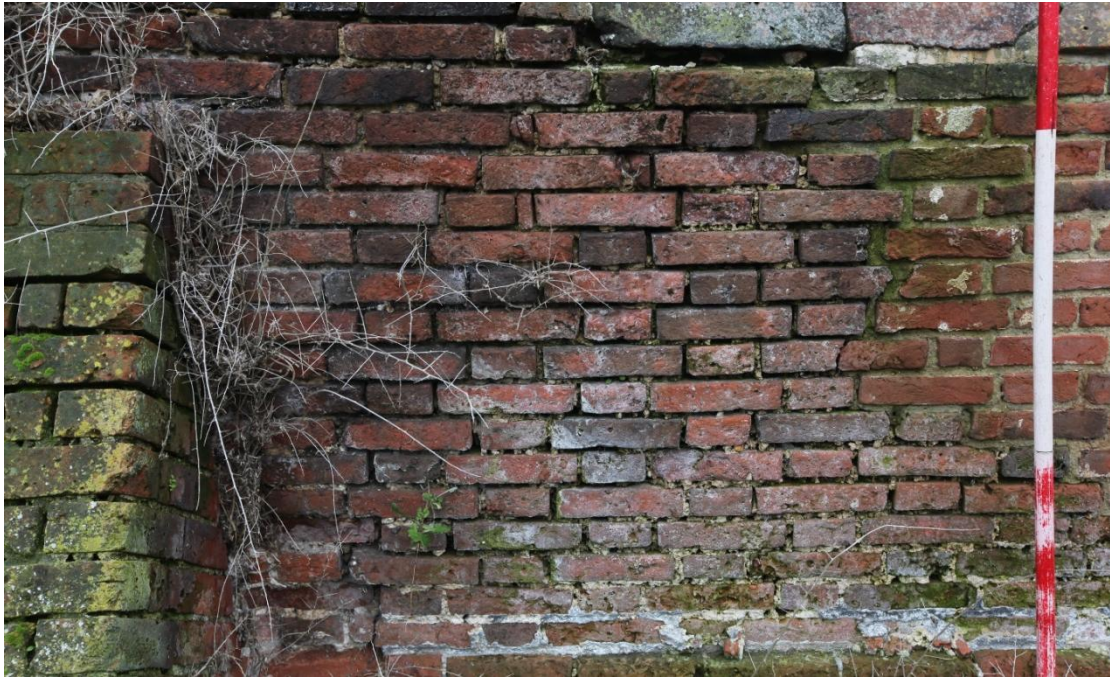
Illus. 13. Section 2 between the buttress (3) and the reconstruction (5) consists of narrow bricks laid in regular Flemish Bond in contrast to the irregular section to the left of the buttress (1). Uniform Flemish Bonding can be found in the 17th century but is more usual in the 18th and early-19th centuries when this section was probably rebuilt.

- 2 A rebuilt section of 4 ft in length to the right of the buttress. This probably dates from the 18th century but consists of the same or similar narrow bricks to those of section 1 laid in a regular Flemish Bond with a plinth chiefly of stretchers (illus. 13). The bricks are likely to have been re-used from the previous wall.

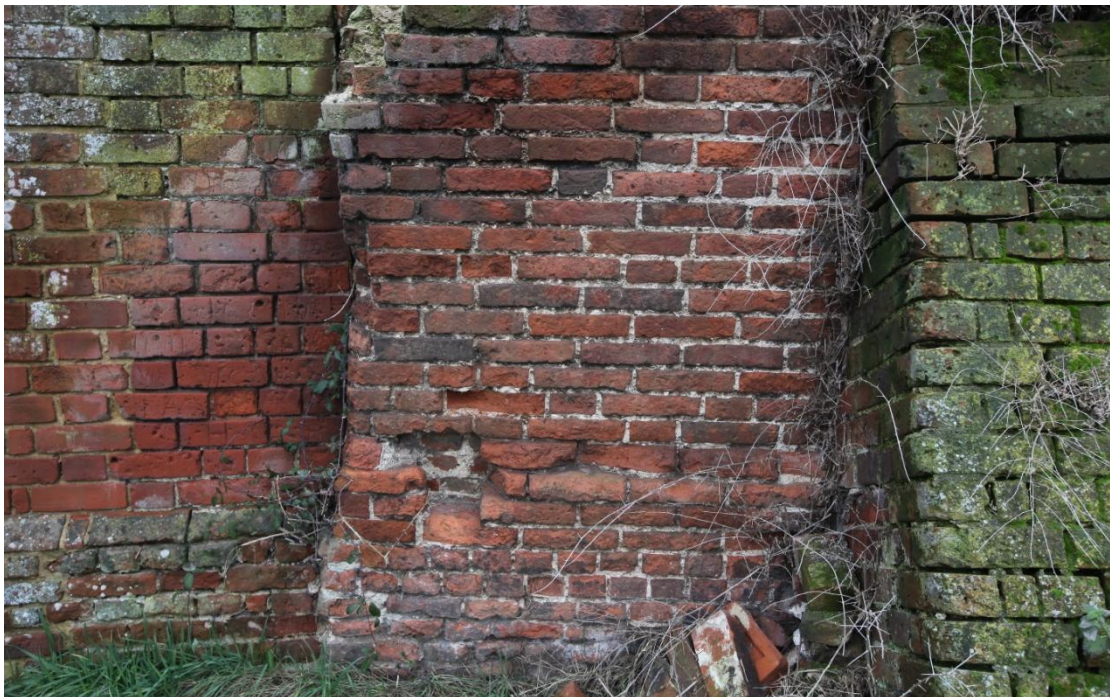
Illus. 14. The section to the left of the buttress in illustration 12 (1) is the oldest part of the structure and differs significantly from its counterpart to the right (2). Its narrow bricks of 9.25 inches by 2 (23.5 cm by 5) are laid in an irregular bond consisting of two or three courses of stretchers divided by courses of alternating headers and stretchers. The plinth is formed chiefly of headers. Brickwork of this kind is typical of the late-16th and 17th centuries, and may be contemporary with the jettied range of the house (i.e. no. 12). It has been truncated on the left where the corner consists of broken bricks, and the buttress presumably supports a hidden vertical joint against the rebuilt section (2).

- 1** The earliest surviving section of the wall, which may be contemporary with the ostensibly 16th and early-17th century house (illus. 14). It extends to only 4 ft or 1.2 m to the north of the 19th century buttress which has arrested an outward lean caused in part by the higher ground in the garden to the east, although more is likely to be hidden behind the buttress. It has been truncated on the north where its irregular edge

consists of broken brickwork. The wall rises to 75 inches or 1.9 m in height on the west excluding its coping tiles and is 14 inches or 35 cm-thick. The ground to the east is approximately 0.75 m higher, reflecting the once gentle slope of the ground. The bricks vary in colour and texture, and are narrow in the typical manner of the late-16th and early-17th century at 2 inches by 9.25 by 4.5 (5 cm by 23.5 by 11.5). The irregular bond is also typical of the period, consisting of several courses of stretchers interspersed with courses of alternating headers and stretchers. The plinth of 27 inches or 0.7 m in height is defined by chamfered plinth bricks and consists chiefly of headers. The lime mortar initially overlapped the individual bricks and would have been painted with red ochre to unify their appearance in the standard Tudor manner. This feature remains most apparent in an ostensibly original recess of uncertain function which extends to 8 inches in height by 5 in width and 4.5 in depth as shown in illustration 15 (20 cm by 13 by 11.5).

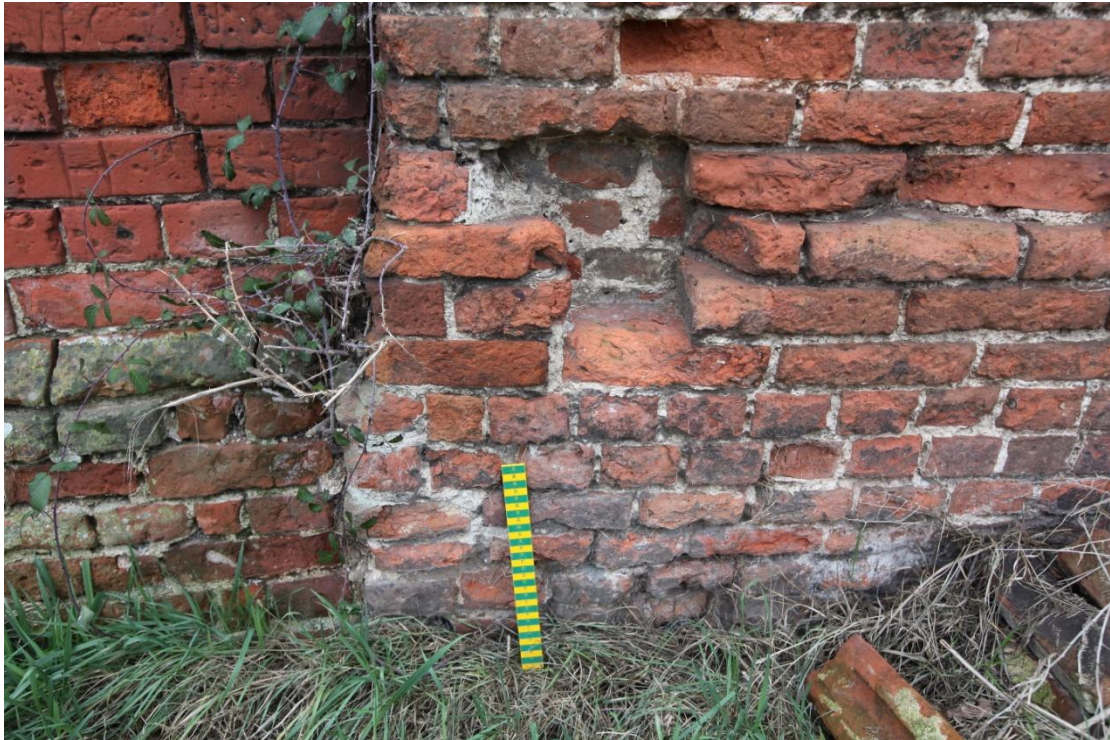
Illus. 15. A detail of a damaged but once neatly cut and ostensibly original recess in the earliest section of wall (1) at bottom left in illustration 14. Such recesses are usually associated with horizontal locking bars, but it is difficult to see how a doorway could have projected at this point.
