Brick Wall at Sun Court, 12-16 Bridge Street, Hadleigh

(Suffolk HER HAD 046)

Historic Building Record

January 2024

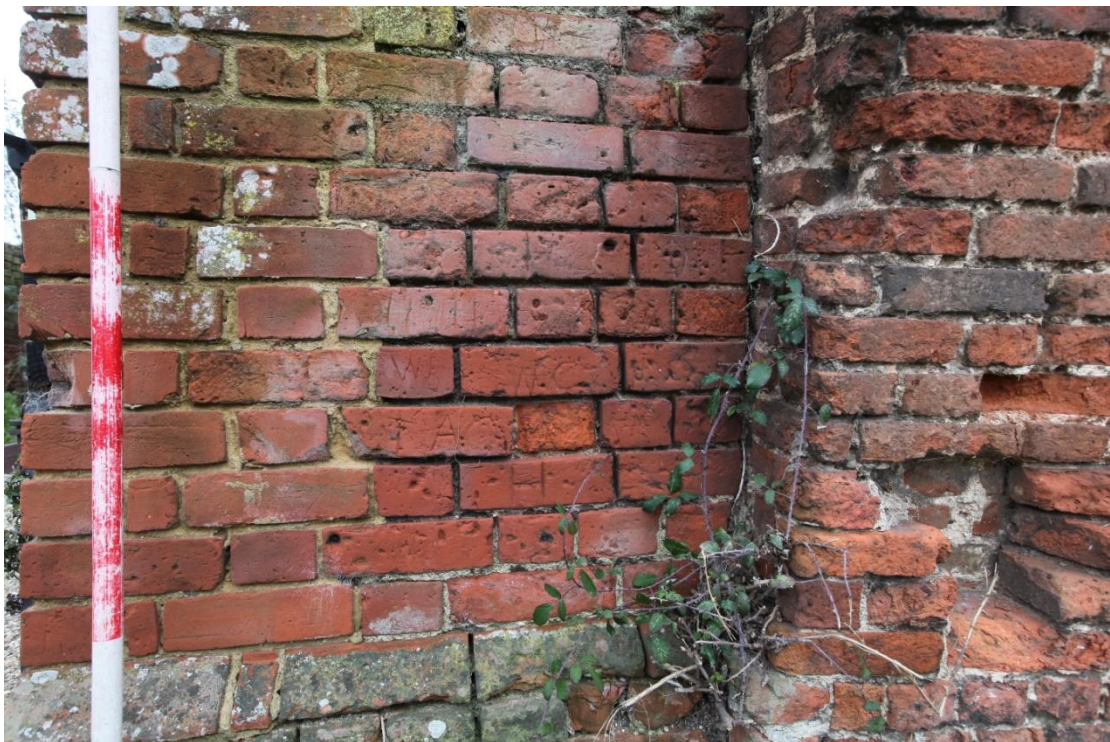
Illus. 16. The short section adjoining the present entrance to the left (4) consists of uniform soft reds of 2.5 inches by 9 in the typical manner of the 19th century. It bears a surprising number of incised initials that would have been impossible on the harder 17th century bricks to the right. The left-hand half of this section has been recently built with matching bricks as indicated by their lighter colour and cement mortar.

- 4 A mid- to late-19th century section of 3 ft or 0.9 m in length adjoining the entrance gate to no. 12 and consisting of standard 2.5 inch uniform soft reds laid in typically Victorian Monk Bond with two stretchers between each header (illustration 16). This is matched by another section to the north of the same entrance. The northern section contains closers (quarter bricks) that respect the present gate but the edge of this southern section has been rebuilt so the gate may have been widened. It remains vertical (illus. 17). Although structurally distinct, as shown in illustrations 27-28, the fabric is identical to that of the partly demolished pantiled shed built between 1839 and 1884 that faced the former farm yard between the road and the large threshing barn in figures 8-9.

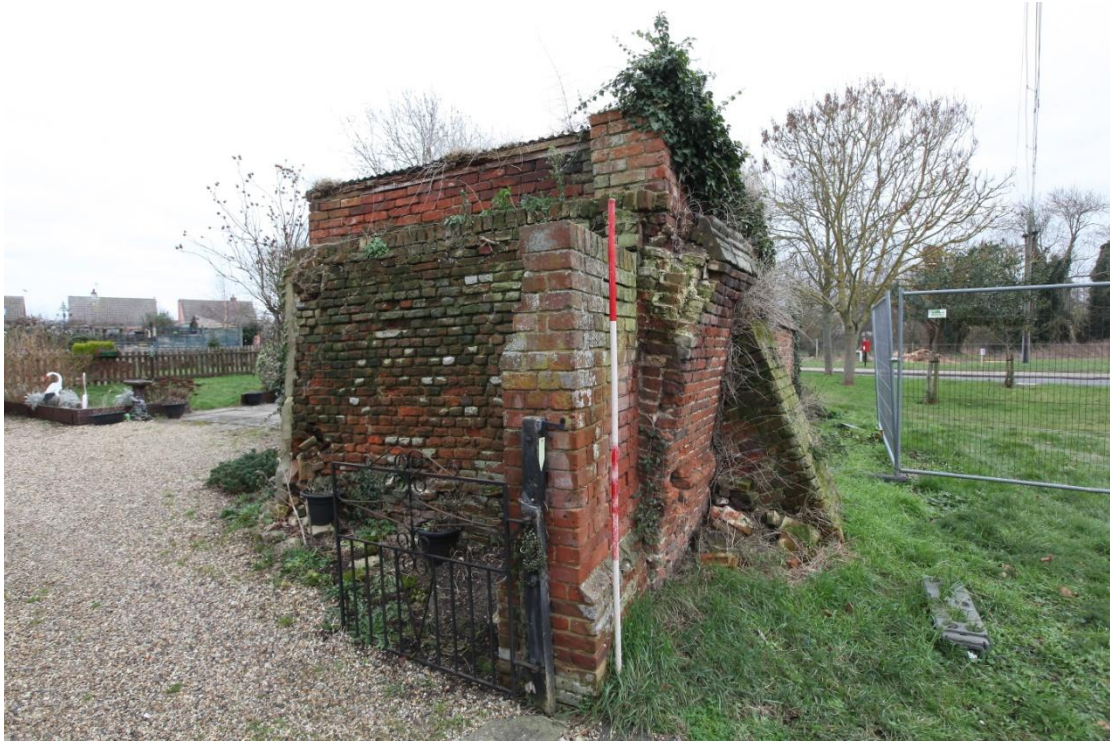
Illus. 17. The historic wall from the entrance to no. 12 to the north-west, showing the 19th century boundary wall (8) overtopped by the 20th century shed (7) on the left. The 16th or 17th century wall (1) is leaning outwards relative to the vertical 19th century section in the foreground, but the 19th century buttress is evidently doing its job as no further movement seems to have occurred since its construction. The recent damage to its top corner has been caused by the ostensibly new corner pier of the 20th century shed which has been built directly above.

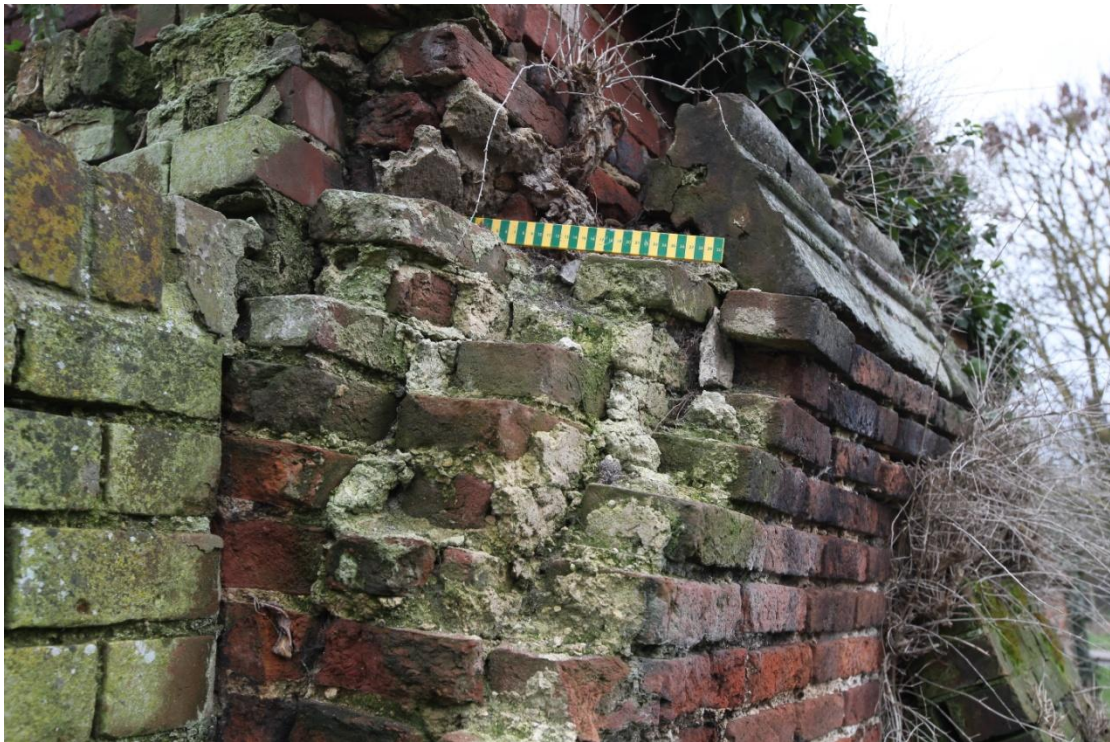
Illus. 18. A detail of the recently damaged corner of the 16th or 17th century wall in illustration 17 (1), showing its width of 14 inches or 35 cms.

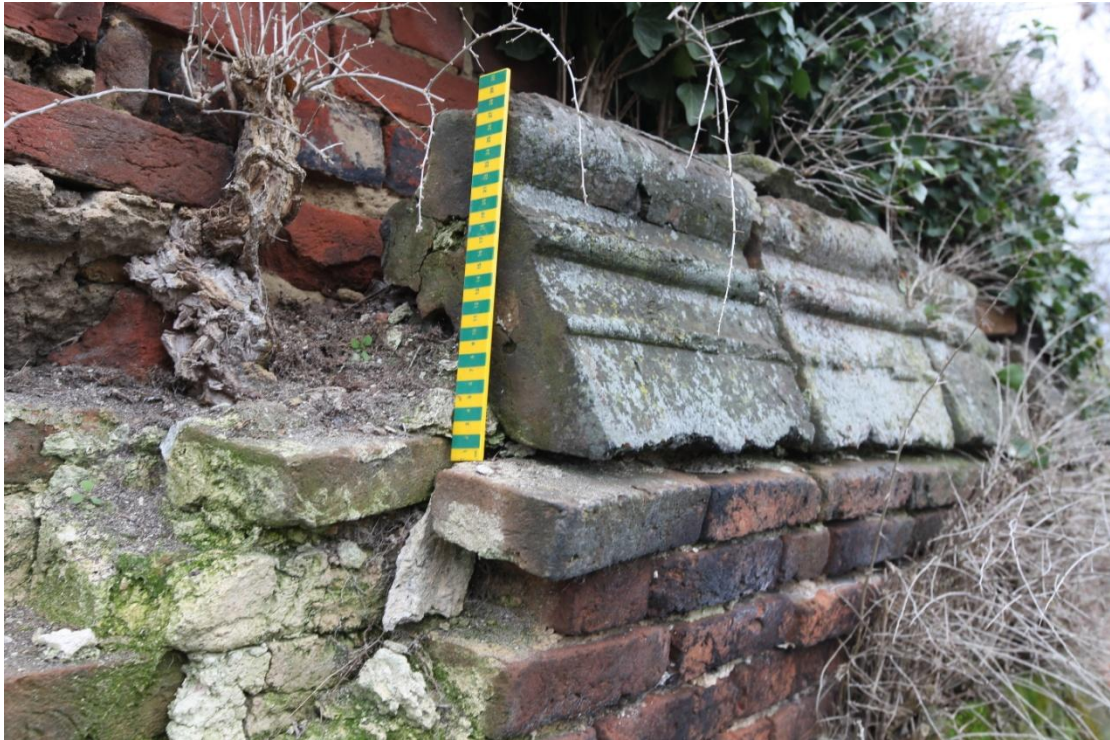
Illus. 19. A detail of the impressive coping tiles in illustration 18 which contain triangular frogs and side ridges of two different sizes below the roll of the ridge. The damaging new brickwork of the 20th century shed (7) is visible at top left. The presence of a root has compounded the problem.

- 7 **The western gable of a mid-20th century brick shed laid in stretcher bond that rests directly on the oldest two sections of the wall and includes a recently renewed corner pier to the north (illus. 20 & 22). The shed was not shown on the accurate 1924 Ordnance Survey but was probably present by that of 1957 in figure 7 which omits smaller structures. Its interior was inaccessible at the time of inspection. The weight and drainage of this shed is evidently damaging the historic wall beneath.**

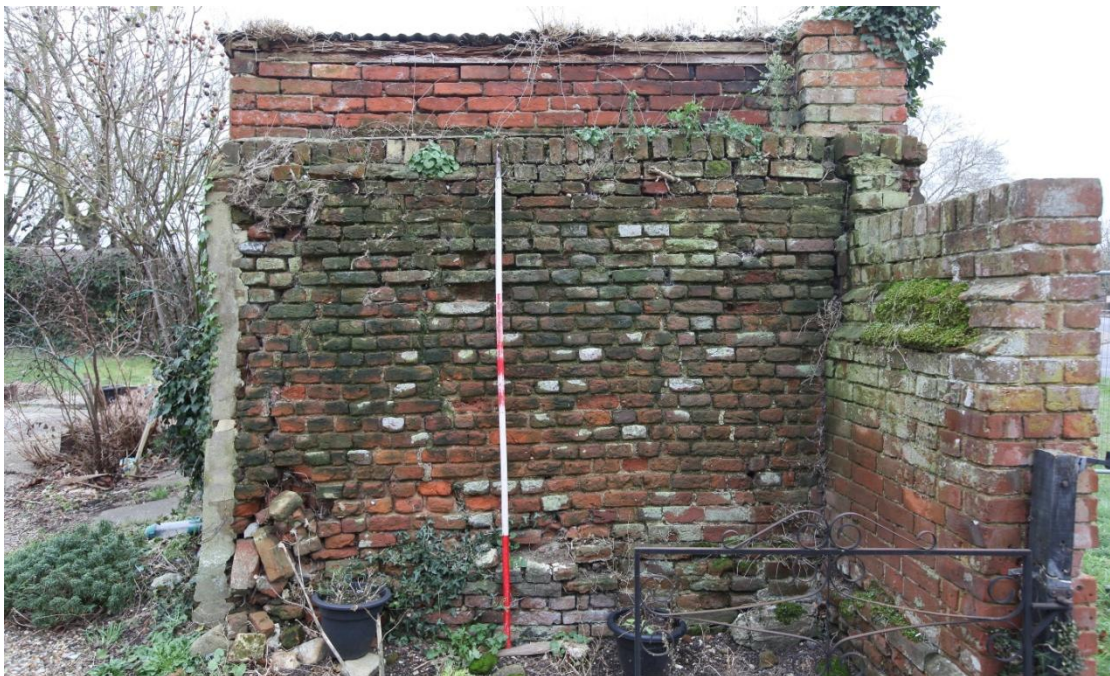
Illus. 20. The former northern wall of the 19th century garden to the south of the house (8), as seen from the entrance to no. 12 to the north. The left-hand edge is formed by broken bricks and this wall once continued to the south-western corner of the house (connecting to the fragment that still remained in 1962 as shown in figure 10). It is crudely constructed almost entirely of headers and is overtopped by the lighter and more uniform bricks of the mid-20th century garden shed which terminates to the right in a recent pier built directly upon the oldest part of the wall.

- 8 **An ostensibly early-19th century 9-inch wall consisting of probably re-used narrow bricks laid mainly in header bond which projects at right-angles from the roadside wall and initially continued to the south-western gable of the house as shown on the historic maps (illus. 20). Its western corner contains closers where it abuts the oldest section of wall (1) against which it was built. A fragment of the same structure survived to the east in 1962 as shown in figure 10. This wall served to divide the garden to the south of the house from a narrow enclosed yard against its western gable.**

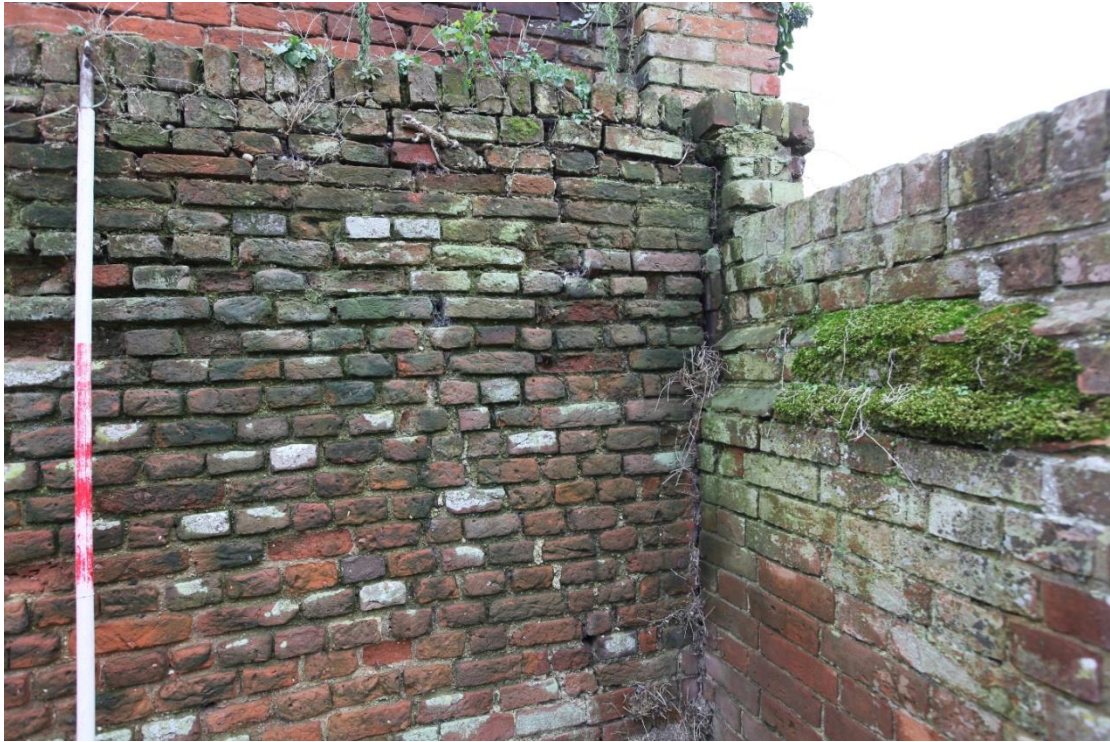
Illus. 21. A detail of the probably 19th century but possibly 18th century garden wall in illustration 20 (8) showing the closers or quarter bricks that respect its right-hand edge where it directly abuts the oldest 16th or 17th century section of the roadside wall (1). This edge remains vertical and no gap has opened against the earlier wall, indicating that the latter's lean has not increased since the addition of the buttress.

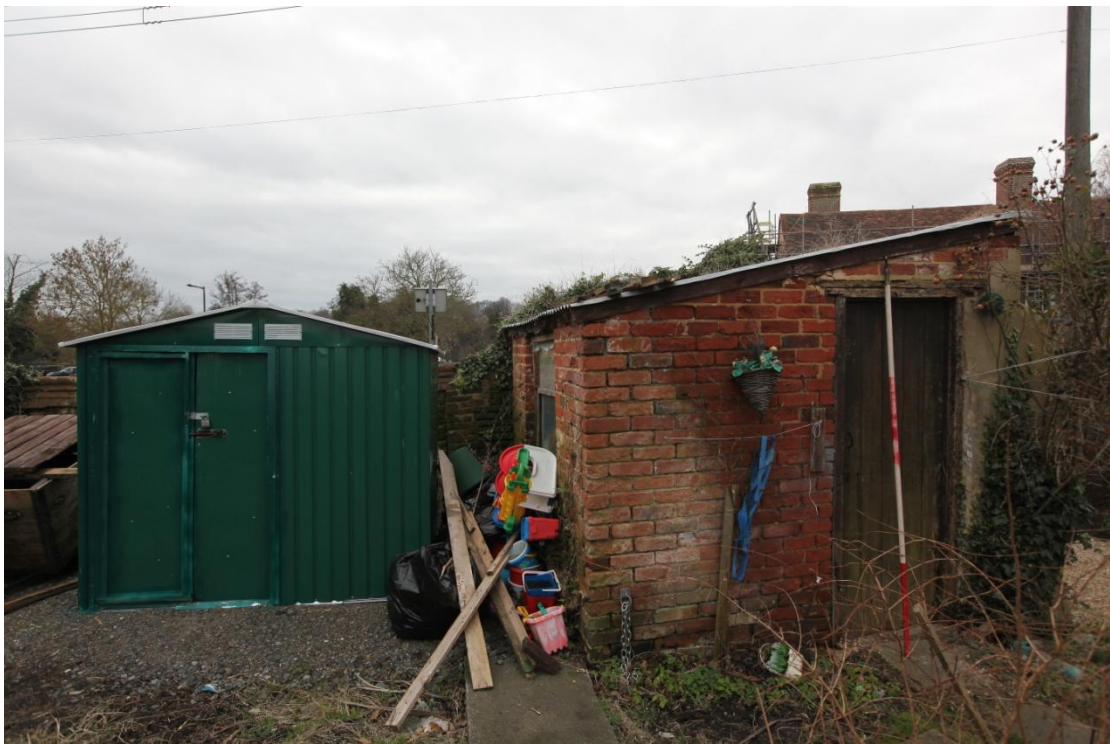
Illus. 22. The roadside wall from the garden of no. 12 to the east showing the mid-20th century shed that was not present in 1924 (figure 6). The poorly built walls of the shed consist entirely of stretchers and are presumably only 4.5 inches thick, but the interior was inaccessible at the time of inspection.

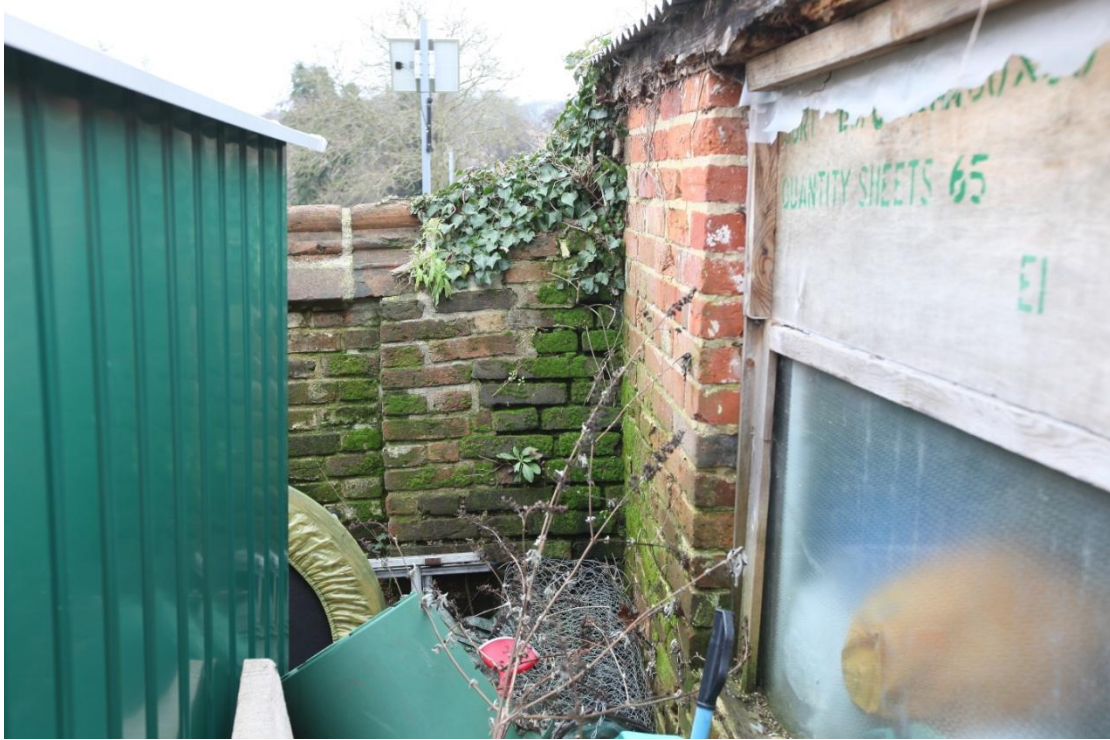
Illus. 23. The eastern side of the roadside wall in illustration 22 showing the vertical step in its face that coincides with the recently rebuilt section (5) to the left.

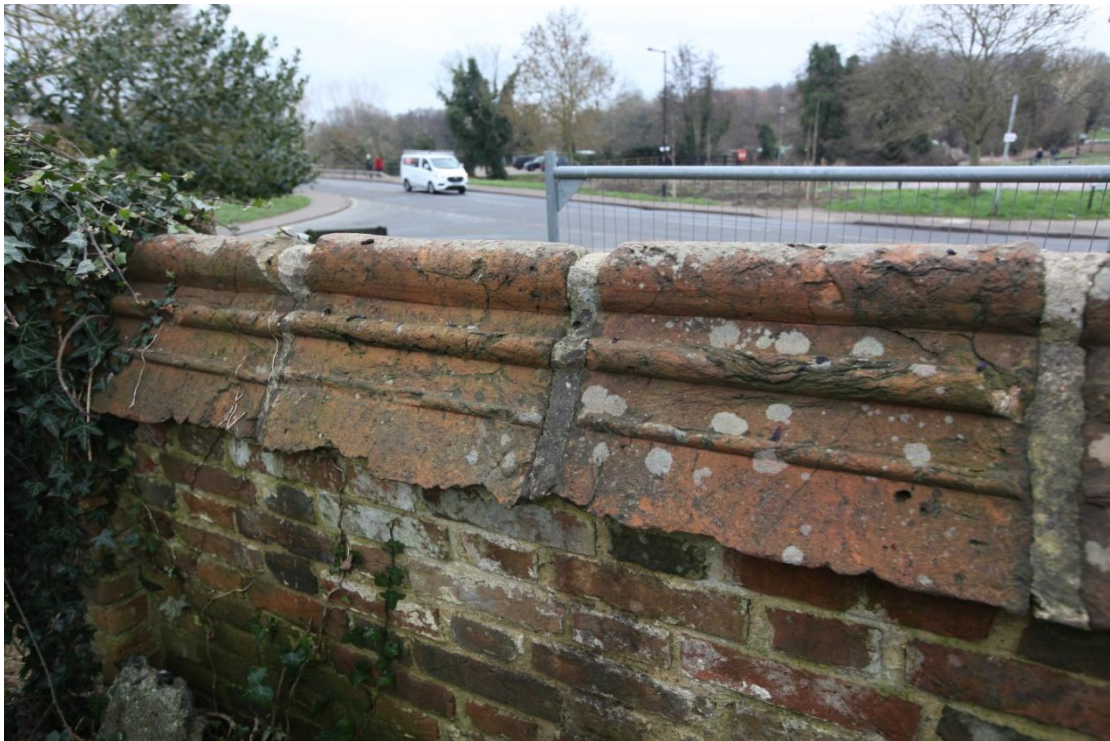
Illus. 24. A detail of the finely moulded re-used coping tiles above the recently rebuilt section of the roadside wall seen from the garden of no. 12 to the east (hidden behind the green portable shed in illustration 22).

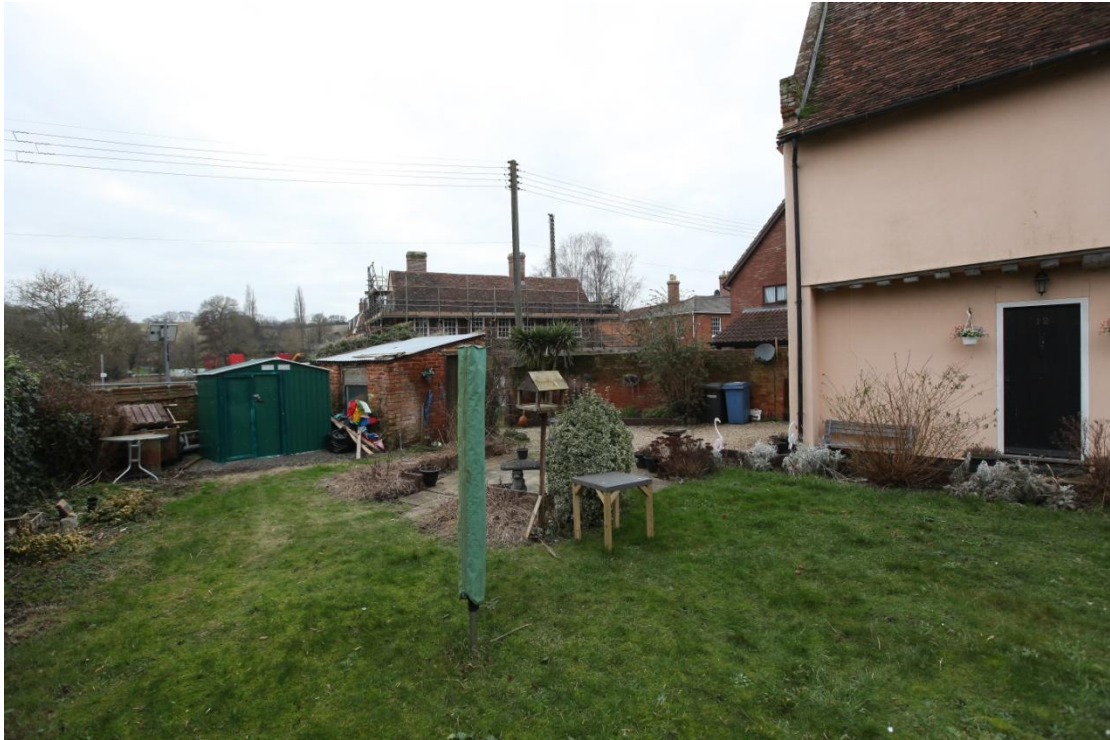
Illus. 25. The garden of no. 12 from the east with the roadside wall visible to the left of the green garden shed. There is no trace of the boundary wall in figure 10 that connected the corner of the house to the remnant preserved by the brick shed in illustration 20 (8).

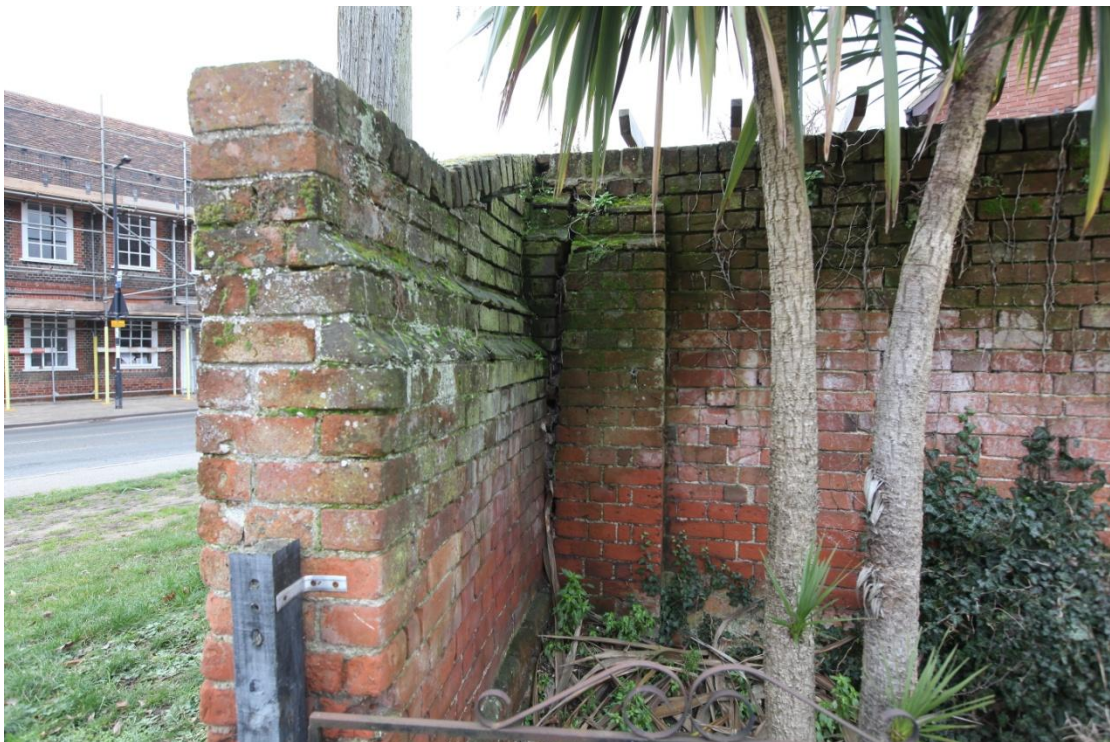
Illus. 26. The north-western internal corner of the garden belonging to no. 12 with the remnant of the pantiled mid-19th century shed to the right and the contemporary or broadly contemporary section of roadside wall to the left. Both consist of uniform soft reds laid in Monk Bond with two stretchers between each header.

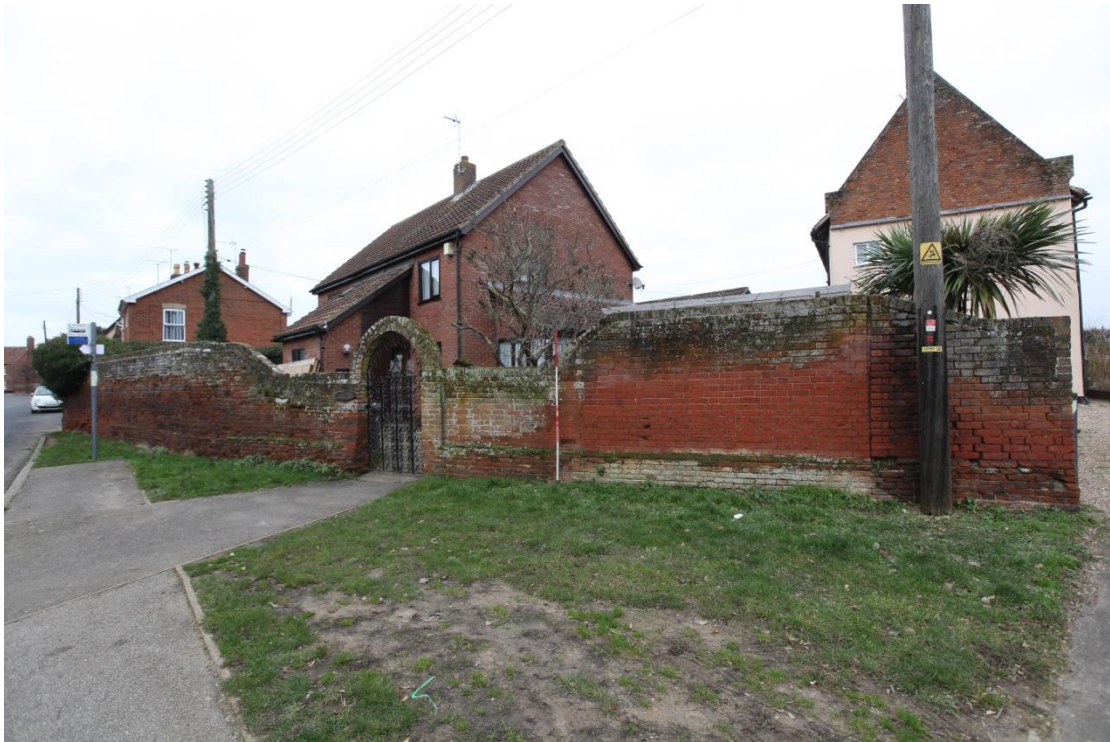
Illus. 27. The northern end of the roadside wall from the triangular section of waste ground showing the straight vertical joint between the surviving gable of the mid-19th century pantiled shed to the left of the telegraph pole and the yard wall of no. 12 to the right. Although structurally distinct these walls are almost identical and clearly contemporary or almost contemporary. The right-hand edge of the yard wall is respected by closers and adjoined a gate from the outset (although the entrance may have been less wide than today as the opposite edge in illustration 16 has been rebuilt).

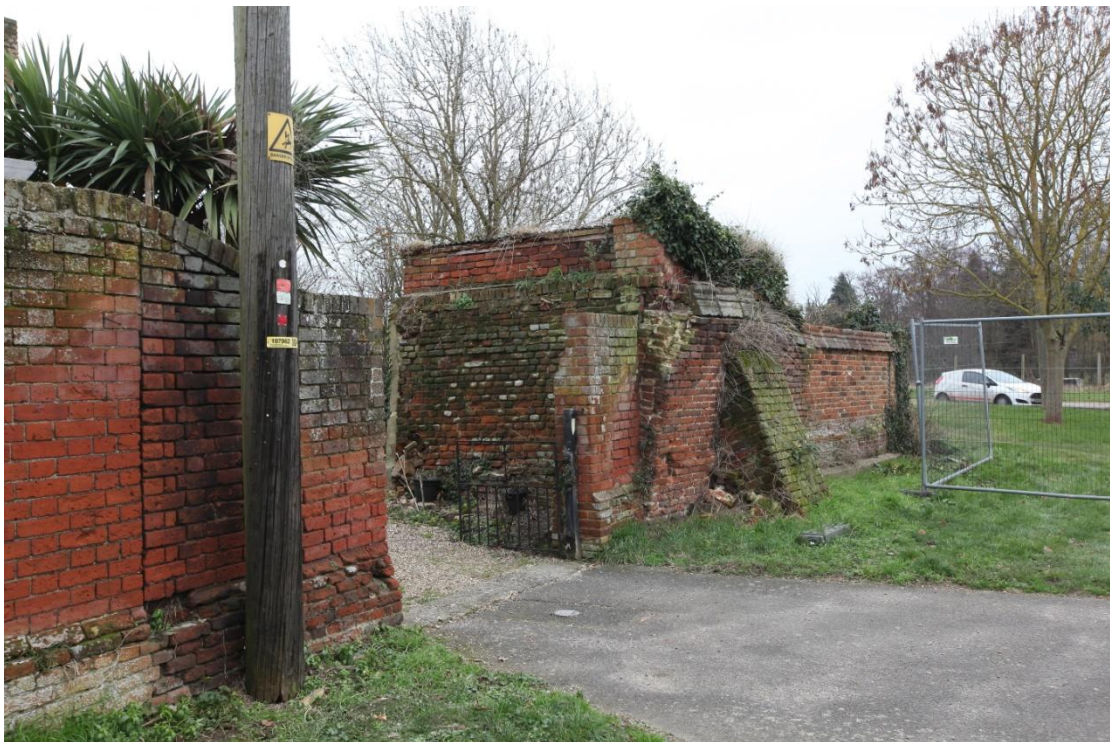
Illus. 28. The roadside wall from the north showing the vertical joint between the yard wall and the matching remains of the post-1839 pantiled farm shed to the left.
