1.0 Site Analysis and Evaluation

1.1 Site Analysis

1.2 Site Photographs

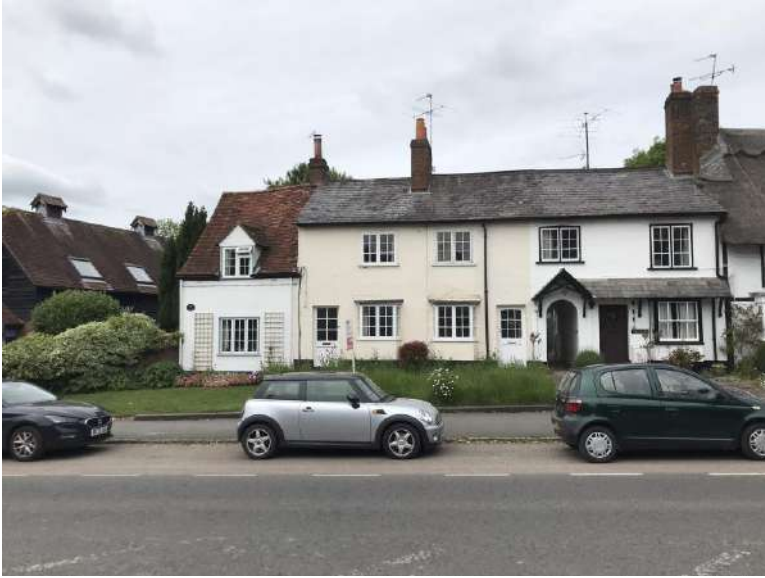
Street view of the site in context with their neighbouring dwellings. The site dwellings are painted cream.

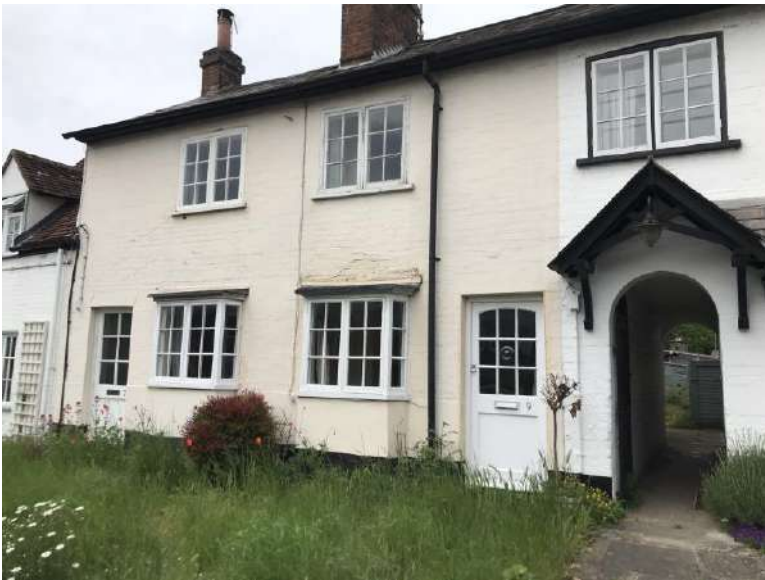
Closer view of the site with the two separate entrance doors, twin ground floor bay windows and the passageway to the right of no.9 leading to the back of the site. Neighbouring no.11 is painted white and its first floor crosses over the passageway

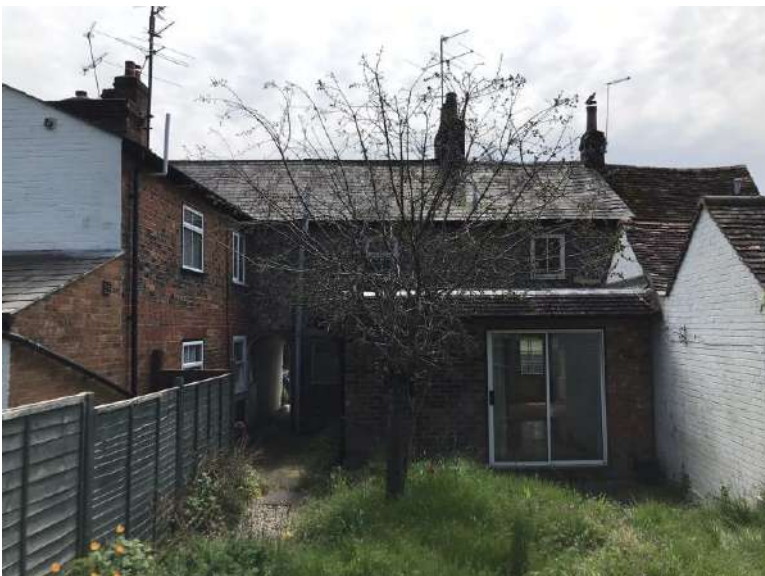
View of the back of the site from the rear garden. Currently, the garden to no.7 and 9 have been combined. The fruit tree can be seen, as well as the rear to no.11 and the single storey twin dual pitched elements to no.5.

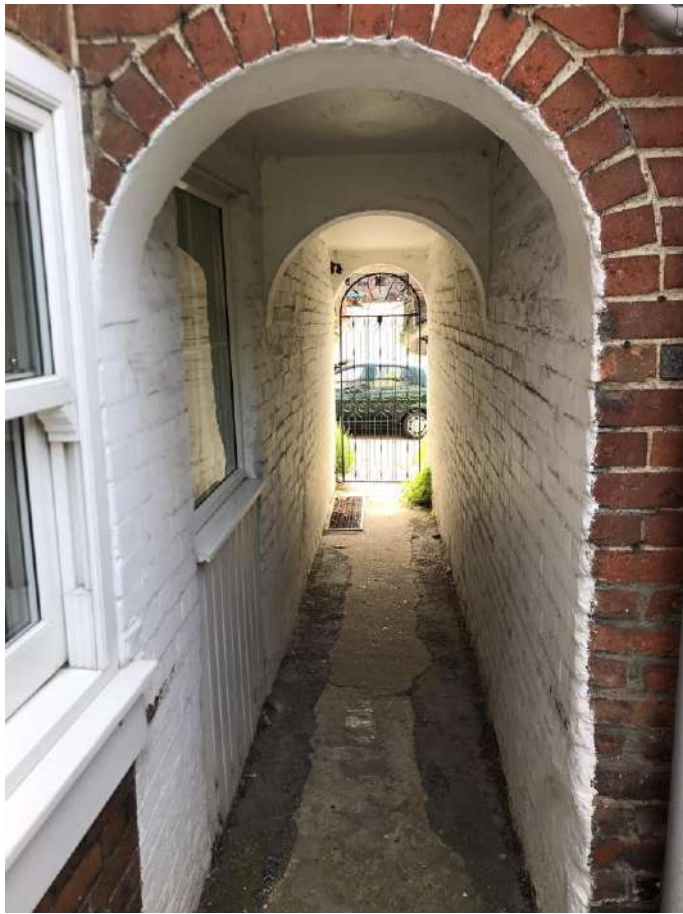
Closer view of the passageway, taken from the rear looking back to the street.

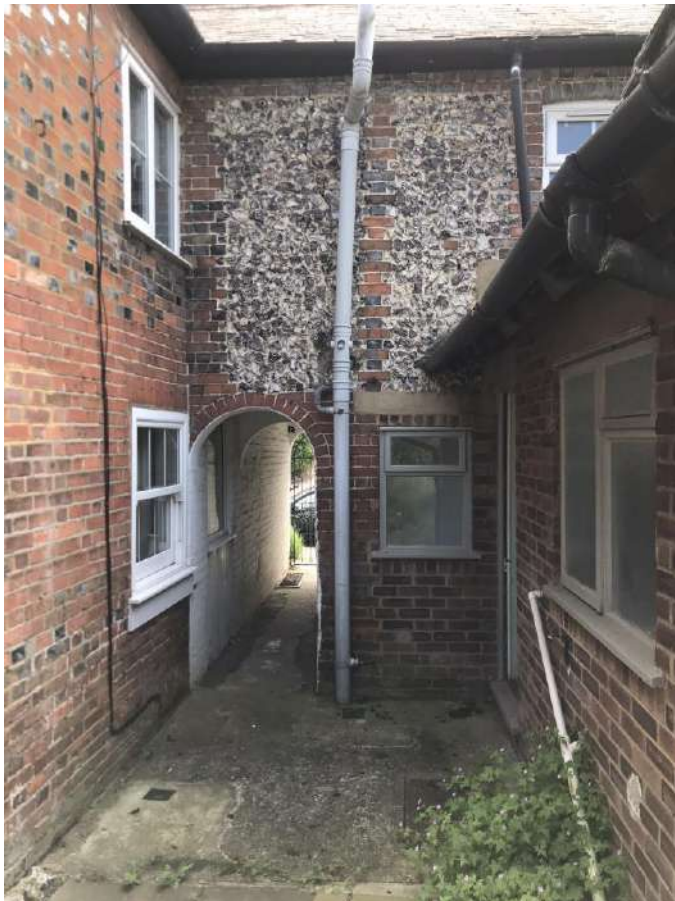
Closer view of the rear of the site between no.11 and 9, showing the relationship between the two, as well as the passageway, fenestration, and external drainage pipework.

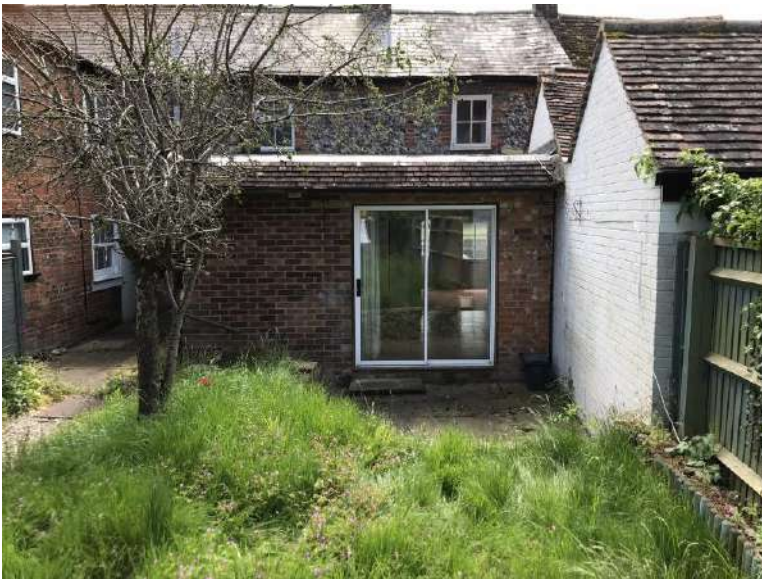
Closer view of the rear extension to the two properties, showing the patio door, tiled mansard roof and brickwork. Also can be seen is the fruit tree and side flanking wall to no.5 and the garden fence.

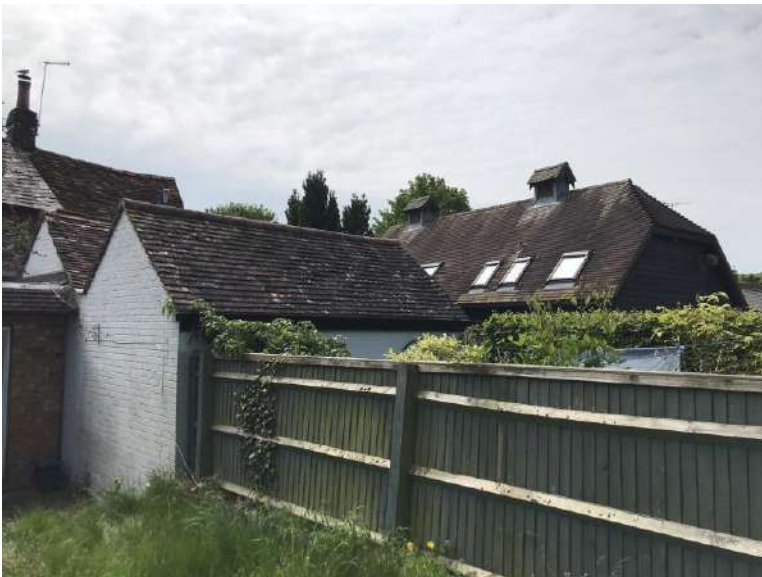
View from the rear garden towards the back of no.5, showing the garden fence and rear single storey element to no.5, with their white painted masonry walls and tiled roof.

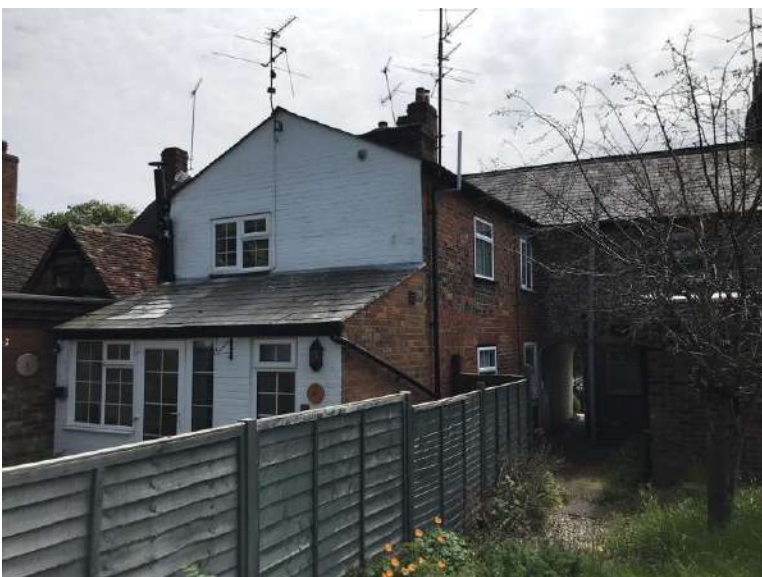
View from the rear garden towards the back of no.11, showing the garden fence and rear single storey element to no.11 and the two storey element with its combination of facing brickwork, painted brickwork and slate roof.

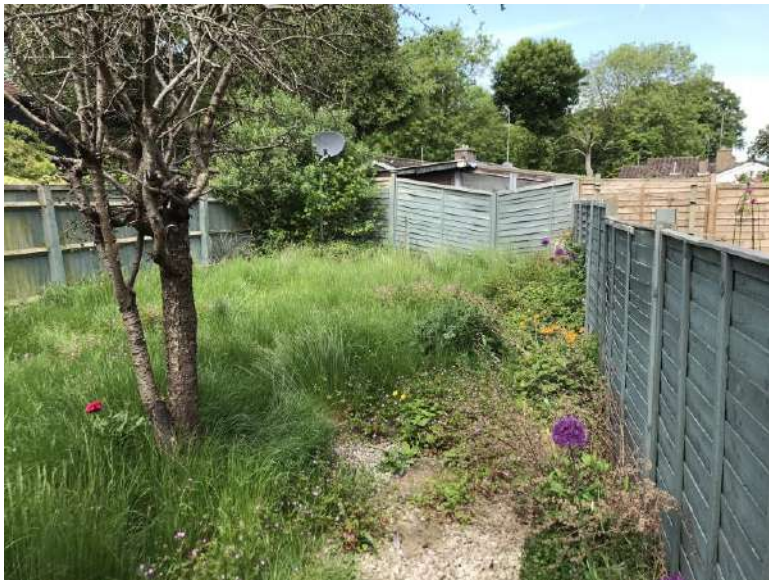
View of the combined garden to no.7 and 9. The boundary garden fence to no.11 is to the right and the fruit tree is in the foreground.

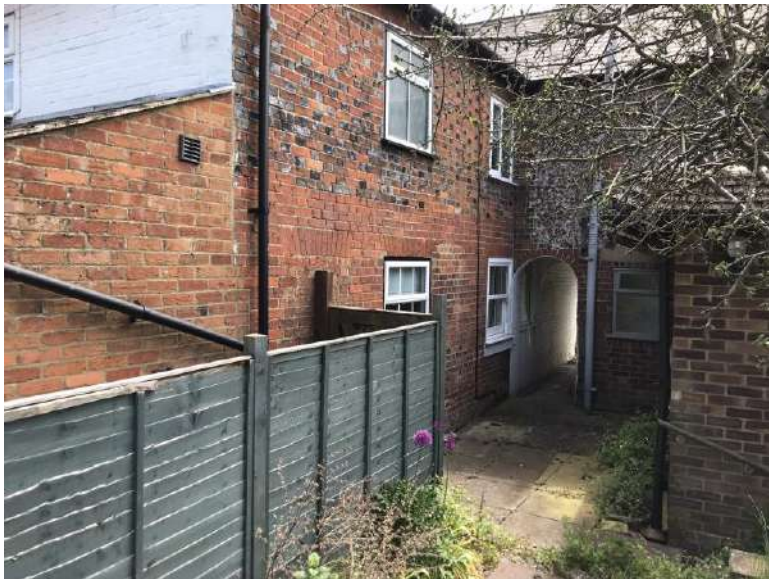
View of the side of no.11, taken from the rear garden, showing the four windows facing the site and the boundary garden fence.

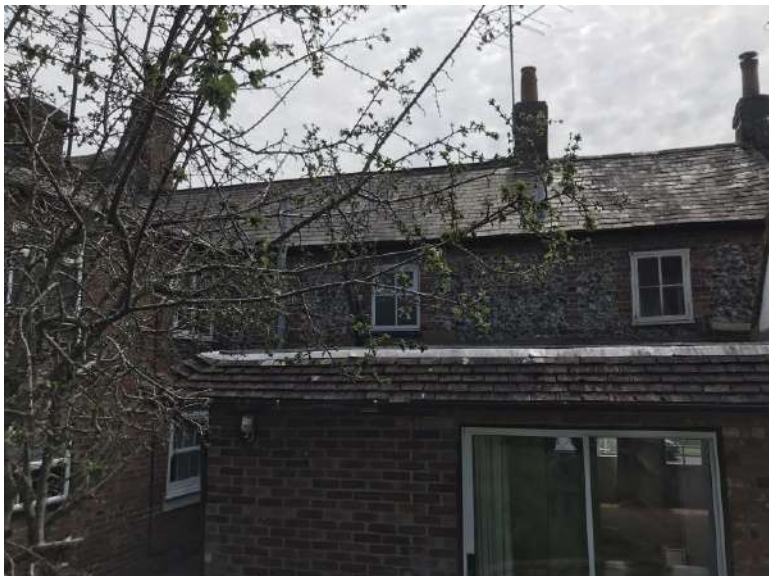
View of the back of the site showing the two first floor windows, the main slate roof and chimneys, the right one serving no.5 and the centre chimney serving no.7 and 9.

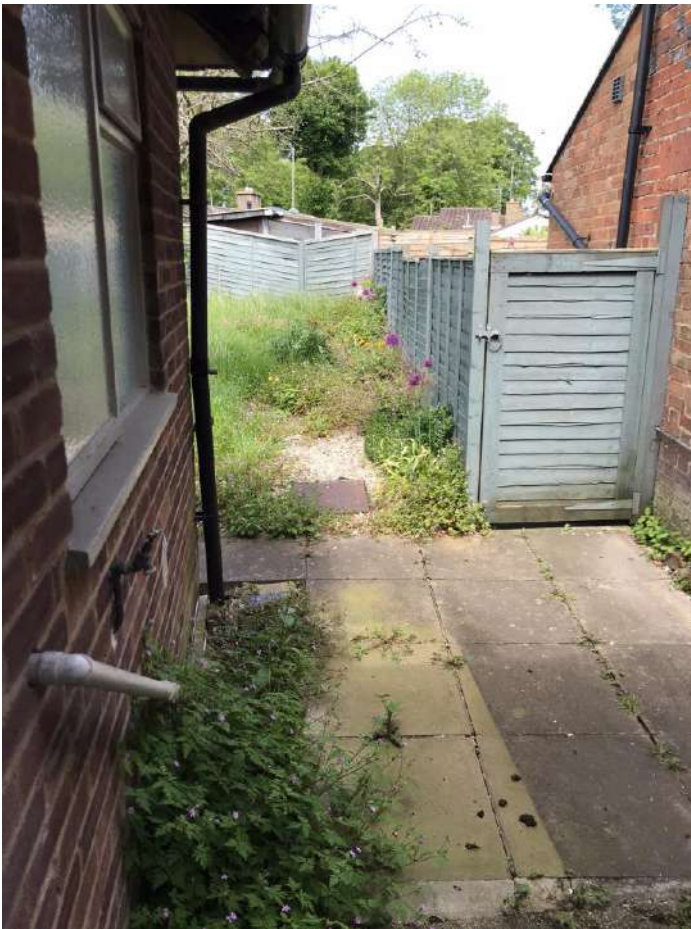
View from the rear passageway between no.9 and 11 looking towards the back garden and the entrance to the garden to no.11. The passageway and right hand element of the path is in the ownership of no.11, but, both no.7 and 9 have access rights over it.

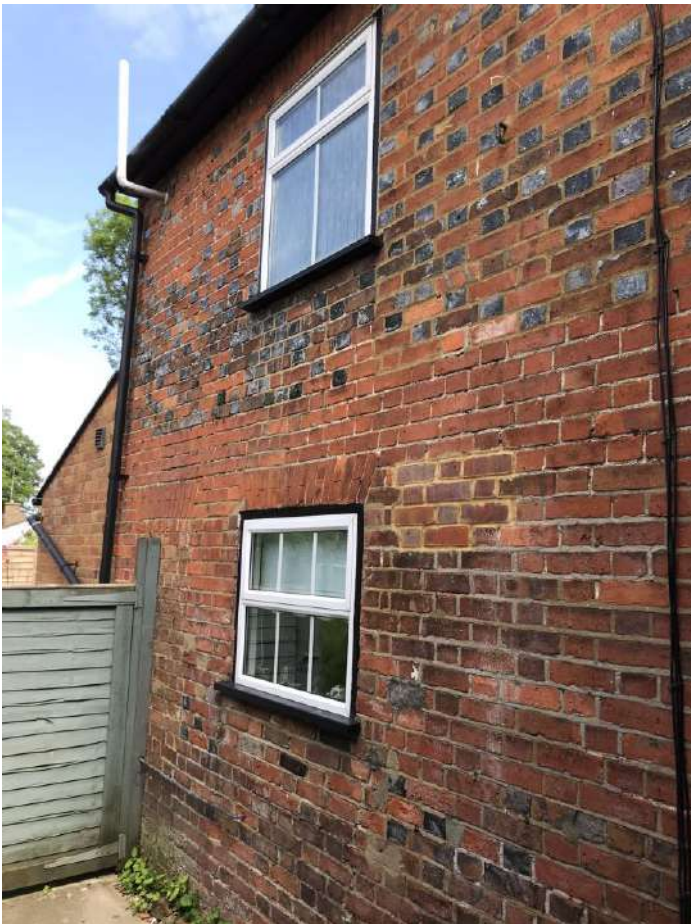
Side view of the rear two storey element to no.11, the single storey lean-to to the back and the access gate to the garden

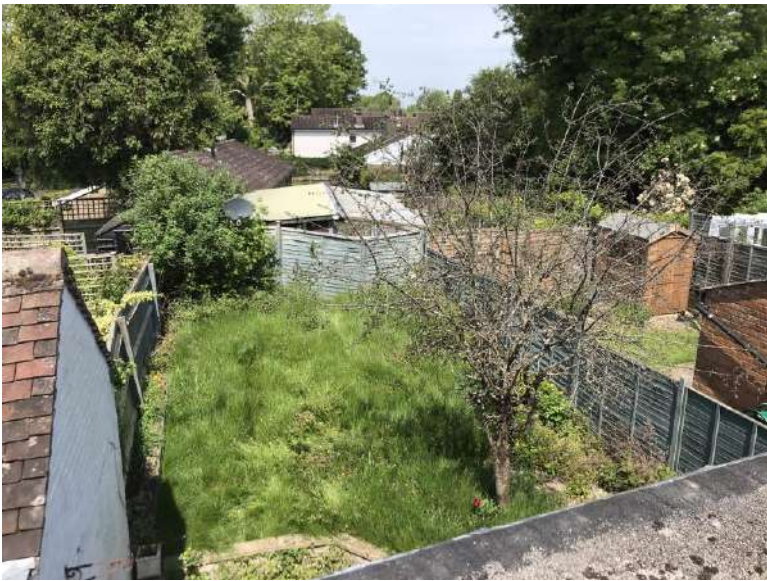
View of the combined rear garden for no.7 and 9, taken from the single storey rear extension.

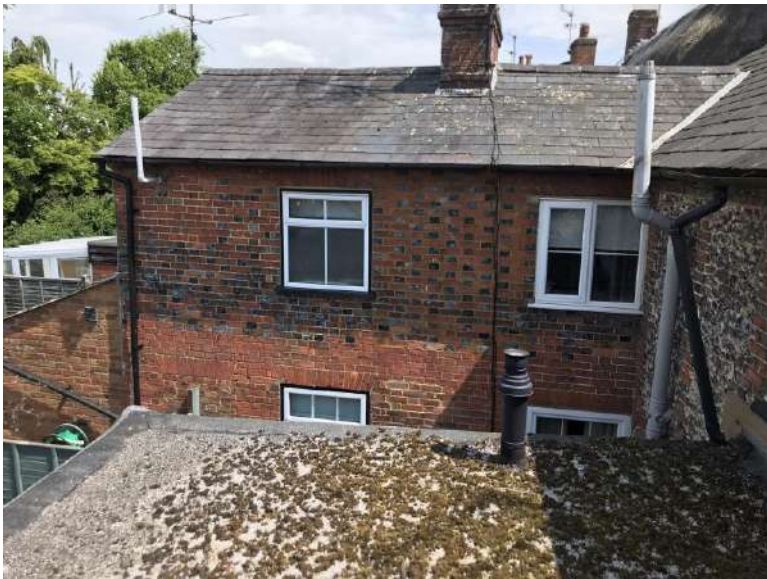
View of the side elevation to the rear of no.11, taken from the roof of the single storey extension to no.7 and 9. The felt roof can be seen and where it laps with the lead flashing that overlaps the tiled mansard roof that runs round the two open eaves. The flue to the boiler to the kitchen extension can be seen projecting through the felt roof.

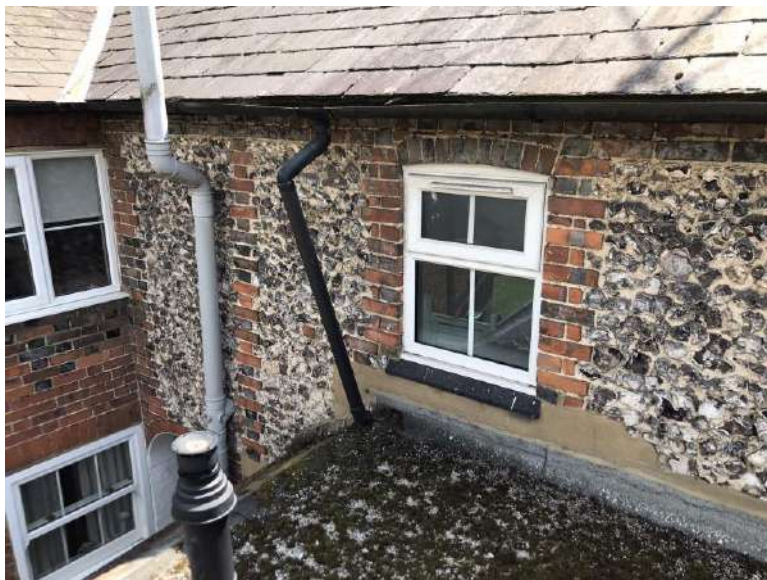
Closer view of the Upvc casement window to the bathroom to no.9, along with the external drainage and boiler flue.

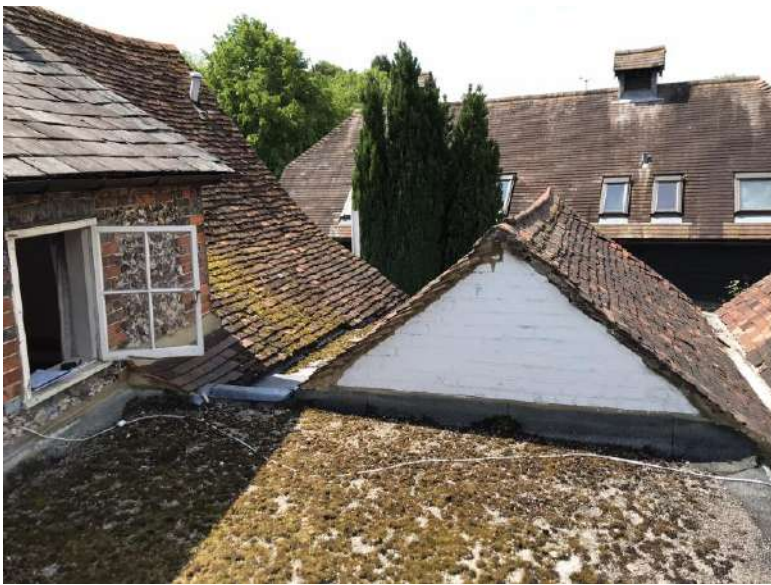
View from the flat roof looking towards no.5 and the dual pitched rear extension abutting the site. The rear extension to no.5 is formed of two dual pitched roofs with lead valley gutters. Also, can be seen the timber side hinged window to the rear of no.7 and the felt flat roof finish

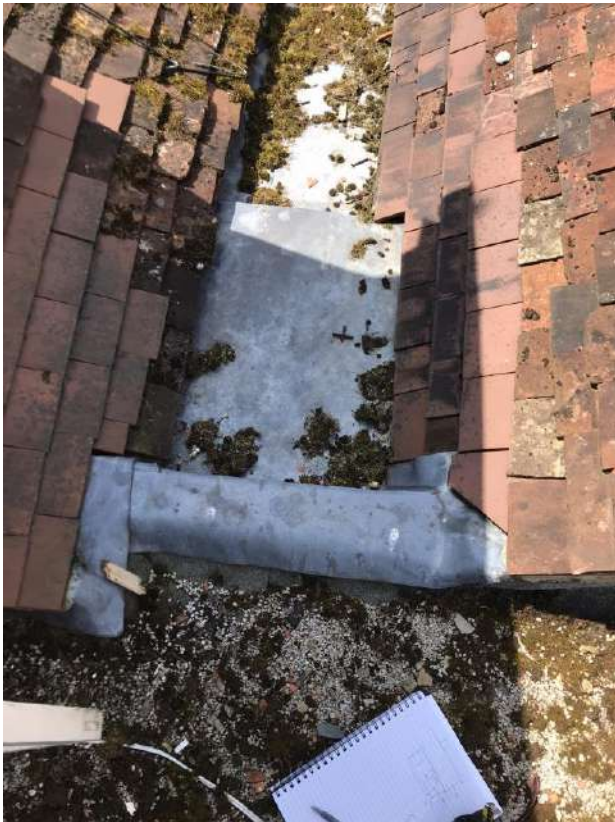
View from the inner lead valley gutter to no.5 where it abuts the felt roof to the site's rear extension.

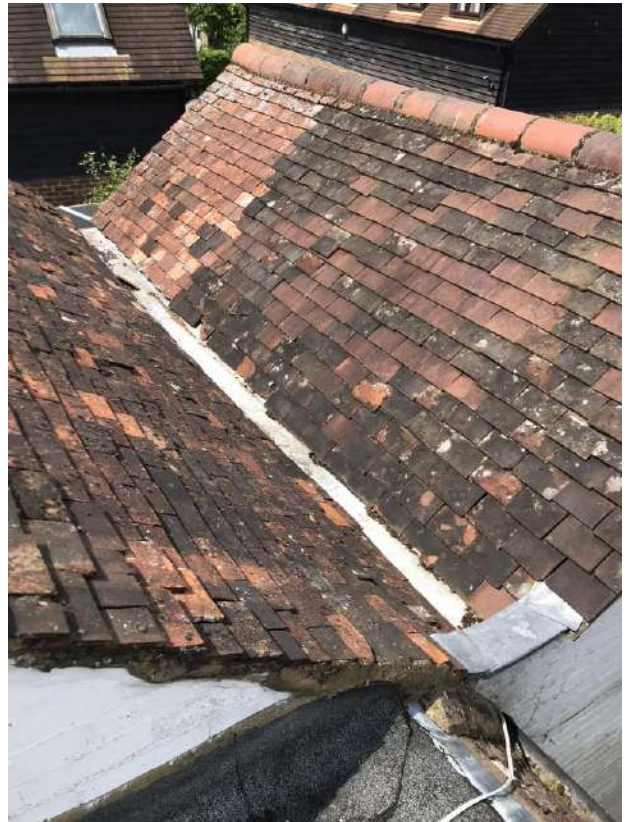
View from the outer lead valley gutter to no.5 between the two dual pitched roofs.

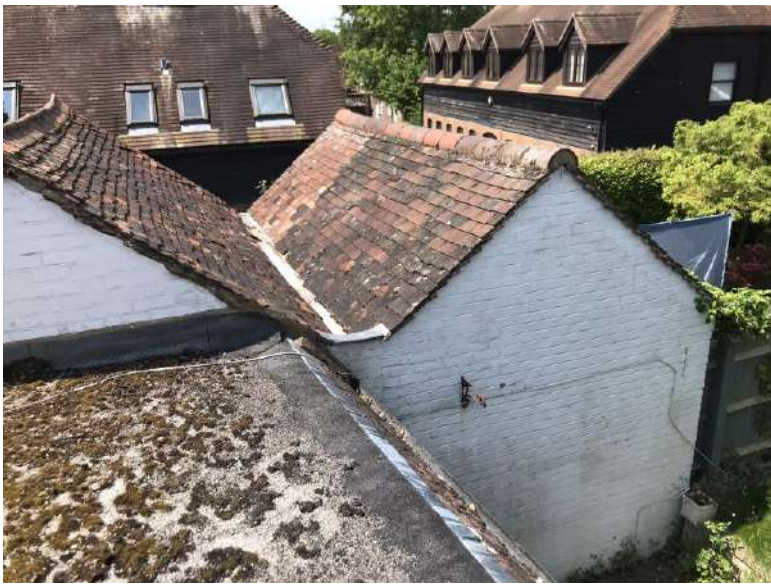
View from the site's rear extension roof towards the flanking wall to the rear extension to no.5

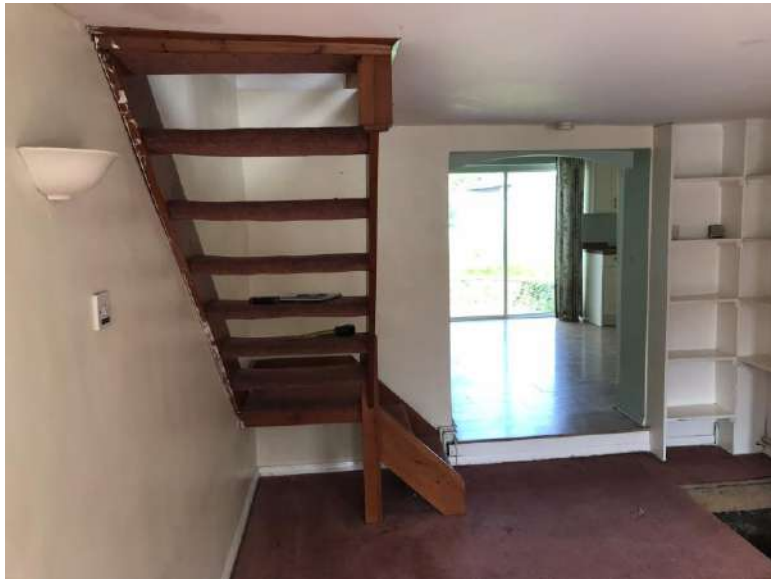
Internal view taken from the ground floor lounge to no.7 looking towards the back and showing the timber stair with its open treads and the opening in the rear wall leading to the kitchen extension.

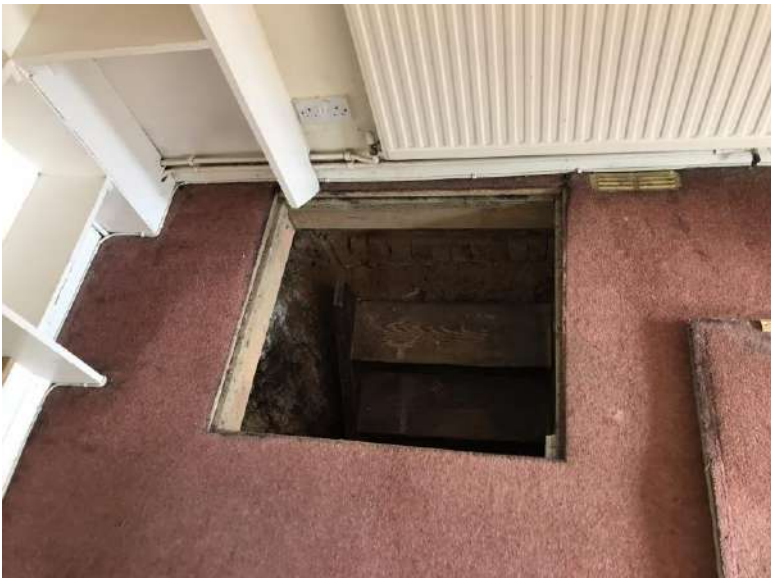
View of the floor opening leading to the steps down to the cellar under no.7

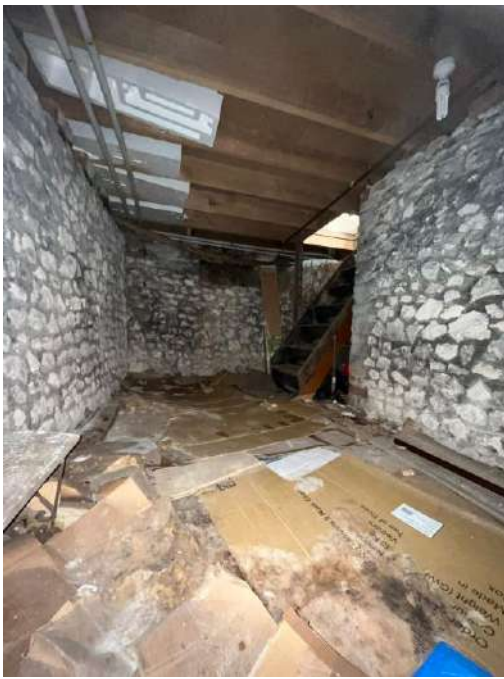
- There is a cellar under no.7, accessed through a floor hatch leading to timber steps. The cellar has very limited headroom and is not fully tanked, with walls of a rough masonry and no natural light. It is currently used for storage, and it is not suitable for a habitable room.

Left – view of the cellar looking towards the staircase

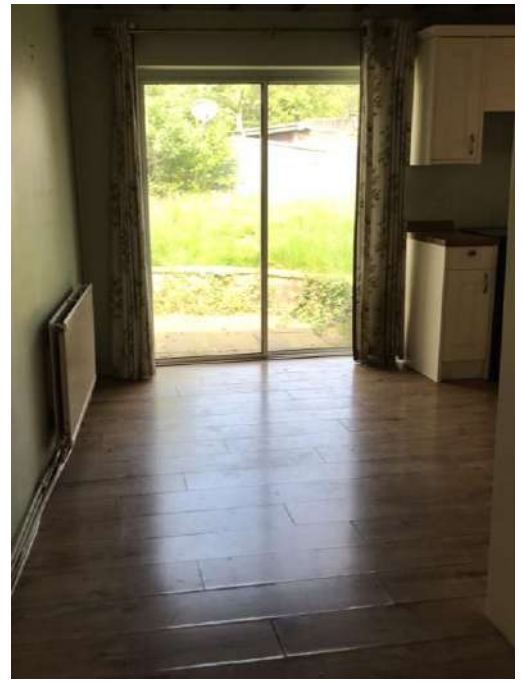
Right - Internal view of the kitchen extension looking towards the patio doors from the opening in the rear of no.7

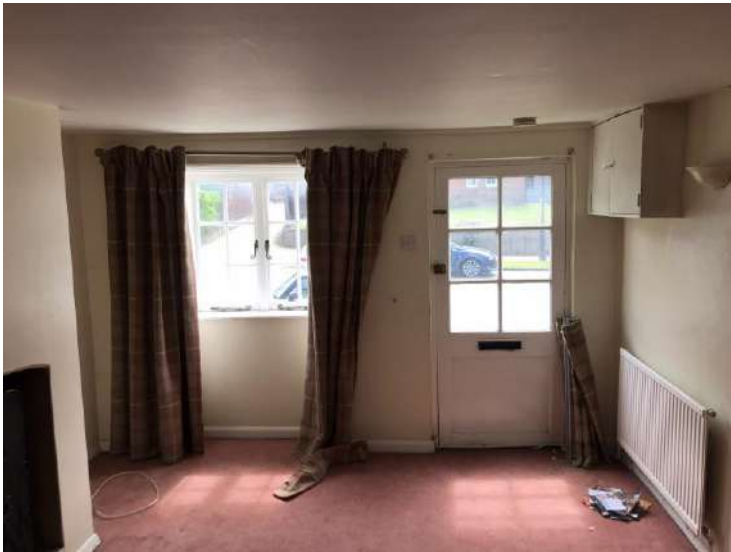
Internal view of lounge to no.7 looking towards the front entrance door and bay. The cupboard at high level adjacent to the door is housing the consumer unit.

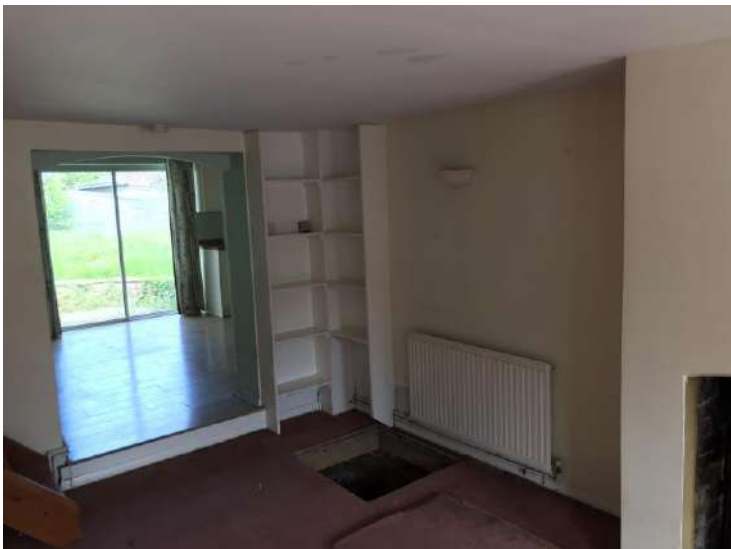
Internal view of lounge to no.7 looking towards the opening to the kitchen and the floor hatch to the cellar. The shelves to the corner are either side of the boxing to the vertical drainage pipe.

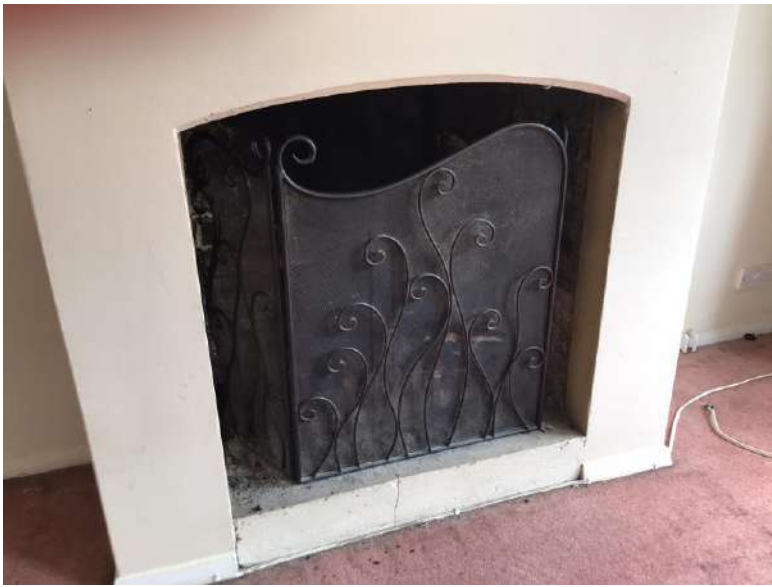
View of the ground floor fireplace to no.7, showing no mantel piece of decorative grate.

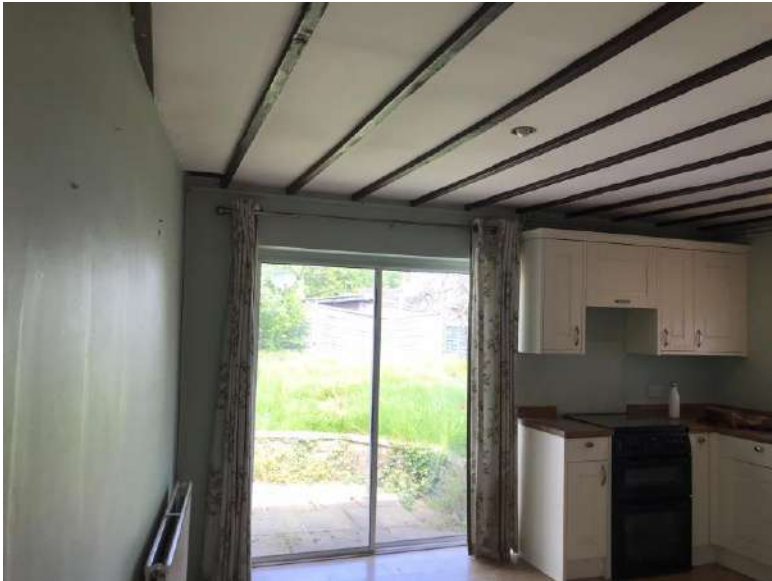
View of the rear kitchen straddling the back of both dwellings. The ceiling is plasterboard with exposed rafters that have been stained.

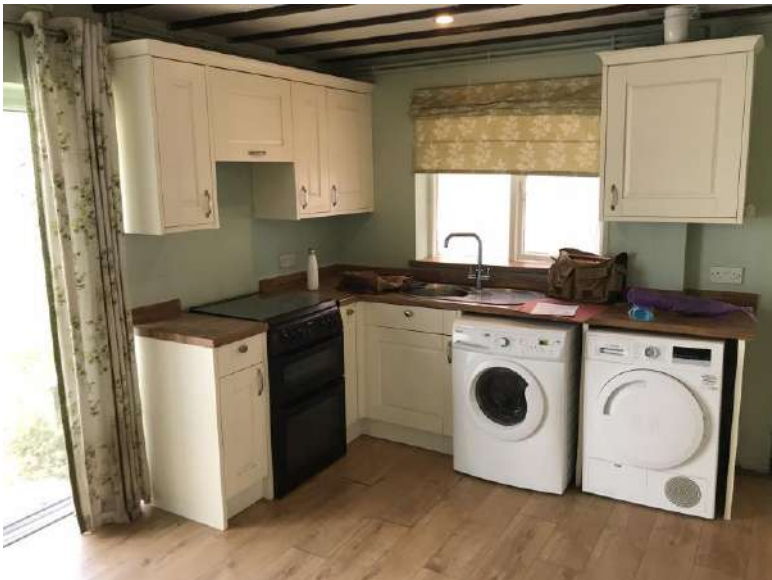
View of the rear kitchen units and the side window facing the passageway with no.11

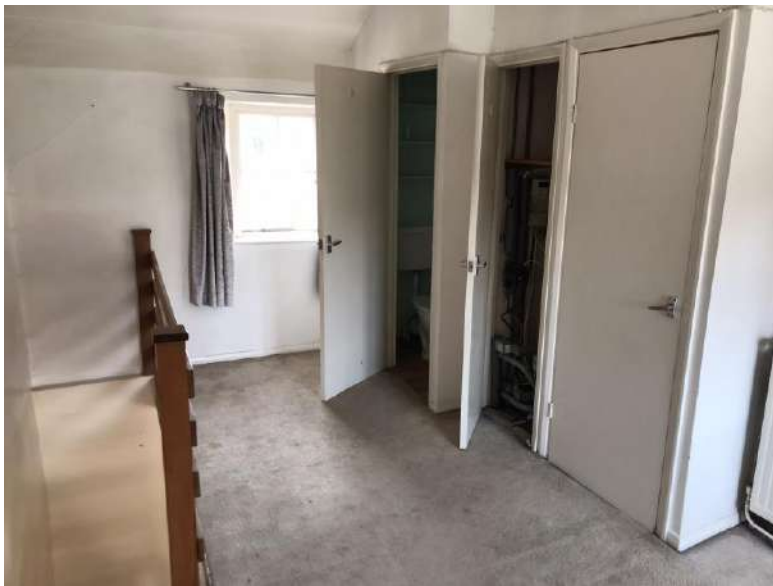
View of the first floor to no.7 looking towards the back and the rear window and staircase. To the right are a series of small rooms/ cupboards containing a wc, hot water cylinder and shower.

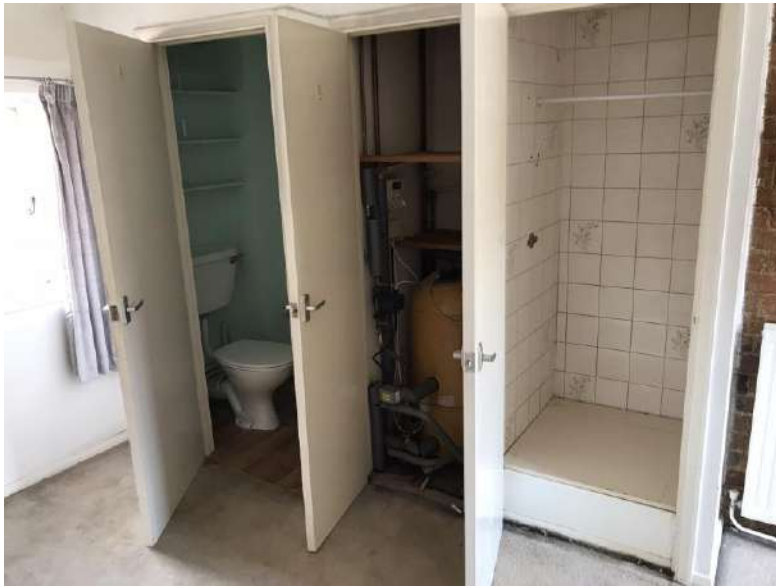
Closer view of the series of small rooms/ cupboards containing a wc, hot water cylinder and shower, all open to the room

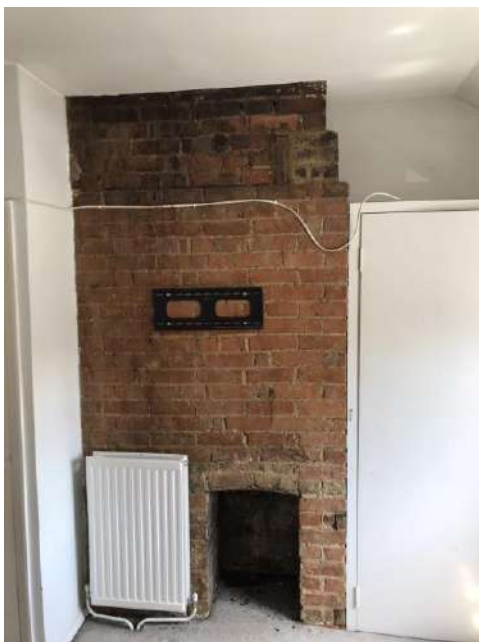
Left – view of the original chimney stack to the first floor room to no.7 and small open fireplace, with a cupboard to the right.

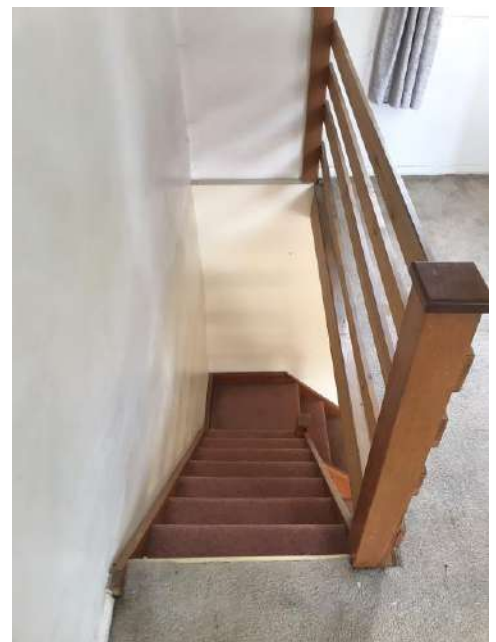
Right – view down the staircase to no.7. The stair was most likely installed as part of the works to build the rear extension and replaced the original stair.

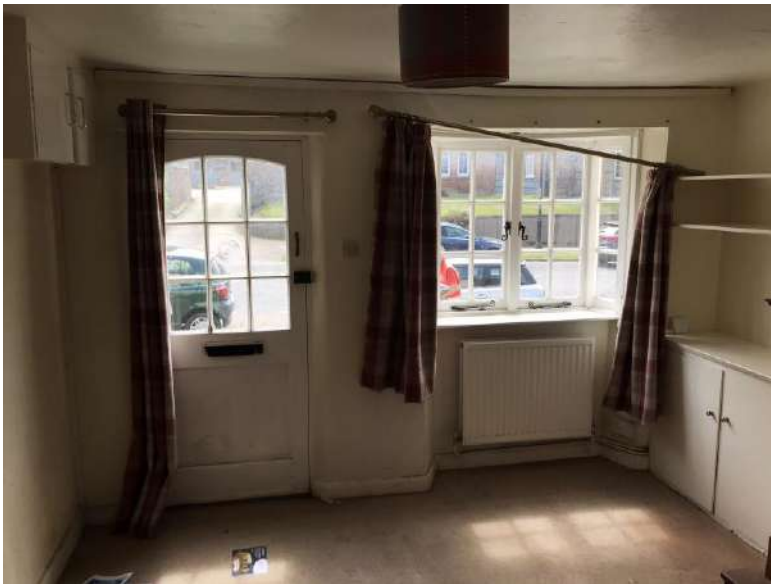
Internal view of the ground floor lounge to no.9, looking towards the entrance door and bay window

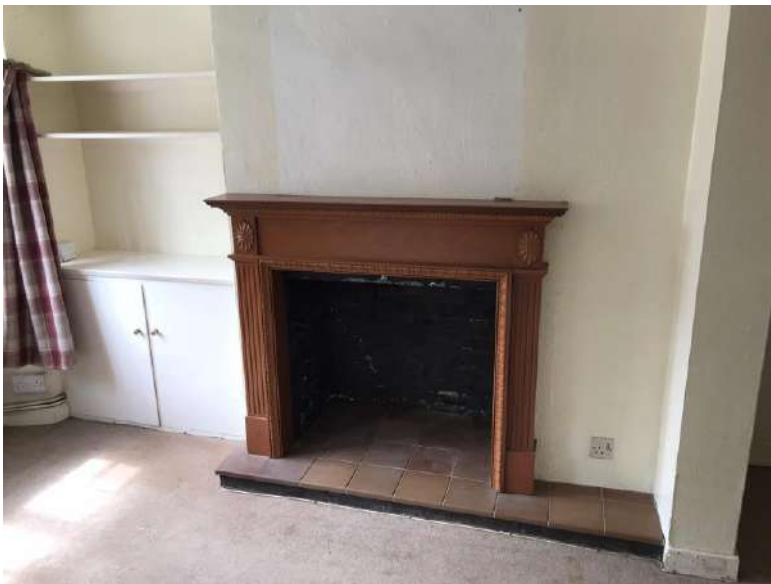
Internal view of the ground floor lounge looking towards the fireplace and chimney stack. The mantelpiece is modern, dating to the 1970s or 1980s. A low level cupboard and shelving, again, a modern addition is visible to the left.

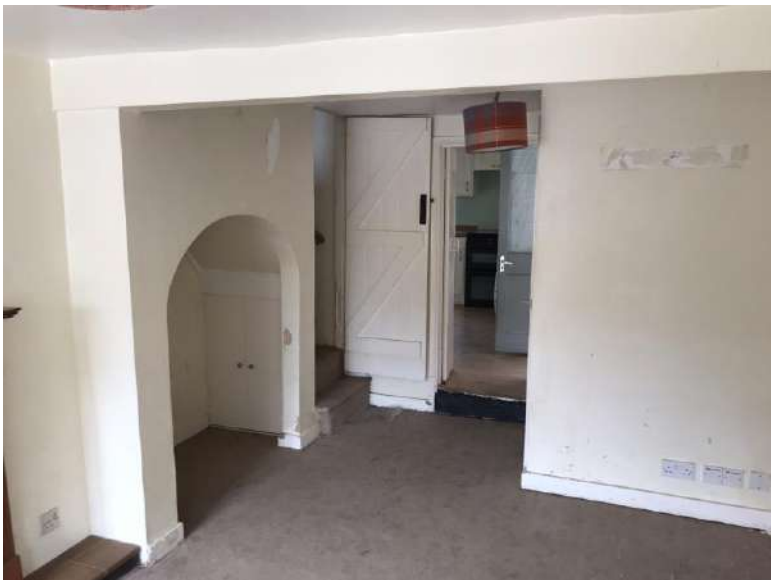
Internal view of the ground floor lounge looking towards an open recess under the staircase. The door to the stair is visible to the centre of the picture, with the wall to the wc to the right. To the background is the opening into the single kitchen straddling both properties

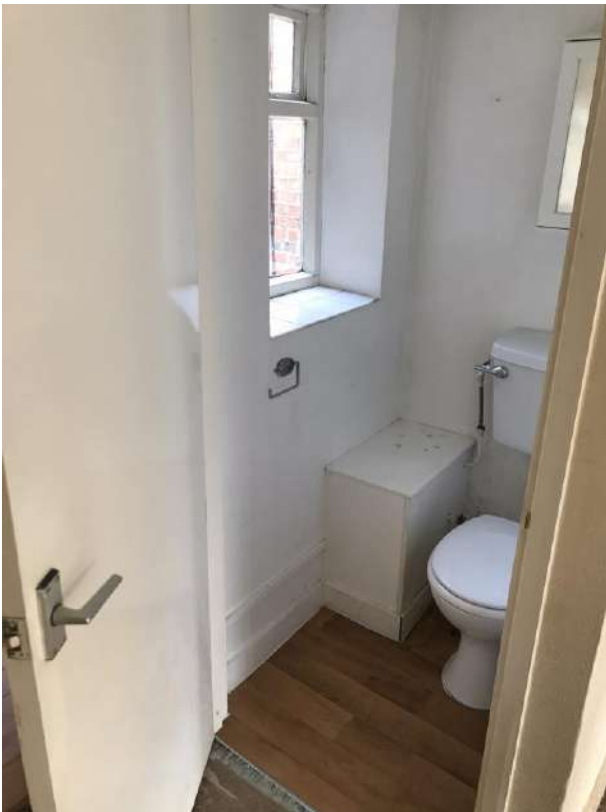
View of the ground floor rear wc to no.9, accessed directly off the main lounge space. The room is served by a small rear window.

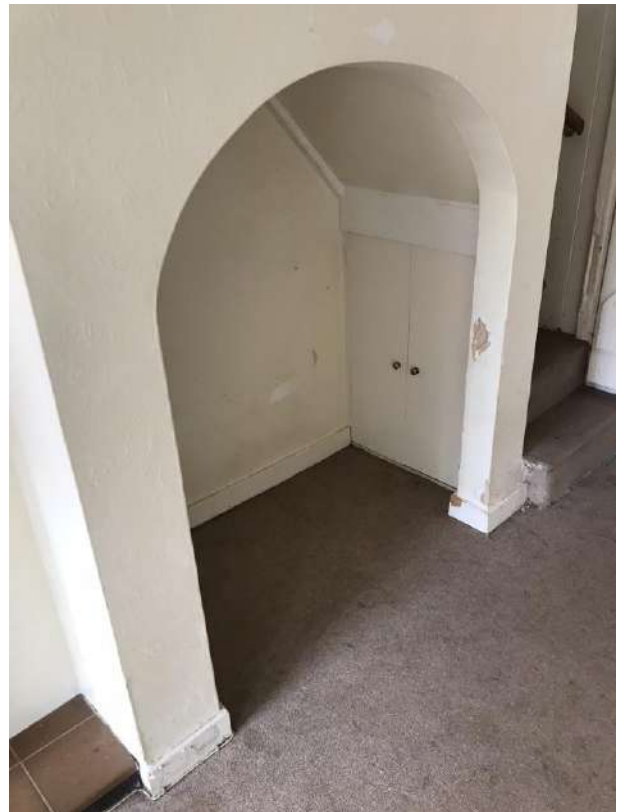
View of the arched opening to the recess under the stairs, with a small storage cupboard under the lower steps

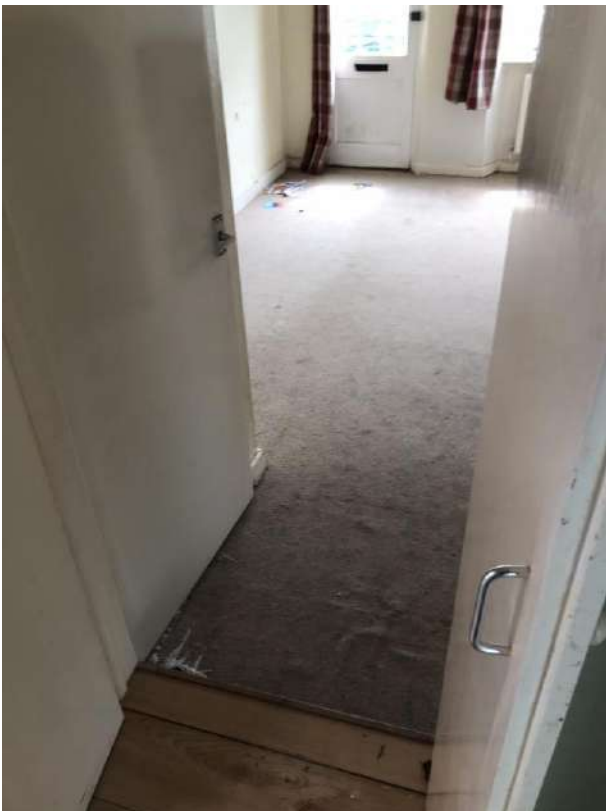
Opening and step into the lounge to no.9 from the kitchen, with the door to the wc to the left and the stairs to the right (obscured)

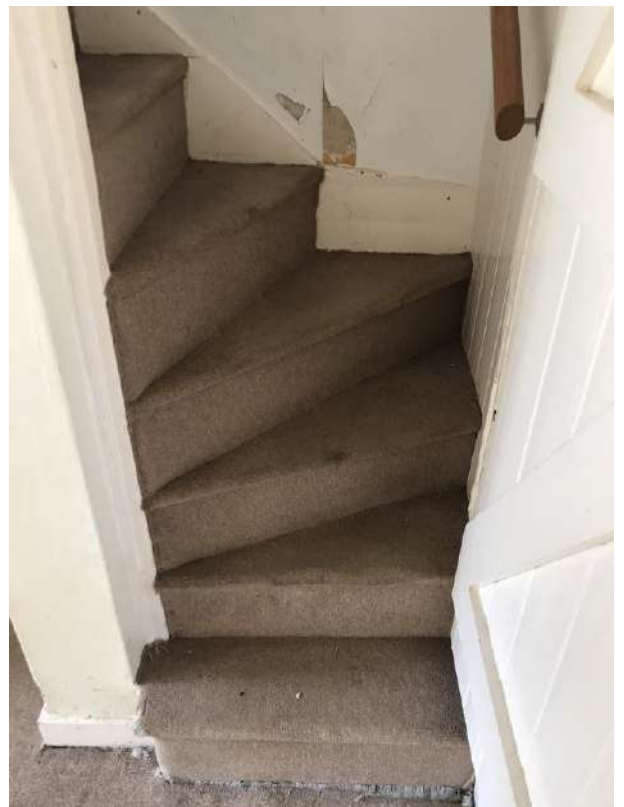
Base of the stairs to no.9, with the door at the first tread

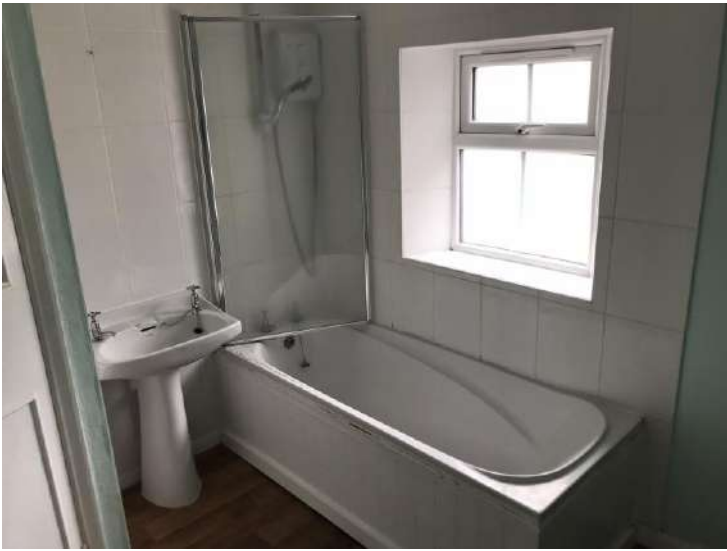
Internal view of the bathroom to the first floor of no.9, showing the bath and sink, with the back Upvc window

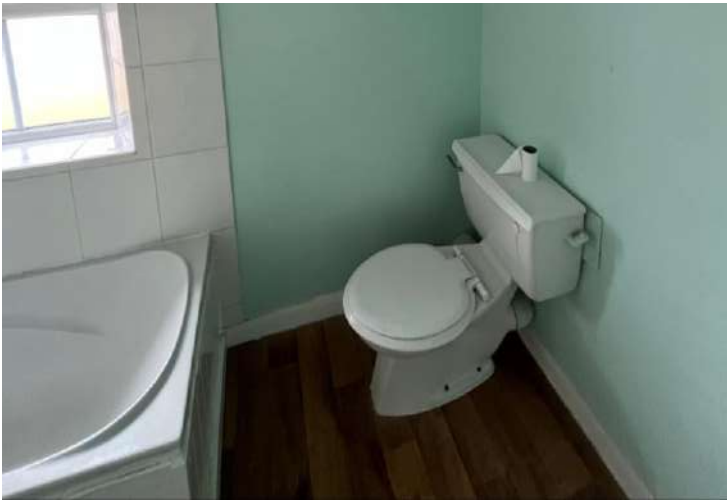
Internal view of the bathroom showing the wc with drainage running straight through the back wall to an outside vertical drainage pipe

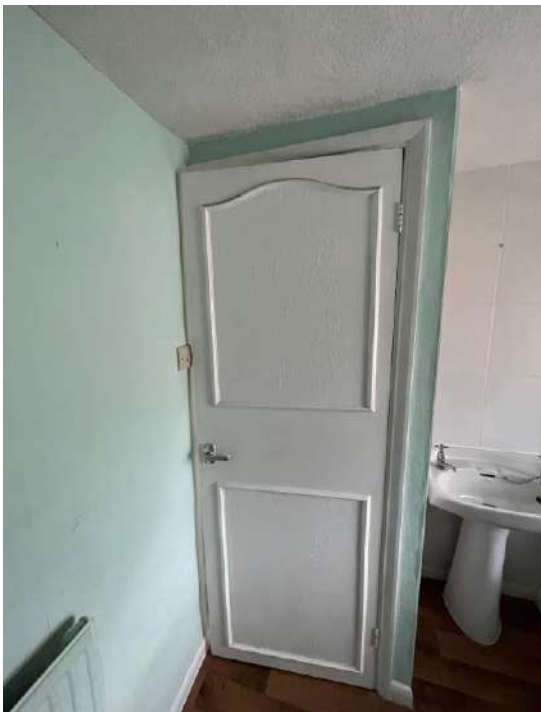
Left – view of the door from within the bathroom

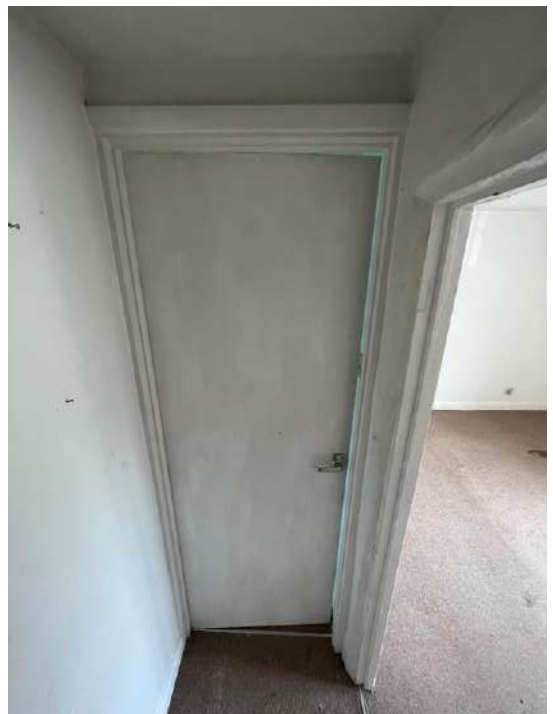
Right – view of the door from within the small landing

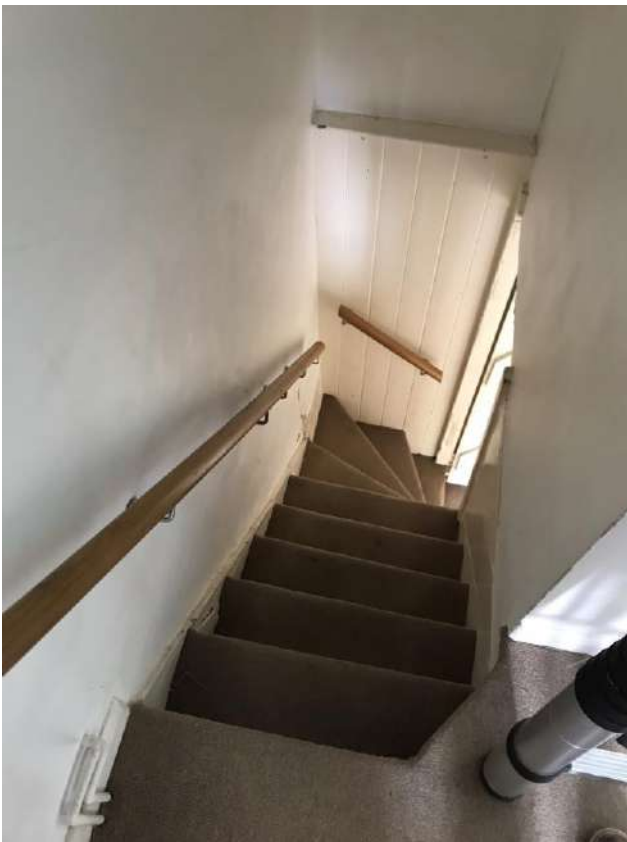
View down the stairs to no.9 from the first floor landing.

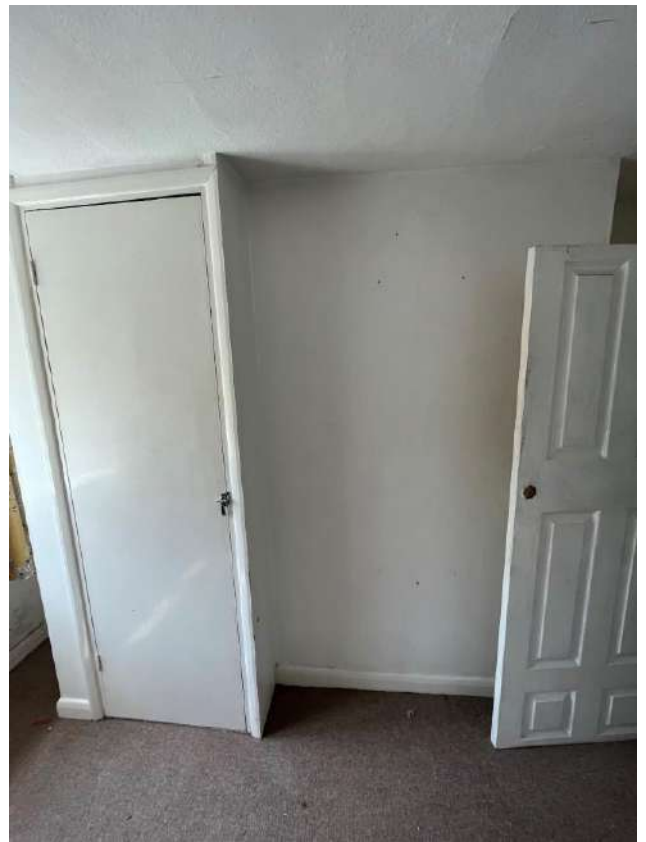
View from the first floor bedroom to no.9 showing the store cupboard and door.
