1.0 Site Analysis and Evaluation

1.1 Site Analysis

1.2 Site Photographs

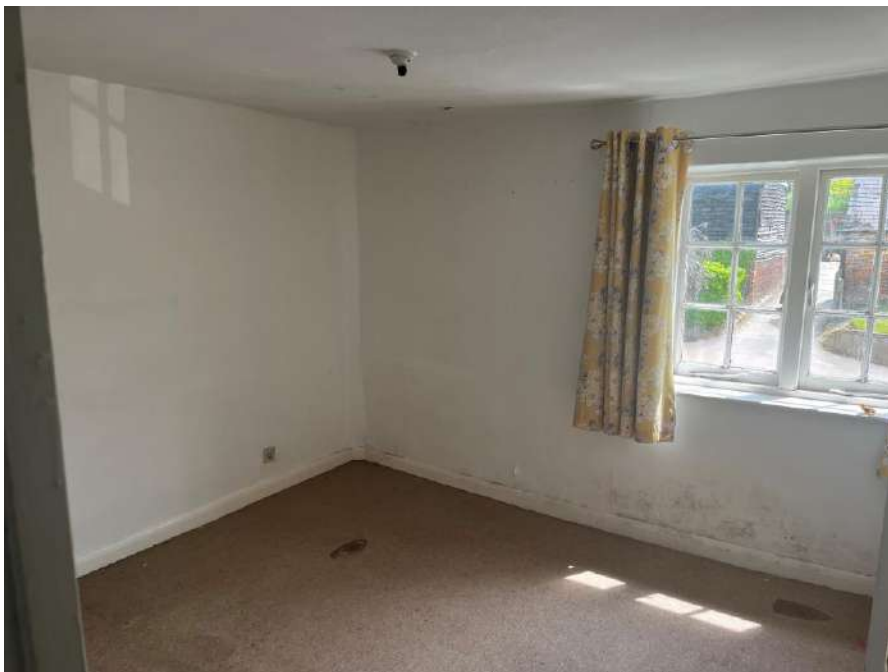
View from the first floor bedroom to no.9 showing the front wall and front window

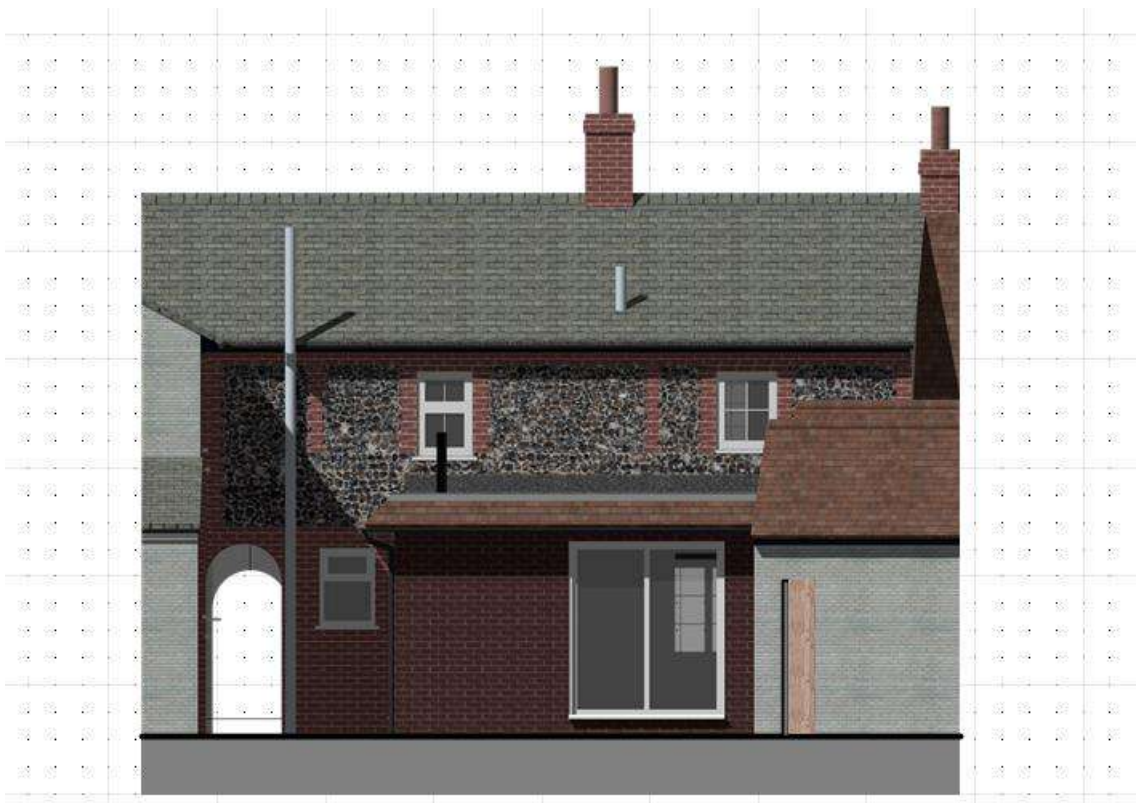
Rear elevation showing the current extension dating from 1988.
