Bat Survey and  
Assessment

Dingly Dell, Furneux Pelham, Hertfordshire

Report ref.:  
KHA101/R001V1

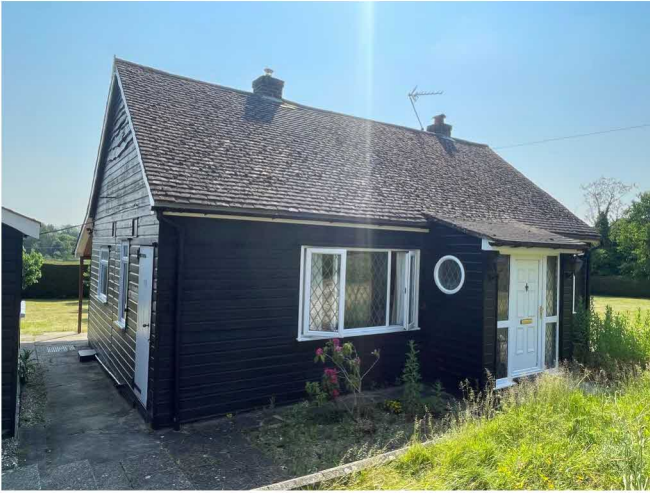
Photograph 1: Front elevation of Dingley Dell

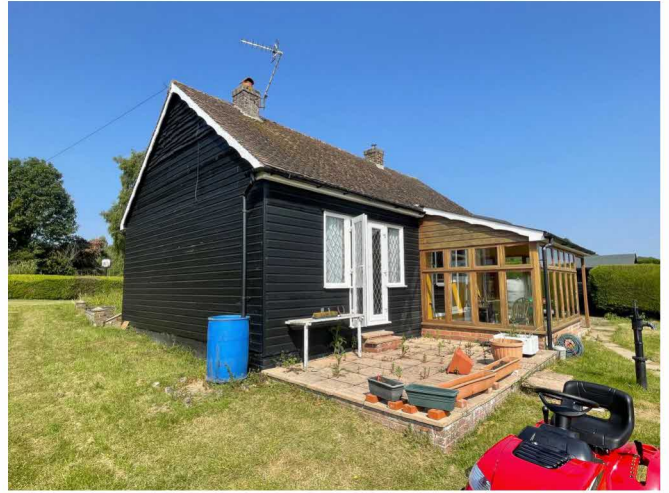
Photograph 2: Rear elevation of Dingley Dell

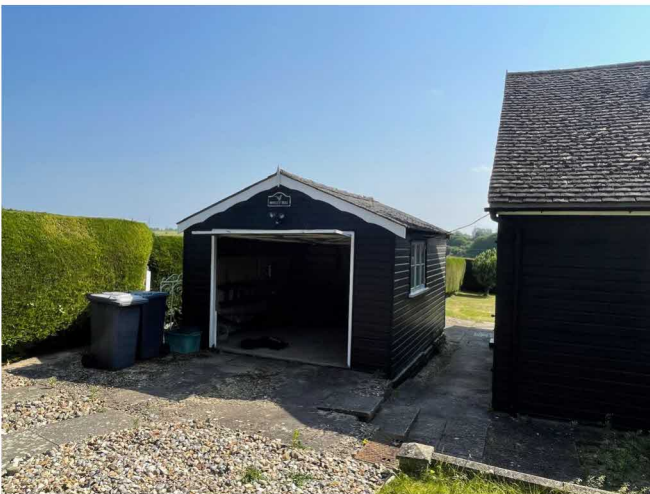
- 4.2.3 No bats or evidence of bats was recorded within the detached garage. However, gaps were recorded under the ridge, eaves and the barge board which may provide access to suitable roosting crevices. The detached garage was assessed as having low potential to support roosting bats. The shed and

Photograph 3: Detached garage

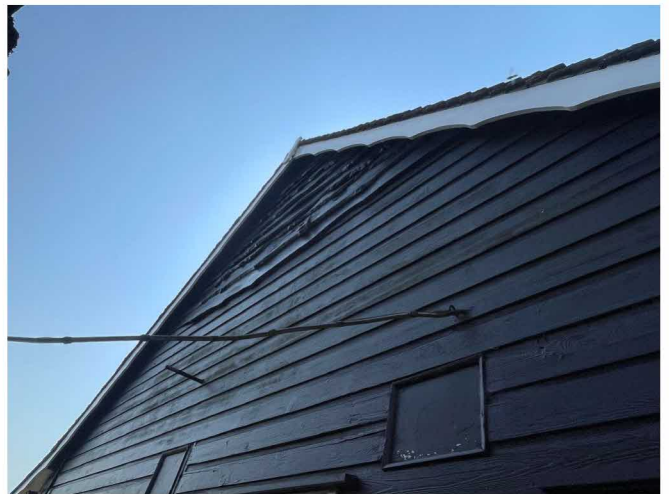
Photograph 4: Wane edge boards on Dingley Dell

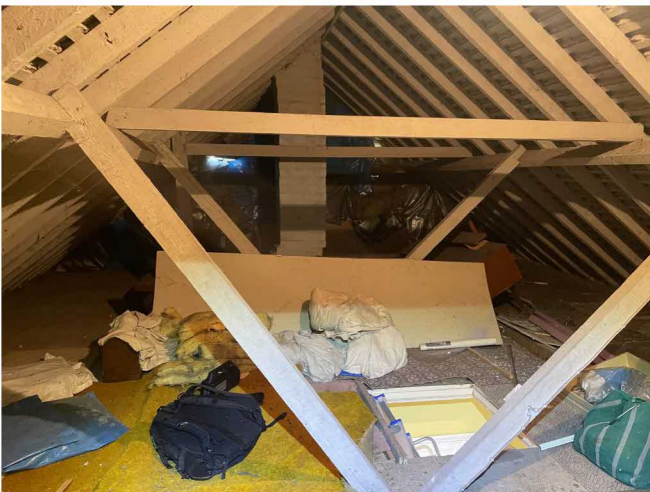
Photograph 5: Loft void within Dingley Dell

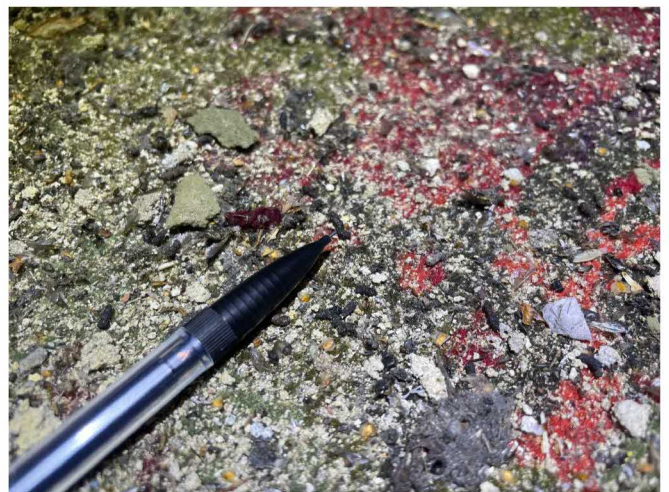
- 4.2.2 No bats were recorded within Dingley Dell; however, approximately 500 mixed age droppings (characteristic of those produced by brown long-eared bats) were recorded throughout the loft void, indicating the presence of a brown long-eared day or transitional roost (Roost 1). Several high-quality access points and potential roosting features were also recorded during the inspection, including gaps under waney edge boarding, gaps under lead flashing and gaps under roof tiles. As well as being confirmed as a day / transitional roost, the property was assessed as having high potential to support further day/ transitional roosts and moderate potential to support a maternity roost and/ or hibernation roost.

4.4.1 The number and age of brown long-eared droppings recorded during the building inspection confirm the presence of brown long-eared day or transitional roost within the loft void of Dingley Dell (Roost 1). The fact that no brown long-eared bats emerged during any of the emergence surveys indicates that the roost is used infrequently, most likely by a low number (<5) of bats. Brown long-eared day/ transitional roosts are considered to be of low conservation value<sup>10</sup>. The results of the survey indicate the likely absence of a brown long-eared maternity roost within the property. However, as brown long-eared bats are known to use buildings year-round, the presence of a brown long-eared hibernation roost cannot be ruled out.

Photograph 6: Bat droppings within loft void of Dingley Dell

One improved cavity bat box (or a bat box of a similar specification) should be installed on a suitable nearby tree or structure prior to the demolition of Dingley Dell, to provide a alternative roost for brown long-eared bats. The bat box will be installed at least 3m from ground level (where possible) with the entrance free from obstruction and not lit by external lighting.

Therefore, roosting features will only be removed from Dingley Dell between 1 April and 31 October. Roosting features will only be removed in suitable weather conditions (no heavy rain or high winds) and once overnight temperatures have been above 8°C for at least three consecutive nights.

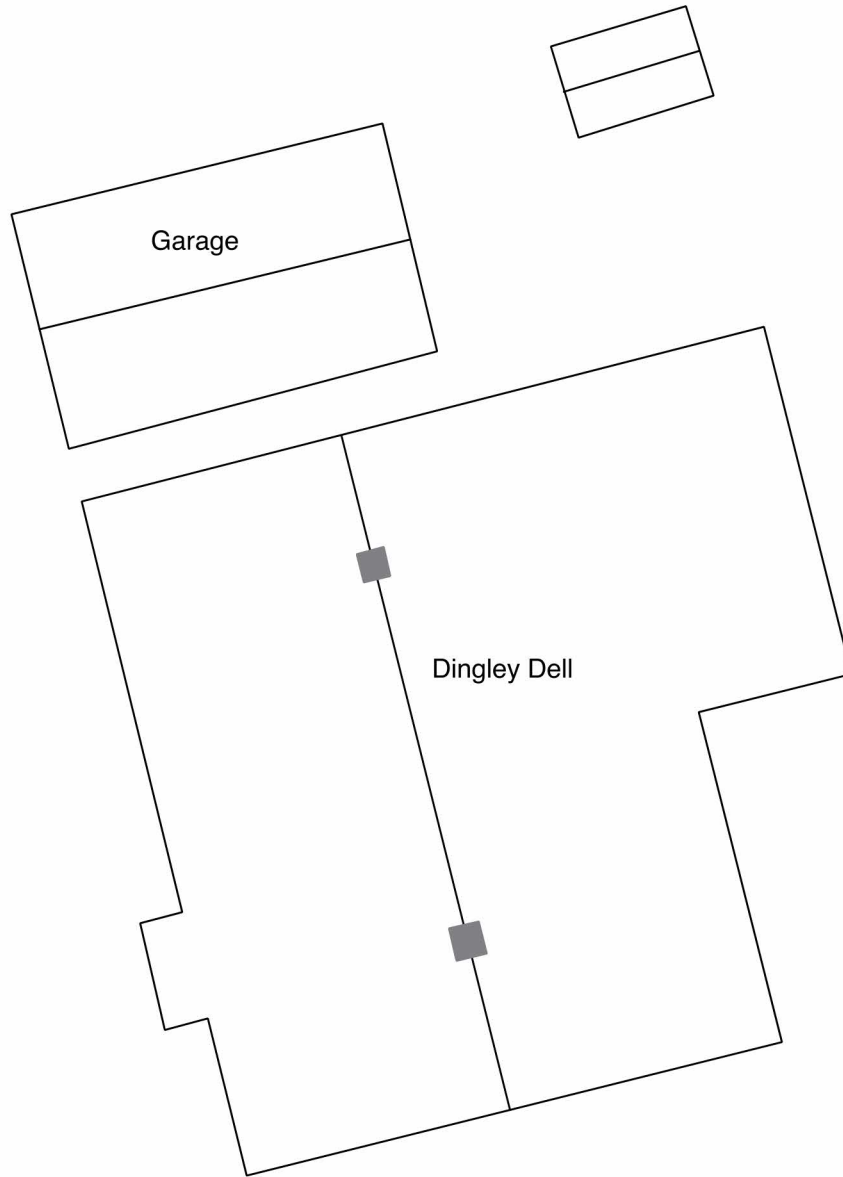
Figure 4.  
Surveyor locations during emergence surveys

4.3.2 Surveyor locations are shown in Figure 4 in Appendix A and incidental records of bat activity are provided in Table 4.

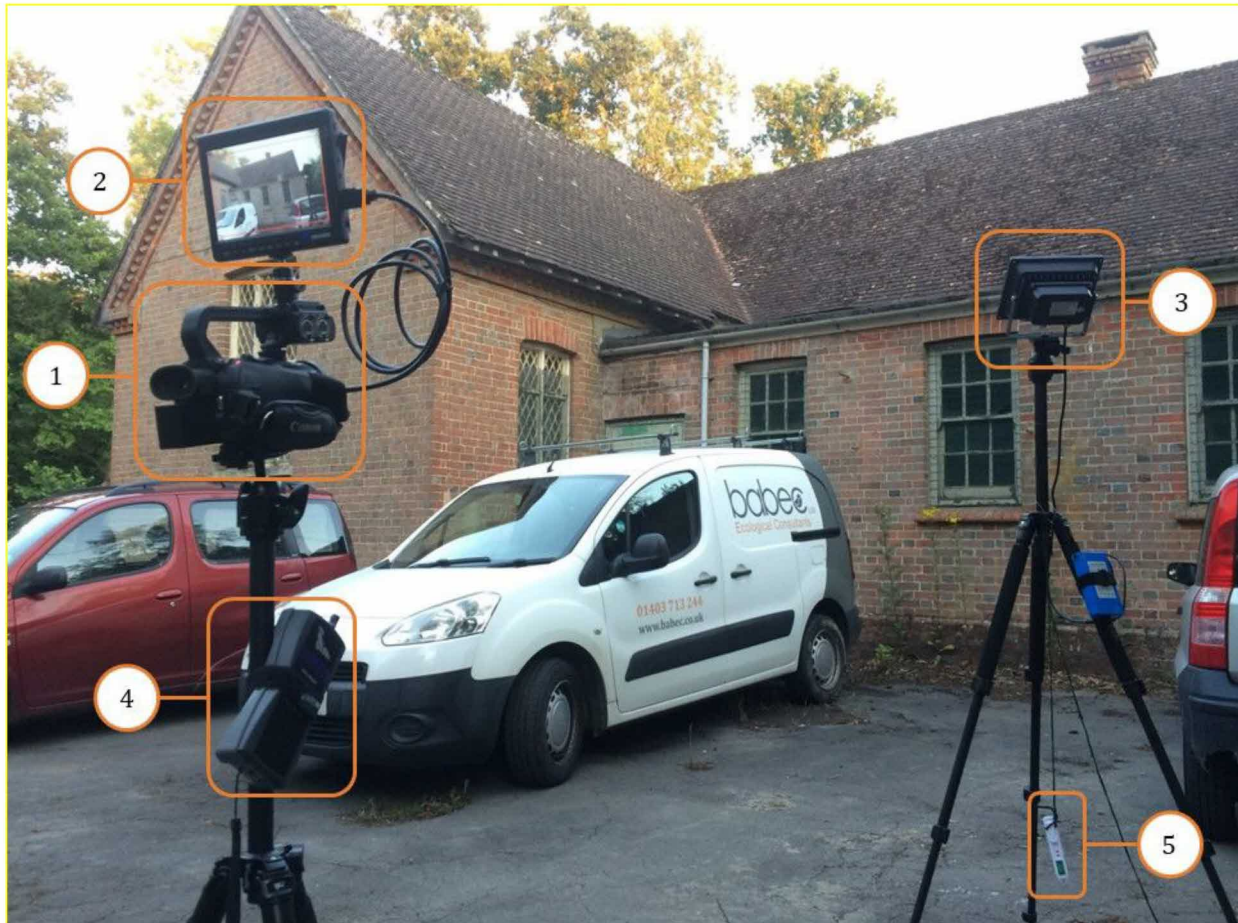
In accordance with Bat Conservation Trust's interim guidance note<sup>13</sup> on the use of night vision aids (NVAs), NVAs were used at each surveyor location on each survey visit. NVAs comprised a Canon XA series video camera equipped with infrared lamps. Surveyors were also equipped with a full-spectrum Elekon Batlogger M bat detector. An example of the equipment used by Babec Ecological Consultants during emergence surveys is provided below:

1. Canon XA series camcorder 2. Screen 3. Infrared floodlamp 4. Batlogger-M 5. Thermometer
