Gardenstown, Banff, Aberdeenshire, AB45 3JQ. Ms R. Stuart & Mr W. Moir.

No 53 Crovie Village,

Internal Alterations

PROPOSAL Dwg.

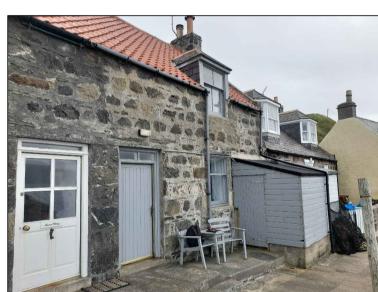
Front Elevation.

The house has two front windows and a front door, shown grey in the photo to the left, it also has two lower level windows to the rear, shown blue in the photo to the right. It's my clients intention to replace these windows with like for like timber true sash and case heritage double glazed windows to the front and with timber casement double glazed windows to the rear. The windows are to be painted white to match those of the neighbouring No54 semi-detached house. The front door is to be replaced with Farrow & Ball "Skimming Stone" code 241 (or equal and approved) coastal coloured door to match the styling of that of the neighbouring No54 semi-detached building on the left, as seen in the left photo. The lower panel of previously agreed with Shaun Norman. The timber lined shed will be painted the same colour to match the door. This colour has yet to be communicated to the Historic Environment team for approval before paint is ordered. New rear timber door and catslide roof fascias all to be white, the catslide roof pan tiles to be reused existing riles, the haffits to have new pan tiles to match the roof in profile and colour; terracotta (pan
