HEMPYARD BRIDGE, IXWORTH (219)

Biodiversity Enhancement Plan

Project Name	Hempyard Bridge		
Document Reference	5101354-MIL-SBR-ZZ-RP-LE-7003_S2_P01 Biodiversity Enhancement Plan		
Contract No.	Suffolk Highways		
Project Address	Hempyard Bridge, Ixworth		
Project Start Date	TBD		
Project Duration	TBD		
Prepared By	Ann Sherwood	Sign:

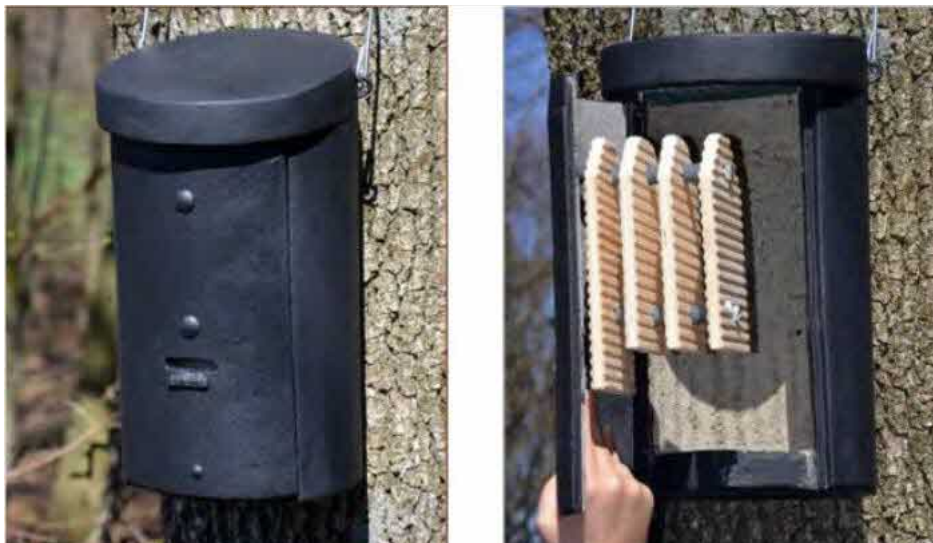
Figure 2. Typical woodcrete bat box.

- 2 x Schwegler 2F – Universal bat box for summer use for a variety of bat species
- 2 x Schwegler 2FN – Large bats such as noctule bats
- 2 x Schwegler 2FS – Large bat colony box suitable for small bats such as natterer, whiskered, daubenton and all species of pipistrelle bats.

Figure 2 shows an example of a Schwegler 2FS bat box.

Six woodcrete bat boxes will be installed on suitable trees to be identified by the ecologist. Woodcrete bat boxes have been selected as these are highly durable lasting years and provide a stable environment.

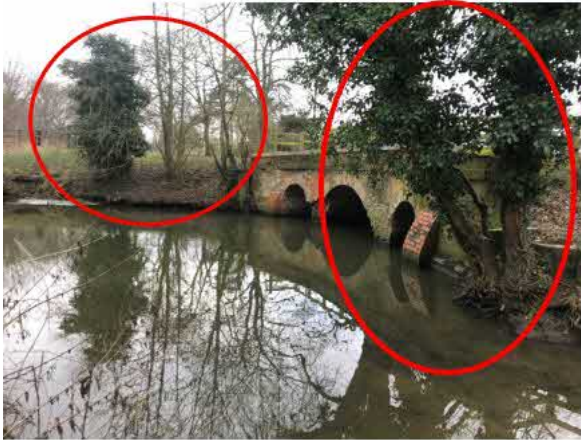
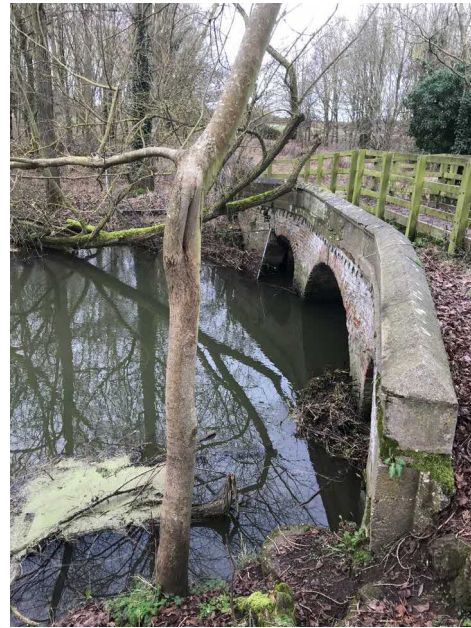
Photo's 1 & 2. Trees to be removed

The trees to be removed are shown in Photos 1, 2, 3 & 4 below and an application for the protected tree works (protected by virtue of being in the Conservation Area of Ixworth) in accordance with the Town and Country Planning Act 1990 has been made to SCC. .

A total of nine trees/shrubs have been identified for removal. The large black poplar will be retained. Tree removal is required to enable access to the bridge structure and to remove trees that if left in situ could compromise the bridge structure in the future.

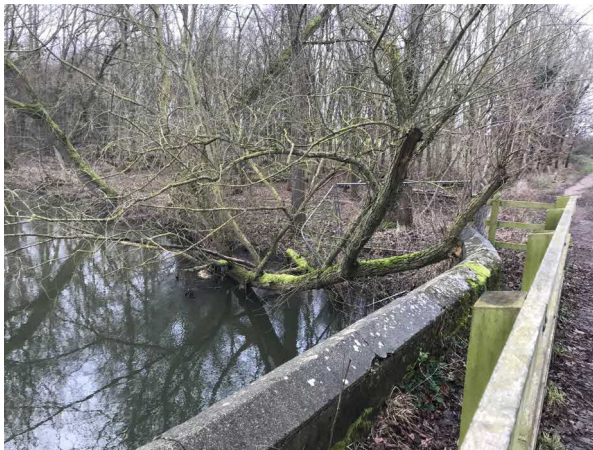
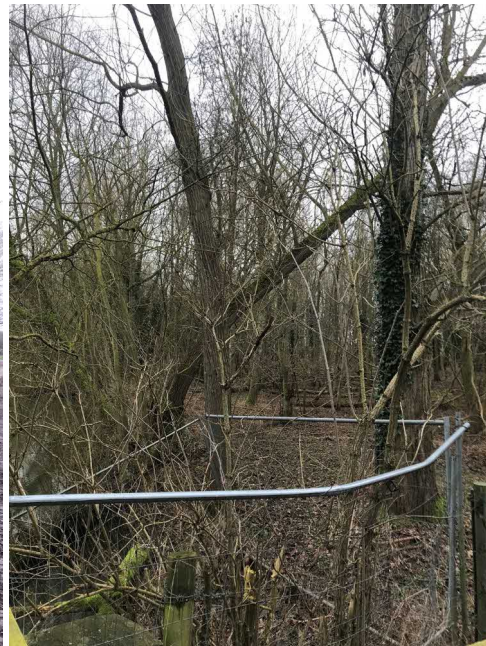
Photos 3 & 4. Willow to be cut back and small trees/shrubs to be cleared around willow.

Photo 4 shows the willow branches that need to be removed. Stumps will also be removed where this is required. The trees/shrubs to be removed were all assessed as having negligible potential to support roosting bats, being young with no obvious suitable roosting features. The feature seen on the ash tree in Photo 4 did not provide opportunities for roosting bats being a shallow wound.

Trees that to be cut back/coppiced will re-grow and provide multi-stemmed specimens with more cover at lower levels in the short term.
