# HEMPYARD BRIDGE, IXWORTH (219)

## Biodiversity Method Statement

Project Name	Hempyard Bridge		
Document Reference	5101354-MIL-SBR-ZZ-RP-LE-7002_S2_P01	Biodiversity	Method Statement
Contract No.	Suffolk Highways		
Project Address	Hempyard Bridge, Ixworth		
Project Start Date	TBC		
Project Duration	TBC		
Prepared By	Richard Hardeman	Sign: [Redacted]	Date: 25/01/2024
Reviewed By	Ann Sherwood	Sign: [Redacted]	Date: 25/01/2024
Approved By	Neil Carter	Sign: [Redacted]	Date: 01/02/2024

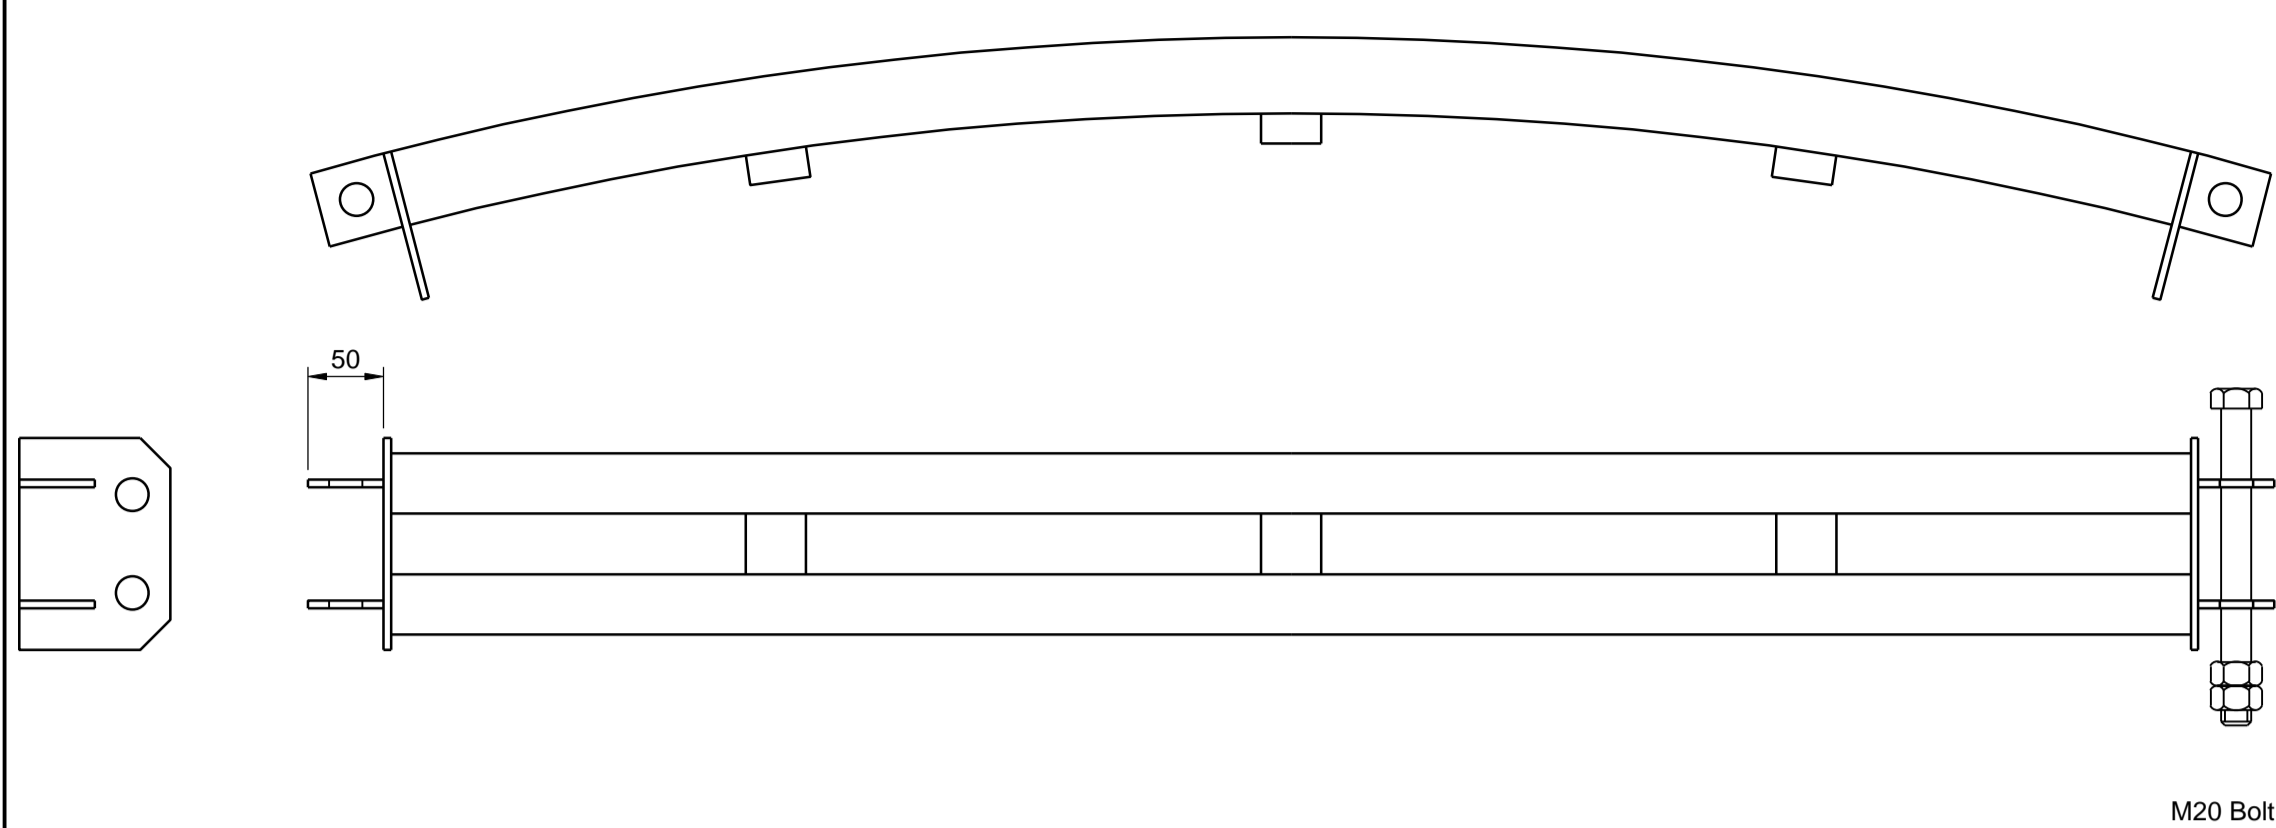
**Typical centring rib for upper haunch and crown replacement**

- b. The integrity of the brickwork surrounding the repair area is maintained using "retention laggings" supported with folding wedges on the centring ribs. This defines the spacing for the "construction laggings". Laggings are placed parallel to the brick course and secured in place with timber packing and folding wedges.

- c. This form of centring is only suitable for recasing repair area in the lower haunches and crown of minimal area and within which the exerted forces are considered negligible by the Employers Representative see drawing 60-20008-DR-0012

- d. Preformed and jointed steel ribs shall be used in the upper haunches and crown.
- e. Centring is not required in vertical walls.
- f. Ribs to be removed upon completion of repairs.

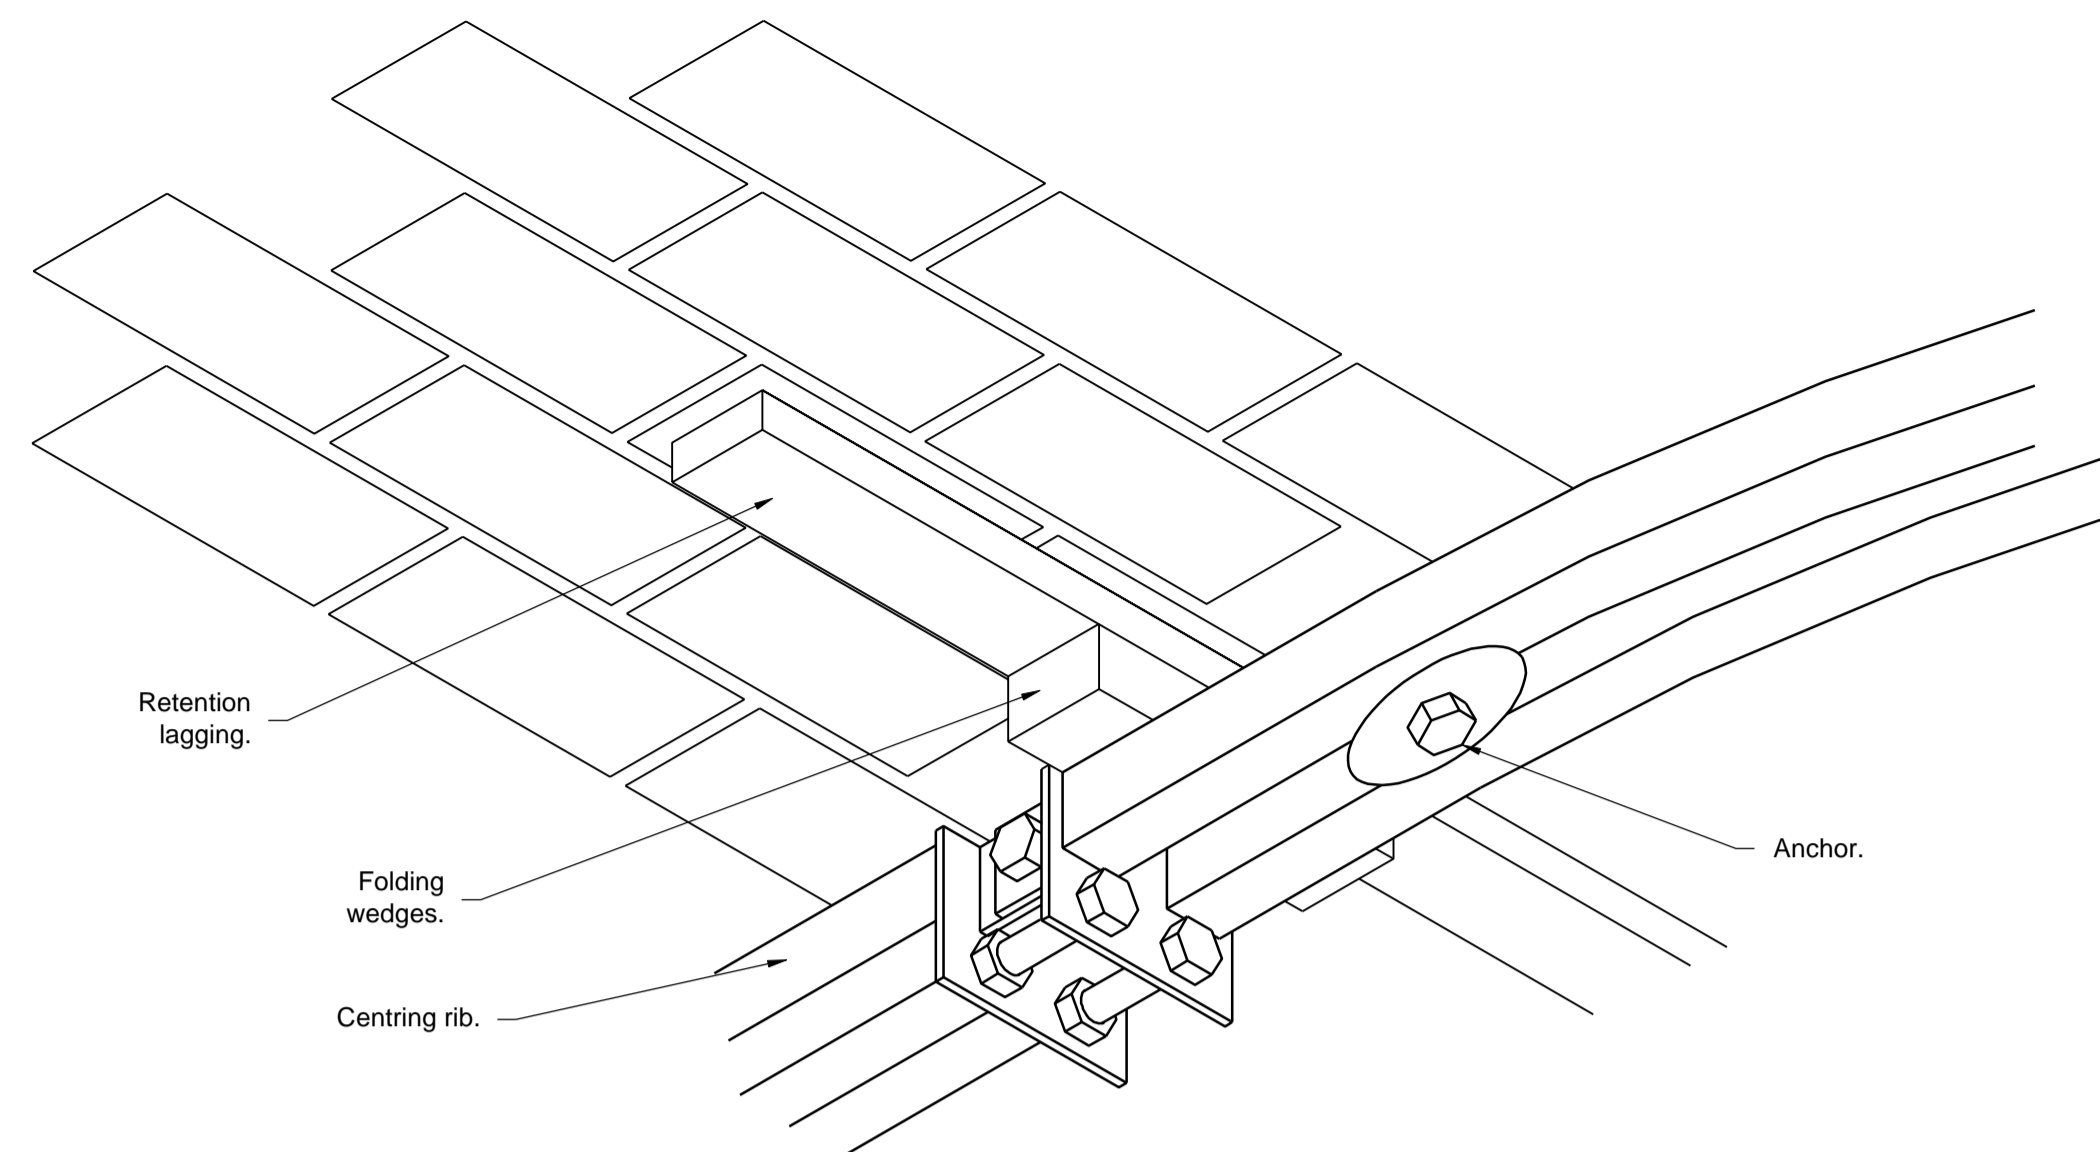
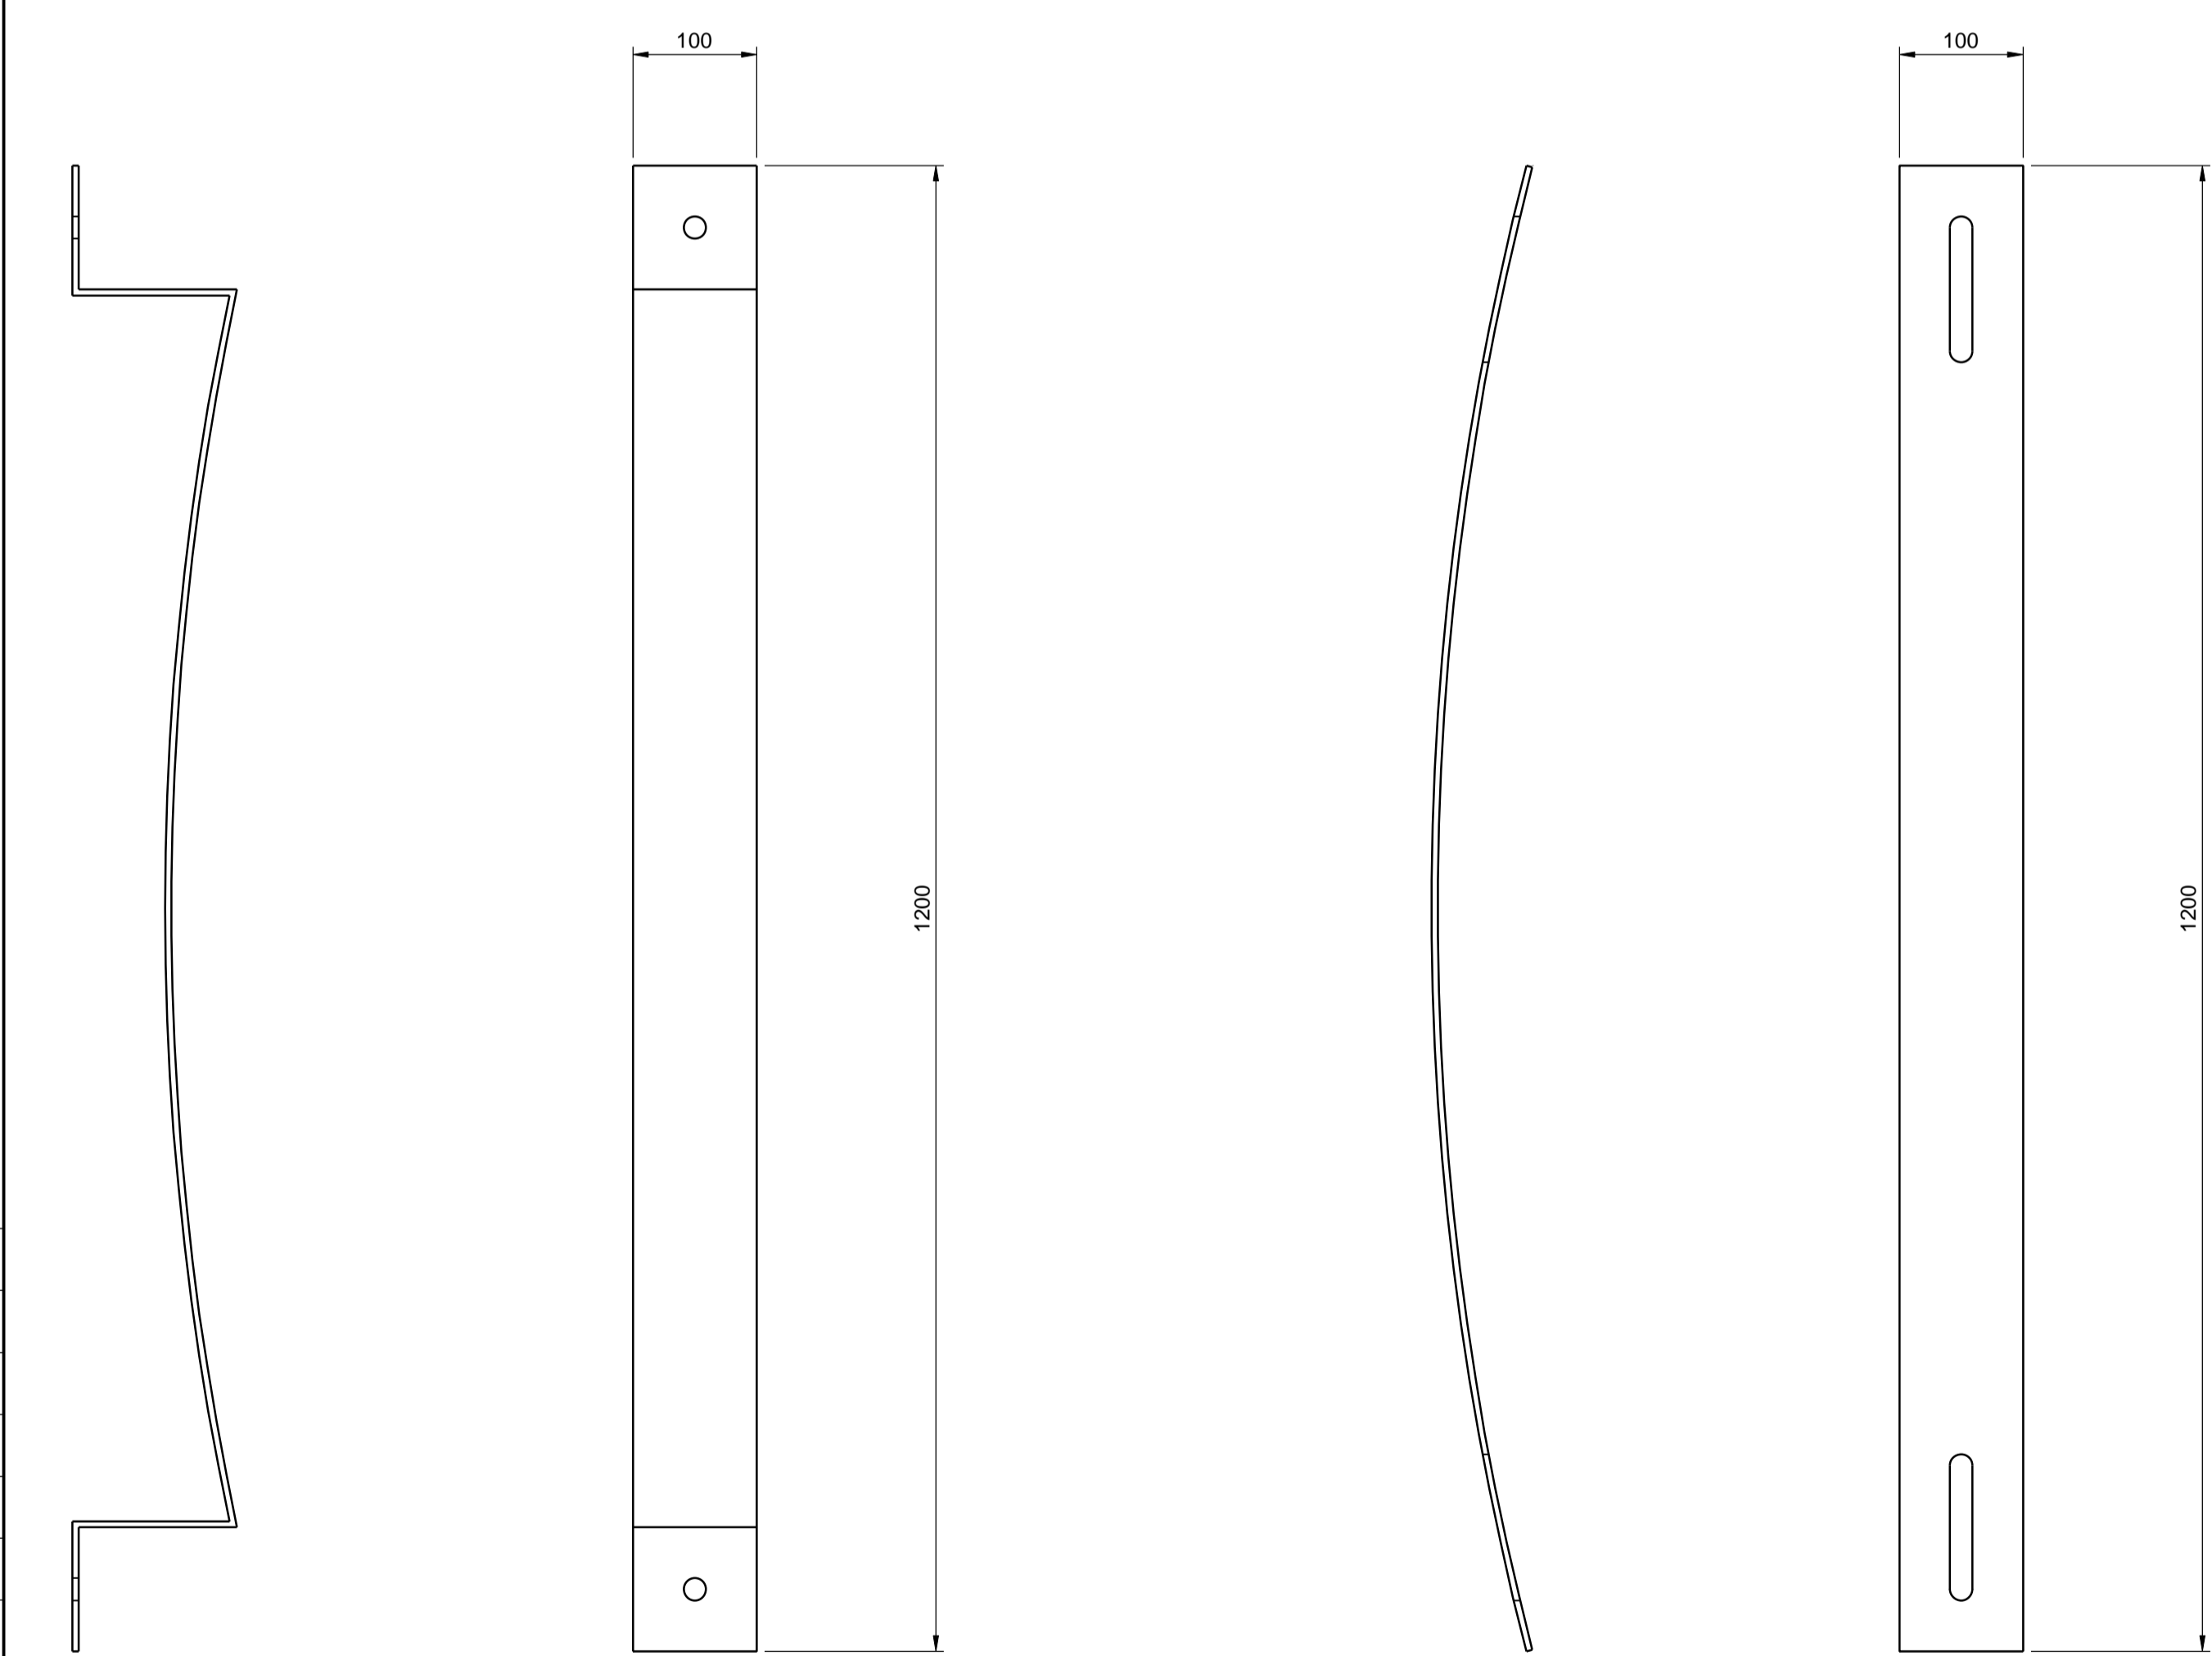
**Typical centring for lower haunch areas less than 1m<sup>2</sup>**

**Typical centring for lower haunch and single ring replacement (and long longitudinal areas)**

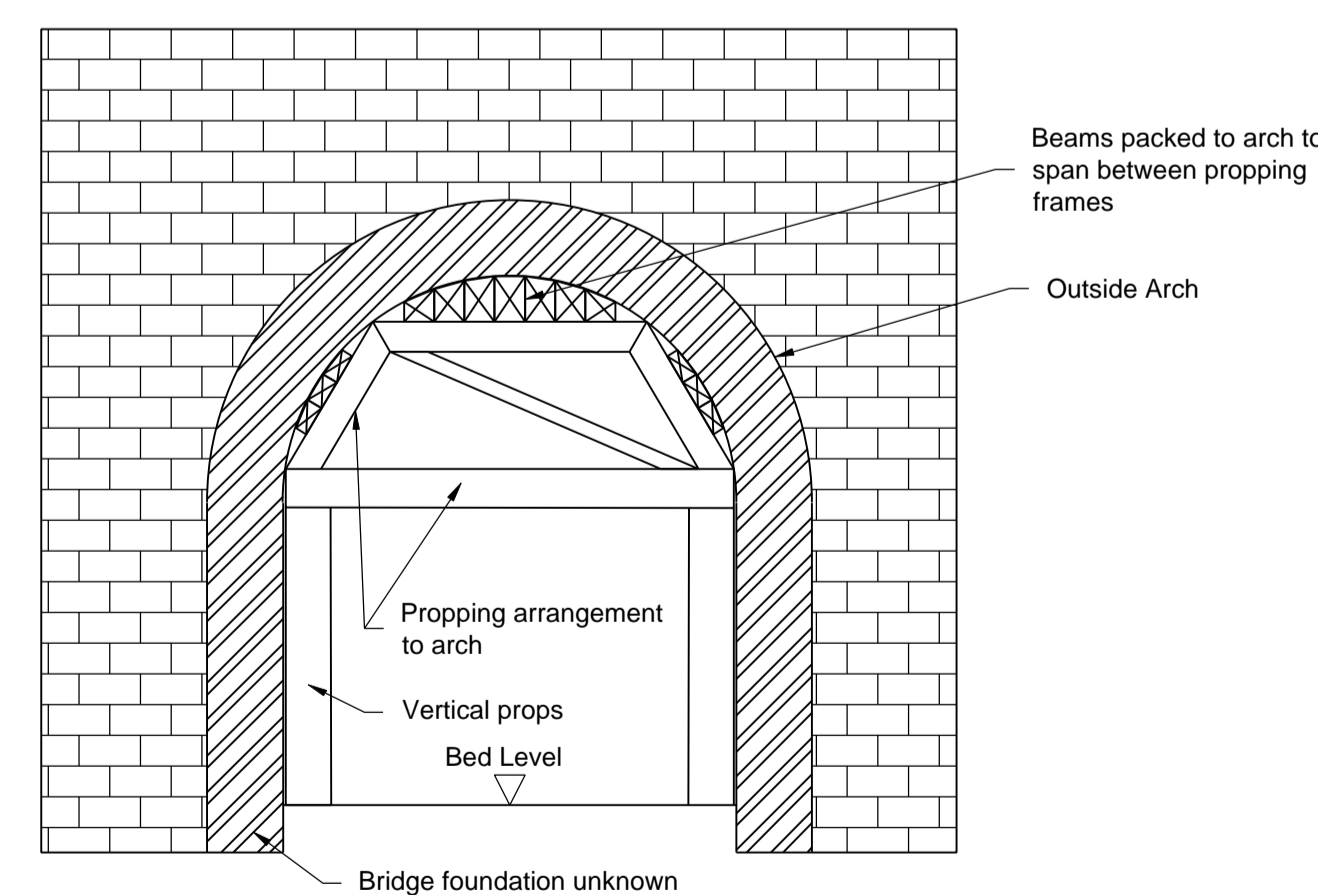
**Indicative Temporary Arch Support Proposal**

- Arch support required where abutments are being reconstructed to ensure stability in the temporary condition.
- Contact points with the arch intrados are to be packed with timber.
- Arch support frames to be installed at approx 1.0m centers.

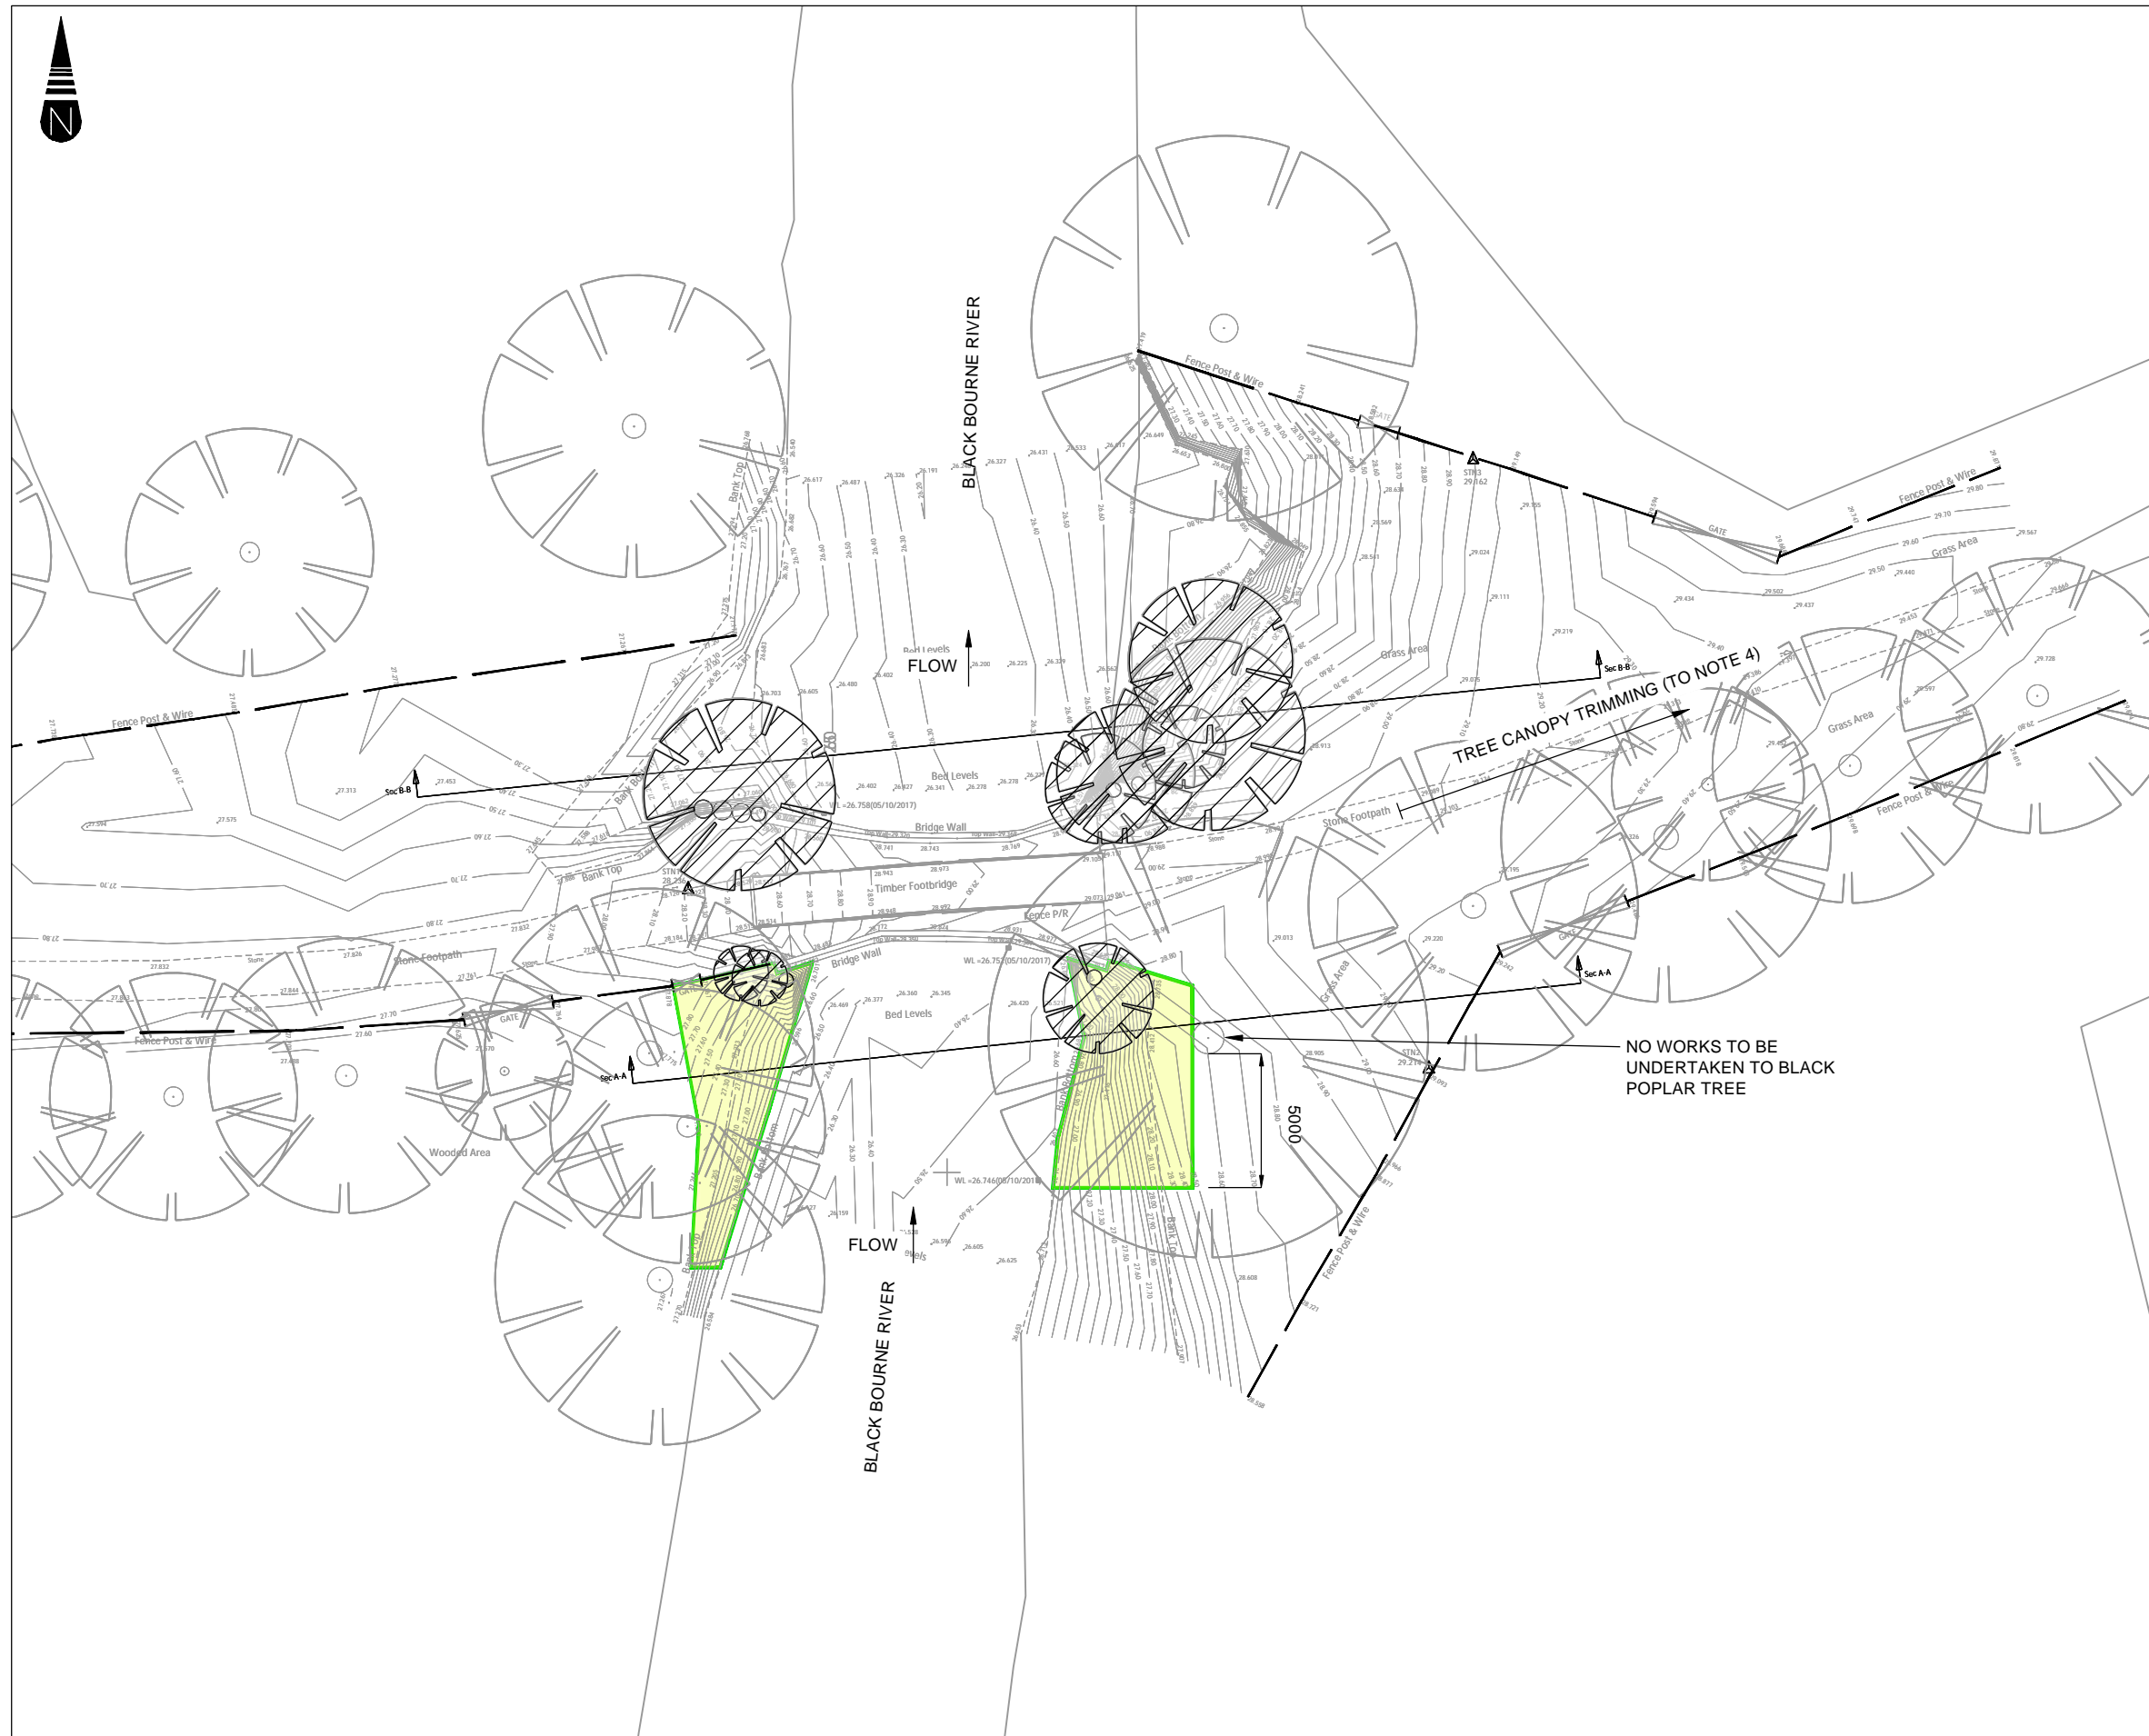
5101354-MIL-SBR-ZZ-DR-CB-7008 Site Clearance Advance Works

- NOTES:
- DO NOT SCALE FROM THIS DRAWING.
  - ALL DIMENSIONS IN MILLIMETRES UNLESS STATED OTHERWISE.
  - TREES TO BE CUT DOWN NEAR TO GROUND LEVEL AND REMOVED AS PART OF THESE ADVANCE WORKS. TREE STUMPS TO BE PHYSICALLY REMOVED BY THE CONTRACTOR AS PART OF THE MAIN CONSTRUCTION WORKS.
  - CANOPIES OF TREES ALONG BRIDLEWAY FROM COMMISTER LANE TO BE TRIMMED TO PROVIDE 4.5m HEIGHT CLEARANCE ABOVE GROUND LEVEL FOR CONSTRUCTION PLANT.

- VEGETATION CLEARANCE TO GROUND LEVEL
- TREES TO BE REMOVED (SEE NOTE 3)
- EXISTING FENCE

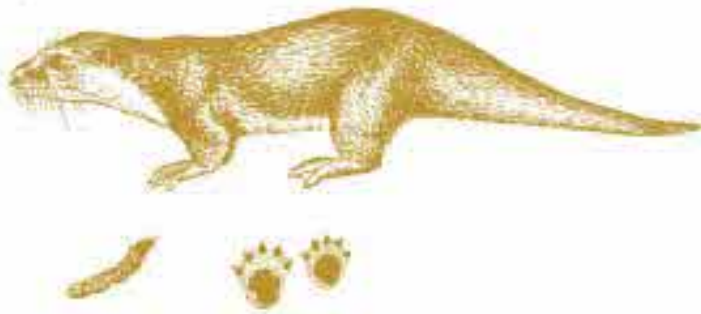
Otter

**Size:** Up to 1.2 metres (4 feet)  
**Weight:** Up to 10kg (25lbs)  
**Tail:** Long, tapering, sleek and muscly  
**Face:** Broad muzzle  
**Footprint Size:** 75mm (3 inches) across  
**Droppings:** Musty, fishy smell, contain fish bones/scales

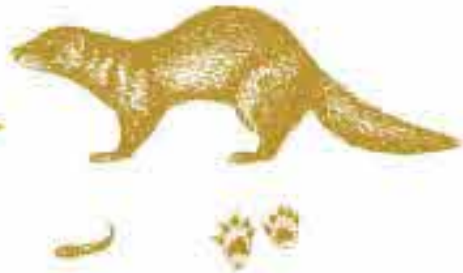
Mink

**Size:** Up to 0.5 metre (2 feet)  
**Weight:** Up to 1 kg (2.5lbs)  
**Tail:** Round and furry  
**Face:** Pointed muzzle (cat like)  
**Footprint Size:** 25mm (1 inch) across  
**Droppings:** Pungent, rancid, contain mammal hair
