Little Oakhill, Brewery Lane, Oakhill

Bat & Bird Scoping Report

Prepared for: Mr & Mrs Hendy

Date: January 2024

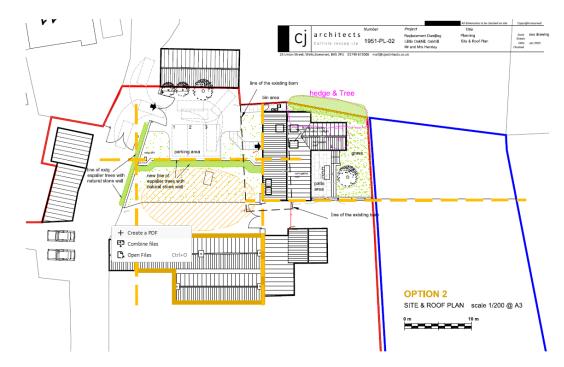
Figure 2: Proposed Development (adapted frrom CJ Architects, 2023)

Nash Ecology Ltd was instructed to carry out a bat assessment of a barn located within the curtilage of 'Little Oakhill, Brewery Lane, Oakhill, Somerset, BA3 5AT' (Figure 1). The assessment was commissioned in relation to current proposals to convert the barn into liveable accommodation (Figure 2). The barn would be relocated slightly to the north (away from the house) and extended to the east (bare ground and amenity grassland). As the works will be restricted to the footprint of the existing building and its immediate surrounds (i.e. hard standing / bare ground / amenity grassland), the ecological receptors most likely to be encountered are bats and birds. As the proposed works have the potential to adversely affect both taxa, a targeted assessment was commissioned to ascertain whether either were present.
