cornwall
environmental
consultants LTD

Bat and Barn Owl Assessment
Bedevire & Bronsley
Bodinnick Road
St Tudy
Bodmin
PL30 3NX

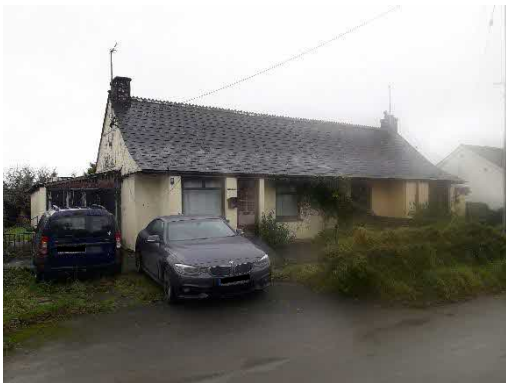
Figure 1 East side of the building

The building is a pair of semi-detached bungalows; the southern one is Bronsley and the northern one is Bedevire. Both have concrete walls and a pitched roof of fibre cement slates. Bronsley has a garage with a sloping roof of corrugated iron attached to the south gable and an extension with a sloping roof of fibre cement slates on the west side; Bedevire has an extension with a sloping roof of natural slates attached to the north gable and a flat-roofed extension on the west side (Figure 1).

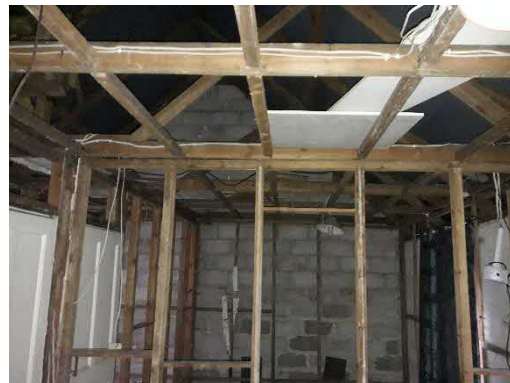
Figure 2 Interior of Bronsley

Asbestos was removed from Bronsley about a year ago which included the false ceiling and internal walls. The floor space, ceiling ties, dividing wall and south gable were searched, as well as the garage. The roof slates in Bronsley are underlined with a plastic underlay (Figure 2).

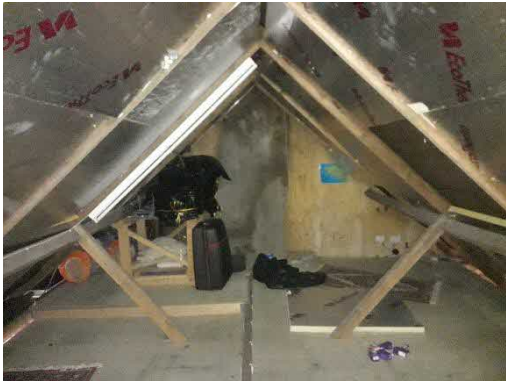
Figure 3 Roof void in Bedevire

Bedevire has a false ceiling with enclosed roof void c. 2m high which was accessed and searched (the roof void in Bronsley was similar before the false ceiling was removed). The roof slates in Bedevire are underlined with bitumen felt with rigid foil-backed insulation boards beneath although some had fallen away and it was possible to view the batten space between the slates and underfelt via gaps where the underfelt was sagging (Figure 3).

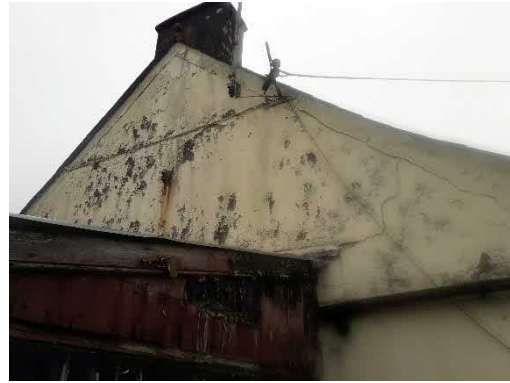
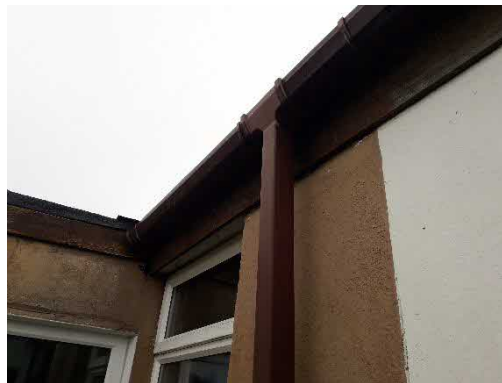
Externally there were no gaps along the roof verges, behind the fascia boards, at the ridge and beneath the roof slates which would be suitable for access by bats. The extensions on the west side of Bronsley and north gable of Bedevire had vaulted ceilings but no gaps where bats would be able to gain access (Figures 4 & 5).

Figure 4 Roof verge

Figure 5 Fascias

Although no current evidence of roosting bats was found it cannot be assumed that bats are not present when works commence. Care should therefore be taken during the work as bats could roost unseen deep within crevices in the structure, particularly under ridge tiles or

beneath wall plates. If any bats are discovered during the work they must not be handled: works must stop immediately and advice sought from CEC (tel 01872 245510).
