12 Church Road, Yatton

Preliminary Roost Assessment

January 2024

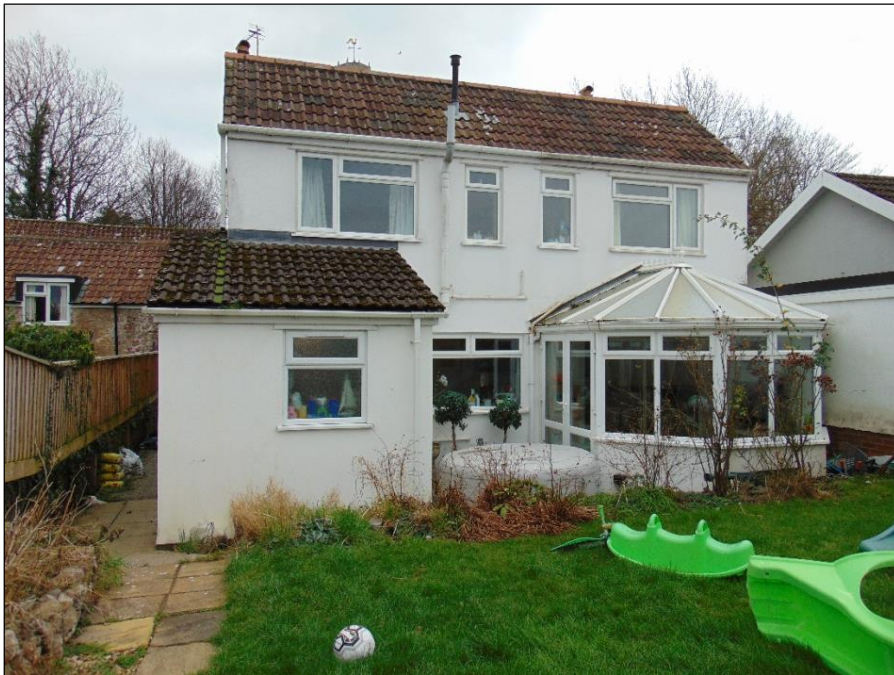
On the north-western side of the extension is a conservatory largely consisting of glass panels on a low brick wall and with an angled roof of Perspex panels.

On the north-eastern side of the 1970s extension is a narrow rectangular utility room and bathroom which has a single pitch roof of the same materials as the main roofs described above. There is a ceiling above this utility room and bathroom but no access into the small roof void.

Above: the rear of the dwelling showing the utility room / bathroom extension on the left and the conservatory on the right

As the dwelling and its curtilage have been determined to have Negligible bat roost potential no further bat survey works or bat mitigation works are required here.
