**GROUND CONTAMINATION
ASSESSMENT REPORT****Berwick Farm****Berwick Lane****Hallen****South Gloucestershire****BS10 7RS****Report Ref: B3326/24****January 2024**

Berwick Farm, Berwick Lane, Hallen, South Gloucestershire, BS10 7RS

Report Reference: B3326/24

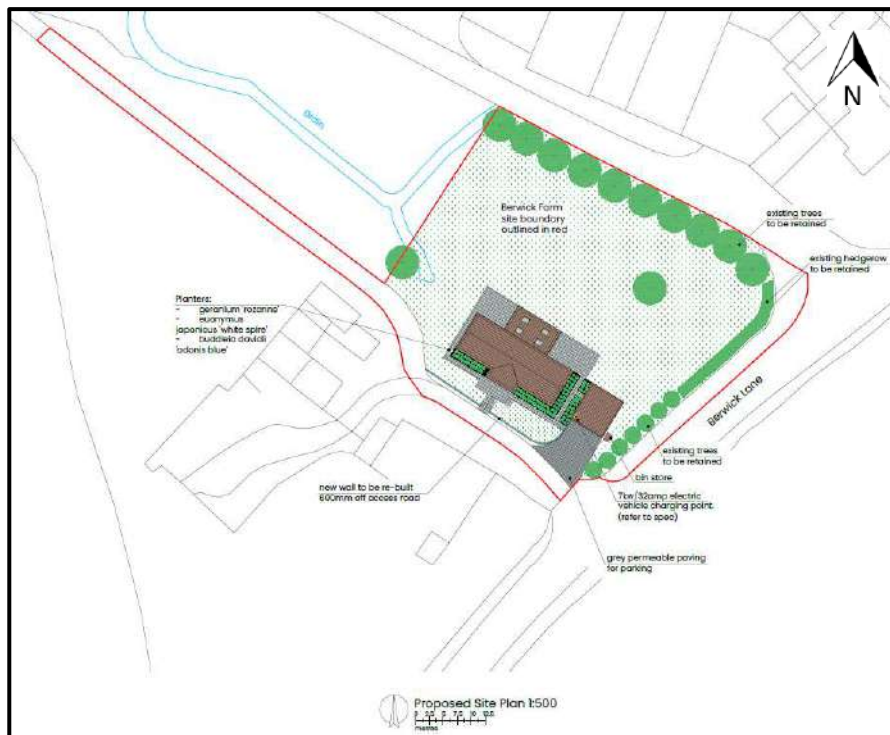
Figure 4 – Proposed Development Details

The proposed development layout details are shown in Figure 4 overleaf.
