Dice
Environmental

301 Shenley Road
Phase 1 Geo-Environmental Report
02/02/2024
Ref: 101206
Version 3.0

Site 301 Shenley Road,
Borehamwood,
WD6 1TH

Project Reference 101206

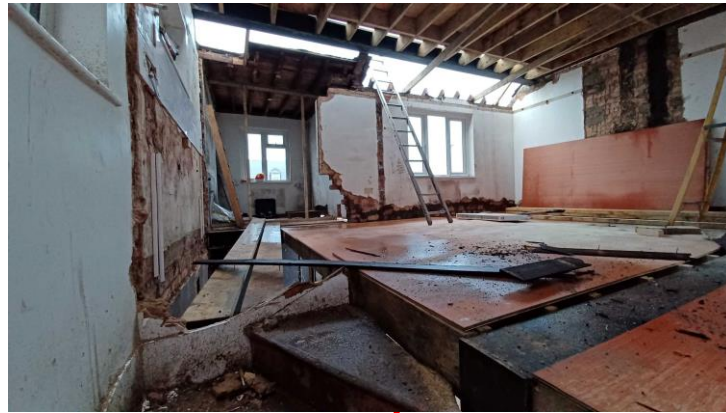
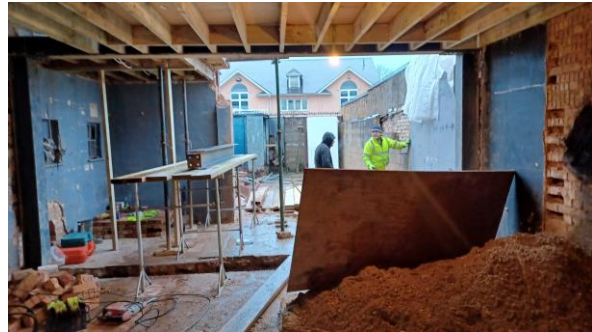
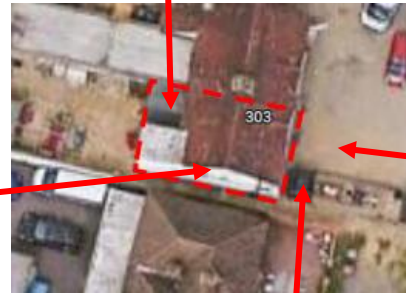
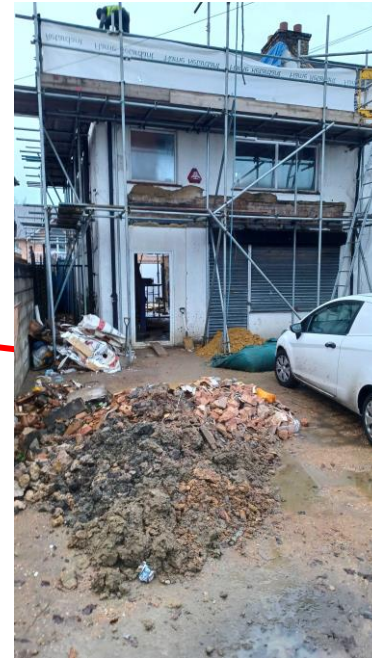
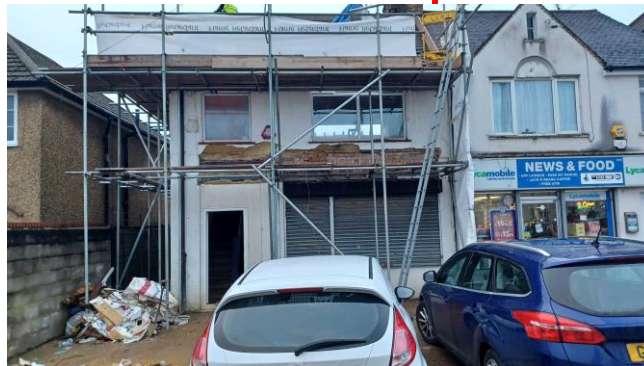
Figure Number
Fig.3

The site is located within a residential area along Shenley Road, Borehamwood. The site comprises a 2-storey semi-detached building. At the time of the walkover, construction had already begun where the interiors of the building had been stripped. The site is directly accessible from Shenley Road.
