**Preston Farm
Preston Brockhurst
Shropshire
NGR: SJ 537 246**

**A
Heritage Statement
&
Outline Heritage Impact Assessment**

December 2018
Mercian Heritage Series 1322

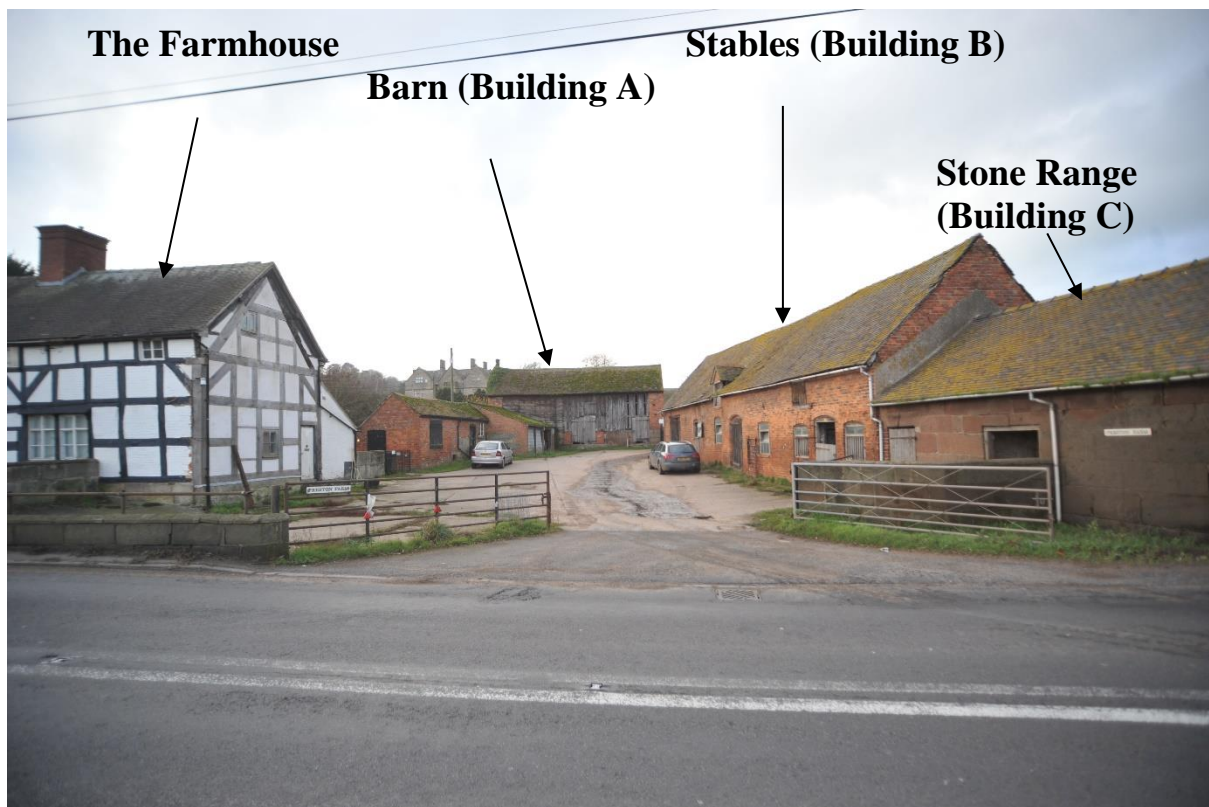
The buildings studied for this report occupy the west and north sides of an informal farmyard immediately to the north of the Farmhouse; there is a larger and more formal farm stead further to the west and on slightly higher ground closer to the northern side of the Old Manor House (see Pl.1).

Pl.1: The farmyard and buildings from the east, with the main road in the foreground.

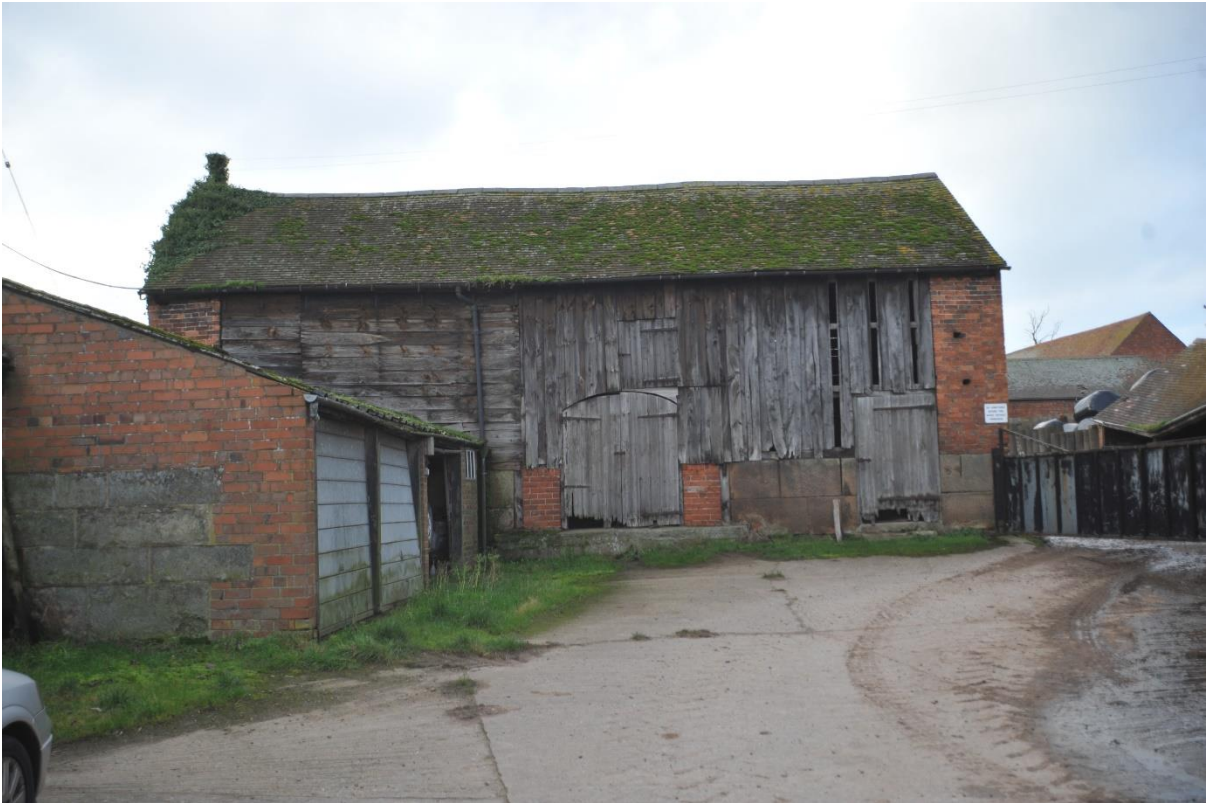
The eastern doorway, to the yard, has been more radically changed and the original doorways have been removed. Instead there is a small pair of strap-hung doors cut into the re-clad weather-boarding of the opening.

These planked doors are formed with a segmental arched head and are flanked, low down, by brick jambs on each side which relate to the narrowing of the original width of the cart opening. Above, and to one side, is a taking-in doorway cut directly into the weather-boarding.

Pl.2: The east elevation of the Barn (Building A).

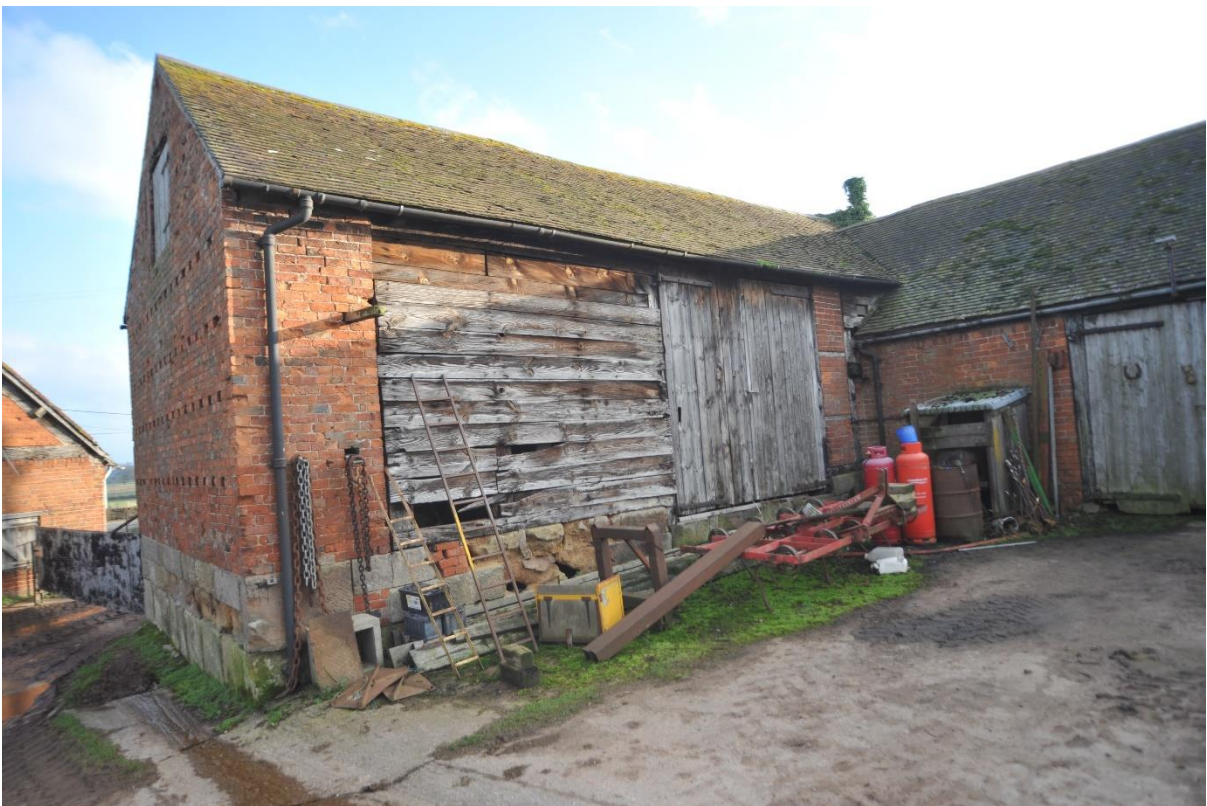
Originally there were large full-height double cart openings in the central bay of each side wall, flanked by thicker bay posts. These openings have been altered. On the west side there is still a pair of strap-hung plank doors which could be original or modified. The original threshold has been built up and the right-hand (or western) jamb has been rebuilt in brick and stud panels.

Pl.3: The Barn from the north-west.

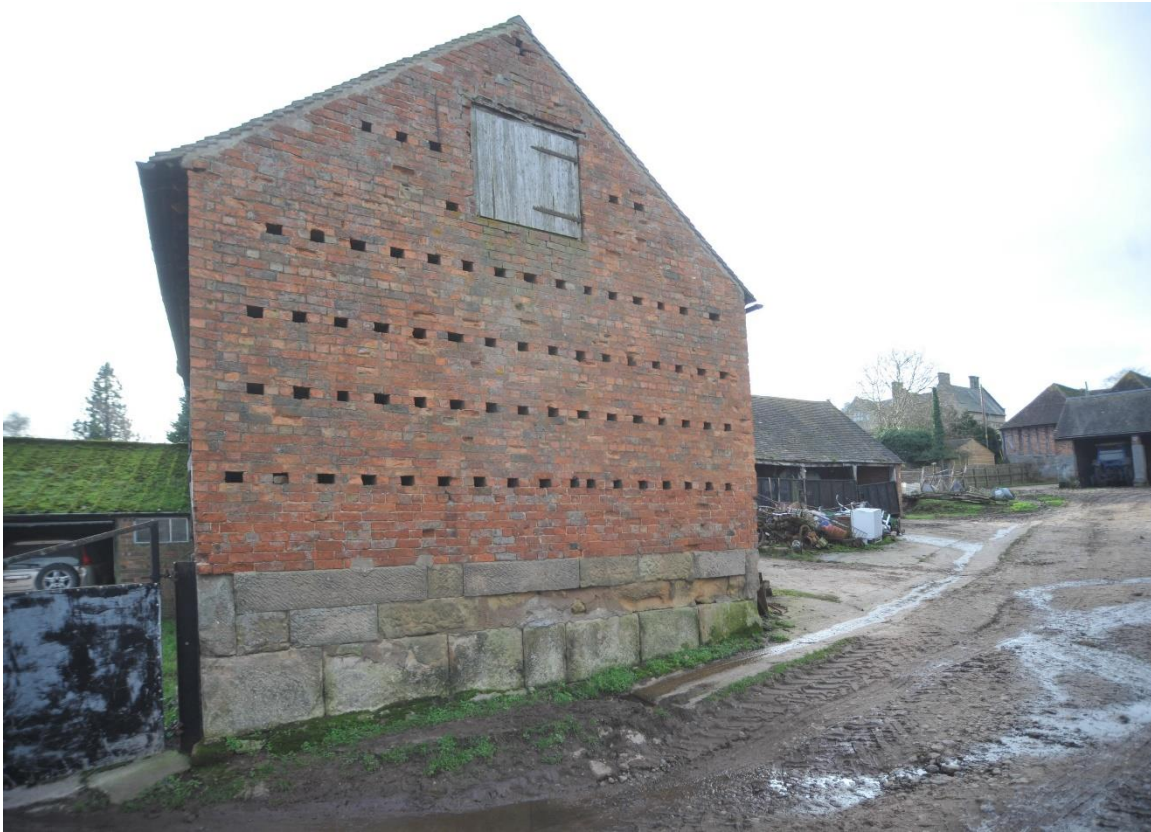
The gable ends and their short returns are of hand-made red bricks laid in lime-rich mortar to an irregular English Garden Wall bond. The gable ends are pierced by widely spaced rows of header vents. And in their upper sections have simple taking-in doorways under plain timber lintels.

Pl.4: The north gable of the Barn; the Old Manor House is in the distance to the right.

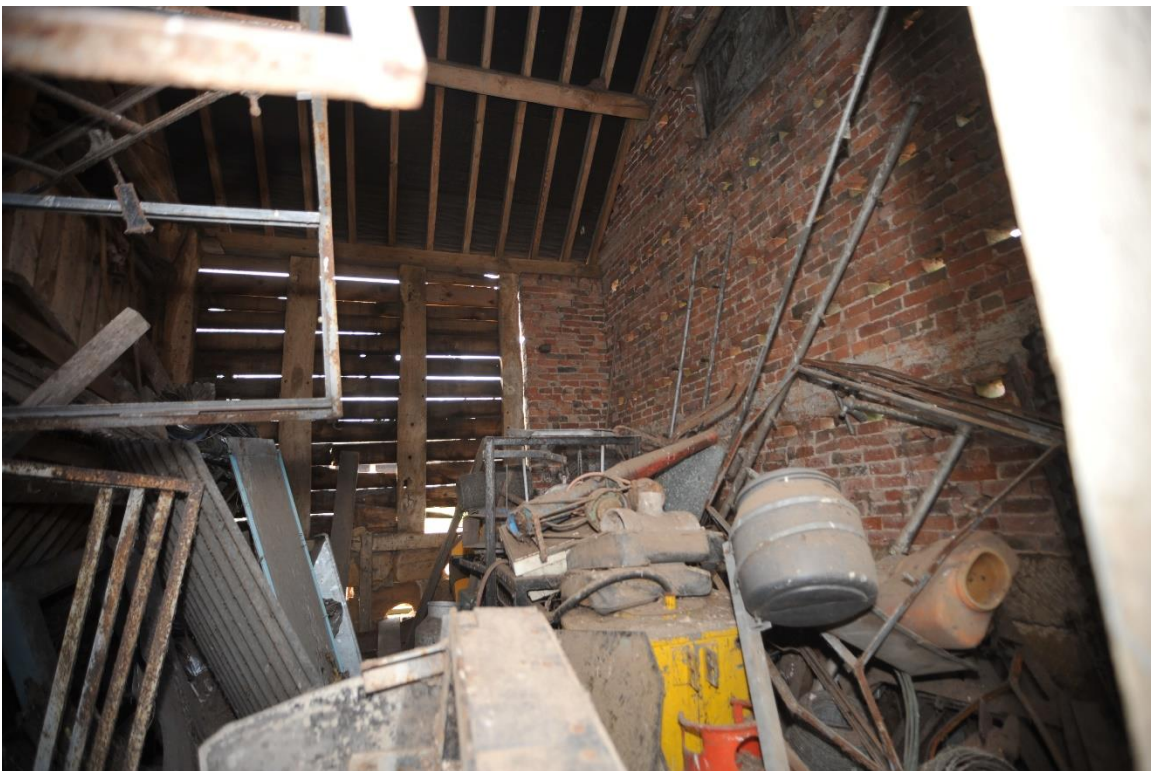
Pl.5: The little altered interior of the northern bay of the Barn.

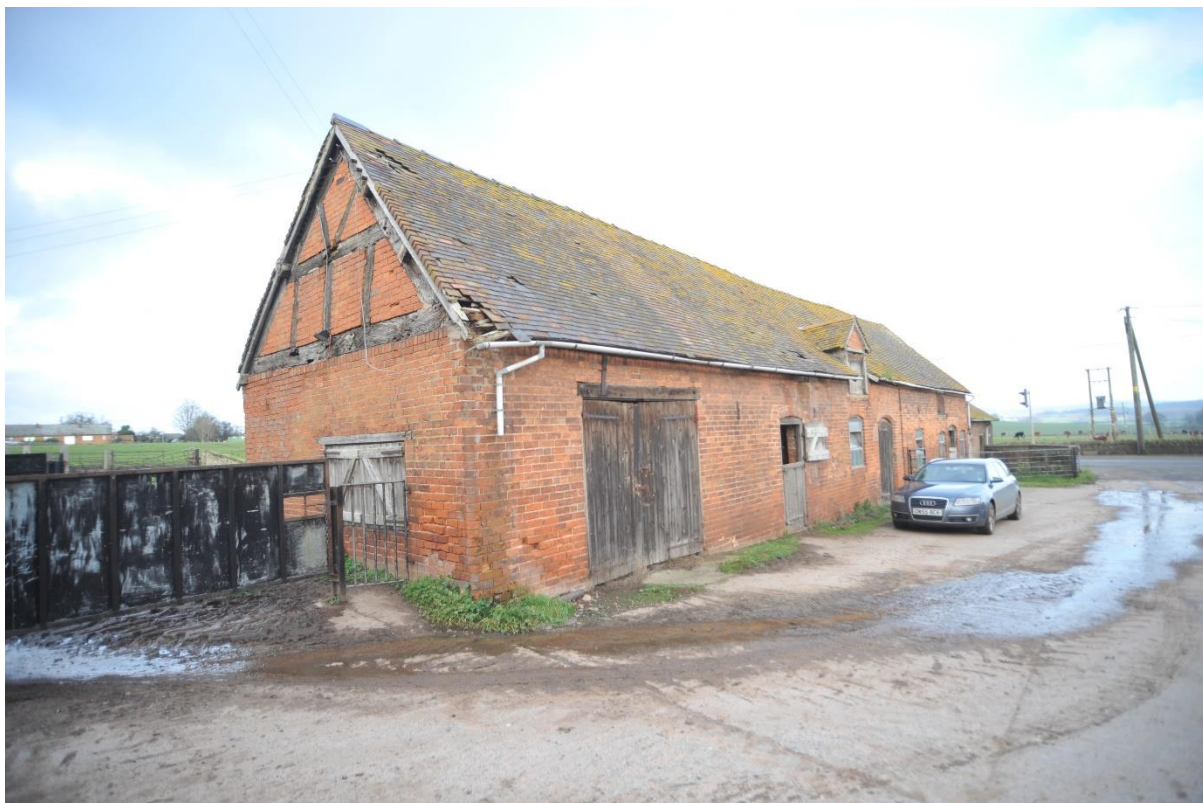
In the right-hand section there is a degree of symmetry at the right-hand end, with a doorway flanked by windows, all with segmental arched heads; that of the doorway is of two-rings, those of the window just one. Above the left-hand window is a low taking-in doorway, its head formed by the wall plate.

Immediately to the east of the vertical construction break is a blocked segmental arch headed window and next to that the present window is set within the blocking of what had been a contemporary segmental arch headed doorway.

Pl.6: The Stable Range (Building B) from the south-east.

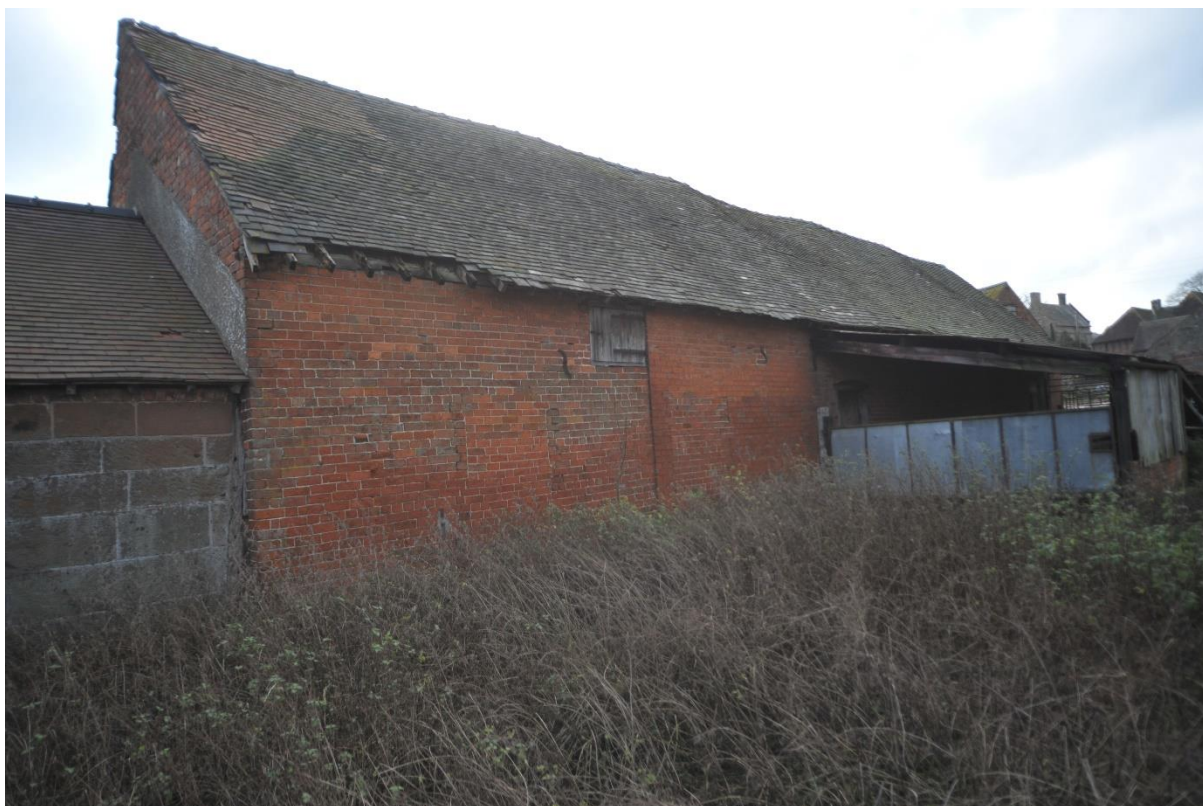
Pl.7: The Stable Range from the north-east.

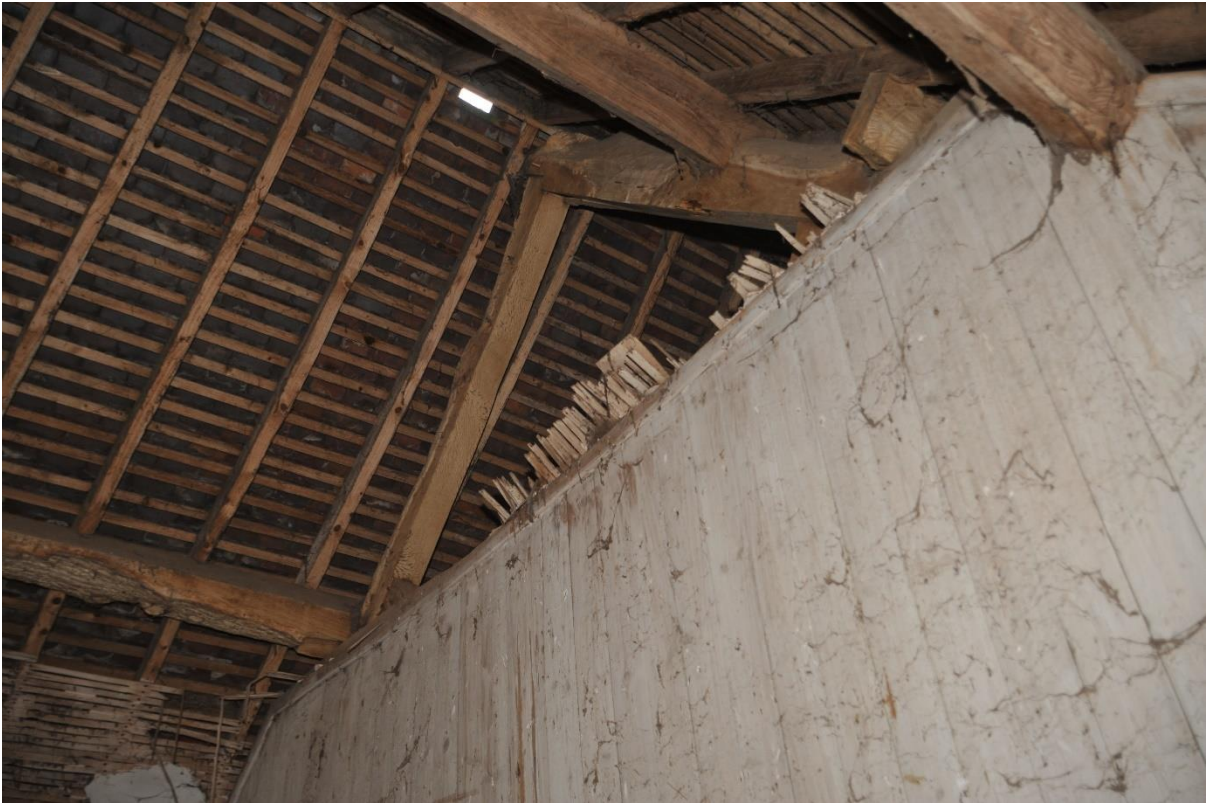
One, the first one in from the west gable, consists of a tie-beam, principal rafters and a single pair of ‘V-struts’ from tie to rafters. The second, on top of the remnant of the cross frame east of the cross-passage, is less easy to see but does seem to be a proper truss of some sort.

Pl.8: Part of the roof structure, showing an open truss of unknown provenance.

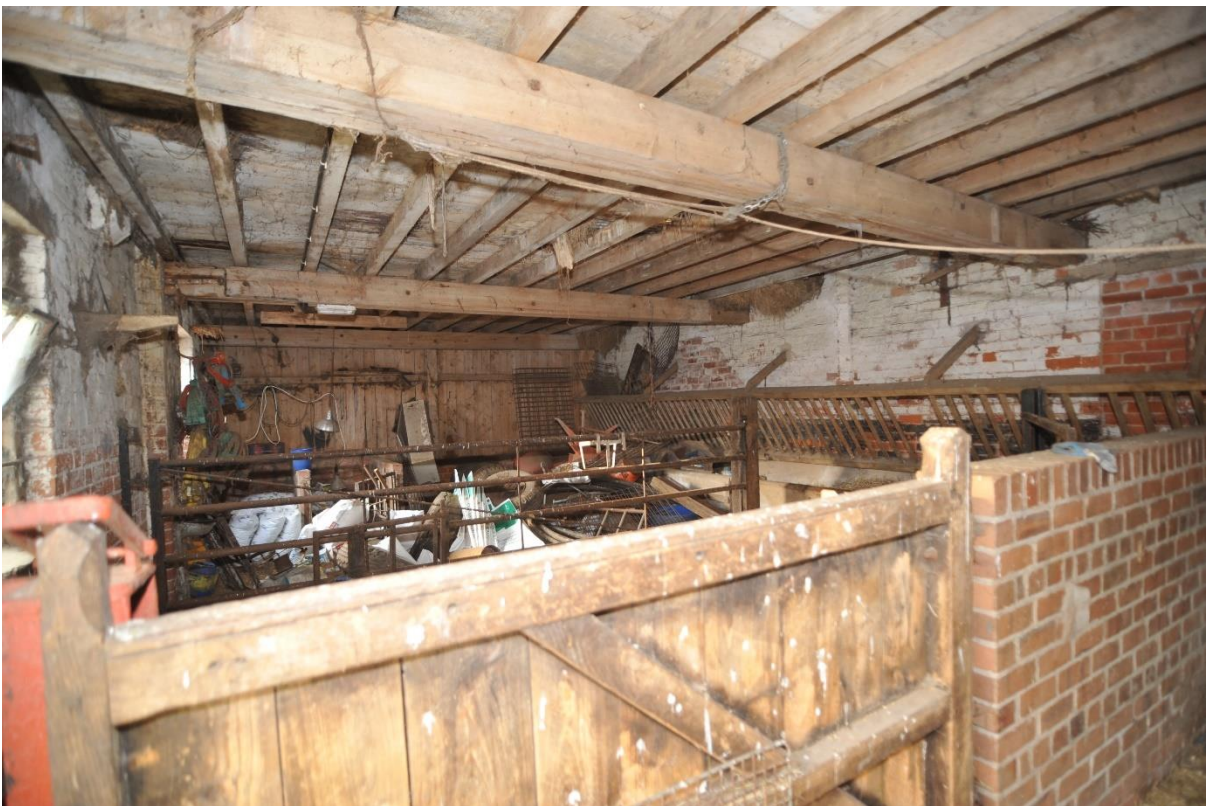
Pl.9: Interior of the central section, looking west and showing the inserted loft floor.

There could another in between that these last mentioned trusses above the loft floor – and there is possibly remnants of a truss in the east gable as well. The purlins are otherwise supported on brickwork. In the visible portion of the structure at the western end, there are two tiers of trenched purlins on the south slope but just one on the north slope. The rafters meet at a ridge-board where visible.

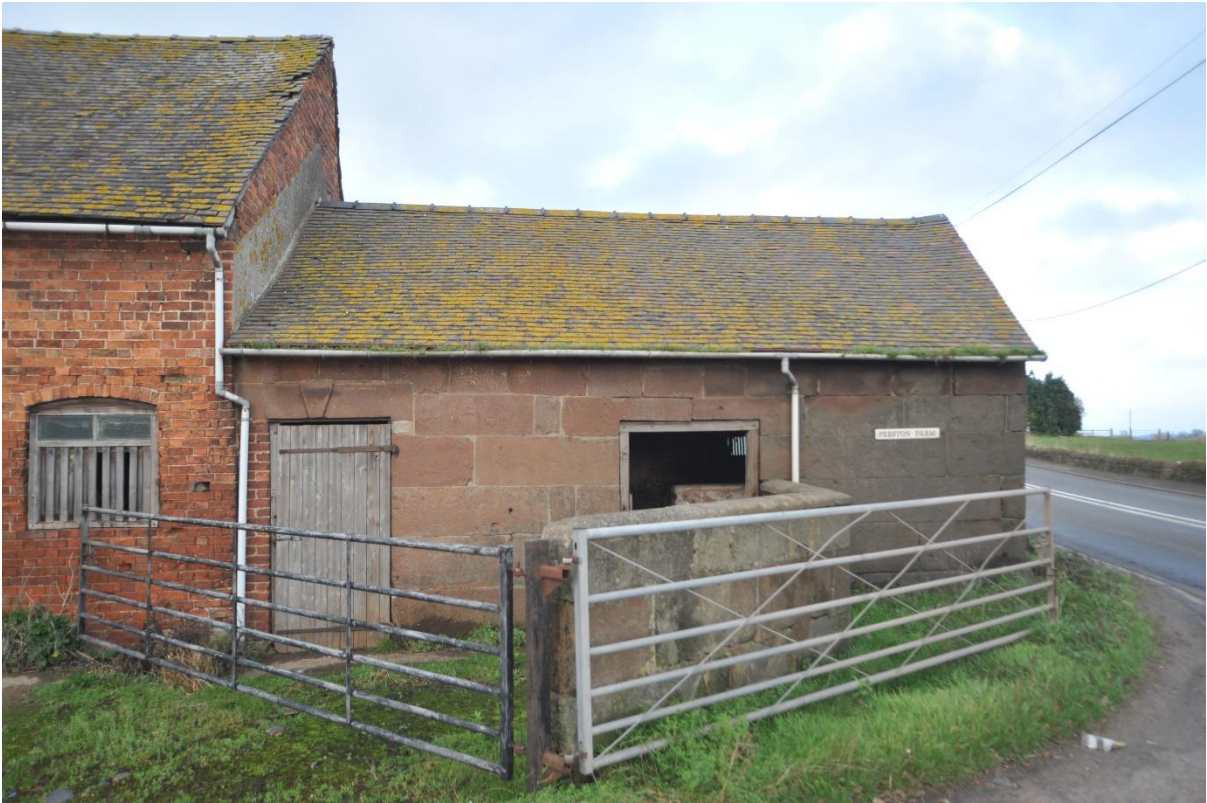
The roof is plain gabled and covered in plain tile. The ridge is of machine-made interlocking angled bonnet tiles. Structurally the roof is of three bays but the trusses, which appear to be well-crafted queen post loft trusses, are in fact rather crude.

Each consists of a tie-beam, which also supported the joists of the loft floor. Two thin scantling studs rise directly to the purlins, which are linked by equally thin straining beams not connected to the studs. There are additional short horizontal timbers nailed between the studs and the wall-plates. The common rafters meet at a ridge-board and are supported by a single tier of purlins.

Pl.10: The south side of the Stone Range (Building C).

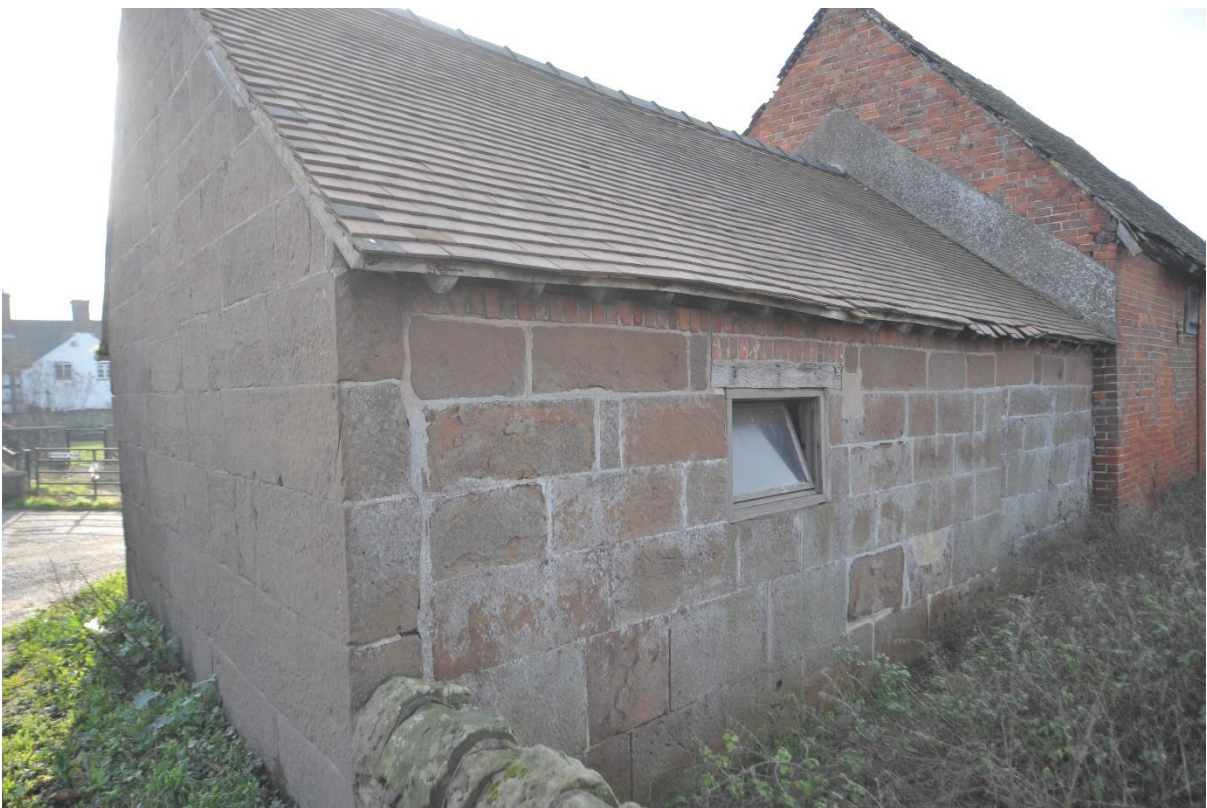
Pl.11: The Stone Range from the north-east.

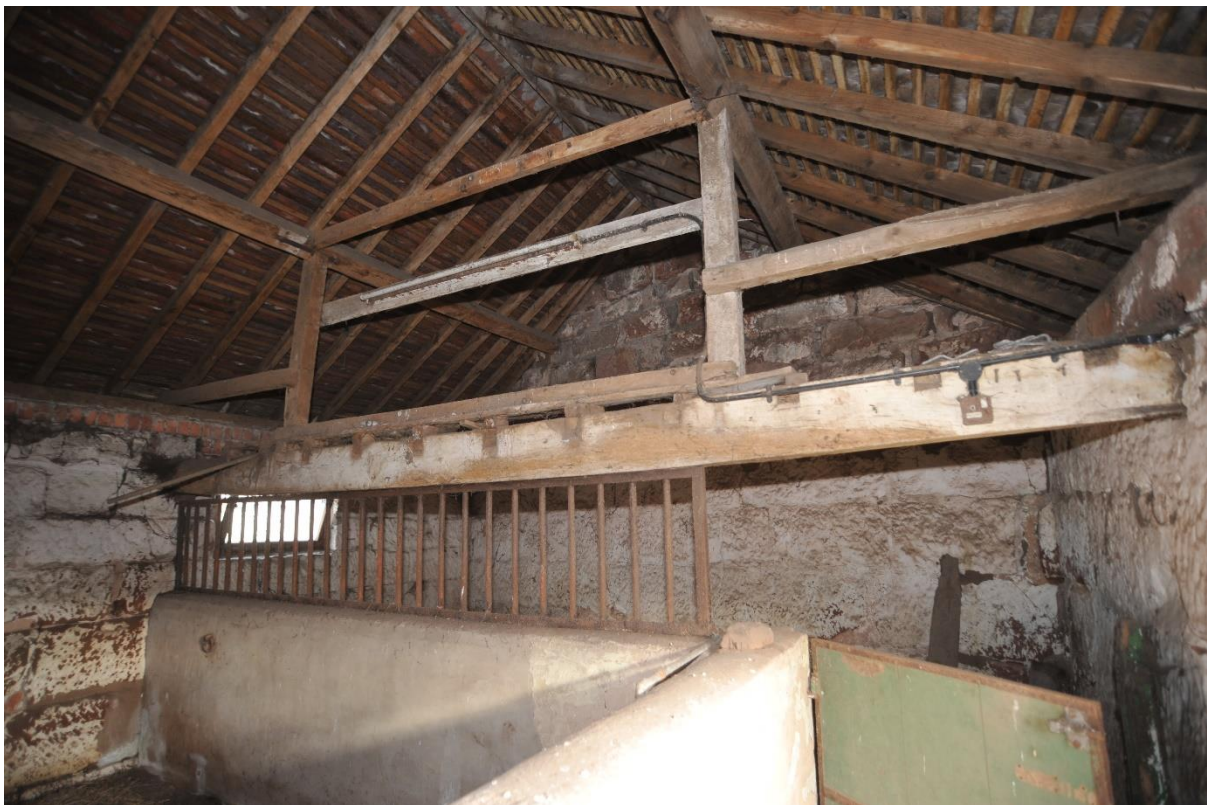
The interior is presently set out as loose-boxes for cattle with timber hay racks against the rear wall. The range was originally lofted throughout, but only the western bay retains its upper floor; the rest of the loft floor has been removed.

Pl.12: The interior of the StoneRange.
