Land at rear of Sturt Avenue  
Camelsdale  
Haslemere  
GU27 3SJ

Casa Coevo Group Ltd

21-171.01  
Version 2

<b>Project Name</b>	Land at rear of Sturt Avenue, Camelsdale, Haslemere, GU27 3SJ		
<b>Project Title</b>	Phase I Geo-Environmental Risk Assessment		
<b>Client</b>	Casa Coevo Group Ltd		
<b>Project Number</b>	21-171.01		
<b>Version</b>	2 (updated November 2023)		<b>Date</b>
<b>Prepared by</b>	Orlando Blackwell BEng (Hons) MSc (Eng)	Principal Engineer	24/05/2021
<b>Prepared &amp; Checked by</b>	James Burkitt BEng (Hons) CEnv MRICS	Managing Director	28/11/2023

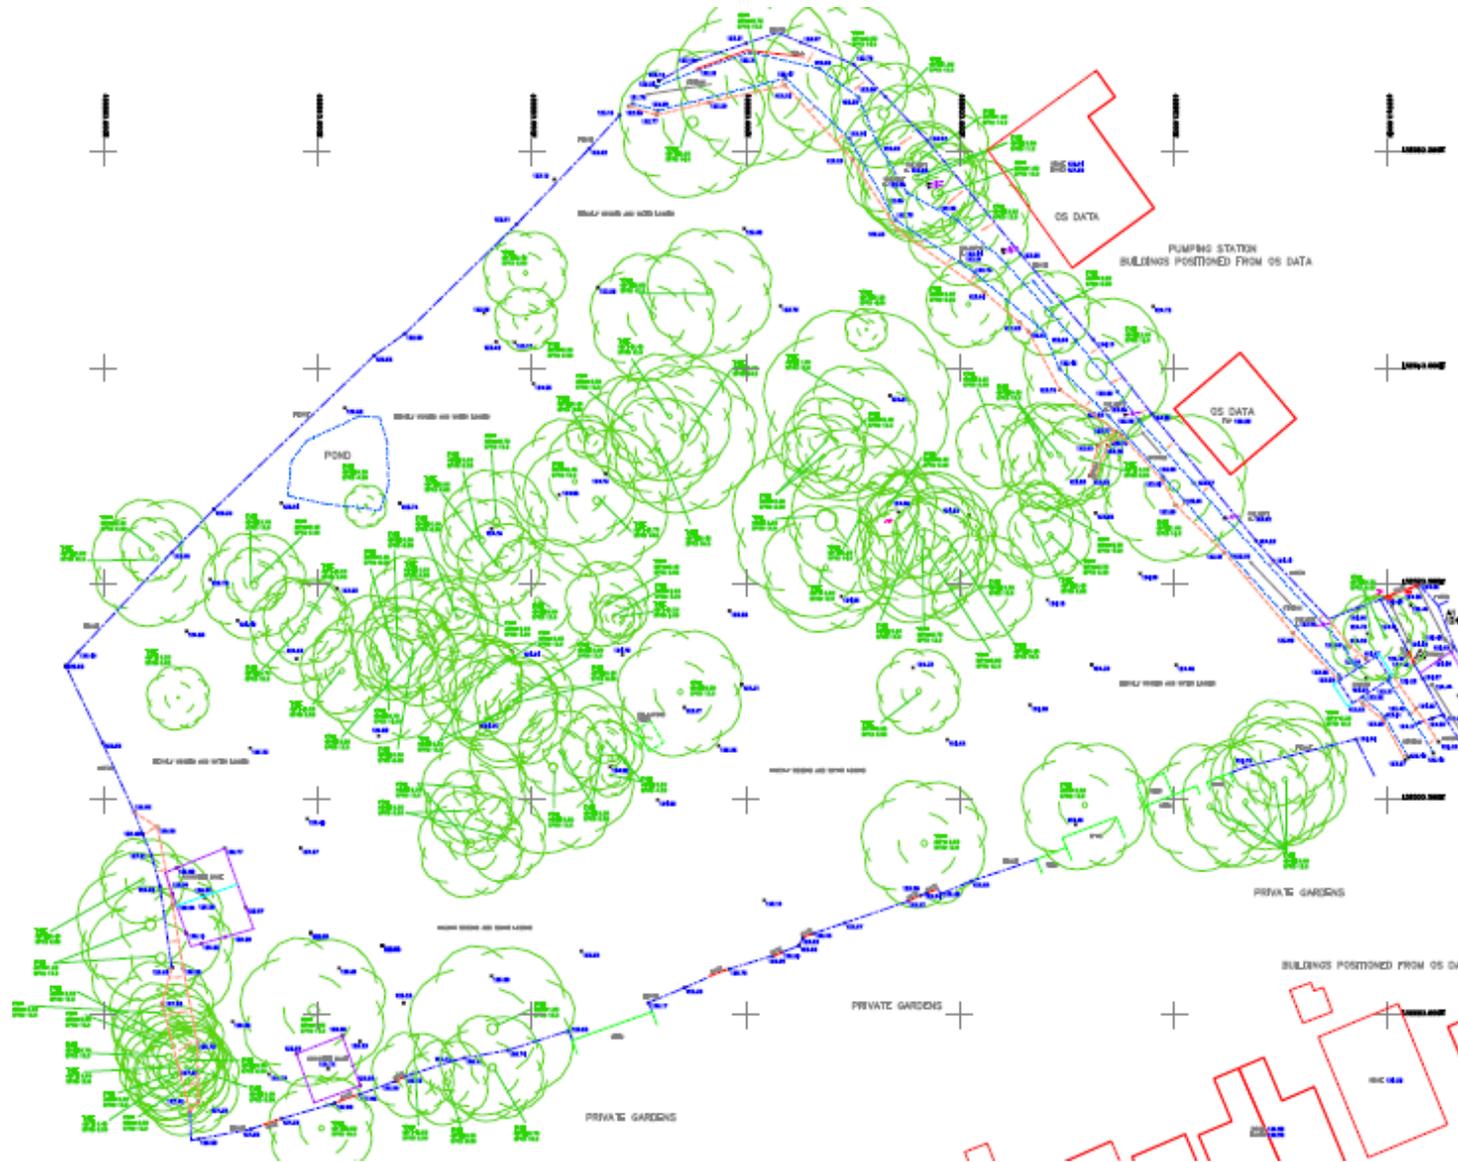
**Figure 1** comprising the Site Layout Plan (surveyed in January 2016) indicates that two concrete bases were located in the south-west of the site at this time, at the locations of the former buildings; however no evidence of the site buildings remained at the time of the site walkover. A number of gates along the south-eastern site boundary suggest that the site was historically accessible to residents of the neighbouring domestic premises.

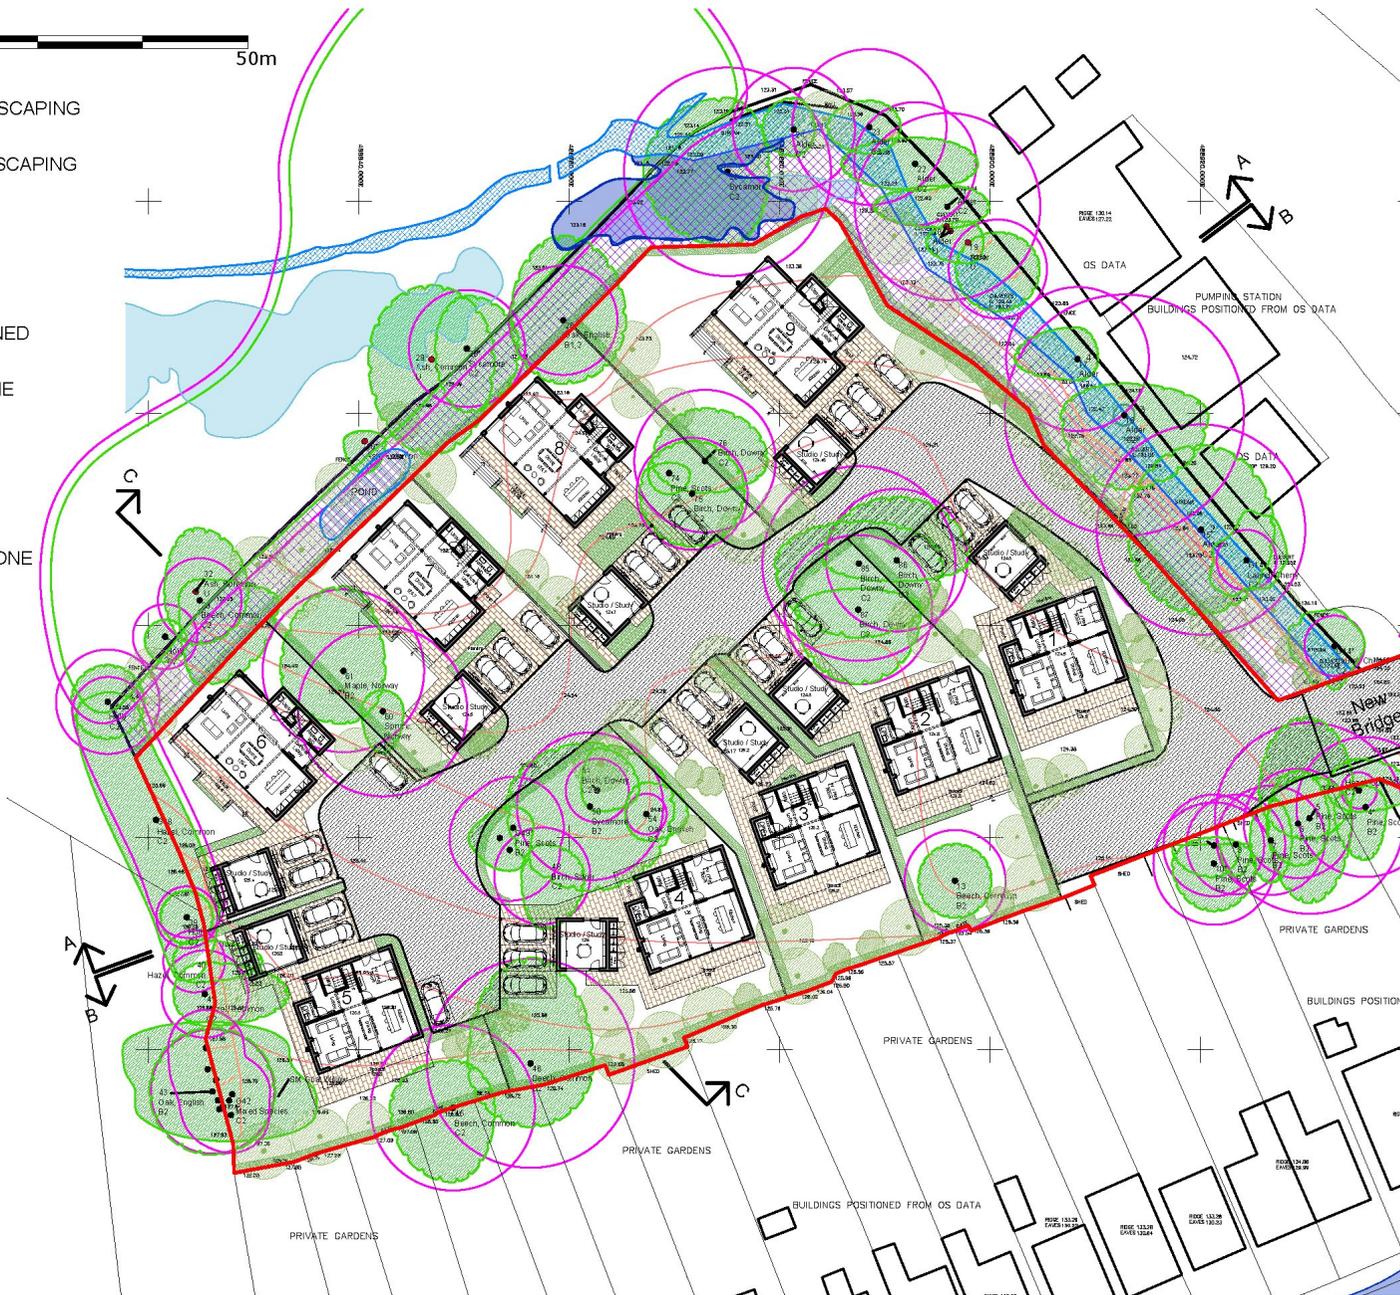
<b>Proposed Land Use</b>	The proposed re-development aims to construct of a number of new homes with gardens and a centrally located access road.  <b>Figure 6</b> is presented as the Proposed Development Plan, including an indicative envelope of houses and gardens.

INDICATIVE CONTOURS  
EACH LINE DENOTES A  
CHANGE IN LEVEL BY  
APPROXIMATELY 0.5M
