BAT SURVEY REPORT

**The Barn, Highfield House, Newark Road,
Wellow, Nottinghamshire**

Date: September 2023

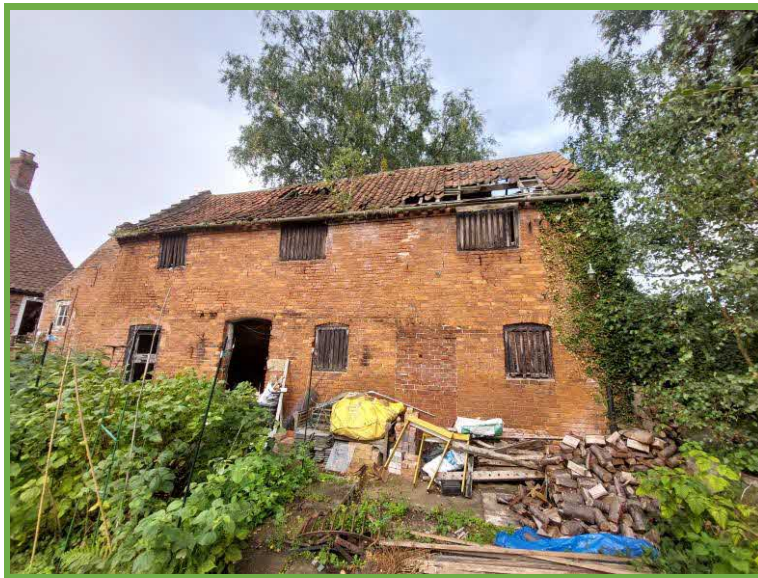
- 3.1 Building 1 (B1) comprised a two-storey, brick-built detached barn with a pitched clay pan-tiled roof with clay ridge tiles (photo 1). Other features of note comprised corbelled brick-work along the eaves of the barn with a single-storey brick-built lean-to extension adjoining the southern gable end of the two-storey barn. Potential bat access points were observed via large sections of collapsed roof, open doors and boarded timber slatted windows. No external evidence of use by bats was identified during the survey.

Photo 1: View of the detached barn (eastern aspect)

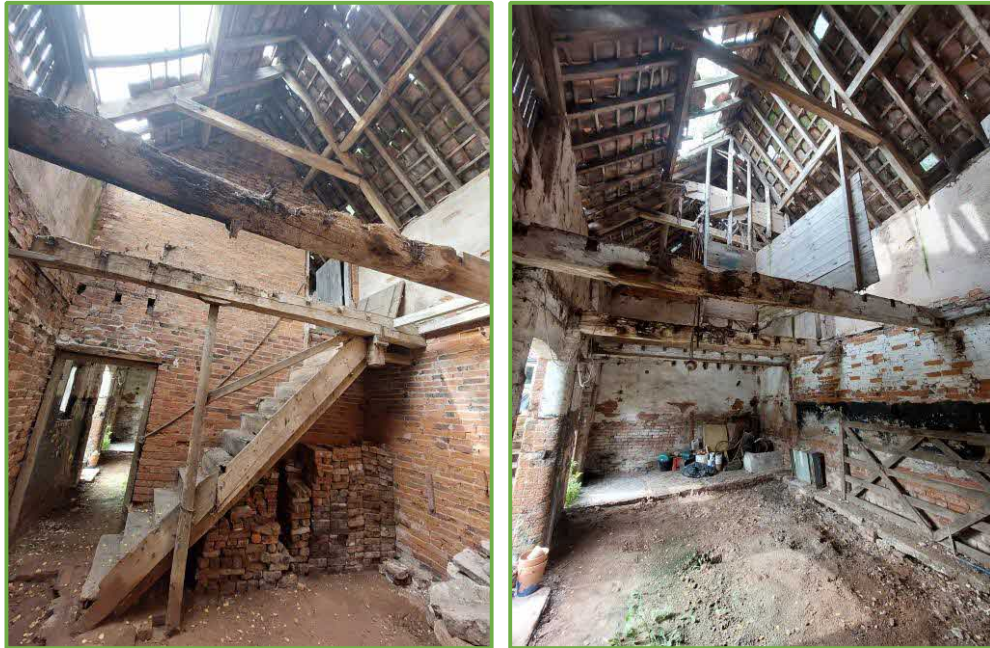
- 3.2 The building remains a shell with only the exterior walls intact. The first-floor flooring was missing as was any first-floor ceiling joists (Photo 2). The internal conditions of the barn were open to the weather elements with large sections of the clay pan-tiled roof having collapsed with numerous roof timbers having rotten (Photo 2 and 3). No under-felt was present under the remaining sections of the pitched roof. No evidence of bats was observed internally. Due to the open nature of the building as a result of large missing sections of roof and internal damp conditions the barn was considered to offer low potential to support roosting bats.

Photo 2 (left) showing large missing section of roof and missing floors.
Photo 3 (right) Showing large gaps in the pitched roof and missing floors

- 4.3 The PRA comprised an internal and external building survey of the detached brick-built barn within the grounds of Highfields House on 24th August 2023. The barn was considered to offer low potential to support roosting bats due to the barn presenting a brick shell with partially collapsed roof present. Therefore, in accordance with industry guidelines (BCT, 2016), a single nocturnal bat survey was carried out on 29th August 2023 to determine the presence / absence of roosting bats.

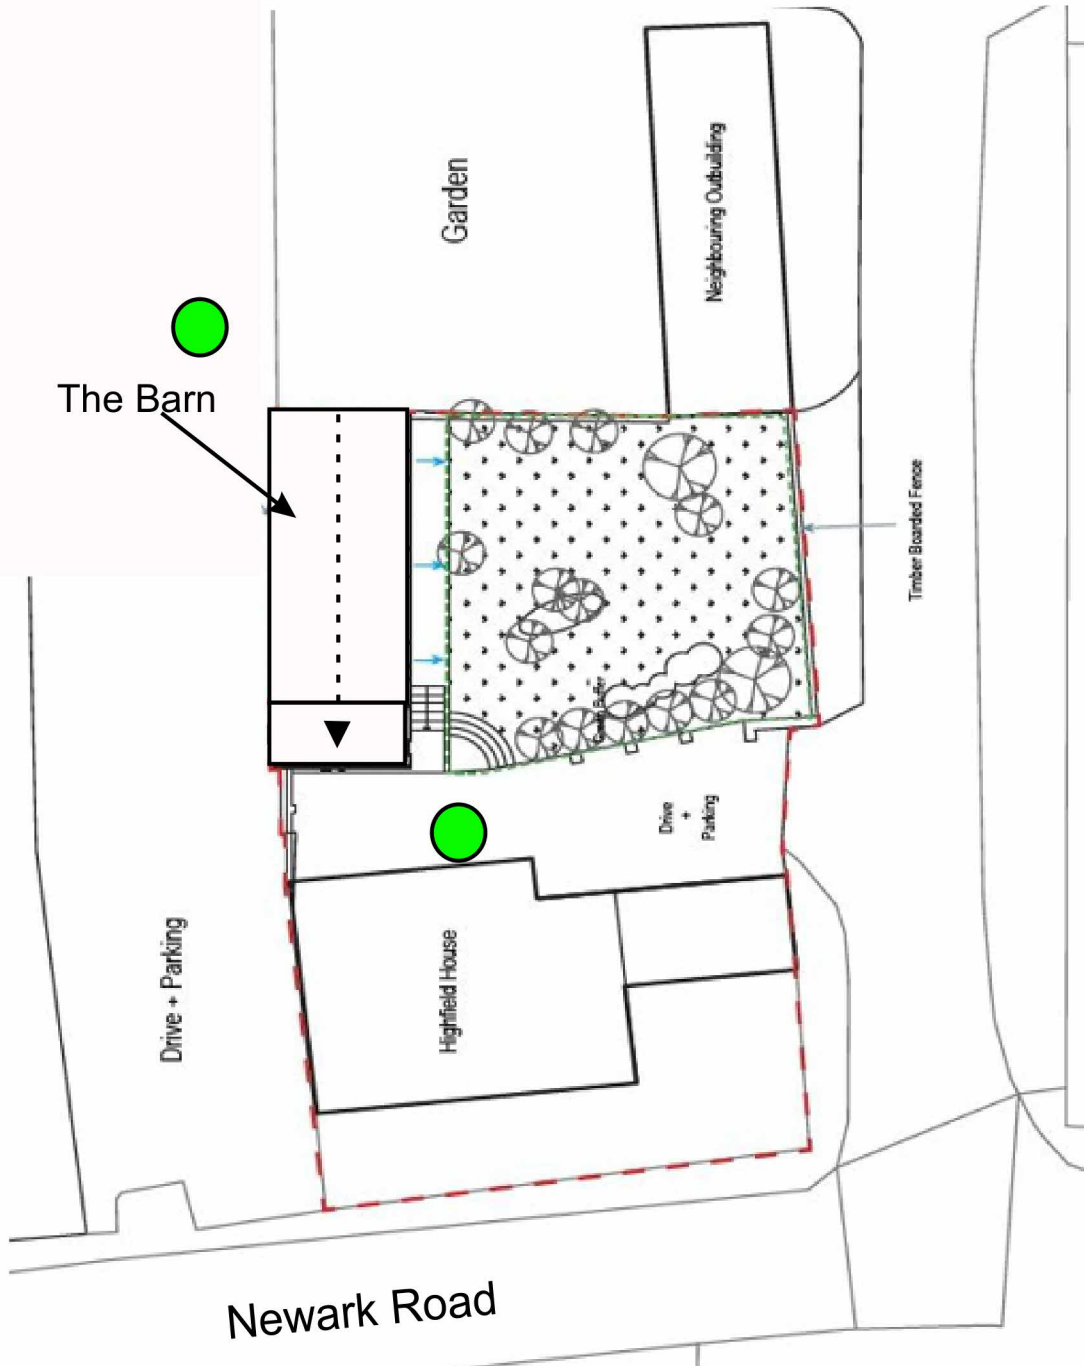
Figure 2: Building and Nocturnal Survey Plan

- 2.6 A single nocturnal survey was completed by experienced ecologists including a licensed bat worker (Natural England Licence Number: 2015-10587-CLS-CLS). During the survey two surveyors were positioned such that all aspects of the building were covered (Figure 2). The dusk emergence survey started approximately 15 minutes before sunset and finished at least 90 minutes after sunset.

- 3.3 During the survey the first bat recorded was a common pipistrelle *Pipistrellus pipistrellus* commuting over the barn entering the survey area from the south heading in a northerly direction at 20:30 followed by a second common pipistrelle at 20:32. Two unidentified *Myotis* sp. was observed commuting along the western aspect of the barn at 20:34 entering the survey area from the south before briefly foraging over the off-site garden habitat north-west of the barn. Occasional unidentified *Myotis* sp.. were also recorded briefly foraging off-site, north-west of the barn at 20:46 and 20:55. A single brown long-eared *Plecotus auritus* bat was observed entering the large collapsed section of roof at 21:05 before dispersing at 21:09. No evidence of a bat roost was observed during the survey.

The Barn with low bat roosting potential

Surveyor Location (29.08.2023)
