Kilmington Primary School, Kilmington, Devon

Ecological Impact Assessment

Type of document (Version)	-
Revisions	
Report reference	23-564-EcIA-RT
Issue date	26 January 2024
Document prepared by	Ruth Testa MSc MCIEEM
Quality control/ checked by	Chris Turner BSc MCIEEM
Information Valid for	One year from the date of the report

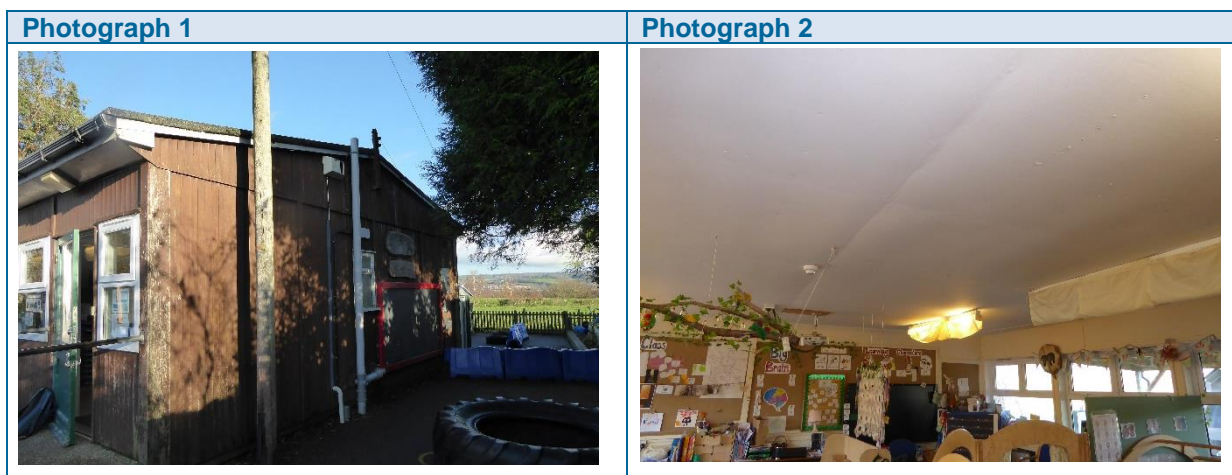
The building comprises a timber clad pre-fabricated classroom built off a blockwork base, under a pitched felt roof (Photograph 1). A boiler flue is present on the eastern roof elevation.

The interior comprises two rooms – an entrance hallway with toilet cubicles and a large open classroom (Photograph 2). It was not possible to access the loft void, due to the location of the loft hatch (above a toilet), and the construction of the classroom ceiling which would not support weight.

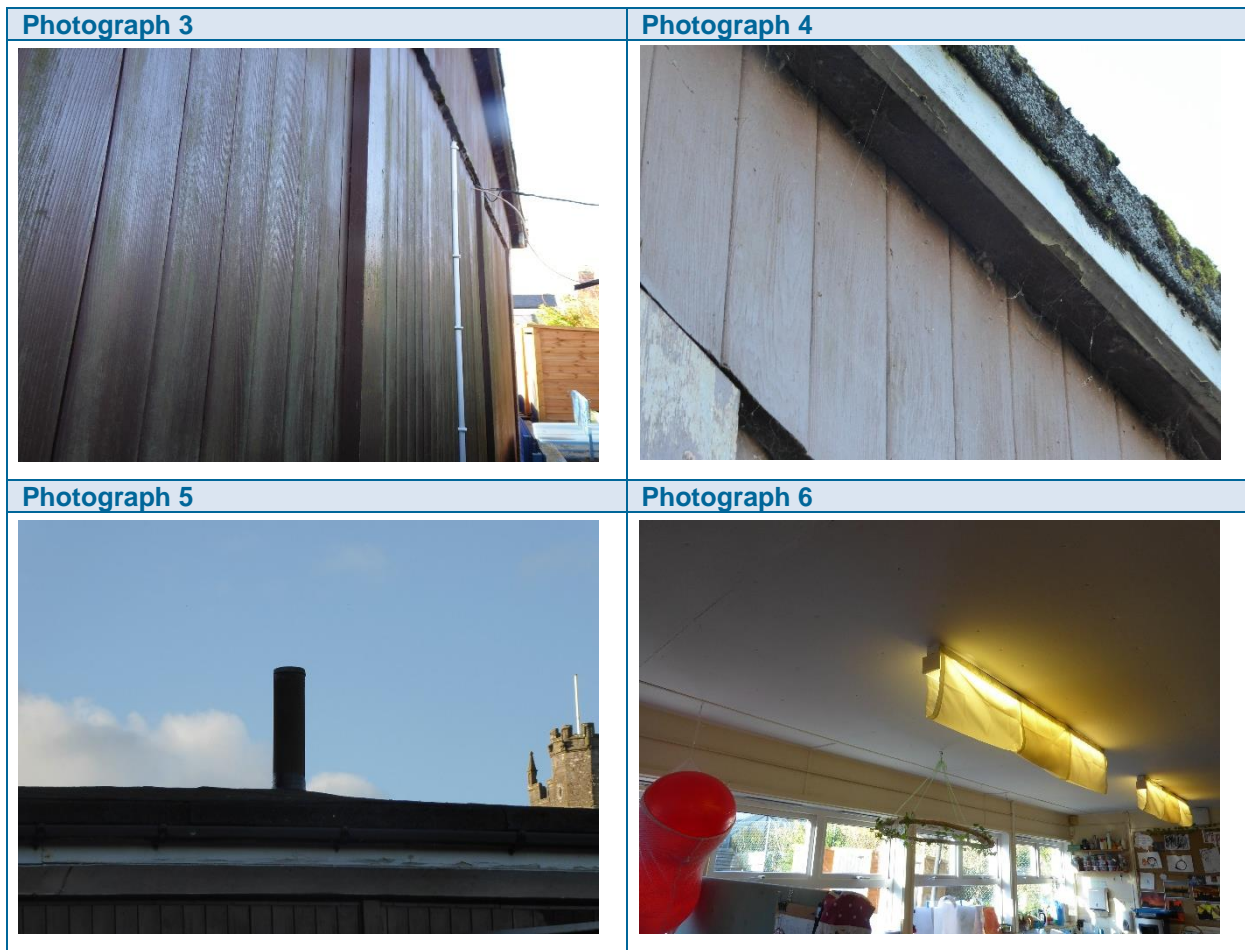
The exterior of the building comprised timber cladding which was tight with no gaps more than 5mm wide that bats could utilise (Photograph 3). The roof covering was tight to the timber fascias, with soffits tight to the timber cladding (Photograph 4). uPVC windows and doors were tight fitting with no potential access points. The boiler flue was well sealed around the base, and provided no access into the loft void (Photograph 5).

The interior of the building was light and airy and in constant use as a classroom (Photograph 6).

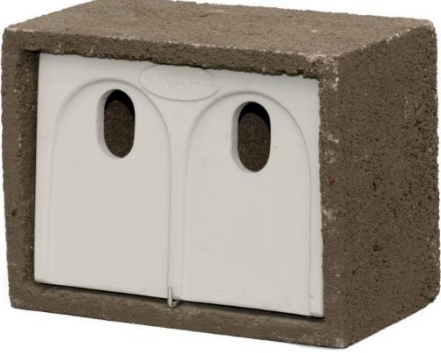
Type (examples – other manufacturers may have slightly different designs)	Location and description
<p>House Sparrow terrace</p>

<p>Installed as high as possible above ground (ideally at least 6m), ensuring that there is unobstructed access for birds entering and leaving.</p> <p>Boxes should be sited under the shelter of eaves or overhanging roofs.</p> <p>Entrance out of direct sun, preferably north or east-facing.</p>
<p>Vivarapro Woodstone bat box</p>

In order to enhance the new building for nesting birds, it is recommended that two sparrow terraces are placed on the northern gable end. Additionally, two in-built crevice-type bat boxes should be installed, close to the apex of the southern gable end of the new building. Boxes should not be sited directly above windows or doors, where droppings may cause a nuisance. Suitable boxes are available from websites such as www.nhbs.com and examples are provided in **Appendix 3**.

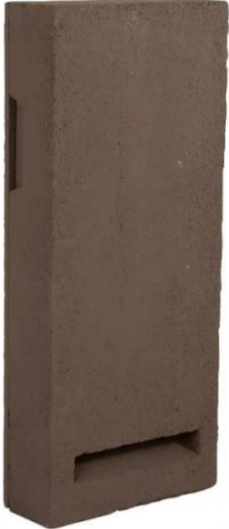
<p>Installed as high as possible, directly beneath the eaves, away from exterior lighting and windows.</p> <p>Boxes can be built into masonry, or installed behind cladding, with only the access slot exposed.</p> <p>Bat boxes should ideally face a range of directions to allow bats to select their environmental conditions depending upon the time of year/ amount of thermal gain from the sun.</p>
