Ecological Assessment for Bats And Breeding Birds

Site Name: Garage at Rectory Cottage, Church Lane,
Lapworth, Warwickshire B94 5NX,

Date of Survey: 6th February 2024

DR PENNY ANGOLD
CONSULTANT ECOLOGIST

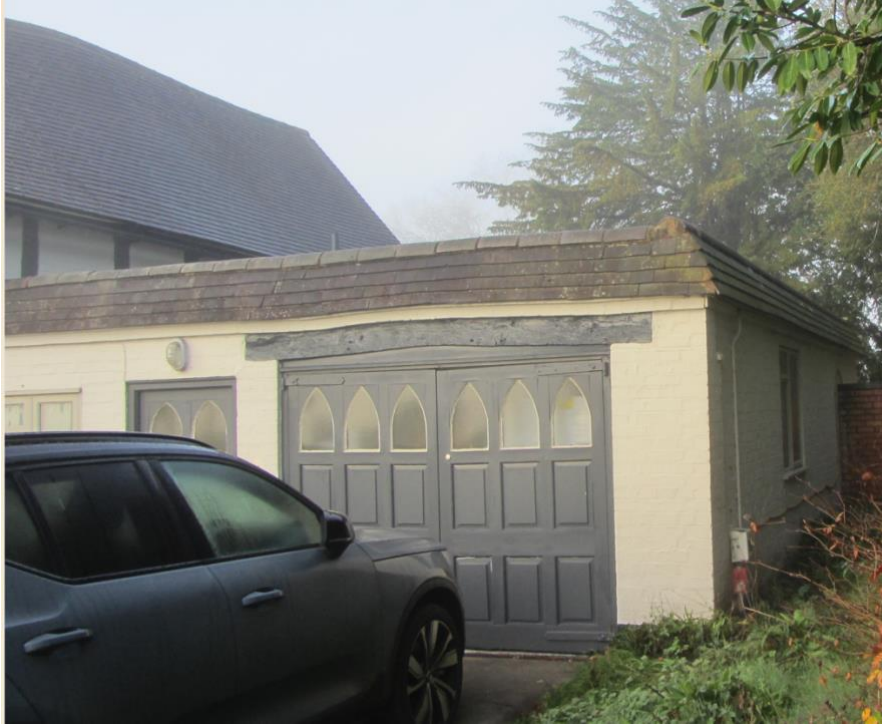
Garage building.

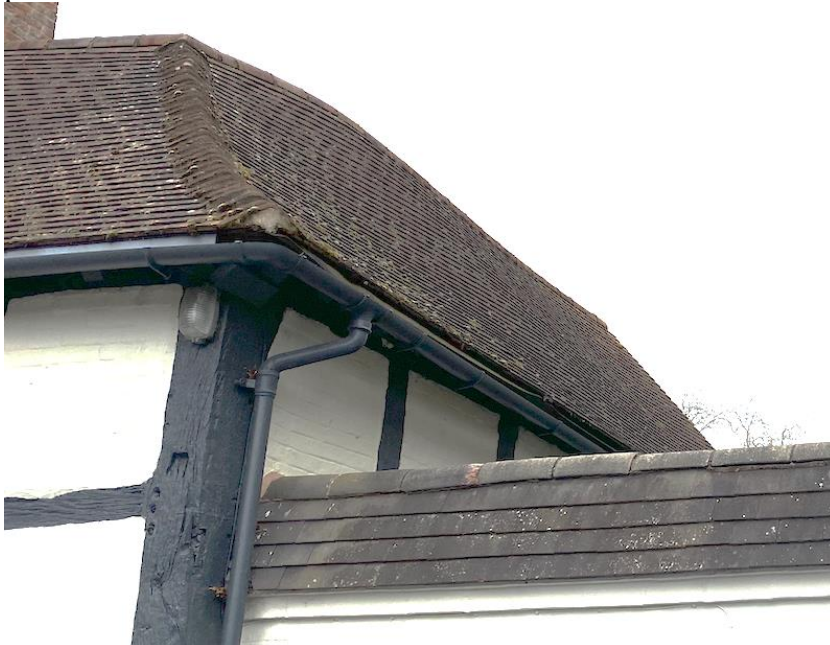
The site appears to be in the same general condition as during the 2019 bat survey, and the northern end of the main house roof remains well sealed with small, close-fitting tiles and no potential roost features for bats identified. There was no evidence of breeding birds, and the second story roof will not be disturbed by the proposed plans.

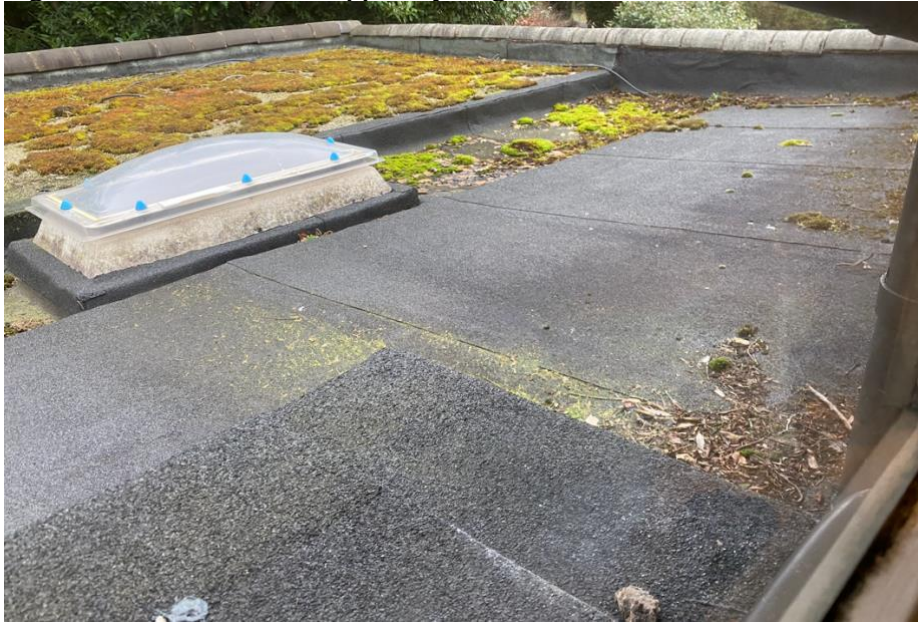
The garage is a single-story, flat bitumastic-roofed structure with a parapet roof 4 tiles high around the outside, topped by ridge tiles.

There are no potential roost features for bats and no evidence of breeding birds.

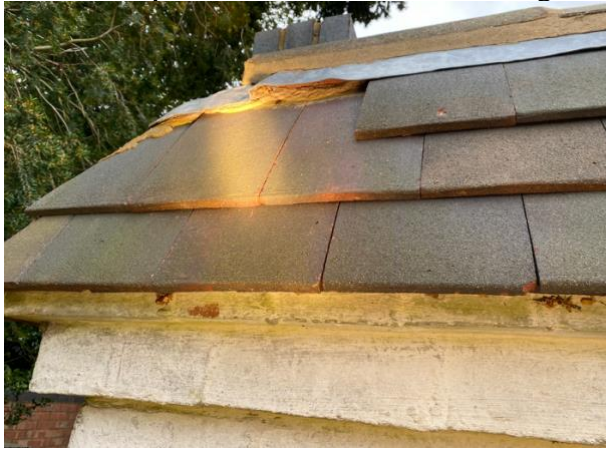
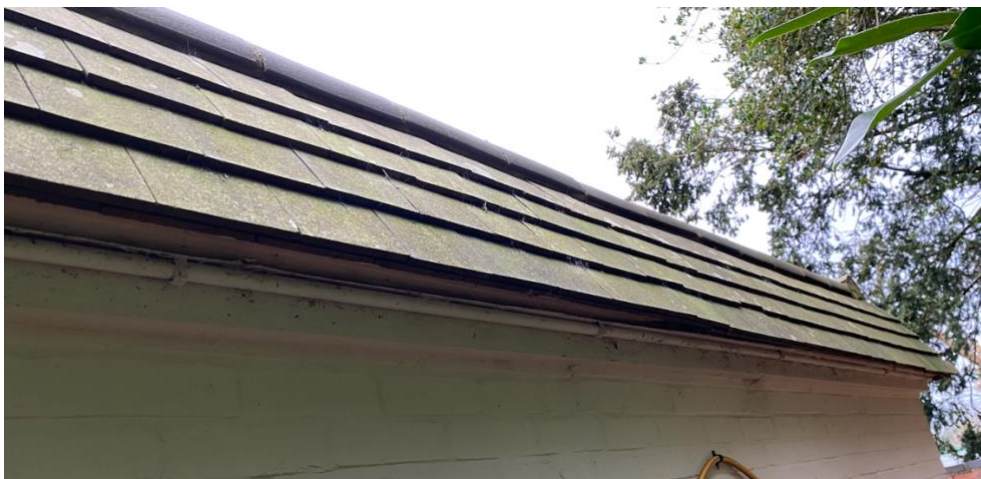
There are some gaps around the exterior tiles, with missing or loose tiles and raised flashing but these areas were able to be fully inspected and no potential roost features for bats, or potential nest sites for breeding birds, were found.

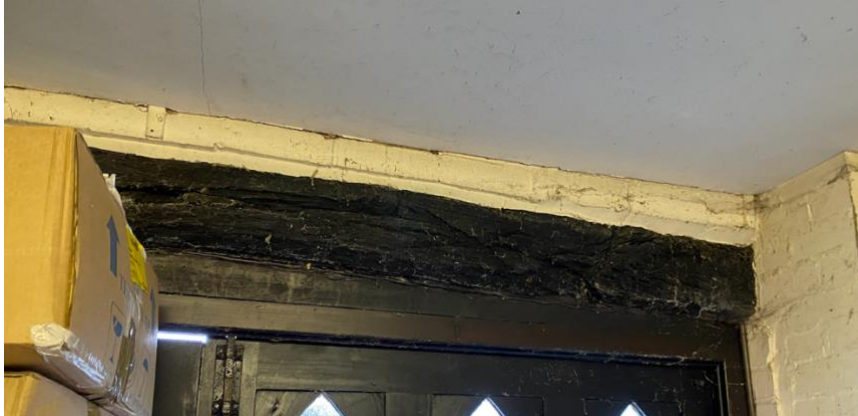
The interior of the garage was plastered, with the only potential access for bats being a gap above the garage door. There were mouse droppings, but no evidence of bats in the garage, and no potential concealed roost features for bats in the smooth walls.

Garage interior

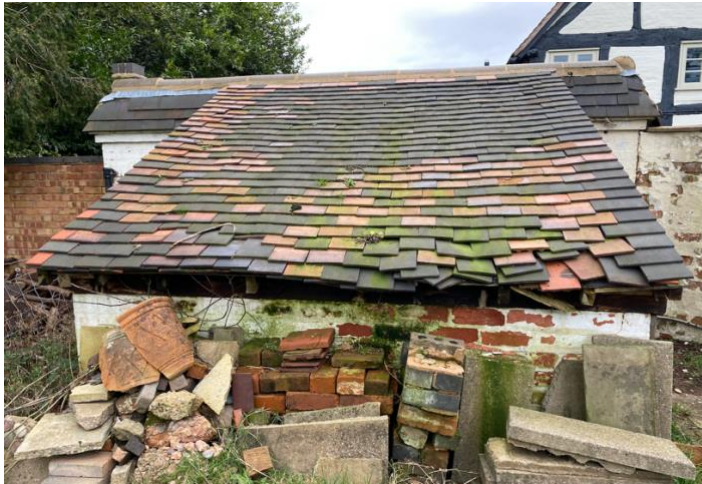
The lean-to shed behind the garage had slipped and uneven tiles especially along the bottom of the roof, and the northern side:

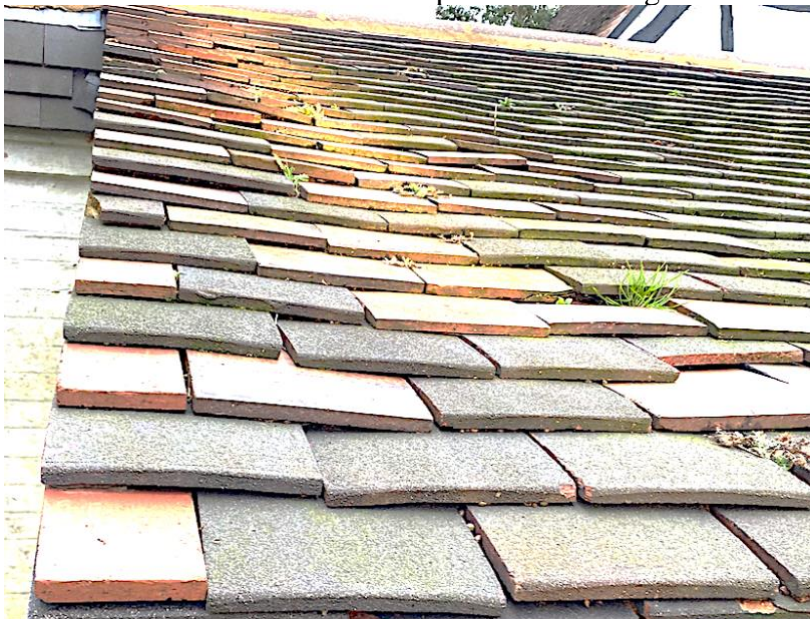
On closer inspection, the gaps under these loose tiles were filled with debris and did not lead to accessible cavities for potential roosting bats or breeding birds:

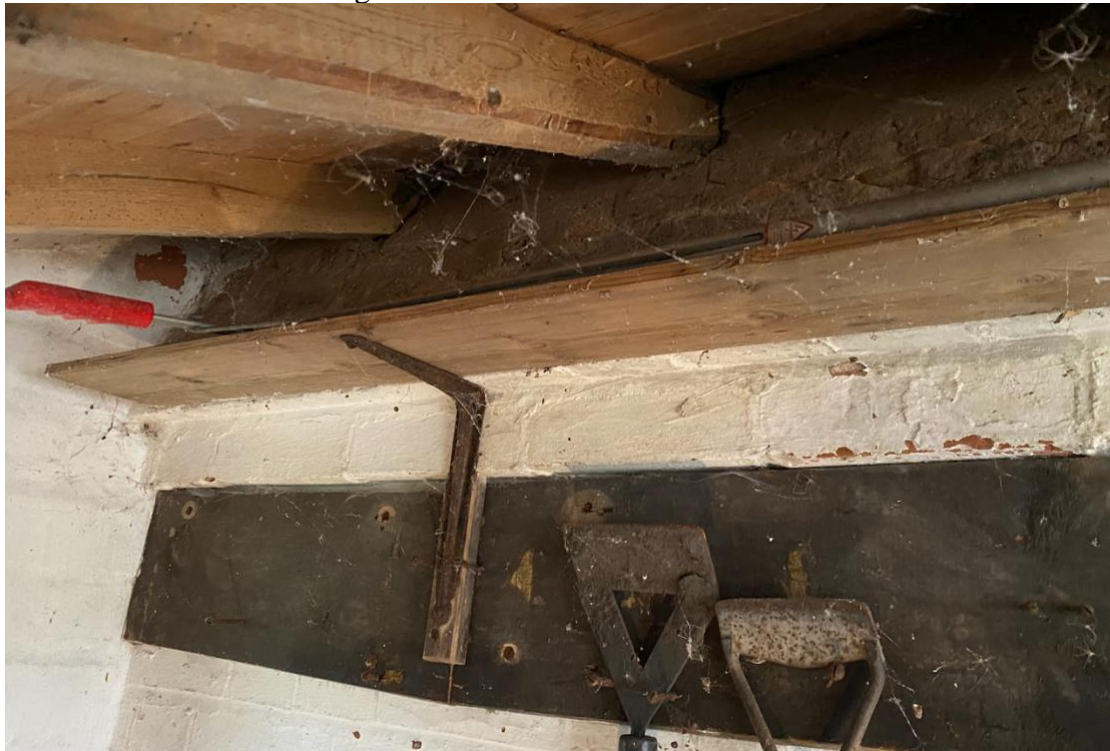
The interior of the shed roof was lined with timber sarking. The shed ceiling was heavily cobwebbed, there were no potential concealed roost features for bats and no evidence of bats in the shed, although there were mouse droppings on the floor. There was no evidence of breeding birds.
