# **Bat Assessment Report**

**Palace Cinema  
Normandy Street  
Alton  
GU34 1DE**

22-091  
August 2022

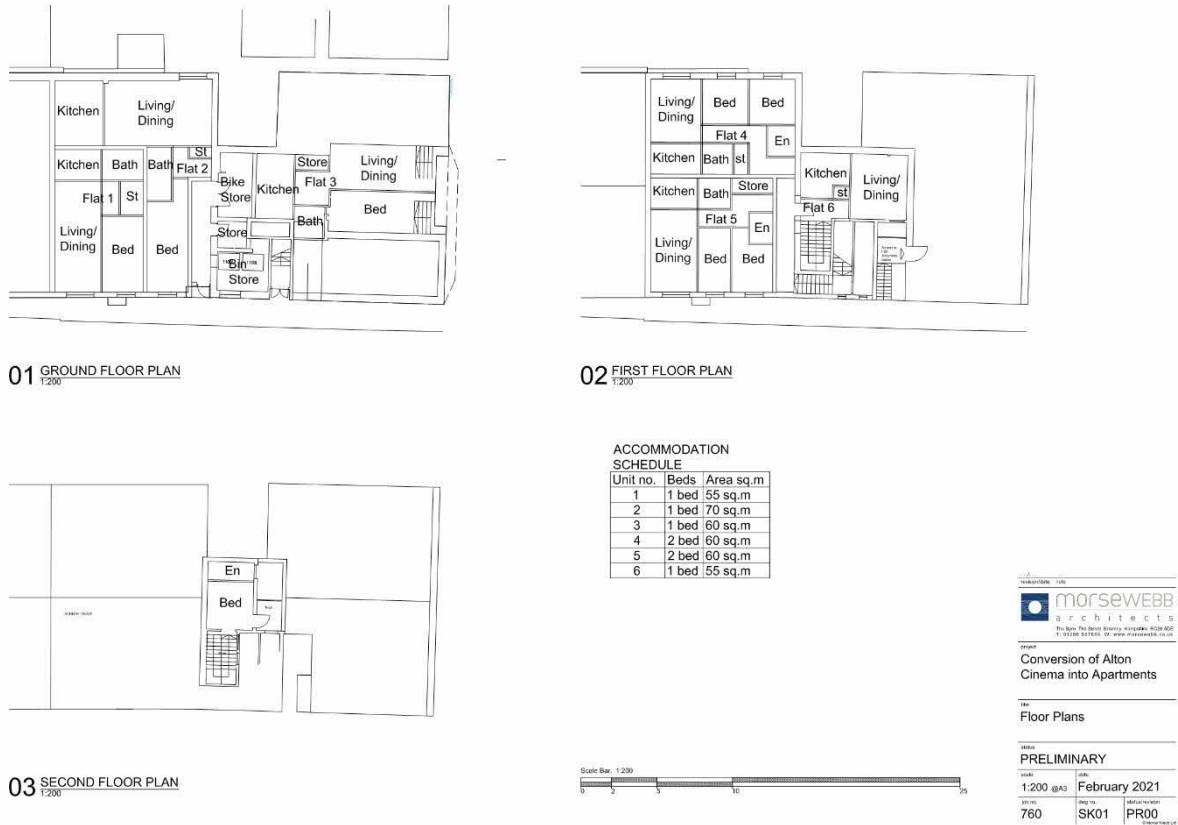
FIGURE 3: SHOWING THE PROPOSED PLANS.

- 1.13 The proposal is for internal conversion of the existing structure to create six apartments.

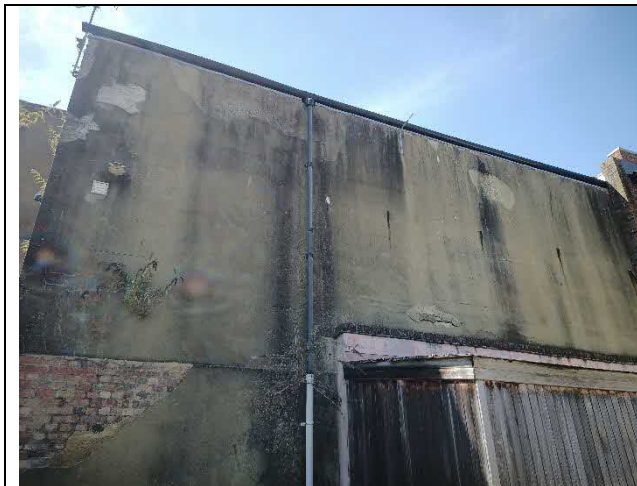
4.4 The location in which the new windows are proposed for creation consists of rendered brick walls with no roosting potential evident in these areas.

**Photograph 1:** *East-facing rendered wall in which windows are proposed for installation*

- 5.2 The building was considered to have low potential to support roosting bats within the batten space of the roof, however the areas proposed to be impacted by the works do not hold any potential for use by bats and, as such, there are no known constraints regarding these species and the proposed development.

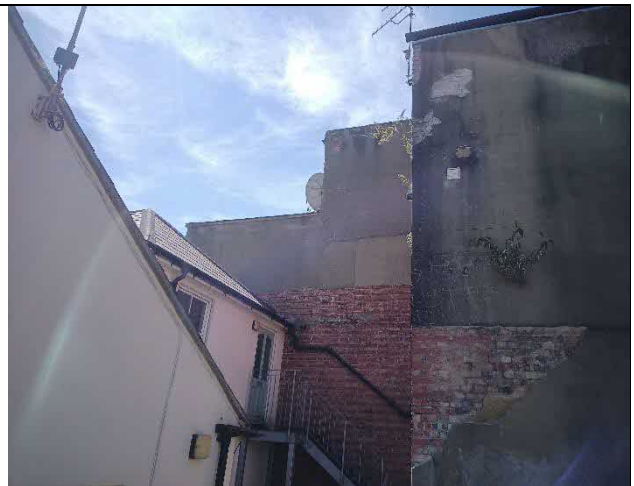
**Photograph 2:** *Flat roof section of building*

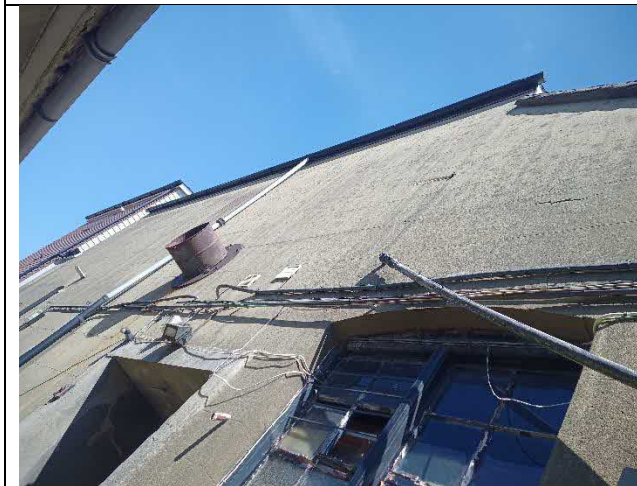
**Photograph 3:** *West-facing rendered wall in which windows are proposed for installation*

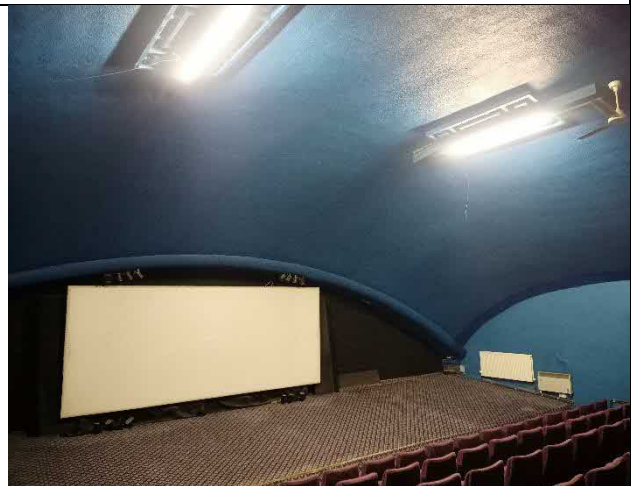
**Photograph 4:** *Main cinema hall*
