## Detailed Unexploded Ordnance (UXO) Risk Assessment

<b>Project Name</b>	Kingston Wharf, Kingston Road
<b>Client</b>	Cowes Harbour Commission
<b>Site Address</b>	Kingston Wharf, Kingston Road, East Cowes, Isle of Wight, PO32 6JS
<b>Report Reference</b>	DA18212-00
<b>Date</b>	28/07/2023
<b>Authored by</b>	CC
<b>Quality Assurance</b>	AB
<b>Final Check</b>	PB

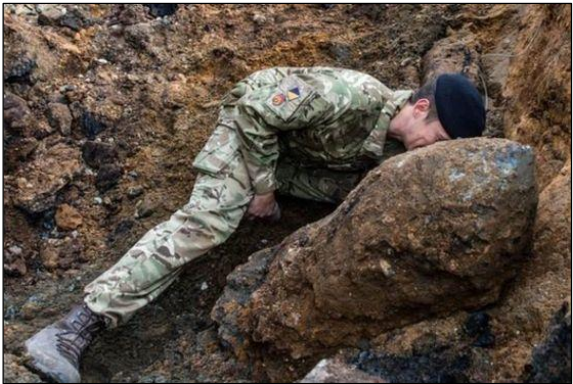
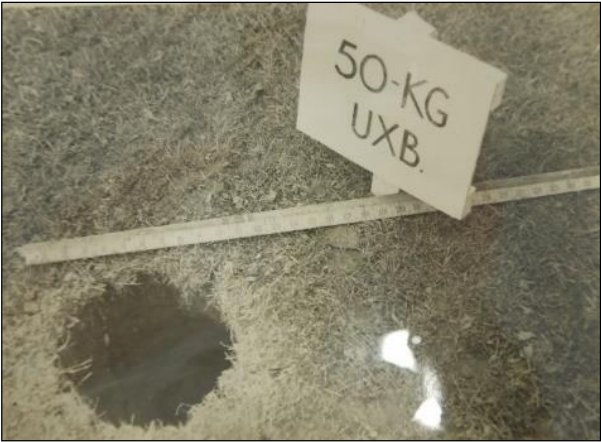
**Top:** J-curve Effect - Due to angle of entry, unexploded bombs would often end their trajectory at a lateral offset from point of entry, often ending up beneath adjacent extant structures/sites. The photograph above shows a 250kg unexploded bomb found in Bermondsey in 2015, pointing upwards, demonstrating ‘J-curve’.

One of the most common scenarios for UXO going unnoticed was when a UXB fell into a ‘bomb site’ (such as the area shown **Top Left**), the entry hole of the bomb obscured by any debris and rubble present. Note that the entry hole of a 50kg UXB could be as little as 20cm in diameter (**Left**).

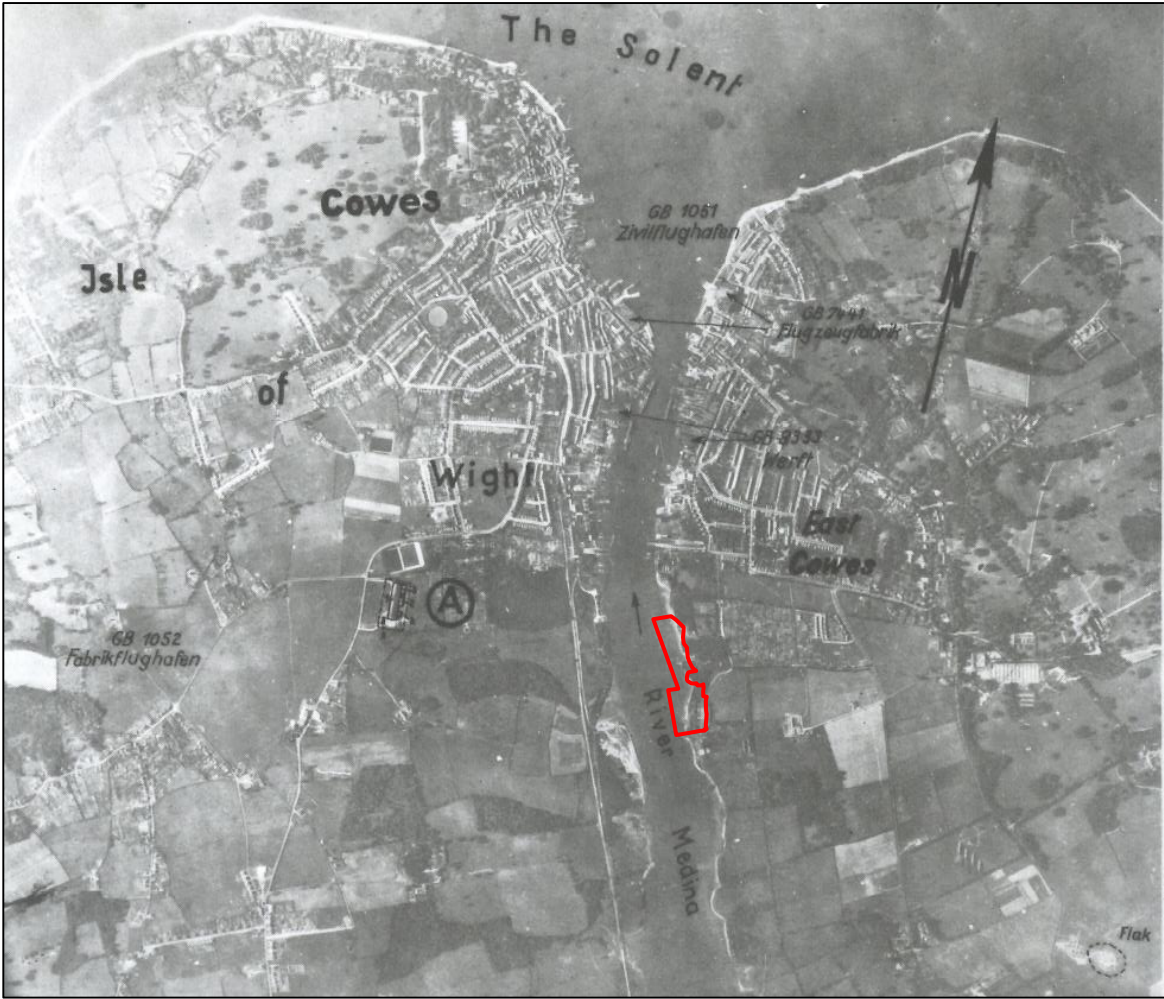
Luftwaffe Photograph, 28<sup>th</sup> July 1940

Isle of Wight – Cowes  
A. Samuel White aircraft factory

The site located approximately 890m east of the aircraft factory.

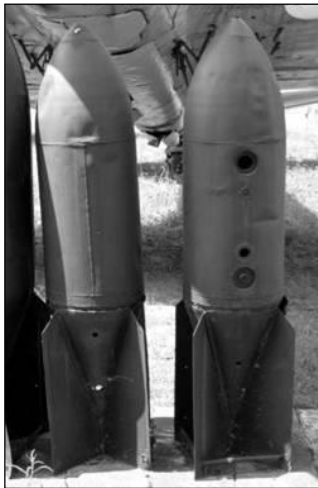
Flam C-250 Oil Bomb

Bomb Weight	Approx. 125kg (276lb)
Explosive Weight	Approx. 1kg (2.2lb)
Fuze Type	Super-fast electrical impact fuze
Filling	Mixture of 30% petrol and 70% crude oil
Bomb Dimensions	1,650 x 512.2mm (65 x 20.2in)
Body Diameter	368mm (14.5in)
Use	Often used for surprise attacks on ground troops, against troop barracks and industrial installations. Thin casing – not designed for ground penetration.

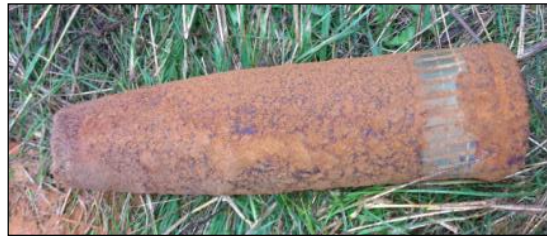
3.7 Inch QF Anti-Aircraft Projectile

Projectile Weight	28lb (12.6 kg)
Explosive Weight	2.52lbs
Fuze Type	Mechanical Time Fuze
Dimensions	3.7in x 14.7in (94mm x 360mm)
Rate of Fire	10 to 20 rounds per minute
Use	The 3.7in AA Mks 1-3 were the standard Heavy Anti-Aircraft guns of the British Army and were commonly used on the Home Front.
Ceiling	30,000ft to 59,000ft

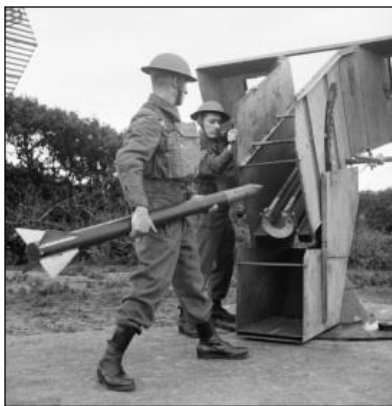
3in Unrotated Projectile (UP) Anti-Aircraft Rocket ("Z" Battery)

HE Projectile Weight	3.4kg (7.6lb)
Explosive Weight	0.96kg (2.13lb)
Filling	High Explosive – TNT. Fitted with aerial burst fuzeing
Dimensions of projectile	236 x 83mm (9.29 x 3.25in)
Remarks	As a short range rocket-firing anti-aircraft weapon developed for the Royal Navy. It was used extensively by British ships during the early days of World War II. The UP was also used in ground-based single and 128-round launchers known as Z Batteries. Shell consists of a steel cylinder reduced in diameter at the base and threaded externally to screw into the shell ring of the rocket motor.

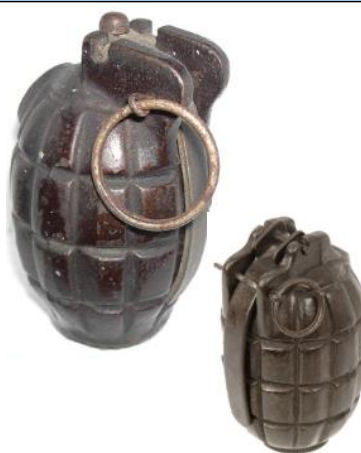
**No. 36 'Mills' Grenade**

Weight	Approx. 765g filled (1lb 11.25oz)
Explosive Weight	71g (2oz) filling.
Fuze Type	4-7 second delay hand-throwing fuze. No. 6 Detonator
Dimensions	95 x 61mm (4 x 2.4in)
Use	Fragmentation explosive at approx. 30m range 100m range of damage.
Remarks	First introduced in 1915, its classic grooved, cast-iron 'pineapple' design was designed to provide uniform fragmentation. The detonator is inserted before use after removing the base plug.

Left: baseplate and detonator removed

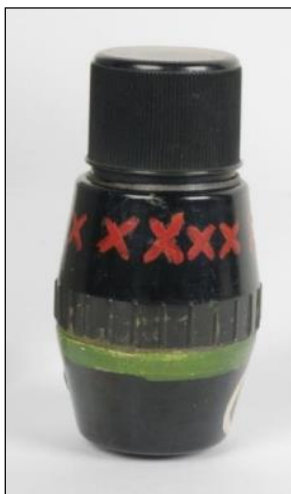
**No. 69 Grenade**

Weight	Approx. 383g ( 13.5oz)
Fill Weight	93g (3.25 oz) of either Amatol, Baratol or Lyddite
Fuze Type	'All-ways' fuze. Comprised of a safety cap, a weighted streamer attached to a steel ball bearing and a safety bolt designed to detonate from any point of impact.
Dimensions	115 x 60mm (4.5 x 2.4 in)
Use	A blast grenade for use as an offensive weapon. Detonator was inserted before use.
Remarks	Introduced December 1940 and made from the plastic Bakelite as opposed to conventional metals. Detection is difficult due to this low metal content.

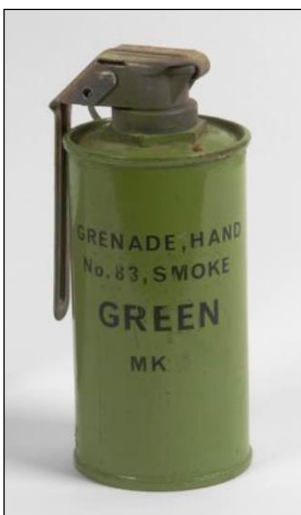
**No. 83 Smoke Grenade**

Weight	Approx. 680g ( 1.5lb)
Explosive Weight	Approx. 170-200g. (6-7 oz)
Fuze Type	Originally used a friction system using a match head composition. Later developed to a striker lever ignition system.
Dimensions	Approx. 62 x 140mm (2.44 x 5.5 in)
Use	Use as a target or landing zone marking device and as a screening method for troop / unit movement.
Remarks	This basic design stayed relatively unchanged up to the 1980's. The letters CCC were often etched into the body of the grenade in the colour of the smoke.

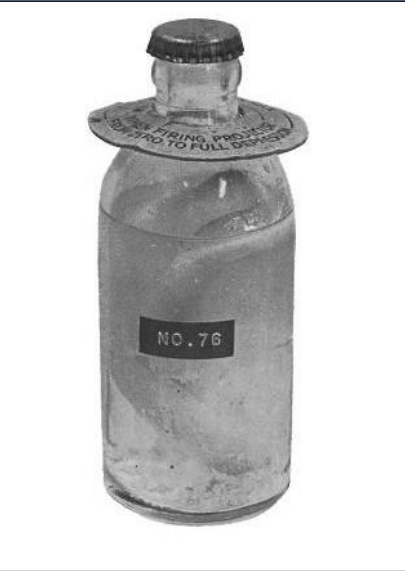
No. 76 Self Igniting Phosphorous (SIP) Grenade

Weight	Approx. 1lb 3oz
Filling	White Phosphorous and Benzene
Design	The filling was contained in a ½ pint sized glass bottle with water and a strip of rubber. Over time the rubber dissolved to create a sticky which would self ignite when the bottle broke.
Use	Originally intended as an anti-tank incendiary weapon deployed by hand. Designed to be produced cheaply without consuming materials needed to produce armaments on the front line.
Remarks	The Home Guard hid caches of these grenades during the war. Not all locations were officially recorded and some caches were lost and encountered post-war. In all cases, the grenades are still found to be dangerous.

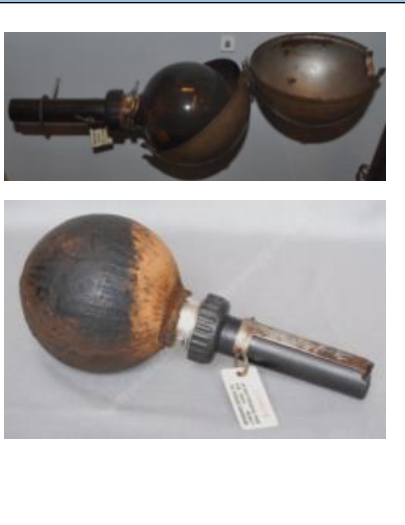
No. 74 Grenade (“Sticky Bomb”) Mk1

Weight	Approx. 1.1kg (2.25lb)
Filling	Approx. 600g Nobel’s No.283 (Nitro-glycerine) (1.33lb)
Design	A glass ball on the end of a Bakelite (plastic) handle. The inside of the ball would contain the explosive filling and the outside a very sticky adhesive coating.
Use	An anti-tank grenade primarily issued to the home guard. It required the user to come in very close proximity of the target and smash the glass explosive container against it.
Remarks	Timer fuze was located in the handle. This would explode after 3-6 secs.

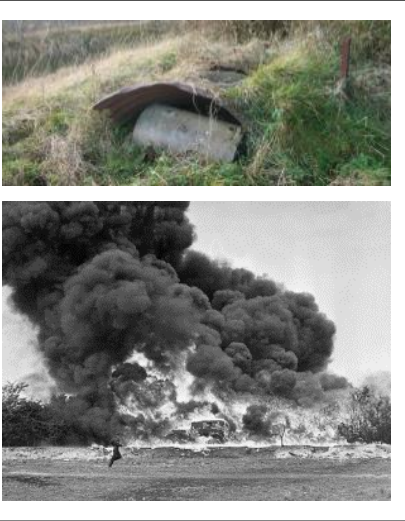
Flame Fougasse Bomb

Weight	Various
Filling	Initially a mixture of 40% petrol and 60% gas. Ammonal provided the propellant charge.
Design	Usually constructed from a 40-gallon drum dug into a roadside and camouflaged.
Use	As an improvised anti-tank bomb. When triggered the Fougasse could project a beam of burning sticky fuel in a fixed direction from up to 3m (10ft) wide and 27m (30yards) long.
Remarks	A highly unorthodox weapon designed by the Petroleum Warfare Department to address a critical lack of weapons in 1940. 50,000 are estimated to have been distributed around the UK.

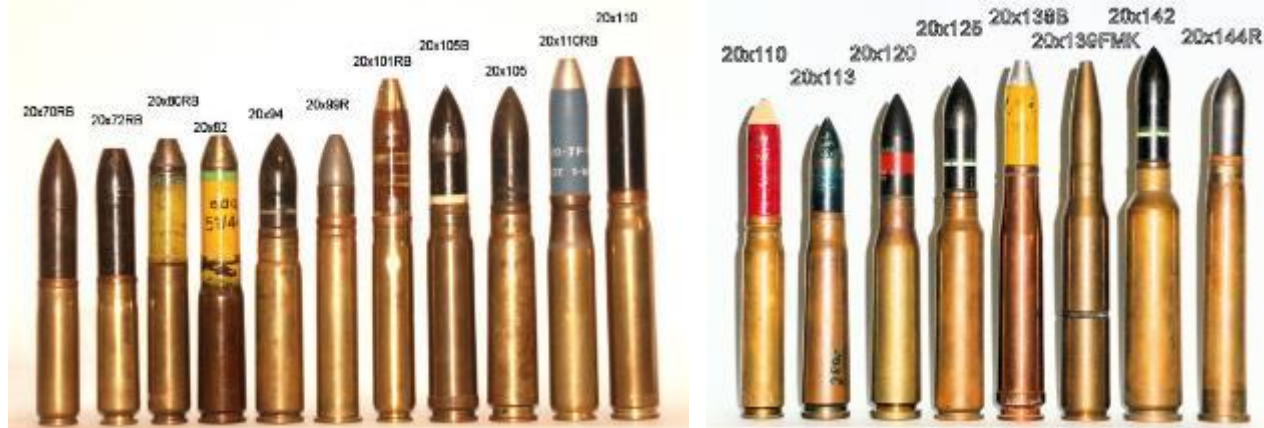
Cannon Ammunition

.303 British Rifle Ammunition

Bullet Diameter	7.92mm

Case length	56.44mm	Bullet Type	Colour of tip	Colour of Annulus		
Overall length	78.11mm	Armour Piercing	Green	Green		
Type	Rifle Ammunition	Ball	None	Purple		
Propellant	Originally black powder. Later Cordite followed by Nitrocellulose	Incendiary	Blue	Blue		
Remarks	First produced in 1889 and still in use today, the .303inch cartridge has progressed through ten 'marks' which eventually extended to a total of around 26 variations.	Observing	Black	Black		
		Proof	None	Yellow		
		Tracer Short Range	White	Red		
		Tracer Dark Ignition	Grey	Red		
		Tracer Long Range	Red	Red
