HOTHAM HALL STABLE AND BARN  
HERITAGE STATEMENT AND IMPACT ASSESSMENT  
ISSUE 01 - DECEMBER 2023

# HOTHAM HALL: HERITAGE STATEMENT

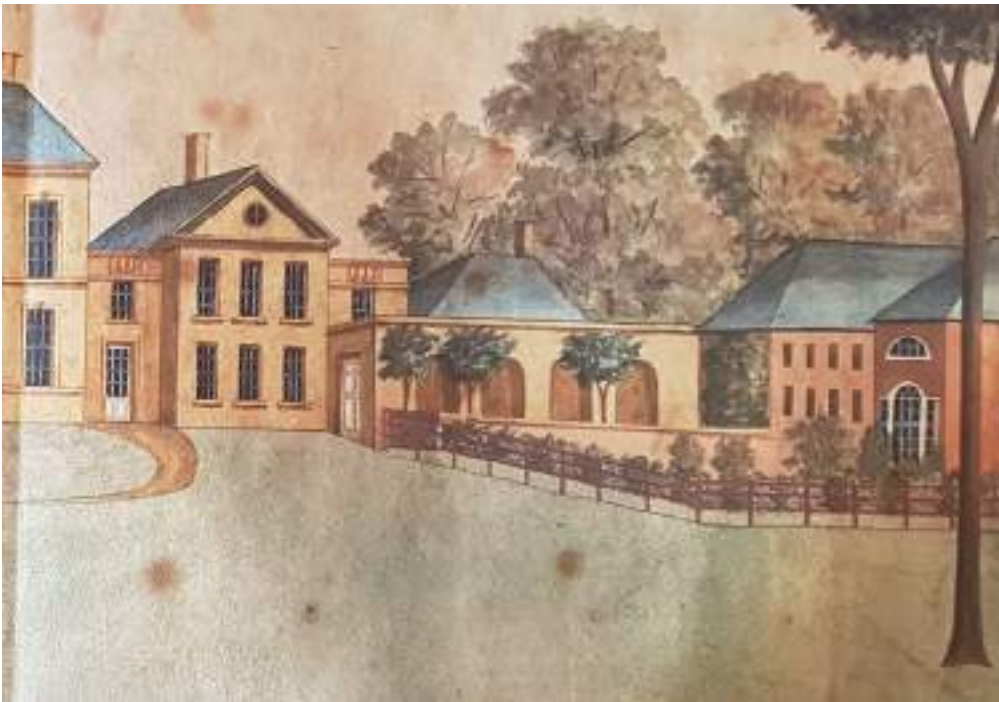
*Detail of painting of Hotham Hall circa 1772 – 1803. The stables are located to the right - the north and south wings are both visible – whilst the north wing's gable end windows are prominent, the gable end of the south wing is concealed behind foliage. The south wing is linked to the east pavilion by an arcade or loggia.*

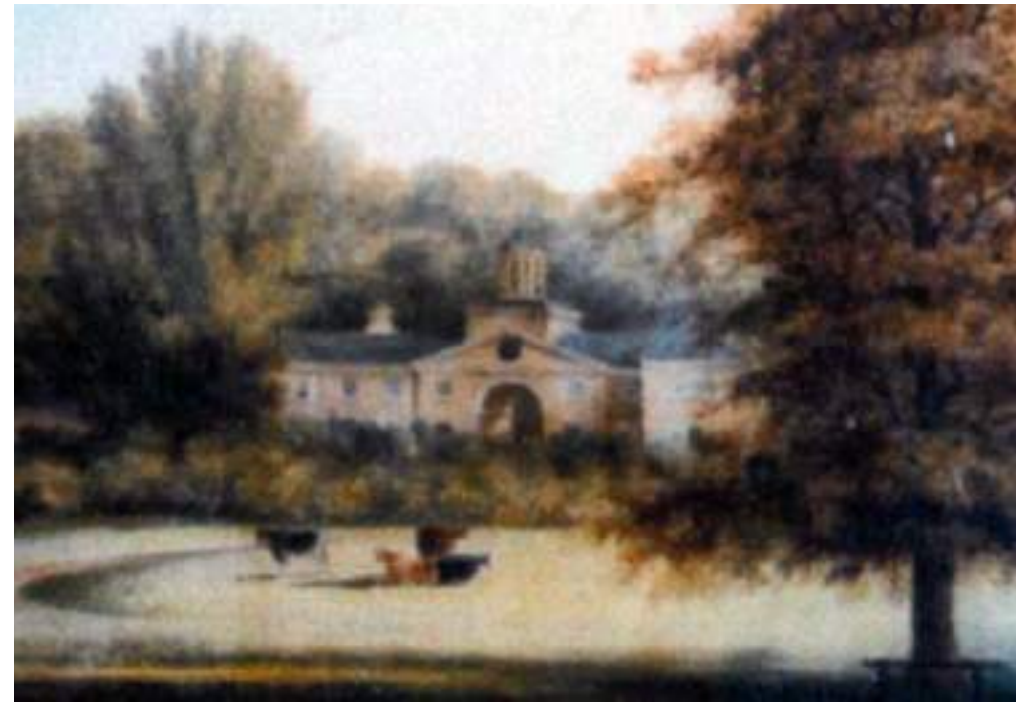
*Detail of painting of Hotham Hall focusing on the stables by RB Harraden. The stables are recognisable by their bell tower, clock face and carriage arch. A large chimney stack (possibly to the to the wash and bake house) is also visible.*

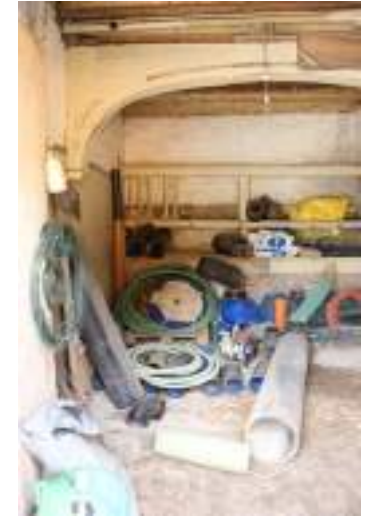
Stable/loose box with brick floor decorative arch and feeding rack

The ground floor also includes a loose box, store with two hot water coppers on the rear wall, and tack room. The loose box features plaster walls, a decorative timber arch (which conceals a beam), lined timber feeding trough and hay rack with tethering rings and herringbone pattern brick floor. The arch and use of timber would suggest this loose box was not upgraded in the Victorian period, and may date to a similar period as the western extension stabling.

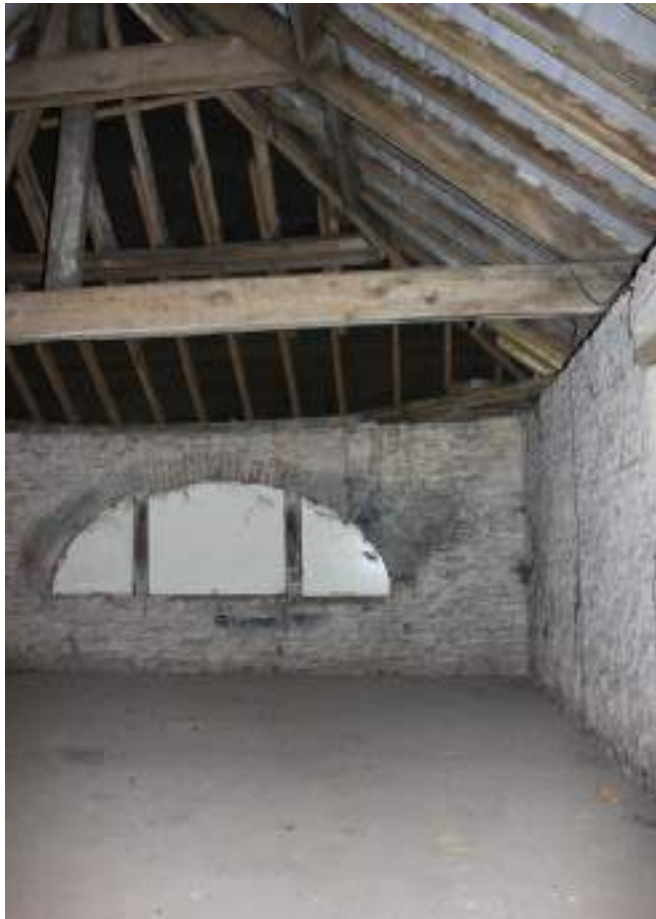
Hay loft or feed store with blocked Diocletian window with brick arch and stone mullions

The first floor is accessed from a timber staircase between the stables within the north wing. This leads directly into a white-washed room – the stair enclosure has been removed and replaced with temporary railings. The floor is modern and open to the rafters. The Diocletian window in the gable end is blocked with no evidence of a window frame or glazing, whilst another 'window' is in fact a pitching door. There is no evidence that this space was plastered or ceiled (plaster only exists to the former stair enclosure) leading to the conclusion that this space was a hay loft or feed store.

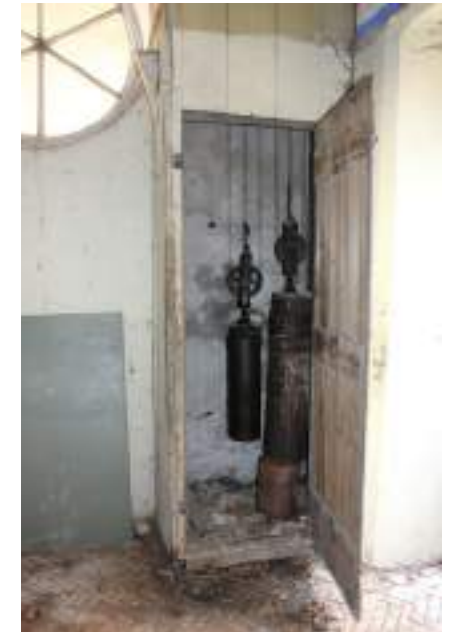
Clock weights in loose box

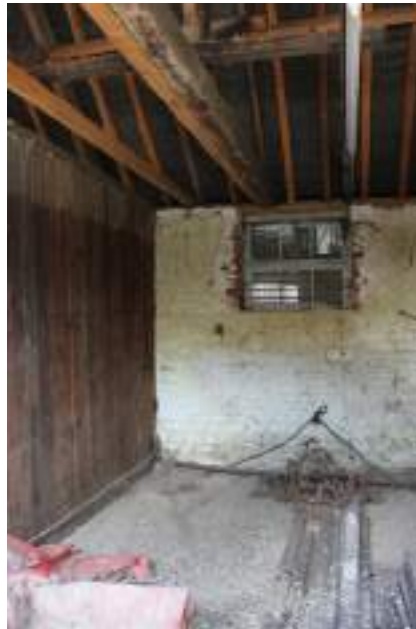
*Interior of loose box with concrete floor and timber partitions*

The gable end wall has a blocked arched opening whilst there are several multipaned sashes and a blocked window on the north elevation. The stables have boarded partitions and concrete floors and are of limited interest.

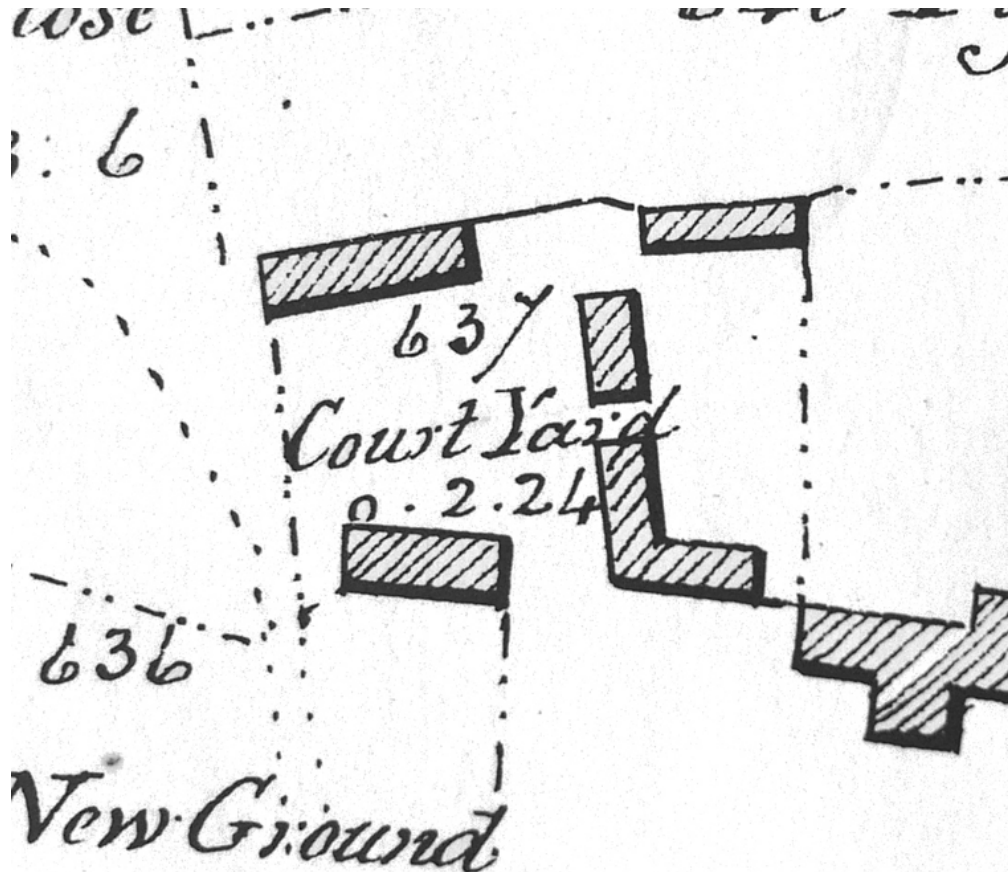
Stable Block as depicted on the 1813 estate plan

The depiction the Stable Block on the 1813 plan of the estate is also curious as it fails to show the building with its characteristic 'U' shaped plan form; the north wing is shown as detached from the rest of the building. This may be an error, as the fabric evidence does not support this particular layout. Two other ranges are also indicated within the outer courtyard on the north side and south side. The area of the proposed spa appears to be subdivided and is annotated 'New Ground'.

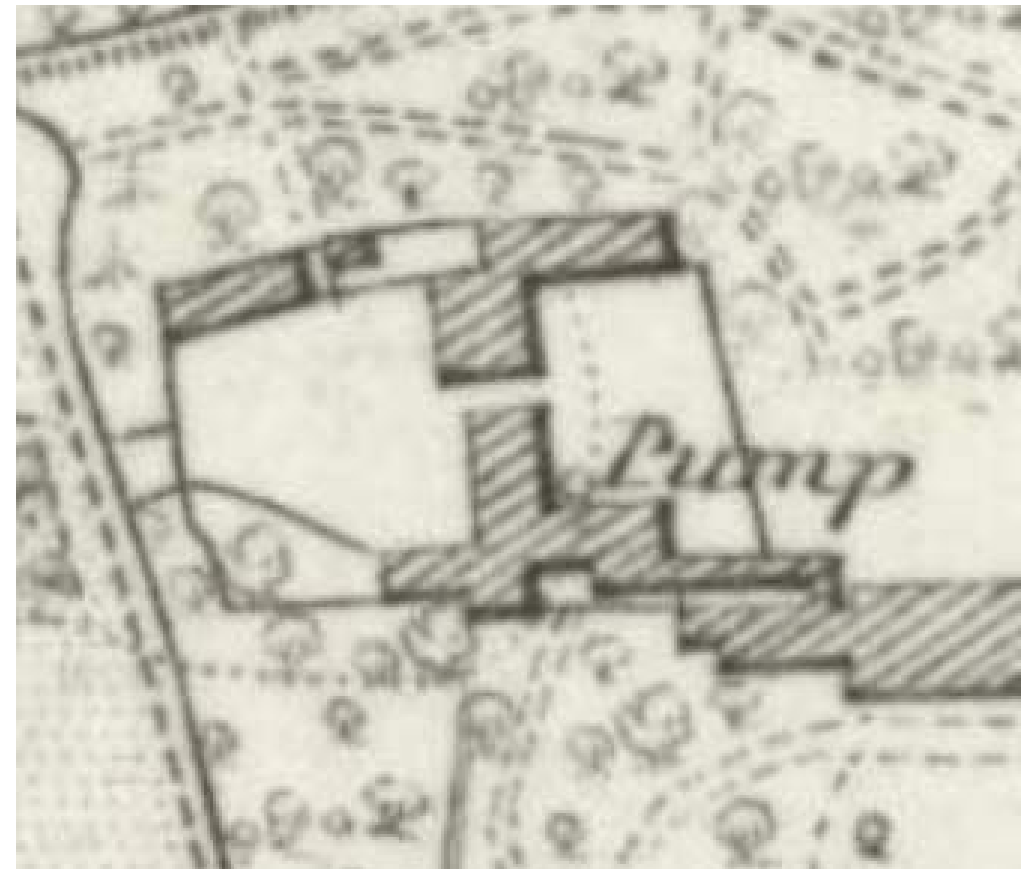
First edition Ordnance Survey of 1852 (surveyed 1852).

A more familiar plan form of the Stable Block is shown on the Ordnance Survey of 1852 (published 1855). The outer courtyard retains the range of buildings on the north side, and a small building is attached to the rear of the south range (a stub of wall can be seen within the estate workshops which may relate to this former building). The stable extension to the rear of the north range is shown and the whole Stable Block is connected to the Hall by what appears to be a covered passageway. A water pump is also indicated close to the entrance to the former wash house. The area of the proposed spa appears to be separated from the main gardens by a wall; a number of trees are indicated.

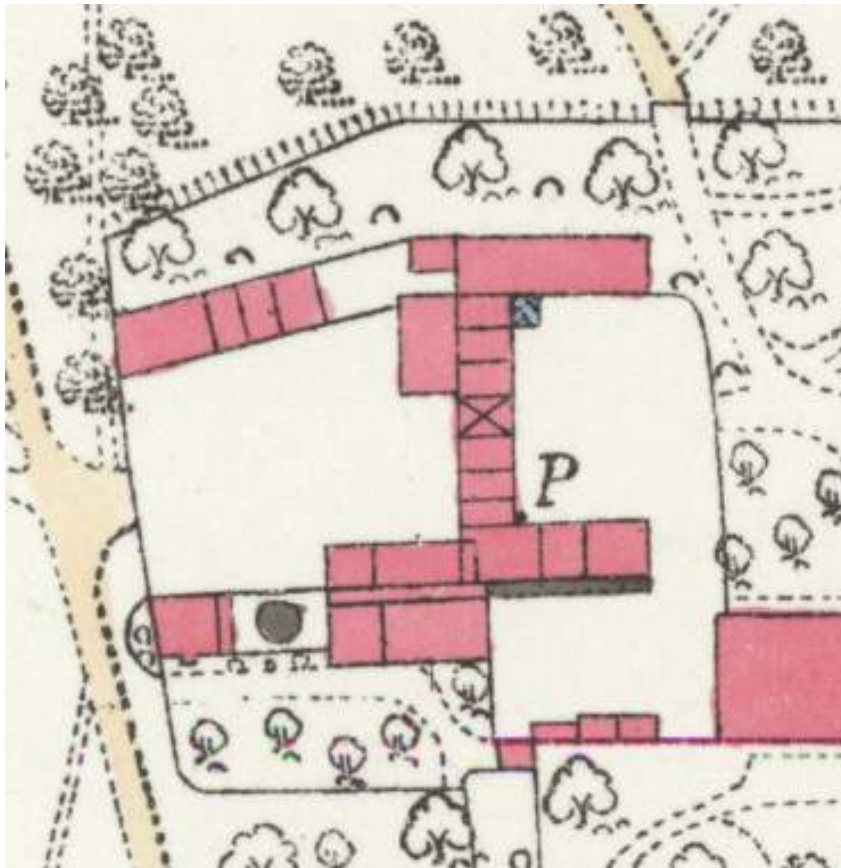
1890 (surveyed 1888) Ordnance Survey 25 inch of Hotham Hall.

The 1888 survey published in 1890 indicates the coach house and yards appear much as they do today. Perhaps in association with the 1872 works, the Stable Block received its southern range of buildings into the outer courtyard. The smithy's yard now contains a building appended to the rear of the north range. The proposed location of the spa is shown as partly enclosed and shows a possible path or road along its northern half.

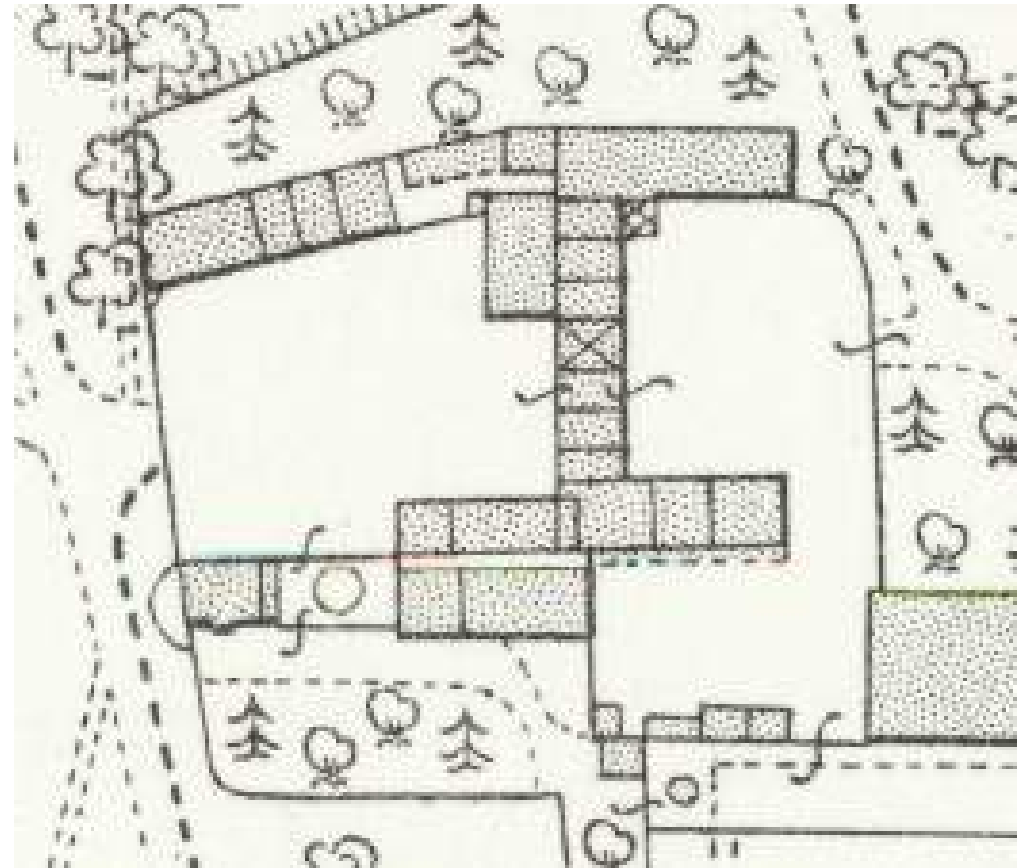
1910 (surveyed 1908) Ordnance Survey Third Edition 6 inch

There are few changes of note on the 1908 Ordnance Survey from 20 years earlier, although the smithy's yard contains a lean-to.

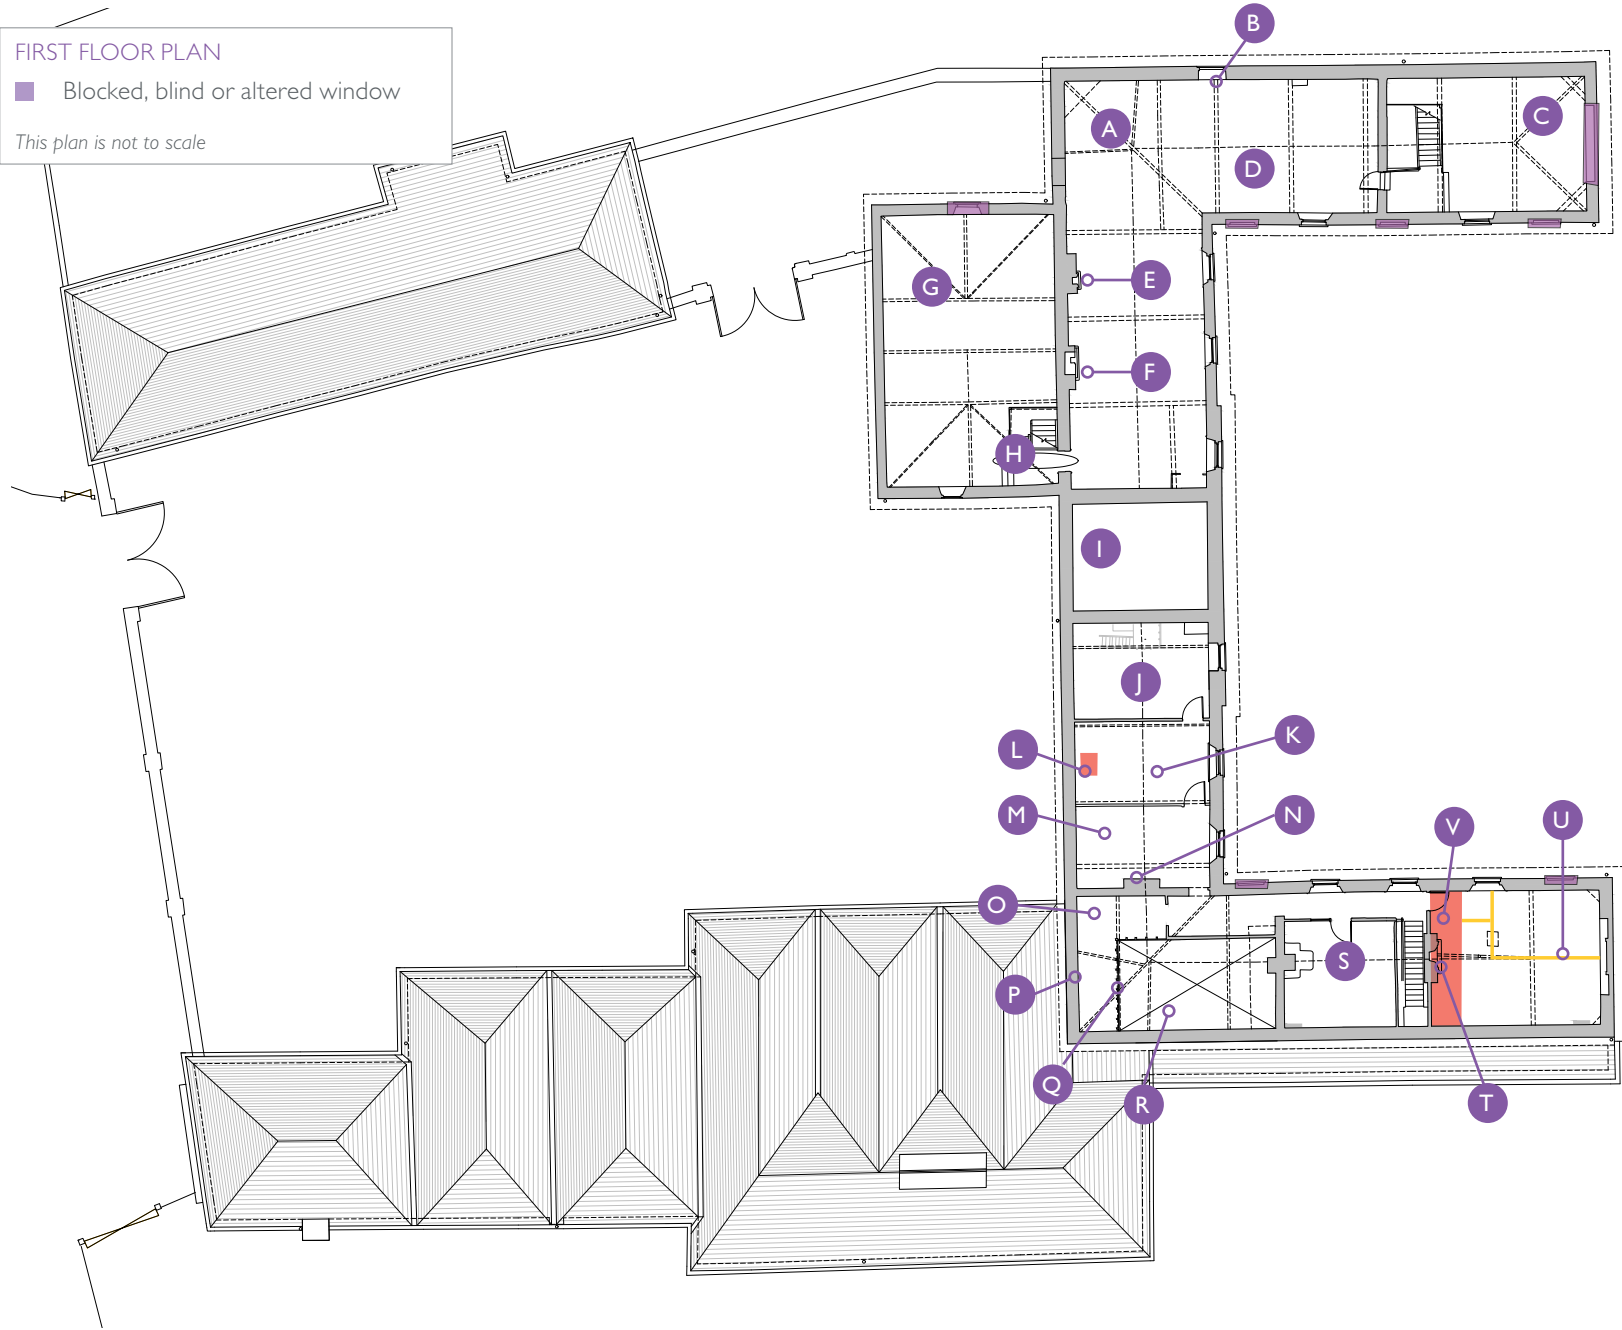
**FIRST FLOOR PLAN**  
 ■ Blocked, blind or altered window  
*This plan is not to scale*

- A Modern floor  
Open to rafters (line of former ceiling visible on rafters)  
Plastered walls
- B Partition formerly cut across window
- C Hay loft, open to rafters, white washed walls, modern floor

- D Hay loft, open to rafters, white washed walls, modern floor
- E Fireplace
- F Kitchen range
- G Hay loft, feed store (?). Modern floor, open to rafters Whitewashed walls
