WOLD ECOLOGY LTD

Hotham Hall, Hotham

Bat Survey, August 2023.

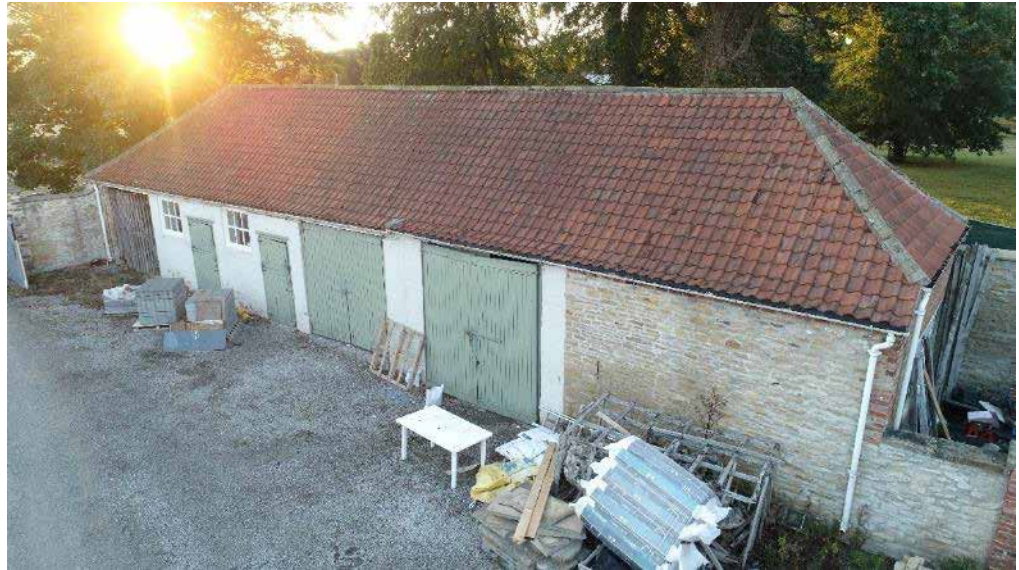
Plate 1 – Stable 1, south elevation.

- Gaps beneath the lead ridges.
- There are no missing ridges.
- Gaps beneath slates although the majority appeared tight fitting.
- Gaps above the eaves.
- There are no gaps in the external mortar suitable for roosting bats.
- The timber doors and timber window frames were tight fitting.
- There was no open doors/window access into the building.
- Gaps between internal roof membrane and slates above.
- There was no open doors/window bat access into the building.
- No evidence of bats was observed.
- Stable 1 has been assessed as having a MODERATE SUITABILITY to support bats.

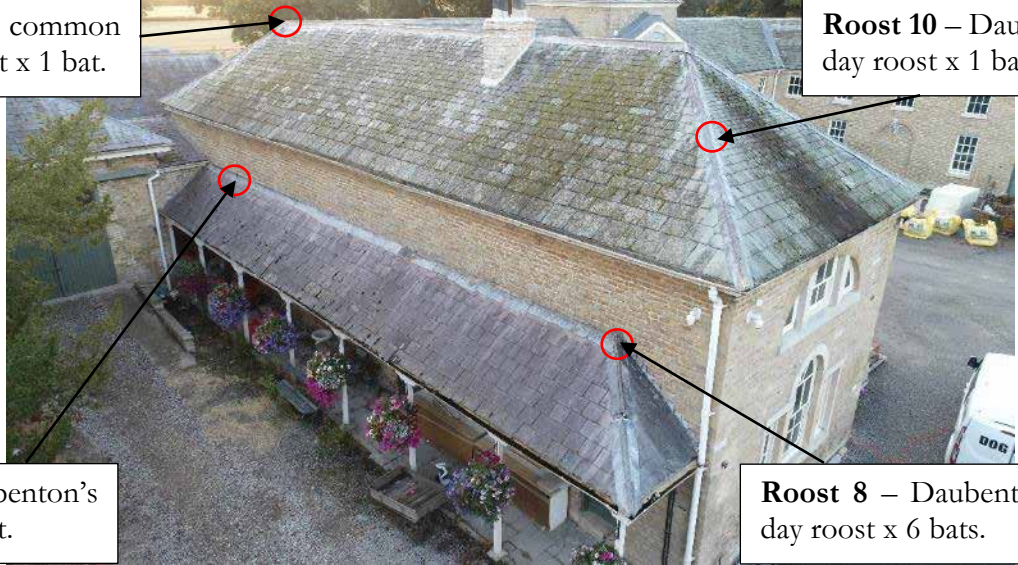
Plate 4 – Stable 2, south and east elevations.

Roost 5 – common pipistrelle day roost x 1 bat.

Roost 10 – Daubenton's day roost x 1 bat.

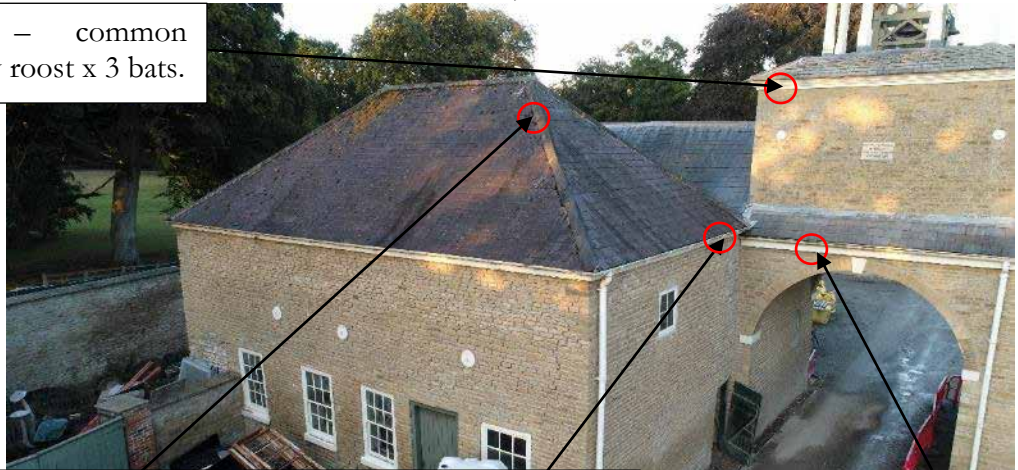
Plate 8 – Stable 2, west elevations.

Roost 3 – common pipistrelle day roost x 3 bats.

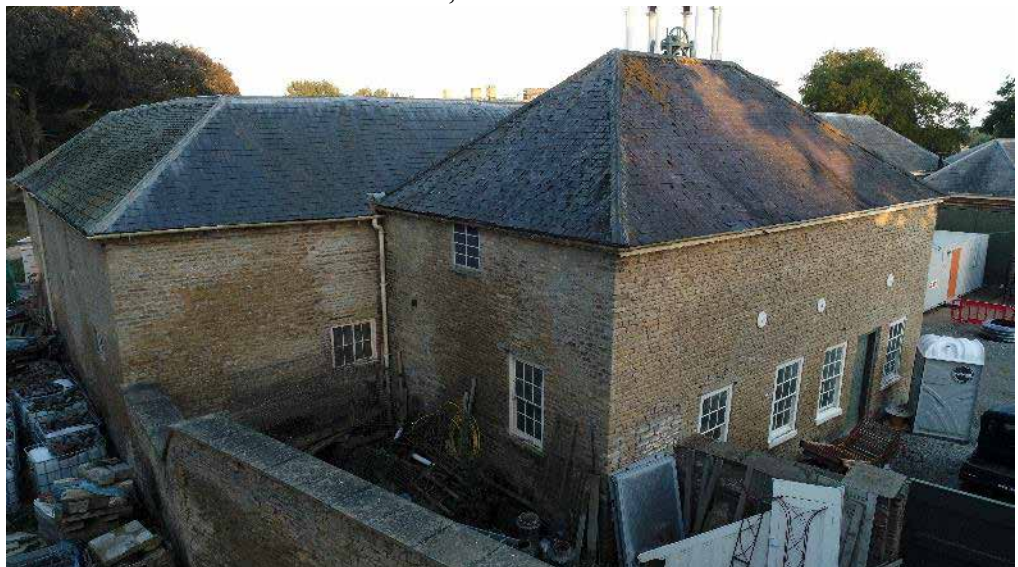
Plate 9 – Stable 2, north and west elevations.

Roost 1 – soprano pipistrelle day roost x 3 bats.

Roost 7 – common pipistrelle day roost x 1 bat.

Roost 4 – common pipistrelle day roost x 2 bats.

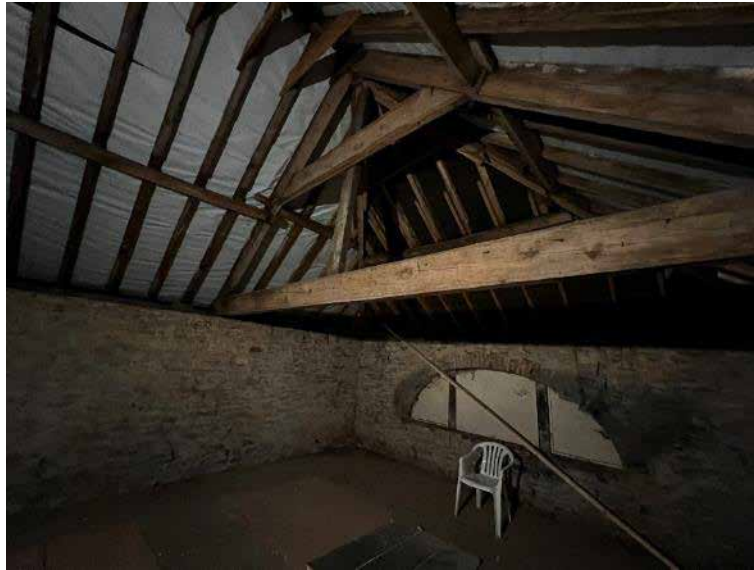
Plate 13 – stable 2, internal roof void.

Roost 11 – brown long-eared day roost x 1 bat.

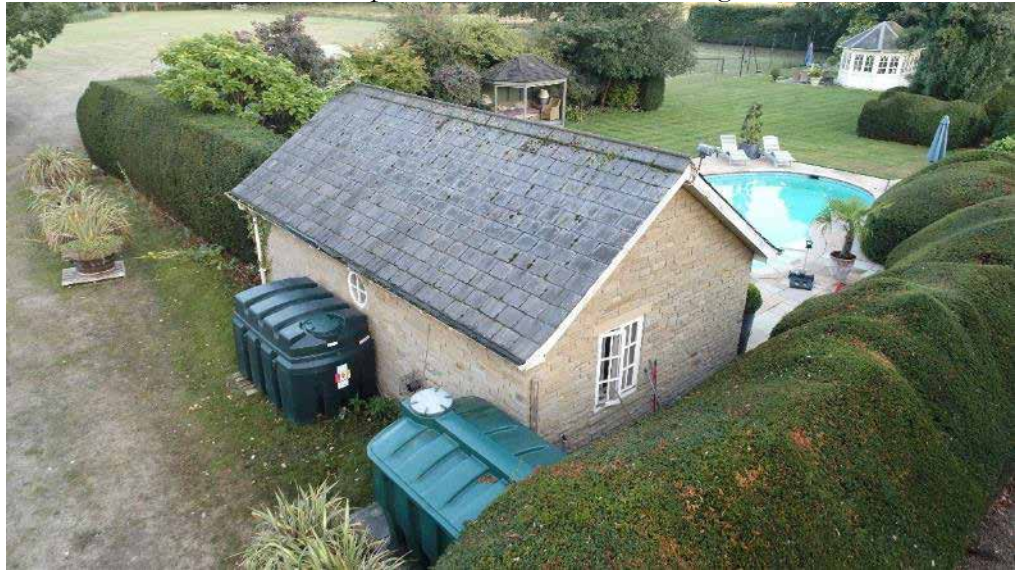
Plate 16 – pool house, south and west gable

- There are no gaps beneath the ridge tiles, and none are missing.
- Gaps beneath slates although most are tight fitting.
- Gaps below the west gable slates.
- Gaps above the boxed timber eaves on the gables.
- There are no gaps in the external mortar suitable for roosting bats.
- The timber doors and timber window frames were tight fitting.
- Gaps above the internal wall plates.
- There was no open doors/window bat access into the building.
- Ivy *Hedera helix* is present on the east gable, but this is considered to be of sub optimum structure to support roosting bats. The abundant foliage restricts free flight access into cavities and the age of the ivy has yet to form large diameter ivy stems with associated gaps and crevices.
- No evidence of bats was observed.
- The pool house has been assessed as having a LOW SUITABILITY to support bats.

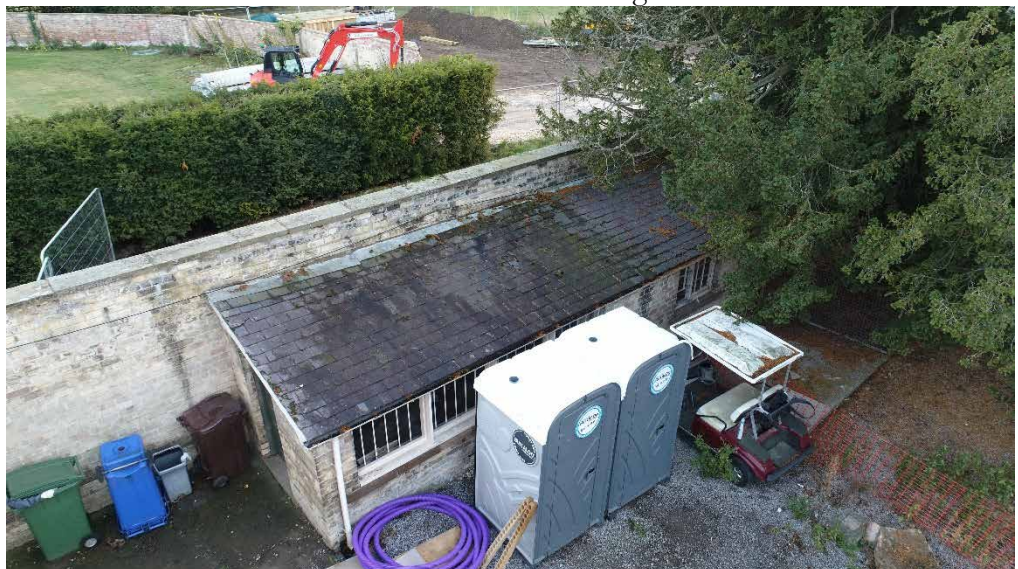
Plate 18 – outbuilding

- Gaps in missing mortar below gable slates.
- Gaps below lead flashing adjacent to chimneys.
- Lead flashing is tight fitting.
- There are no gaps in the external mortar suitable for roosting bats.
- The timber doors and timber window frames were tight fitting.
- Bat access into the building is provided by barred windows.
- No evidence of bats was observed.
- The outbuilding has been assessed as having a LOW SUITABILITY to support bats.

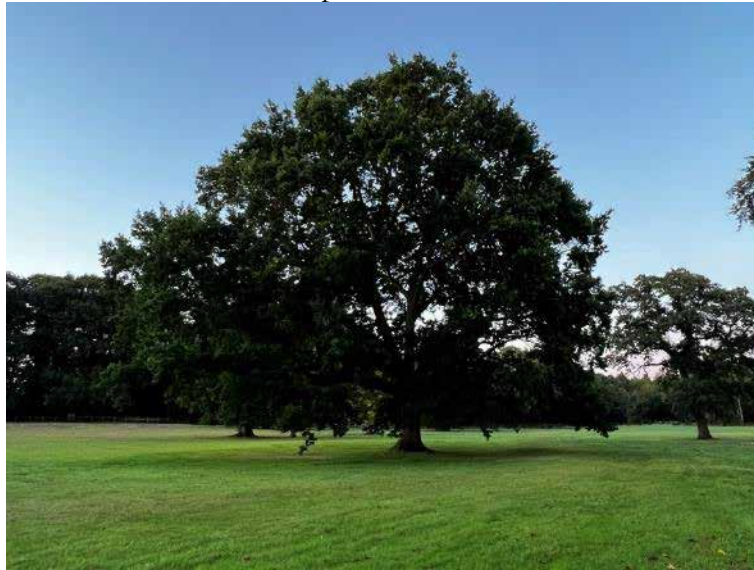
Plate 19 – pedunculate oak tree

- A single knot hole was observed in a lower branch. The cavity extends up to 20cm in the branch and the entrance hole has an approximate radius of 4cm
