Richard Jackson
Engineering Consultants

Brook Hall Farm, Church Road, Crowfield, Suffolk, IP6 9TG

Project no: 60742

Title: REVISION A - REMEDIATION METHOD STATEMENT
 Project: Brook Hall Farm, Church Road, Crowfield, Suffolk, IP6 9TG
 Client: Joy Cox
 Project No.: 60742

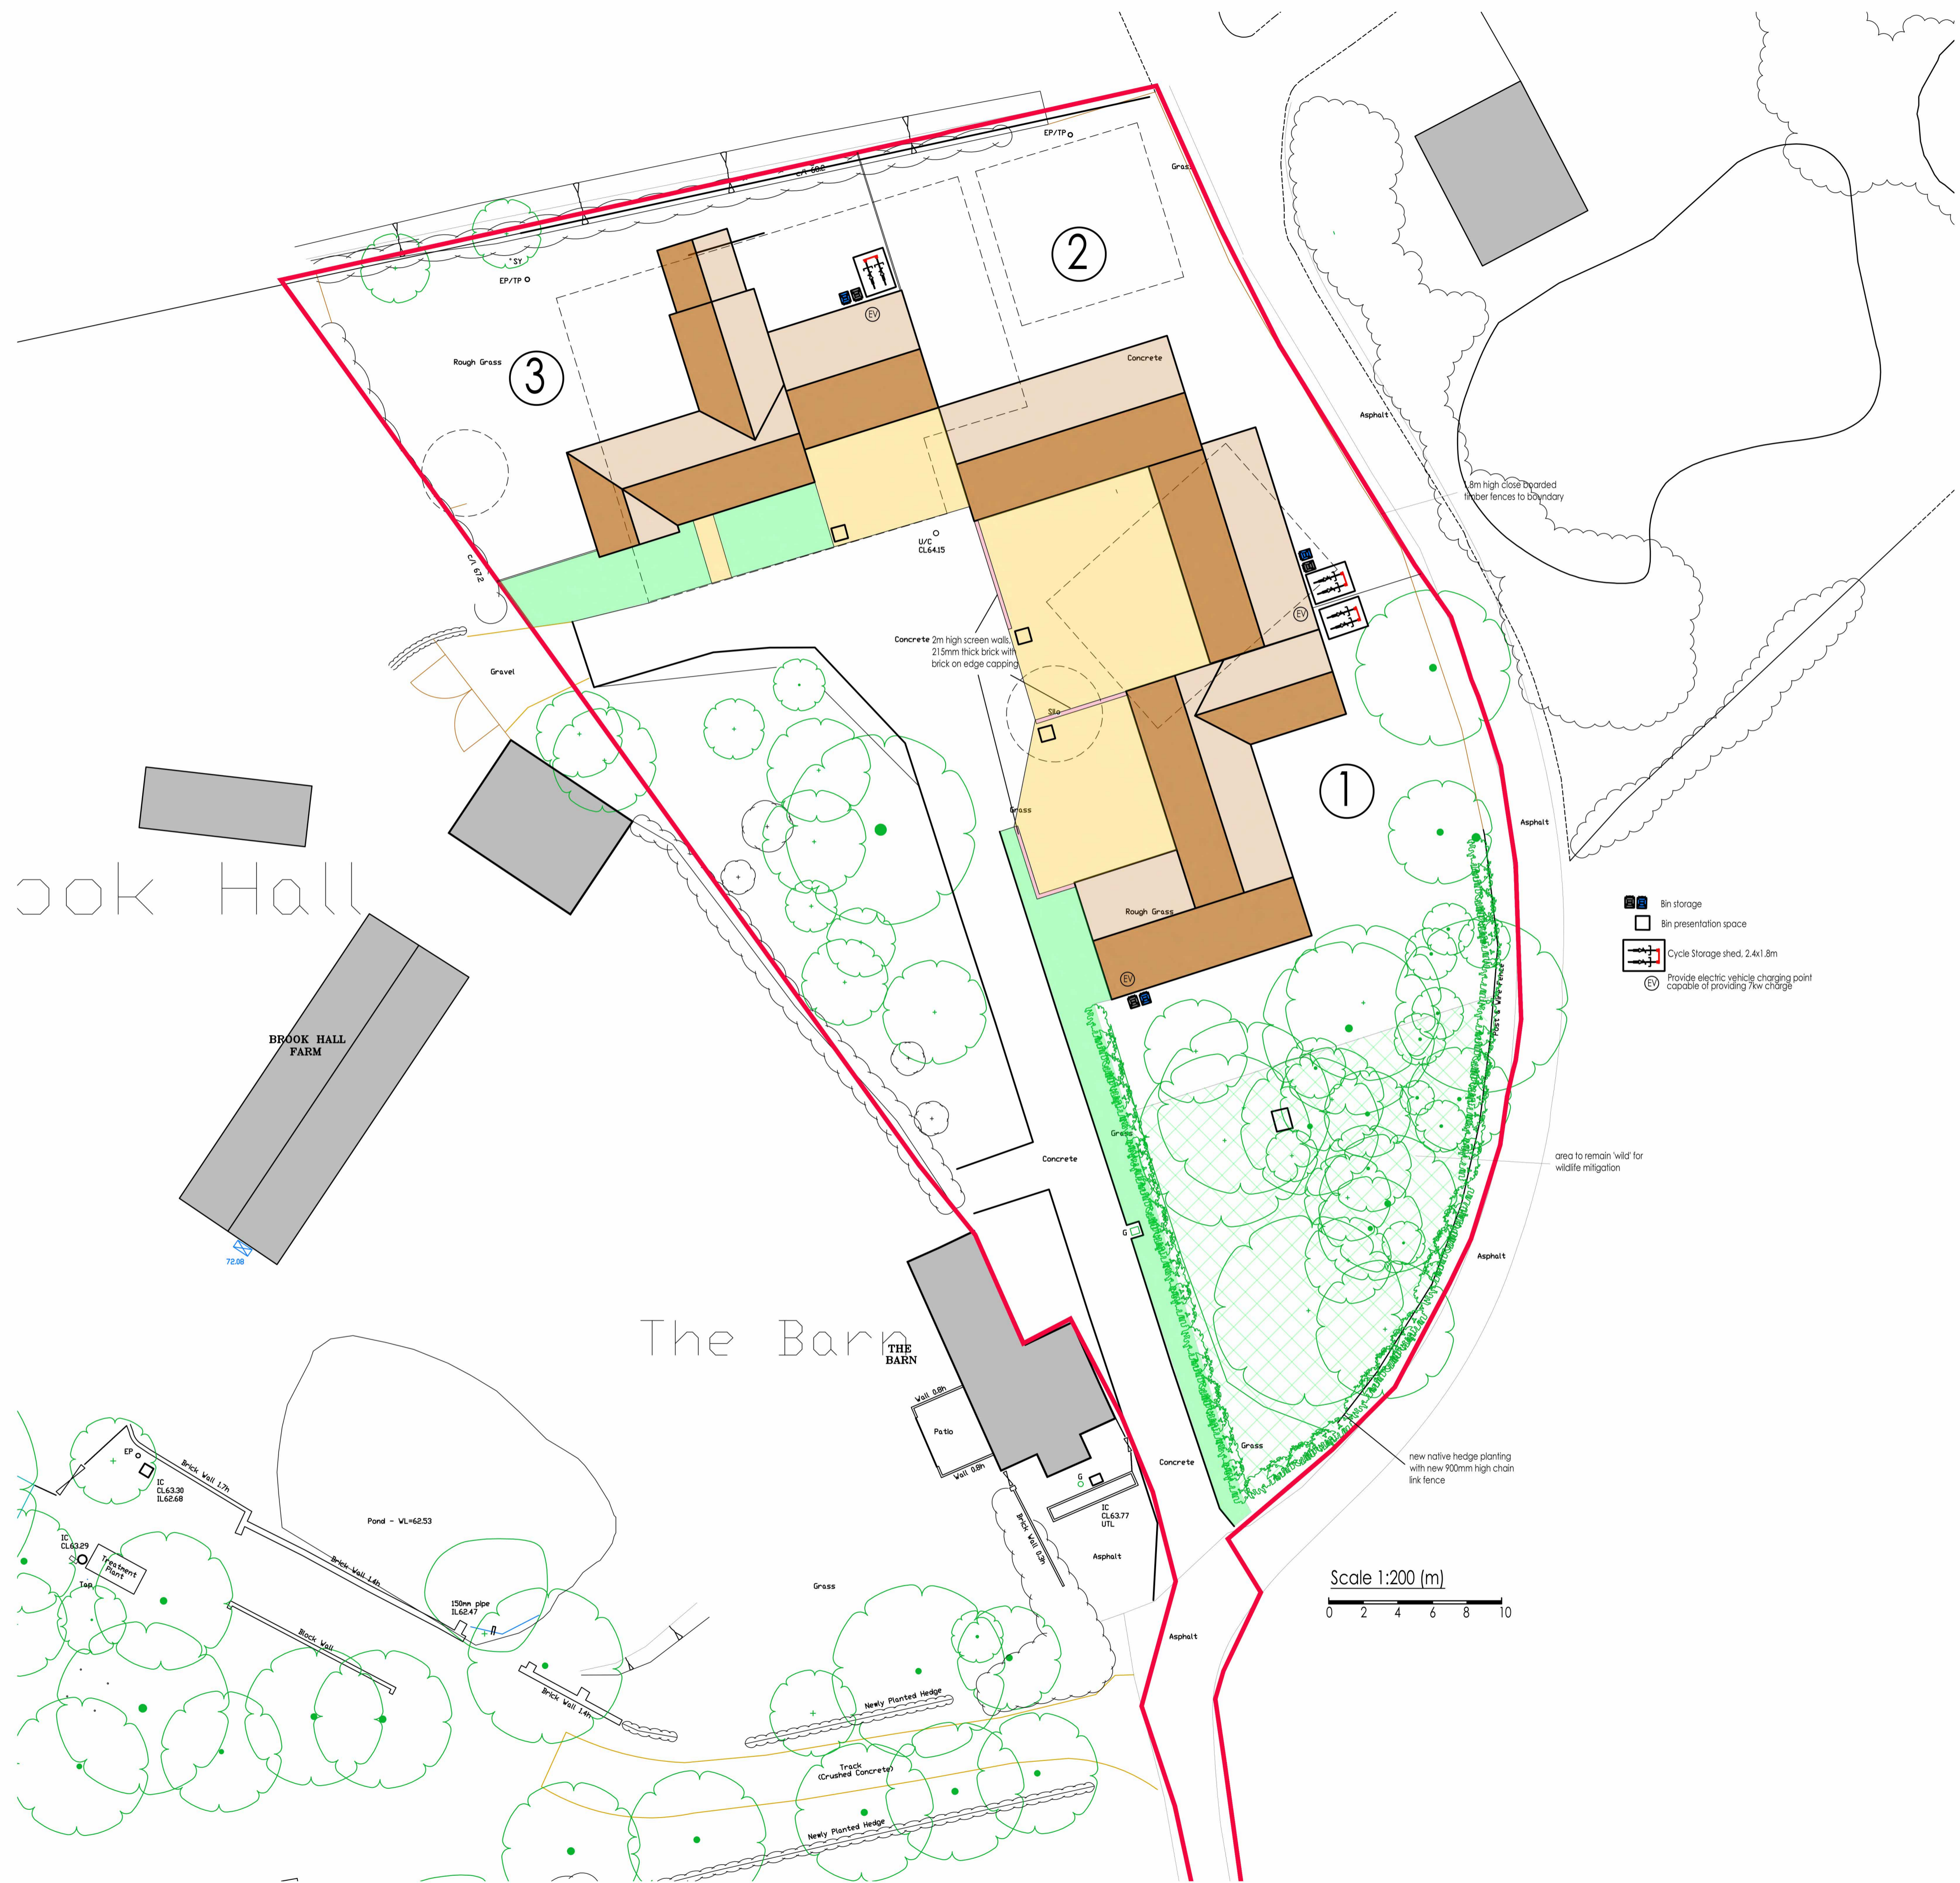
NOVEMBER 2023
DELINEATION
INVESTIGATION

REV	DATE	DESCRIPTION	DRAWN	CHECKD
A	NOV 23	Delineation Investigation Trial Pitting	AJS	CW

The works comprised the mechanical excavation of 7no. trial pits (TP01-TP07) to depths of between 1.00m below ground level (bgl) (TP03) and 1.50m bgl (TP01-TP02, TP04-TP07):

- TP01, TP02 & TP05 were advanced through the former infilled pond;
- TP03, TP04, TP06 & TP07 were not advanced through the infilled pond.

Exploratory hole location plans are presented as FIG02 Rev A & FIG03 Rev B in Appendix A, with respect to the existing and proposed site plans respectively.
