**BAT AND BARN OWL SURVEY OF AN OUTBUILDING AT
LAWNDOWNS, GRAMPOUND ROAD, TRURO, CORNWALL**

BAT AND BARN OWL SURVEY OF AN OUTBUILDING AT LAWNDOWNS, GRAMPOUND ROAD, TRURO, CORNWALL.

Report No: 22-150_BBO_Lawndowns

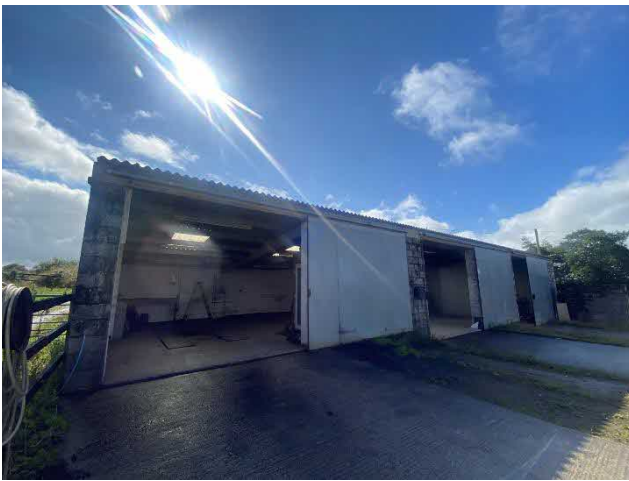
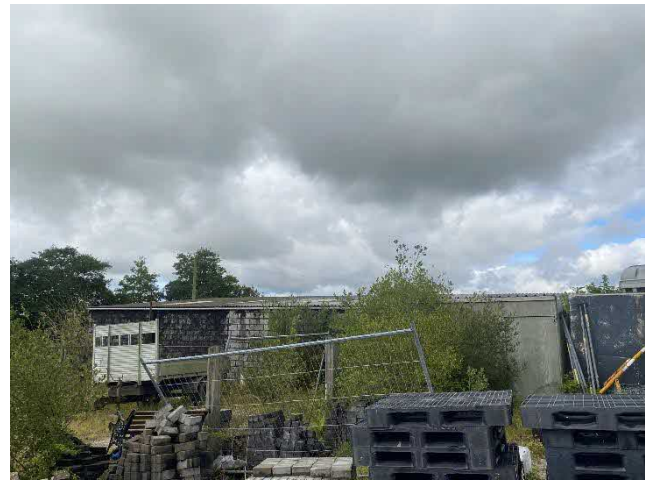
The building is a single storey long barn which has been divided into several rooms. The roof is flat, mono pitched and sloping to the east. The building is comprised of concrete blocks with a corrugated asbestos sheet roof. The entrances to the rooms are on the western side of the building and consist of large metal sliding doors. Along the wall tops expanding foams fills gaps between the corrugated roof rises and walls. The rear of the building does not contain any windows or doorways.

Figure 1: The externals of the building from the west (left) and east (right).

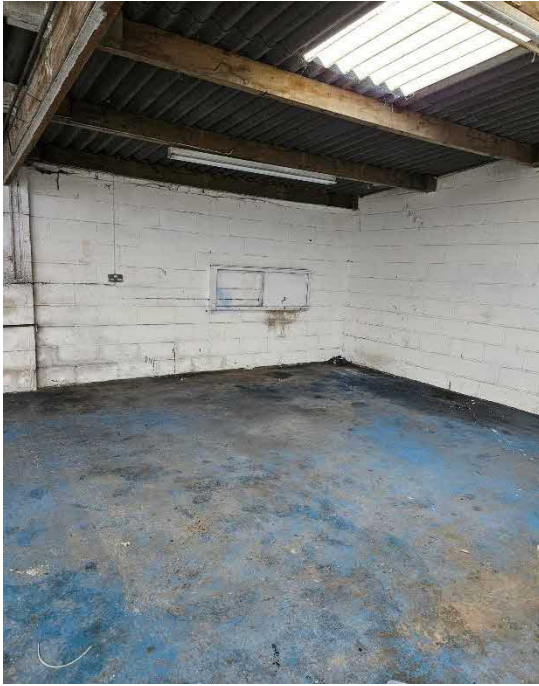
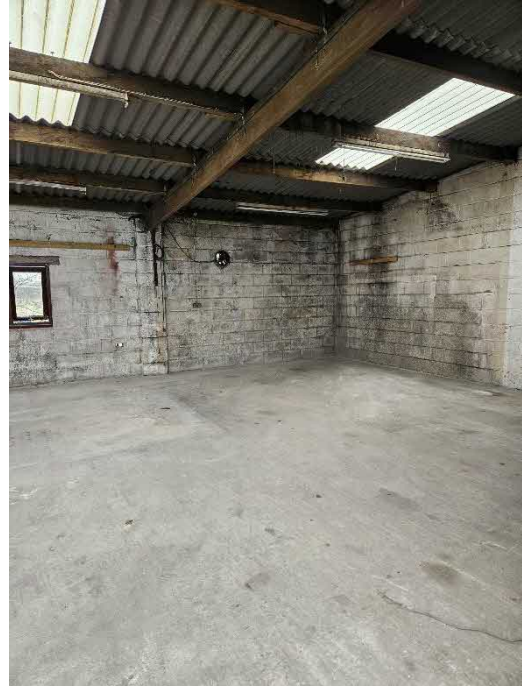
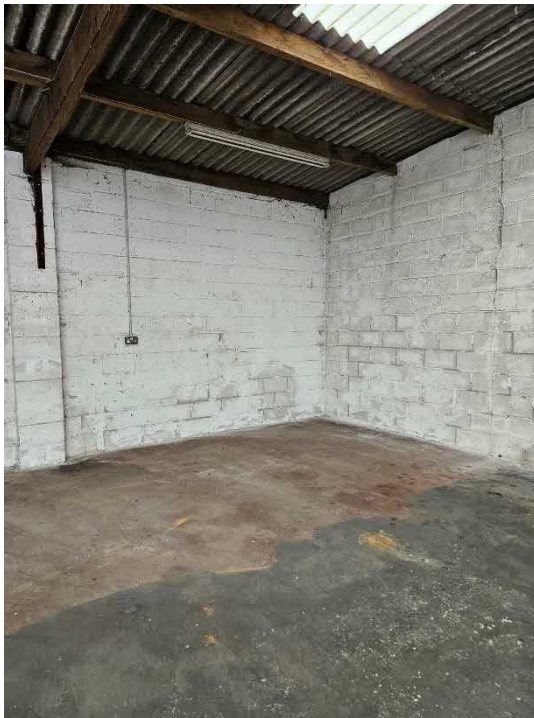
Room 1: The first room surveyed was a large open space which lies on the northern end of the building and was empty. There were several Perspex sheets within the roof and an area has been segregated on the western end of the room to create a small office like space.

Room 2: The central room of the three was mostly open with a small window within the rear wall. There are also several Perspex sheets in the roof of this room.

Room 3: This room is to the south of the building and is an open space which is clean and empty.

Figure 2: The internals of room 1 on the northern end of the building (top left), room 2 (top right) and room 3 to the south of the building (bottom left).

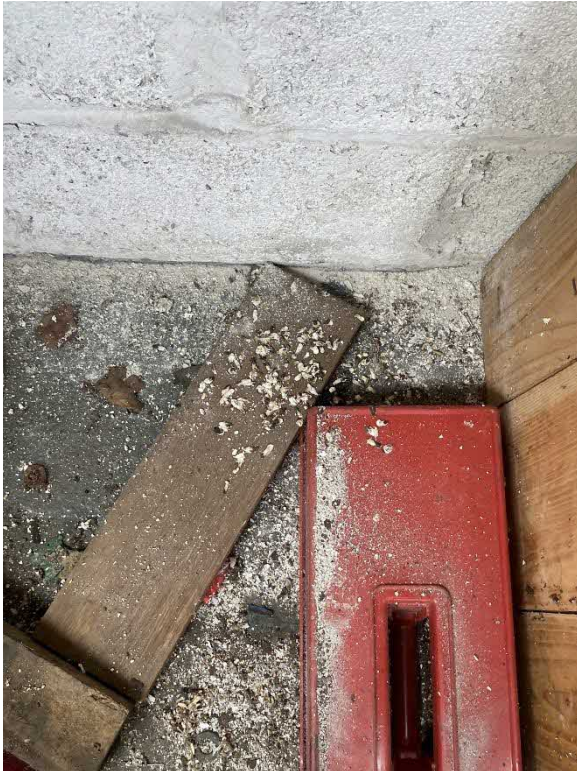
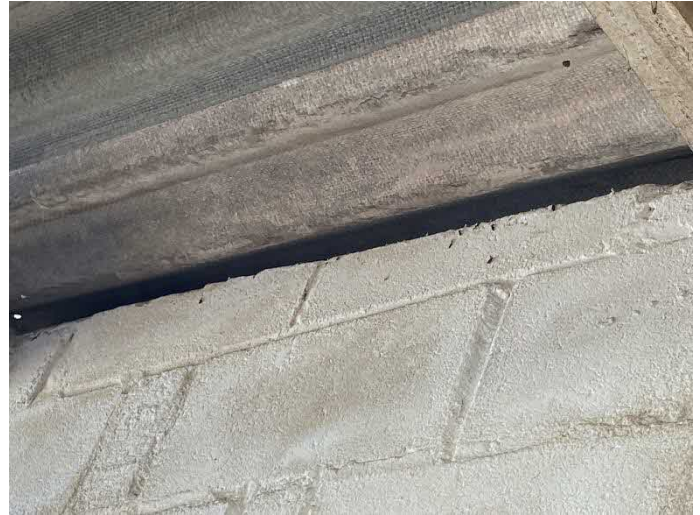
Evidence of roosting birds was discovered in the form of collections of droppings on the floors within all three rooms and along areas of the wall tops.

Figure 5: Evidence of roosting birds within the rooms on the floor and wall tops in the form of droppings.

No recommendations necessary however, evidence of roosting birds was discovered within the buildings and bird species could be incorporated into the proposed designs.

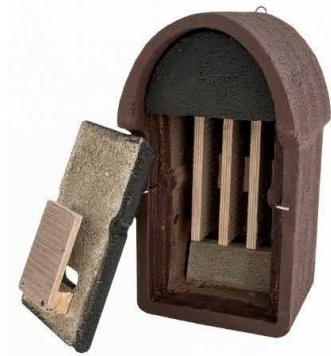
Vivaro Pro Woodstone bat box

Bat boxes can be included within the proposed plans. These can be mounted onto any south facing aspects, so they are warmed by the sun, or, alternatively, aspects that are facing particularly good features such as the estuary or nearby trees. We usually recommend Schwegler if available as these are the most durable. There are other durable products on the market but if alternatives are to be used then these should be appraised by a qualified bat

expert to ensure their suitability. Please note that durable bat boxes are heavy and will need secure fixings (see below for some examples).

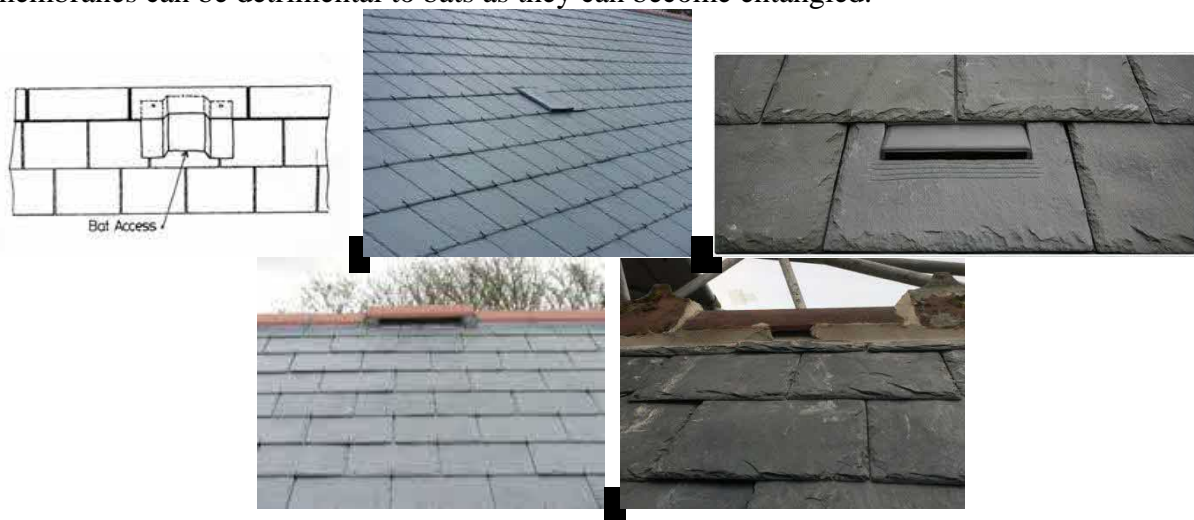
There is no obligation to do so, however, access into the roof void of the proposed building could be provided for bats to include bat slates and ridge tiles which are lifted slightly to allow access for bats. Bat slates can be built by making the appropriate shape with an off-cut of lead. The opening should be 15-25mm wide by at least 50mm long. This allows bats to land on the roof and crawl into the roof void. The bat slates or vents will be installed approximately one third of the way down the roof slope. A small hole (25mm x 50mm) would be cut into the roof lining/membrane under the bat slate to allow bats access.

Modified ridge tile bat accesses can be created by overlapping one ridge tile over its neighbours. The gap created should be 15-25mm wide by at least 50mm long. Mortar should be applied sparingly on nearby ridge tiles so that a tunnel-like void is created through several ridge tiles.

Figure 6: Examples of bat access slates (top) and modified ridge tiles (bottom).

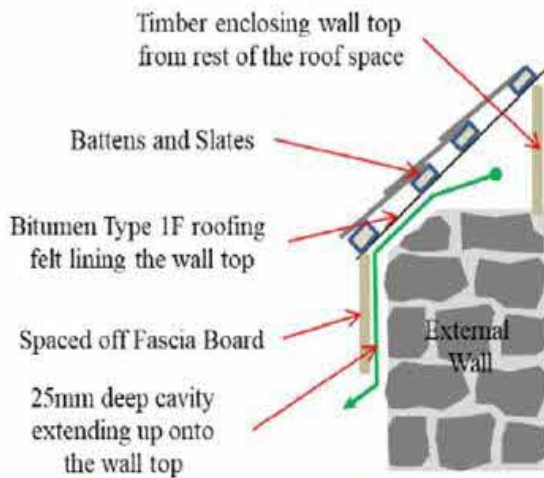
Access to the wall tops from outside of the proposed building can be created, ideally including a cavity around the outside of the building by spacing off any new the fascia boards by 25mm. This will allow bats to roost behind the fascias and access the wall tops above.

Figure 7: Diagram demonstrating access to wall tops for crevice dwelling species.

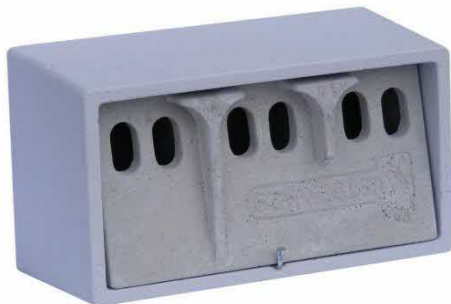
Figure 8: An example of a House Sparrow nesting terrace which can be integrated or bolted onto the outside of buildings (1SP Schwegler Sparrow Terrace).

New nesting areas could be incorporated into the proposed development of the building and as a temporary measure for after the proposed re-pointing works which will lead to a loss of this nesting habitat. This could include pre-fabricated Sparrow terraces integrated or added to the externals of the buildings.

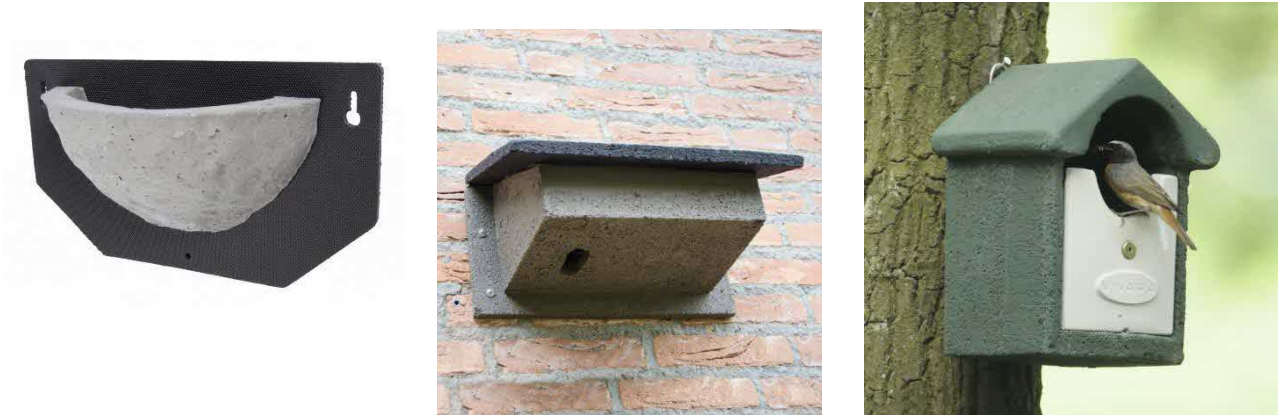
Figure 9: Example Swallow (left) and Swift (centre) boxes which can be erected onto the proposed building. Passerine nest boxes can also be provided onto nearby trees or onto the buildings (right, Vivara WoodStone® Barcelona Open Nest Box).

Additionally, if the owners were interested, the site could be enhanced for birds by providing either bolt on or integrated pre-fabricated nest boxes on the buildings or placed on surrounding trees or within scrub to benefit additional species including Robin, Dunnock, Wren, Blue Tits and Great Tits. Deep over-hanging eaves would enhance the site for Swallow and House Martins or could include providing an open structure such as a shed or woodstore. Pre-fabricated nest cups are also available (right - Eco Swallow Nest - NHBS).

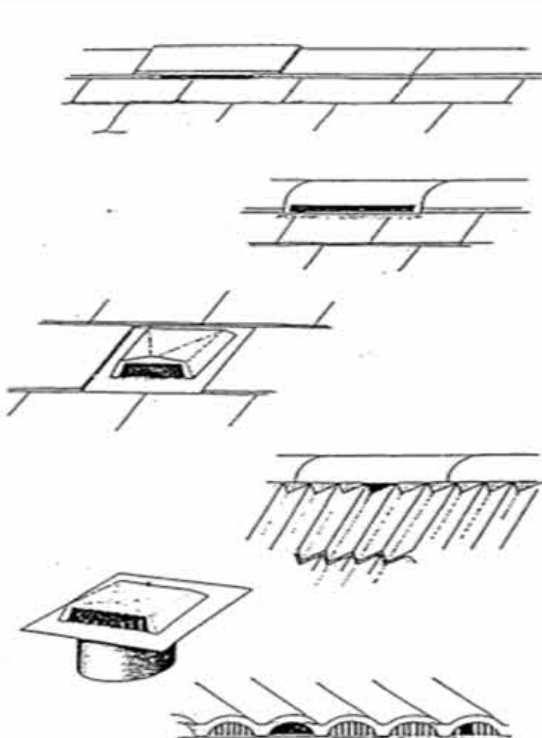
Walling bricks for creating bat access points. A standard brick is shown top left

Ridge ventilators can be adapted as bats access points. It may be necessary to remove internal plastic moulding.
